A R K A N S A S  
Department of Environmental Quality

## NPDES Compliance Inspection Report

Name and Location of Facility Inspected ( <i>For industrial users discharging to POTW, also include POTW name and NPDES permit number</i> ) <b>City of Van Buren POTW-South Plant</b> <b>1401 Port Road</b> <b>Van Buren, AR 72956</b>	Entry Time/Date <b>1530/ September 4, 2008</b>	Permit Effective Date <b>December 1, 2003</b>
Name(s) of On-Site Representative(s)/Title(s)/Phone and Fax Number(s) <b>Steve Dufresne / Utilities Supervisor / 479-474-5067 &amp; Darrel Manus/ Utilities Supervisor / 479-474-5067</b>	Other Facility Data	
Name, Address of Responsible Official/Title/Phone and Fax Number <b>Gary Smith/ Utilities Director / 479-474-5067 / fax / 479-471-8969</b> <b>P.O. Drawer 1269</b> <b>Van Buren, AR 72956</b>	Contacted Yes <input type="checkbox"/> No <input checked="" type="checkbox"/>

**Water Division NPDES Photographic Evidence Sheet**

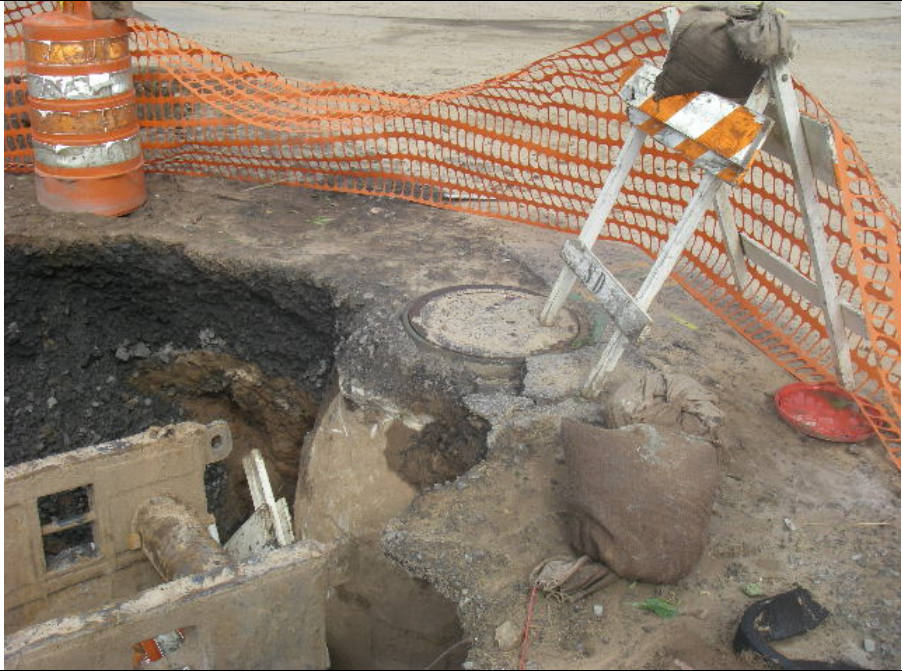
**Photo #** 1    **Of** 4      **Date:** 09-04-08    **Time:** 1415

There was evidence which indicated that an overflow of raw sewage had occurred at a manhole located up gradient of 302 Scott Street in Van Buren. City personnel, who I met with at the site, confirmed that the overflow had occurred. Apparent problems associated with a pump malfunction attributed to the overflow.

**Description:** Location where overflow occurred because of pump failure.

A Sanitary sewer overflow occurred at 302 Scott Street on September 4, 2008. The overflow was caused by a combination of line construction and pump malfunction. The occurrence was reported to the ADEQ within the 24 hour time period as required by the NPDES Permit. (Confirmation attached) We attributed the overflow to pump failure, the pump station was out of service for approximately four (4) hours while the pump motor was being repaired, and the sewer line replacement project that washed debris into the sewer line during a heavy rainfall.

The sewer line replacement project up gradient of 302 Scott Street has been substantially completed; a final inspection is scheduled for Friday October 24, 2008. Construction of the 4<sup>th</sup> Street Pump Station down gradient of the area is tentatively scheduled for completion in June of 2009, (NPDES Permit No. AR0021482C) however; with construction proceeding ahead of schedule the pump station may be in operation in March of 2009.

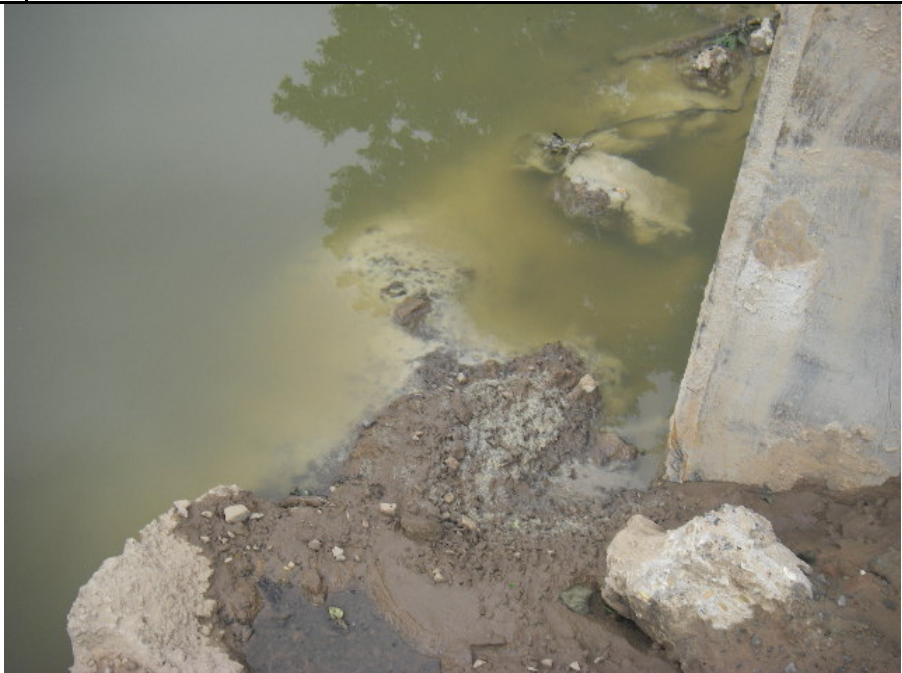
**Photo #** 2    **Of** 4      **Date:** 09-04-08    **Time:** 1415

**Description:** Ditch where overflow of sewage occurred.

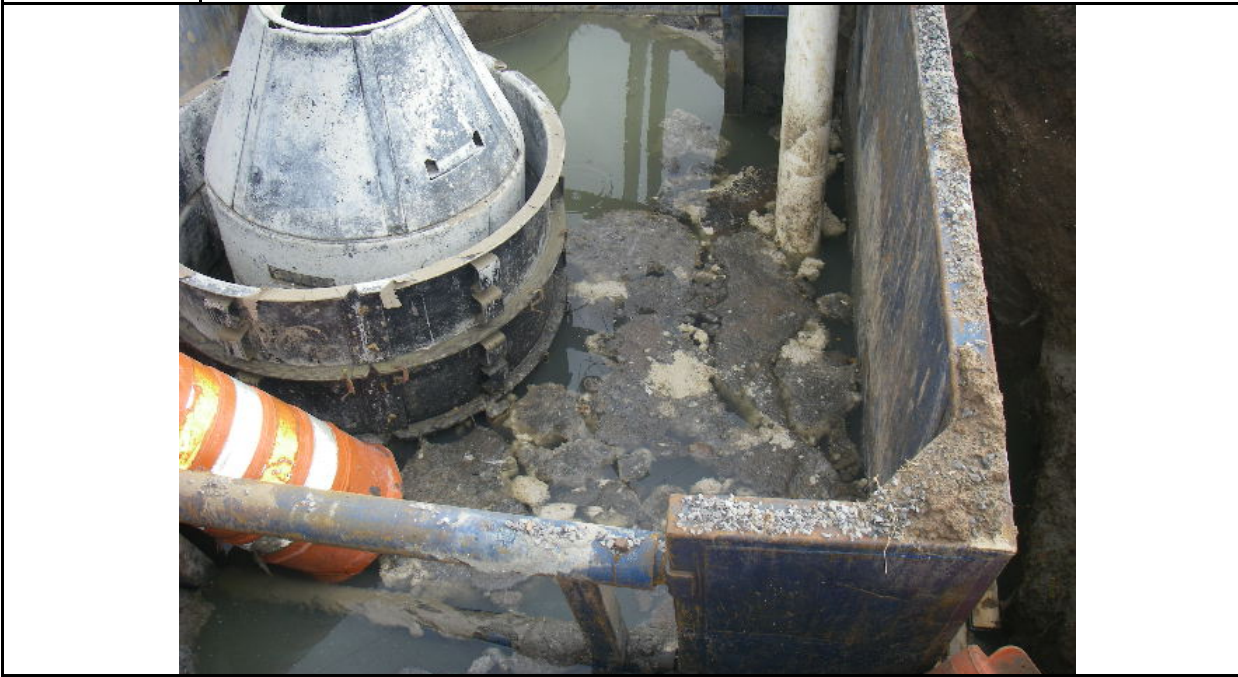
**Photo #** 3 **Of** 4 **Date:** 09-04-08 **Time:** 1436

**Description:** On-going construction at a manhole and evidence of sewage.

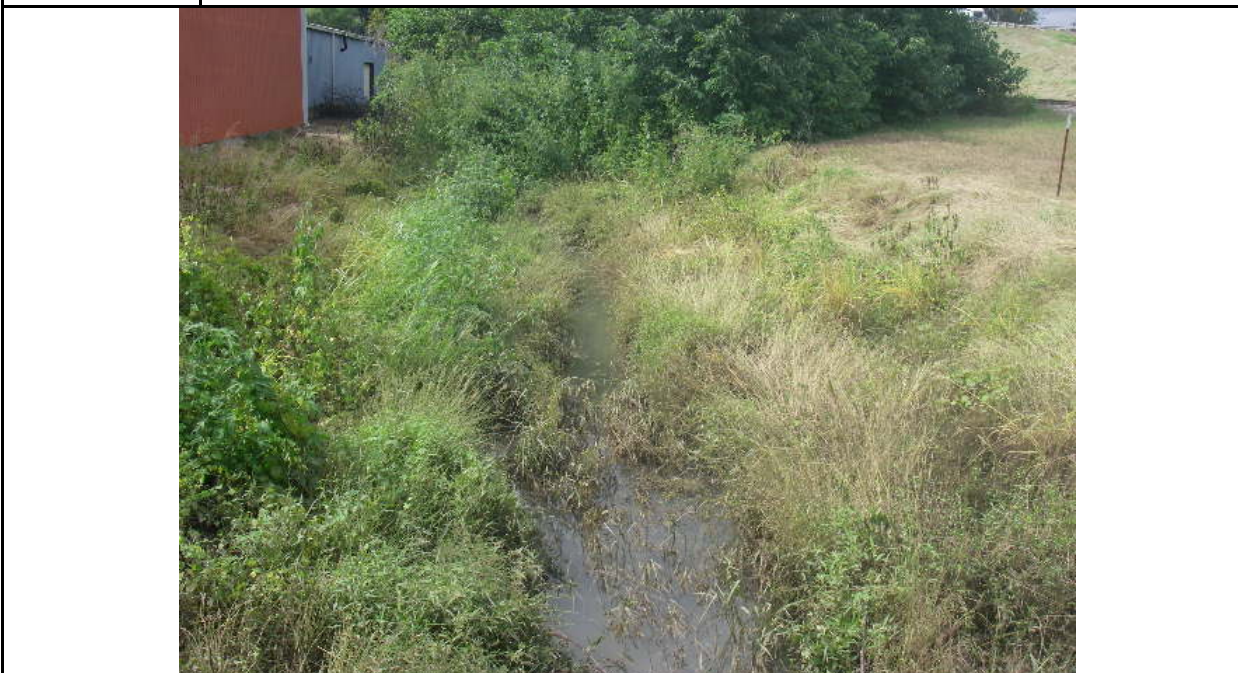
**Photo #** 4 **Of** 4 **Date:** 09-04-08 **Time:** 1402

**Description:** Ditch that runs along complainant's business where sewage had flowed.
