ARKANSAS  
Department of Environmental Quality

March 9, 2009

On March 3, 2009, I performed a recon inspection on a sanitary sewer overflow of the collection system at 302 Scott Street in response to complaint. This inspection was performed in accordance with the provisions of the Federal Clean Water Act, the Arkansas Water and Air Pollution Control Act, and the regulations promulgated thereunder. The inspection revealed the following violation:

## NPDES Compliance Inspection Report

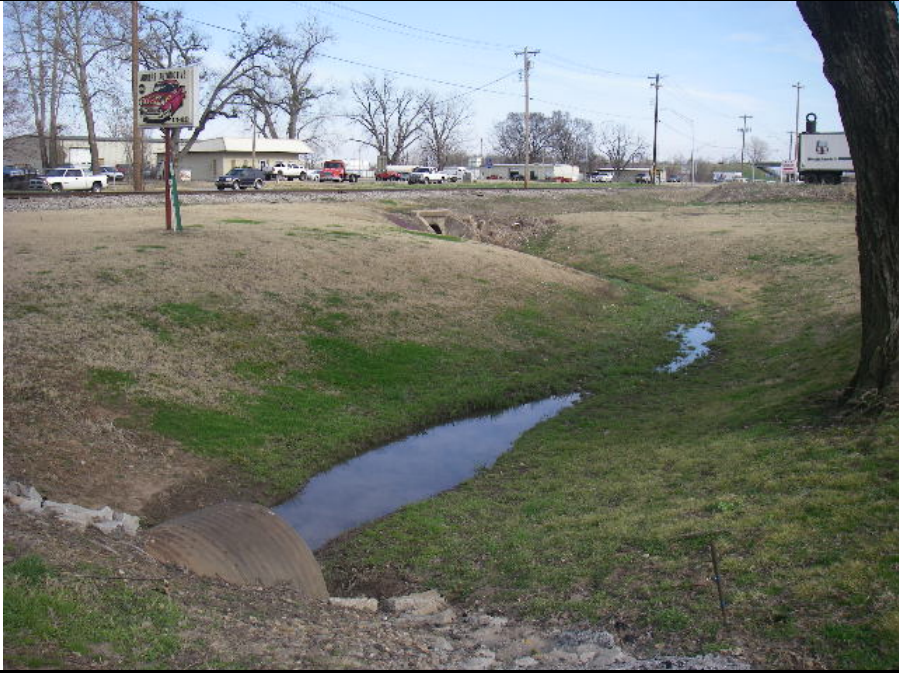
**Photo #** 1    **Of** 4      **Date:** 03-02-09    **Time:** 1516

**Description:** Ditch which had been impacted by the sewer overflow on March 1, 2009

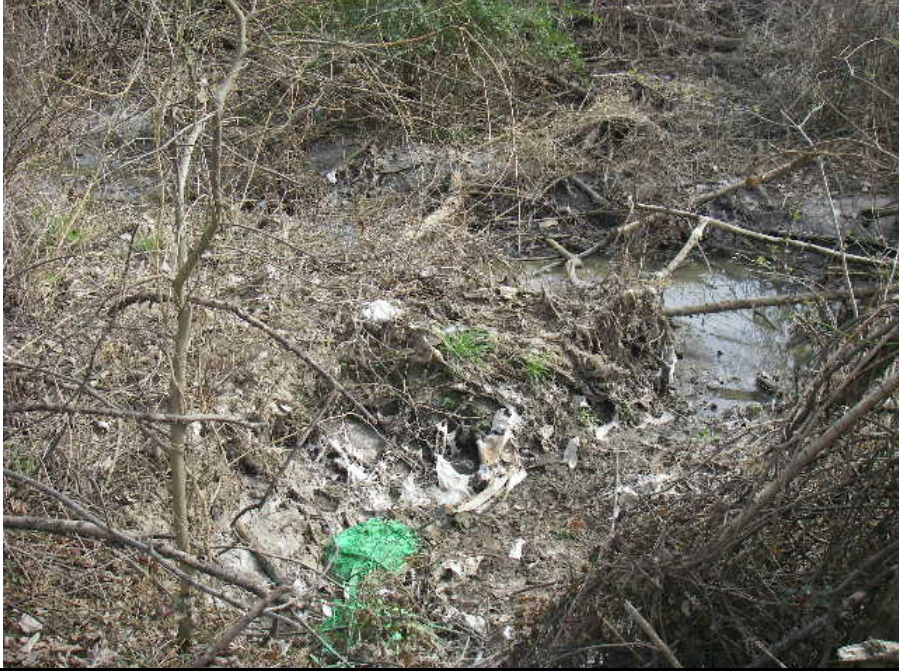
**Photo #** 2    **Of** 4      **Date:** 03-03-09    **Time:** 1504

**Description:** Evidence of sewage and waste water debris in ditch. Location is up gradient from 302 Scott.

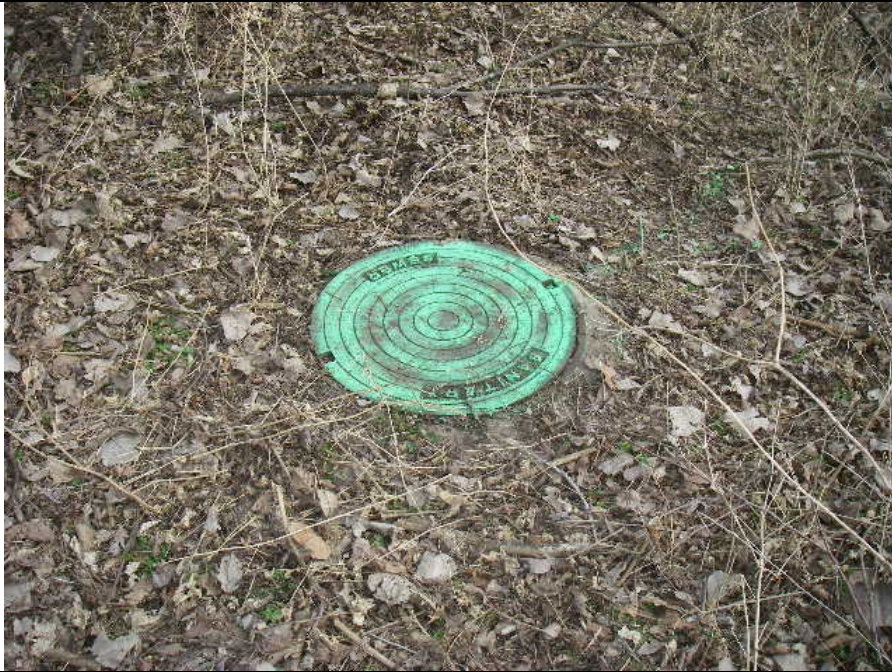
**Photo #** 3 **Of** 4 **Date:** 03-03-09 **Time:** 1504

**There was evidence to confirm that an overflow of raw sewage had occurred prior to my inspection date. I met with Mr. Steve Dufresne, with the City of Van Buren Utilities Department, who confirmed that the overflow occurred on March 1, 2009. Mr. Dufresne provided me a copy of the sanitary sewer overflow report which was submitted to the ADEQ Enforcement Branch. He also advised that an apparent problem with the transducer at the new Fourth Street pump station was the cause for this overflow incident.**

**Description:** Manhole where overflow incident occurred.

Violation 2. On March 13, 2009, the overflow relief pipe in the referenced manhole was sealed with concrete from the inside and outside of the manhole.

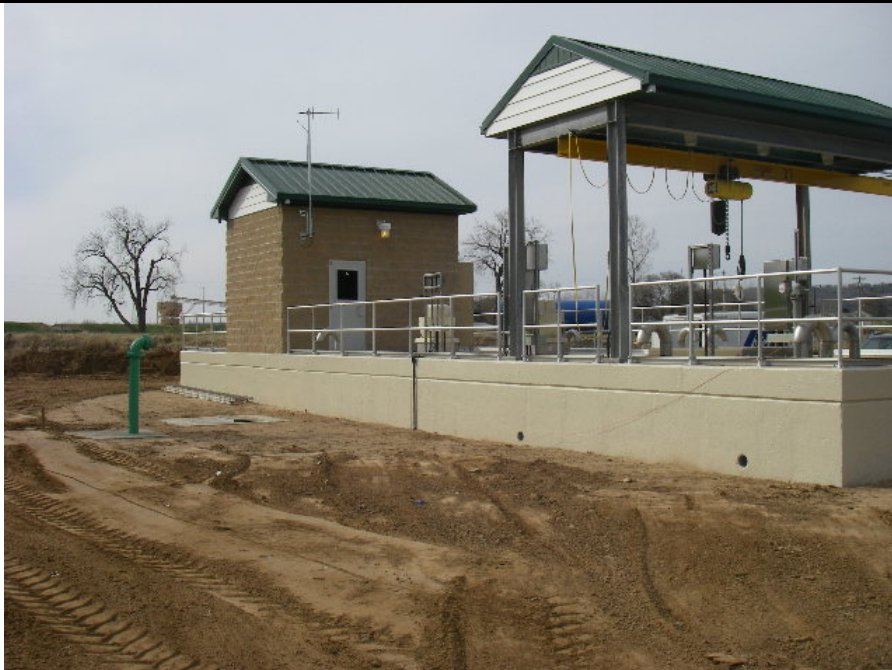
**Photo #** 4 **Of** 4 **Date:** 03-03-09 **Time:** 1452

**Description:** Newly constructed Fourth Street pump station located south of 302 Scott Street.

Violation 1. The Sanitary sewer overflows which occurred up gradient of 302 Scott Street on March 1<sup>st</sup> and March 6<sup>th</sup> of 2009 were both caused by a transducer malfunction in the new 4<sup>th</sup> Street Pump Station. The pump station was designed with a pressure transducer in a stilling well, which sends a wet well level signal to the pump controls. It was discovered that the transducer orifices were stopping up with grease, and sending an incorrect signal to the pump control unit; therefore the pumps were not starting and the high level alarm was not functioning. (The control unit was receiving a signal showing only six feet of water in the wet well)

On Saturday March 7, 2009, the transducer was removed from the stilling well and placed into the middle of the wet well to prevent grease buildup, and is being cleaned periodically, as of today; we have not had any further problems.

After discussion with Hawkins – Weir Engineers, Inc., it was determined that we should; replace the transducer with a model which has a larger sensor surface, not place the transducer back into the stilling well set up, and install a float sensor as a back up to the transducer. A construction change order has been issued; the parts have all been received and are scheduled to be installed on Monday April 6, 2009 under the current contract with Van Horn Construction.
