ARKANSAS  
Department of Environmental Quality

March 12 2009

NPDES Permit No.: AR0021482

## NPDES Compliance Inspection Report

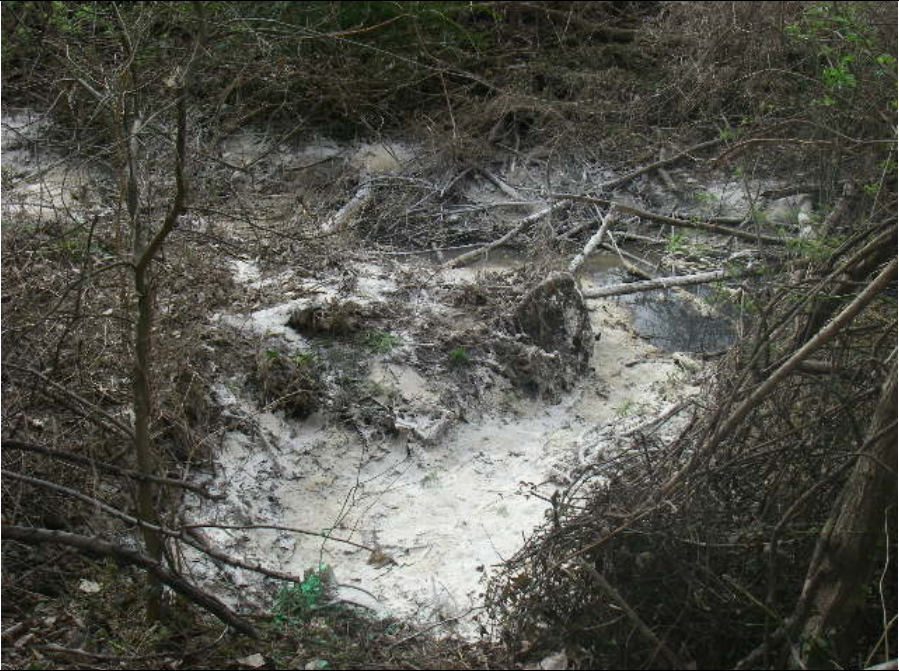
**Photo #** 1    **Of** 4      **Date:** 03-10-09    **Time:** 0949

- 1. There was evidence to confirm that an overflow of raw sewage had occurred prior to my inspection date. Mr. Steve Dufresne, with the City of Van Buren Utilities Department, reported that the overflow occurred on March 6, 2009. An on-going problem with the transducer was again determined to be the cause of the pump failure at the Fourth Street pump station. Mr. Dufresne provided me a copy of the sanitary sewer overflow report which was submitted to the ADEQ Enforcement Branch.**

**Description:** Ditch which had been impacted by the sewer overflow with evidence of lime.

On Saturday March 7, 2009, the transducer was removed from the stilling well and placed into the middle of the wet well to prevent grease buildup, and is being cleaned periodically, as of today; we have not had any further problems.

After discussion with Hawkins – Weir Engineers, Inc., it was determined that we should; replace the transducer with a model which has a larger sensor surface, not place the transducer back into the stilling well set up, and install a float sensor as a back up to the transducer. A construction change order has been issued; the parts have all been received and are scheduled to be installed on Monday April 6, 2009 under the current contract with Van Horn Construction.

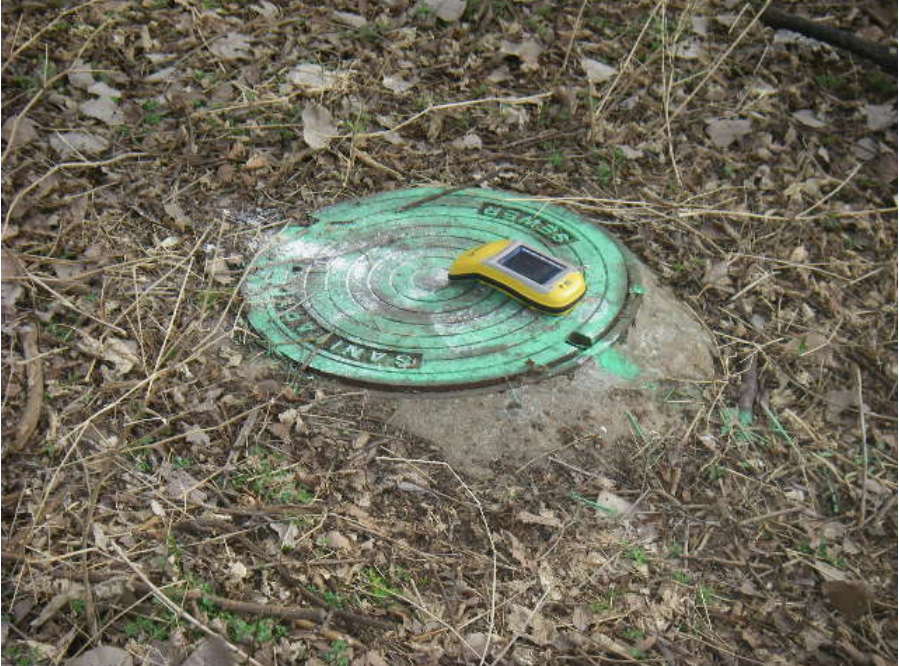
**Photo #** 2    **Of** 4      **Date:** 03-10-09    **Time:** 0949

**Description:** Manhole located approximately 25-35 feet from ditch.

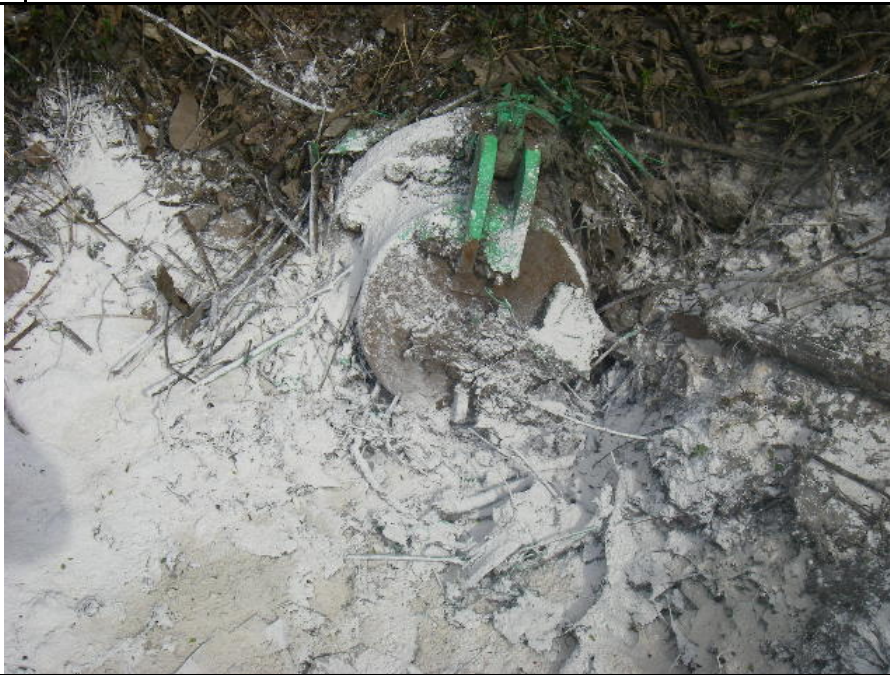
**Photo #** 3 **Of** 4 **Date:** 03-10-09 **Time:** 0958

- 2. During this inspection, I observed a sewer relief overflow pipe in the side bank of the ditch. This overflow pipe appeared to be cast iron and was approximately eight inches in diameter. All discharges would flow directly into the ditch. This pipe allows for the City of Van Buren to discharge untreated effluent to the waters of the State which is a violation of the permit. This sewer relief overflow pipe and any others located throughout the City must be removed.**

On March 10, 2009, I investigated the location to determine if clean up efforts had taken place. There was evidence of lime that had been applied in the ditch. During the inspection, I observed a sewer relief overflow pipe in the ditch. It was located approximately 25-30 feet from the manhole. I contacted Steve Dufresne and discussed the overflow pipe. I advised that it was considered to be an intentional discharge of untreated effluent and was in violation of the permit. I also advised that the pipe and other sewer relief pipes should be capped or removed.

**Description:** Sewer relief overflow pipe located in ditch directly below the manhole.

Violation 2. On March 13, 2009, the overflow relief pipe in the referenced manhole was sealed with concrete from the inside and outside of the manhole.

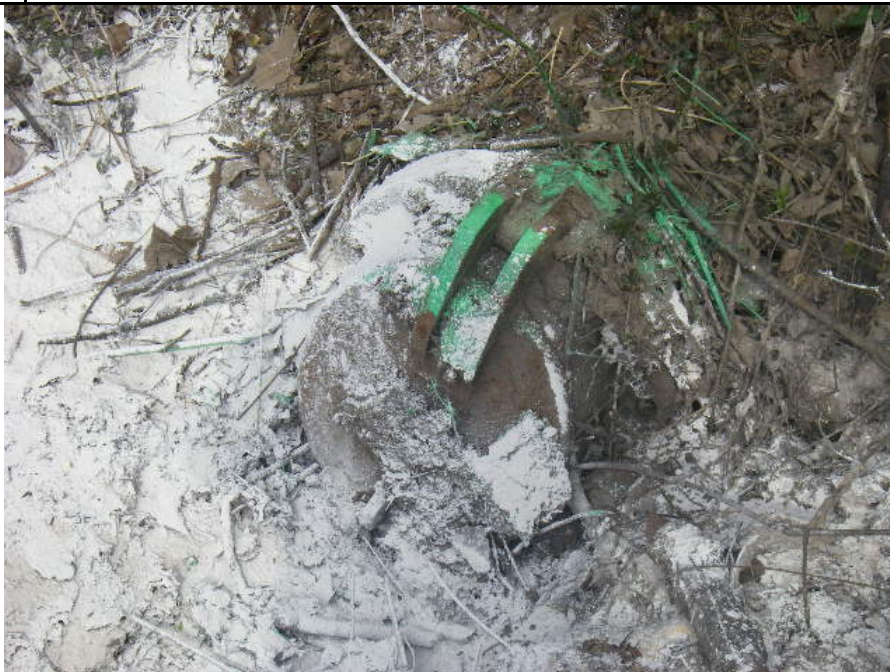
**Photo #** 4 **Of** 4 **Date:** 03-10-09 **Time:** 0958

**Description:** Sewer relief overflow pipe located in ditch.
