RE: Sanitary Sewer Overflow Inspection at the South Plant

AFIN: 17-00062                      NPDES Permit No.: AR0021482

**Water Division NPDES Photographic Evidence Sheet**

**Location:** City of Van Buren POTW (Fourth Street pump station)

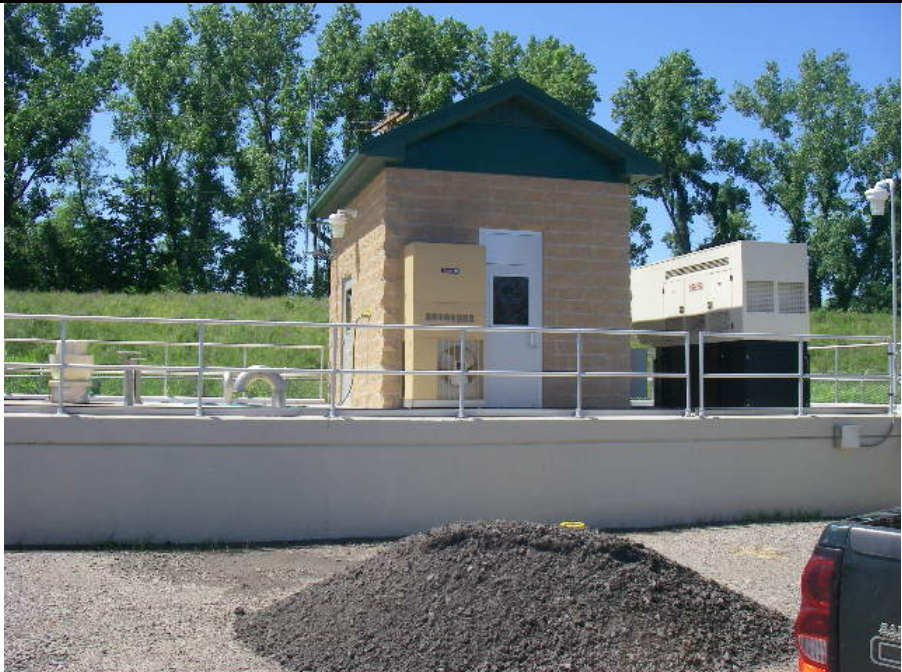
**Photo #** 1    **Of** 2      **Date:** 05-19-09    **Time:** 1022

**Description:** View of pump station and generator

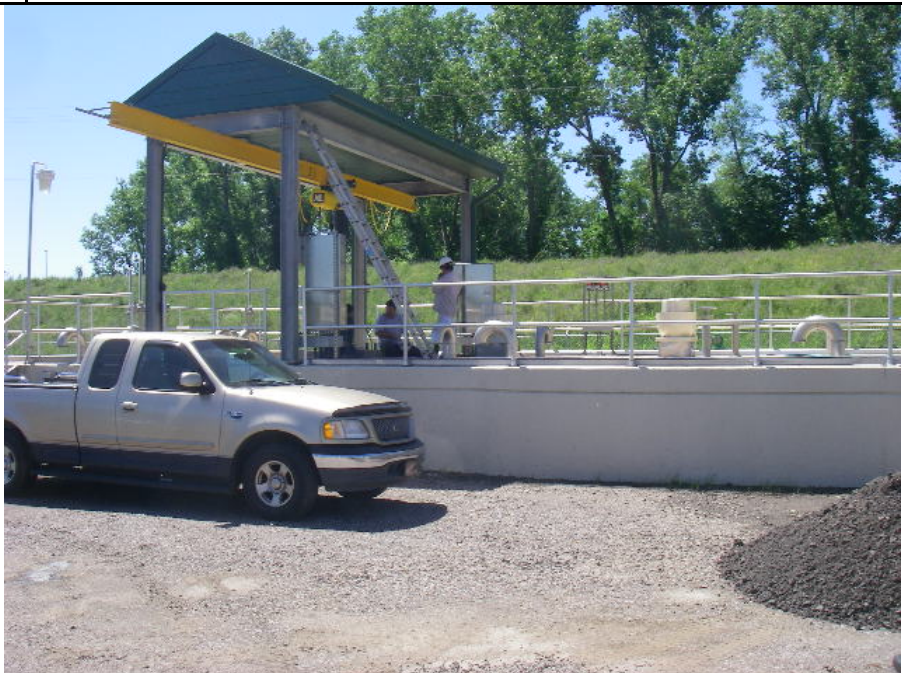
**Photo #** 2    **Of** 2      **Date:** 05-19-09    **Time:** 1022

**Description:** View of pump station.
