RE: Sanitary Sewer Overflow Complaint Investigation

NPDES Compliance Inspection Report

Sewer Main Leak – Spring Creek – SSO Event # 21628

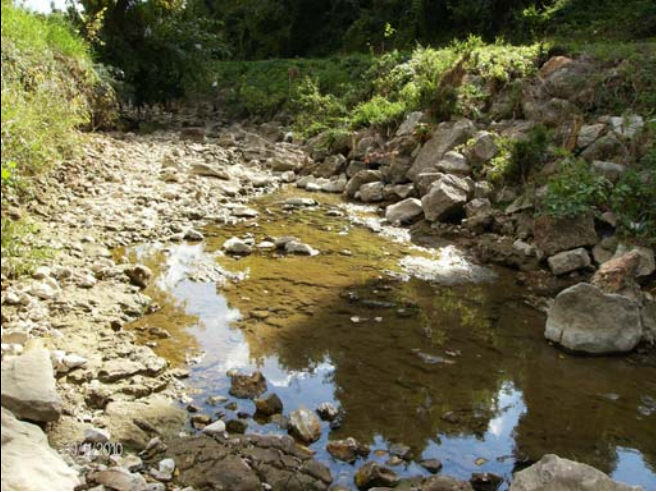
Location:		SSO Event # 21628-Spring Creek south of Sanders Avenue bridge						
Photographer:		Alison West			Witness:		NA	
Photo #	1	Of	12		Date:	10-11-2010	Time:	3:23 p.m.
Description:		HPIM1268. Upstream of sewage discharging into Spring Creek.

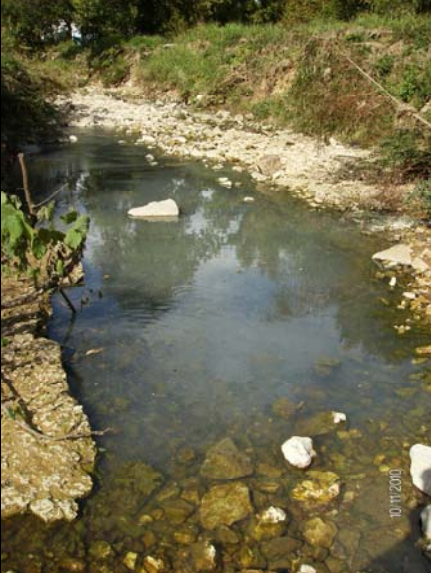
Photographer:		Alison West			Witness:		NA	
Photo #	2	Of	12		Date:	10-11-2010	Time:	3:24 p.m.
Description:		HPIM1269. Looking downstream, clear water mixing with sewage.

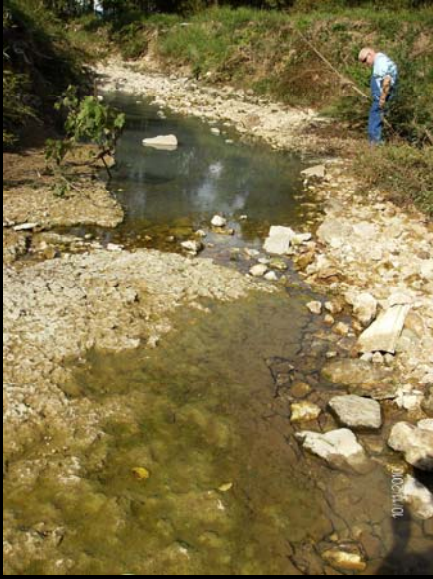
Location:		SSO Event # 21628-Spring Creek south of Sanders Avenue bridge						
Photographer:		Alison West			Witness:		NA	
Photo #	3	Of	12		Date:	10-11-2010	Time: 3:24 p.m.	
Description:		HPIM1270. Looking downstream, another angle of clear water mixing with sewage.

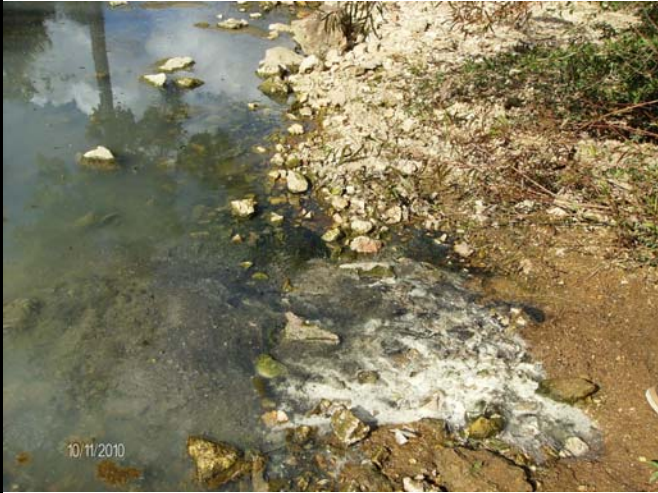
Photographer:		Alison West			Witness:		NA	
Photo #	4	Of	12		Date:	10-11-2010	Time: 3:24 p.m.	
Description:		HPIM1271. Raw sewage entering Spring Creek.

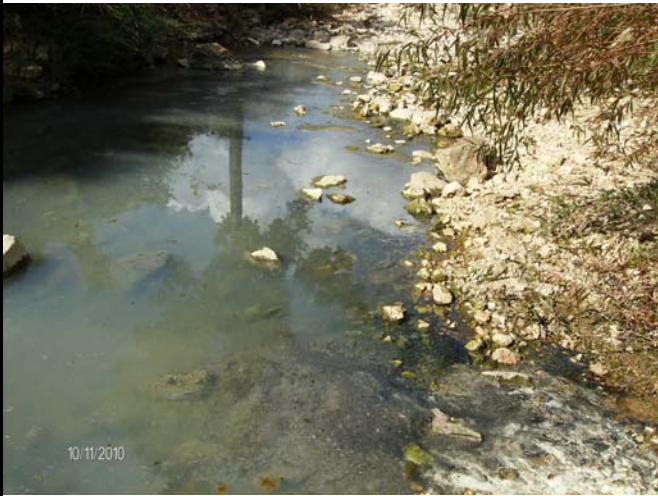
Location:		SSO Event # 21628-Spring Creek south of Sanders Avenue bridge					
Photographer:		Alison West			Witness:		NA
Photo #	5	Of	12		Date:	10-11-2010	Time: 3:25 p.m.
Description:		HPIM1272. Raw sewage entering into Spring Creek. Solids observed. Same area as seen in HPIM1271.

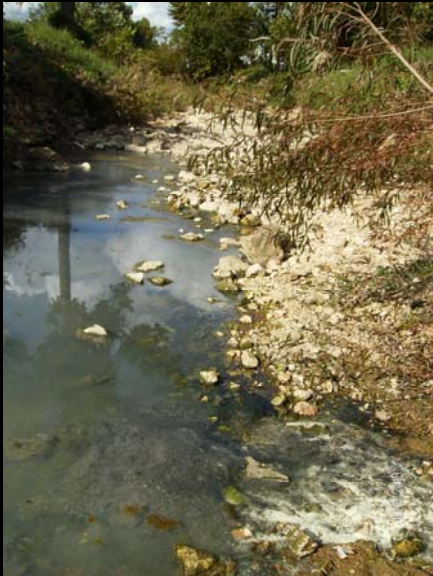
Photographer:		Alison West			Witness:		NA
Photo #	6	Of	12		Date:	10-11-2010	Time: 3:25 p.m.
Description:		HPIM1273. Raw sewage entering into Spring Creek. Same area as seen in HPIM1271.

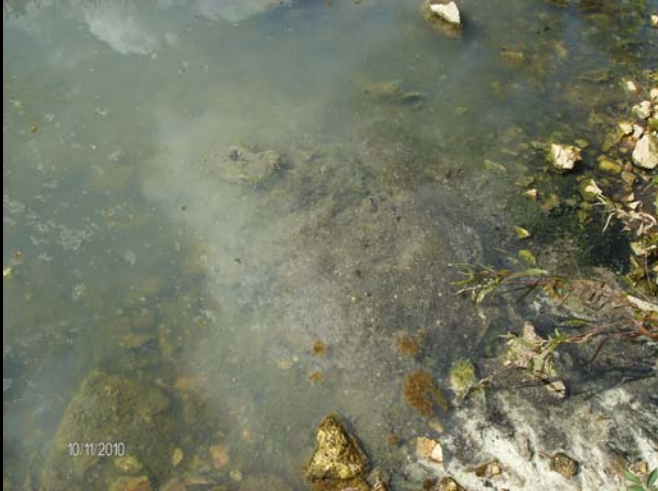
Location:		SSO Event # 21628-Spring Creek south of Sanders Avenue bridge					
Photographer:		Alison West			Witness:		NA
Photo #	7	Of	12		Date:	10-11-2010	Time: 3:25 p.m.
Description:		HPIM1274. Close-up of solids.

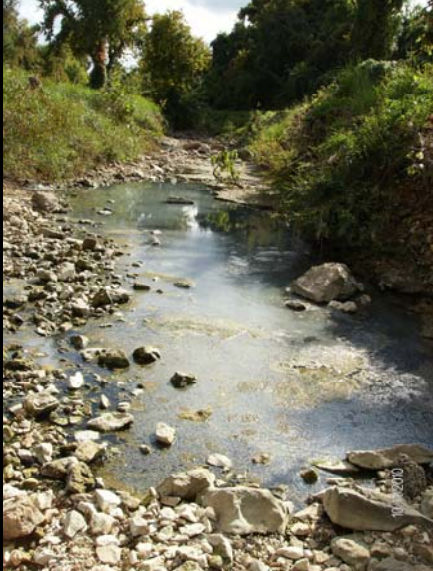
Photographer:		Alison West			Witness:		NA
Photo #	8	Of	12		Date:	10-11-2010	Time: 3:26 p.m.
Description:		HPIM1276. Sewage in Spring Creek downstream from HPIM1271.

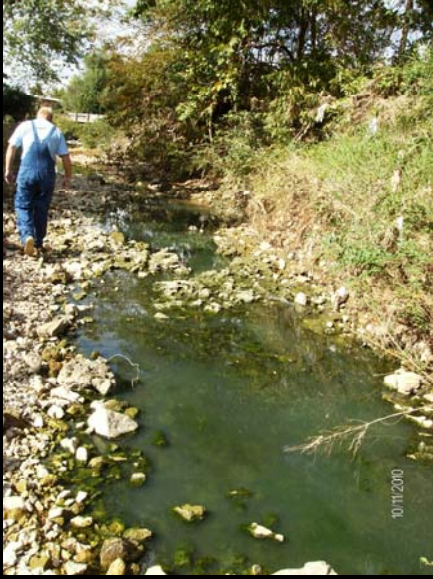
Location:		SSO Event # 21628-Spring Creek south of Sanders Avenue bridge					
Photographer:		Alison West			Witness:		NA
Photo #	9	Of	12		Date:	10-11-2010	Time: 3:27 p.m.
Description:		HPIM1279. Sewage in Spring Creek.

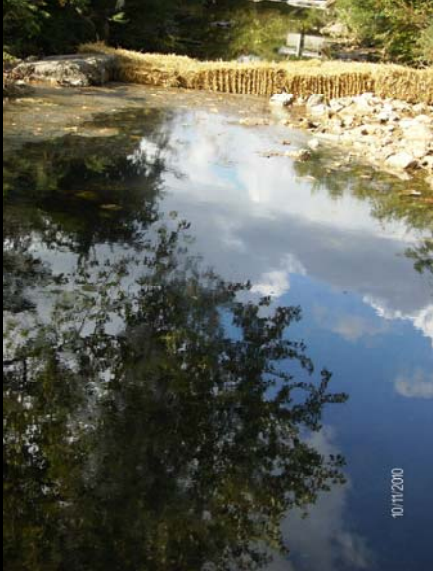
Photographer:		Alison West			Witness:		NA
Photo #	10	Of	12		Date:	10-11-2010	Time: 3:29 p.m.
Description:		HPIM1283. Straw bales set up the width of the creek to contain solids.

flow. Mr. Fazio suggested trying to capture any solids entering the creek while allowing the natural flow to continue. Based upon his recommendation, city crews placed a double row of straw bales across the width of the creek at a point downstream of the leaking sewage. Placing straw bales across the creek seemed to work as it allowed creek water to continue flowing downstream while solids were kept from migrating further downstream.

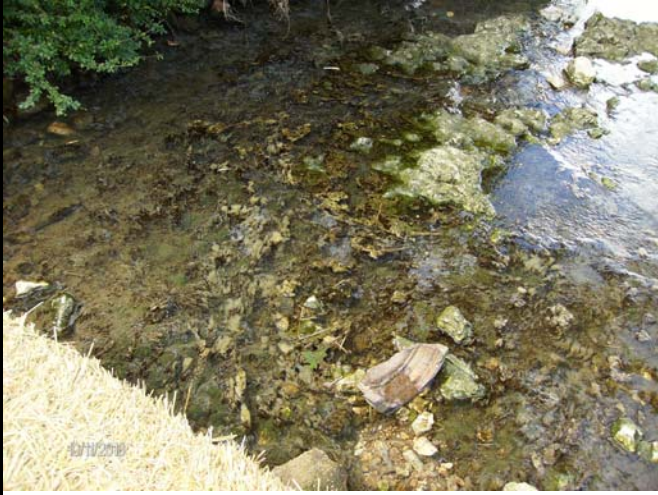
Location:		SSO Event # 21628-Spring Creek south of Sanders Avenue bridge					
Photographer:		Alison West			Witness:		NA
Photo #	11	Of	12		Date:	10-11-2010	Time: 3:33 p.m.
Description:		HPIM1288. It appears there are a few solids downstream from the straw bales.

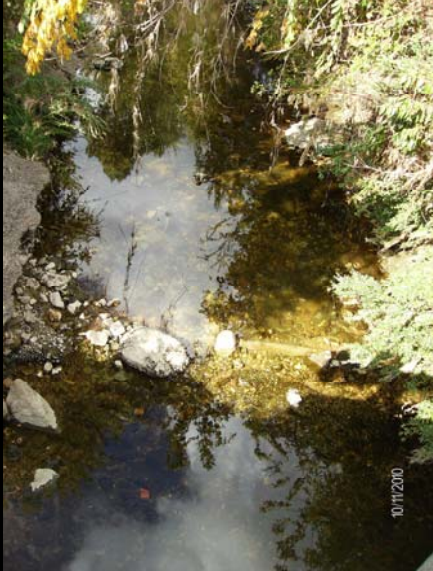
Photographer:		Alison West			Witness:		NA
Photo #	12	Of	12		Date:	10-11-2010	Time: 3:39 p.m.
Description:		HPIM1291. Spring Creek downstream from Sanders Avenue bridge.
