NPDES Compliance Inspection Report

Name and Location of Facility Inspected (<i>For industrial users discharging to POTW, also include POTW name and NPDES permit number</i>) City of Springdale POTW 2910 Silent Grove Rd. Springdale, Arkansas	Entry Time/Date 9:35 a.m./10-27-2010	Permit Effective Date April 1, 2004
	Exit Time/Date 10:30 a.m./10-27-2010	Permit Expiration Date March 31, 2009
Name(s) of On-Site Representative(s)/Title(s)/Phone and Fax Number(s) Rene Langston/Executive Director/479-751-5751 James Clark, City of Springdale, 479-751-5751	Other Facility Data	
Name, Address of Responsible Official/Title/Phone and Fax Number Rene Langston, Executive Director, 479-751-5751 City of Springdale P.O. Box 769 Springdale, Arkansas 72765	Contacted Yes <input type="checkbox"/> No <input checked="" type="checkbox"/>

RE: Spring Creek sewer leak, SSO event # 21628

Sewer Main Leak – Spring Creek – SSO Event # 21628

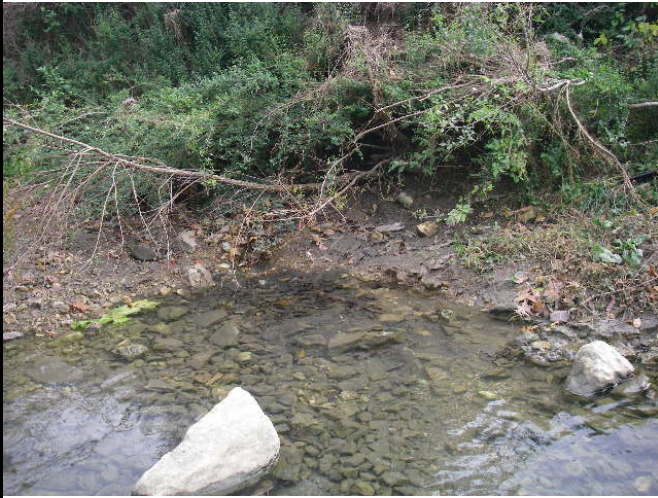
According to Mr. Clark, a city crew began pressure washing the creek channel on October 17, 2010, with non-chlorinated water. A vacuum truck was used to collect debris dislodged by high pressure washing. This reconnaissance inspection was a follow-up to the reconnaissance inspection conducted on October 11, 2010. On October 27, 2010, John Fazio, District Field Inspector, and I met with James Clark, Technical Service Director, after an on-site investigation was conducted of Spring Creek that had been impacted by sewage caused by a leaking 24" sanitary sewer main. During the investigation, Mr. Fazio and I noticed a minor amount of solids entering the creek and informed Mr. Clark. Mr. Clark believed that it was residual from the leaking main and stated that he would investigate it. I spoke with Mr. Clark on December 8, 2010, to see if solids continue to enter the creek. Mr. Clark stated that he conducted a follow-up the week of November 8, 2010, and a few particles were still entering the creek. Mr. Clark believes that this continues to be residual from the leaking main.

Location:		SSO Event # 21628-Spring Creek south of Sanders Avenue bridge						
Photographer:		Alison West			Witness:		John Fazio	
Photo #	1	Of	4		Date:	10-27-2010	Time:	9:44 a.m.
Description:		HPIM5654. A minor amount of particles/solids were observed entering Spring Creek. This is believed to be residual from the sewer main leak.

At approximately 8:00 a.m., a city crew began pressure washing the creek channel using non-chlorinated water. A vacuum truck was used to collect debris dislodged by high pressure washing. The cleaning procedure was completed around 6:00 p.m.

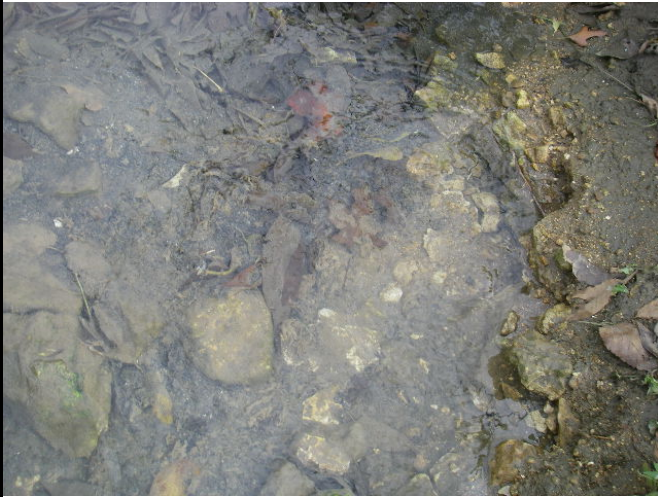
Photographer:		Alison West			Witness:		John Fazio	
Photo #	2	Of	4		Date:	10-27-2010	Time:	9:45 a.m.
Description:		HPIM5656. Close up of creek bed in the area of HPIM5654. Few particles were entering Spring Creek.

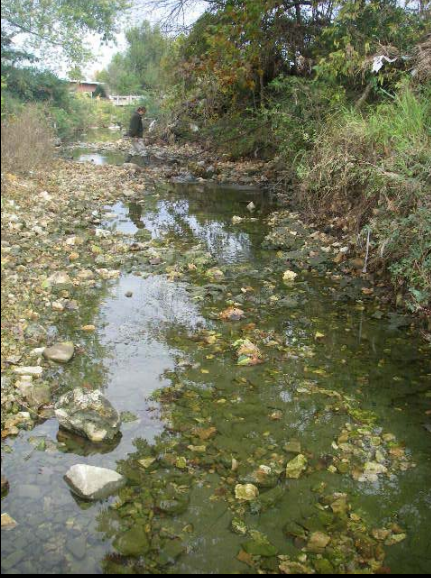
Location:		SSO Event # 21628-Spring Creek south of Sanders Avenue bridge						
Photographer:		Alison West			Witness:		John Fazio	
Photo #	3	Of	4		Date:	10-27-2010	Time:	9:56 a.m.
Description:		HPIM5661. Minor amount of solids observed in Spring Creek. Water was clear.
