# NPDES Compliance Inspection Report

Name and Location of Facility Inspected (For industrial users discharging to POTW, also include POTW name and NPDES permit number) <b>Cabot Water &amp; Wastewater Comm. – From NLR Office go east on I-40 to Highway 67/167 North to Cabot. Take the first Cabot exit and go east (right) on Highway 321 approximately 2.75 miles to CO road 449 (turn left) and go ~1 mile to Marshall Road. Turn left on Marshall Road. Plant is a end of Road.</b>	Entry Time/Date 10:54 AM ON 05/09/11	Permit Effective Date 11/1/2007
	Exit Time/Date 11:20 AM ON 05/09/11	Permit Expiration Date 10/31/2012
Name(s) of On-Site Representative(s)/Title(s)/Phone and Fax Number(s) <b>Jana Kohlmann, Operator; Bill Hawk, Superintendent; Tim Joyner, General Manager</b>	Other Facility Data	
Name, Address of Responsible Official/Title/Phone and Fax Number <b>Tim Joyner Cabot Water &amp; Wastewater Comm. PO Box 1287 Cabot, AR 72023 (501) 843-3566</b>	Contacted Yes <input checked="" type="checkbox"/> No <input type="checkbox"/>

## **NPDES Compliance Inspection Report Further Explanation**

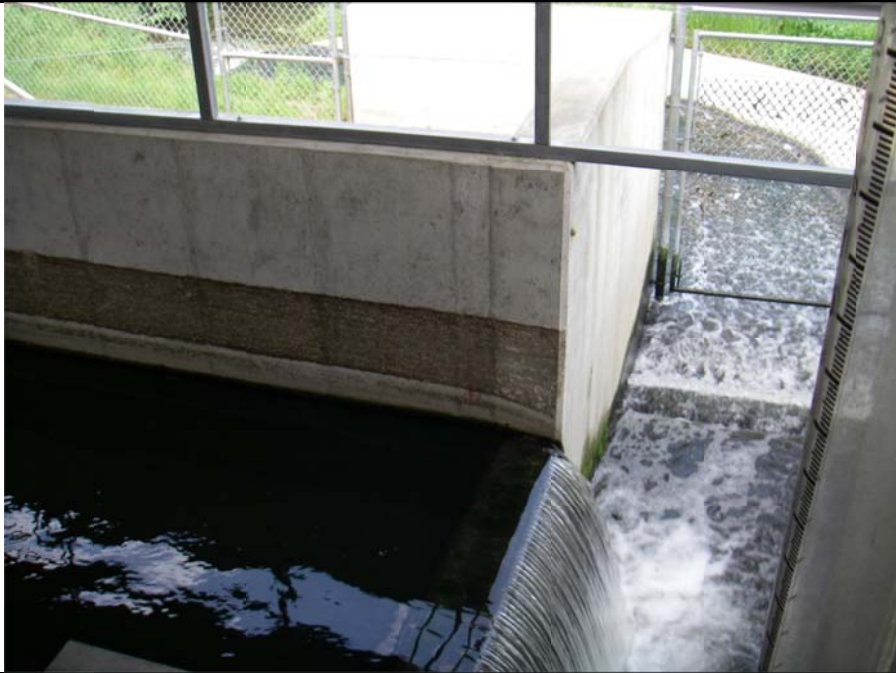
Recon level inspection conducted at the request of the Enforcement Branch in response to the POTWs report of a hydraulic overload and loss of biomass during significant rain event on May 1, 2011. During the event, the facility received over 7 inches of rain (documented in their operational logs) and the facility's flow peaked at 11.335 mgd. This is the daily flow and not the instantaneous peak flow during the event. The operator speculated it could have been as high as 16 mgd. The design flow of this facility is 6.0 mgd. In response to the hydraulic load, the permittee removed the uv lights and shut off the brush rotors. However, because of lack of capacity in the sludge storage lagoon the facility was operating with a significant blanket in the secondary clarifiers and a significant MLSS in the activated sludge basin. Cabot has been running aerators in the sludge storage lagoon to 'hopefully' further degrade the sludge in the lagoon to try to free up space, however, they have not determined the MLVSS of the sludge so they don't know if they will get further reduction and/or if the effort is worth the cost of energy. It should be noted that although this facility peaked at almost 2 times the design, within 48 hours of the end of the rainfall, the flow was almost back to normal. This is a good indicator that I&I efforts are paying off.

<b>Location:</b>	Cabot Water & Wastewater Comm.						
<b>Photographer:</b>	Dennis Benson			<b>Witness:</b>	None		
<b>Photo #</b>	1	<b>Of</b>	2	<b>Date:</b>	05/09/11	<b>Time:</b>	11:00 am
<b>Description:</b>	Staining on outfall wall reveals height of water when solids were lost.

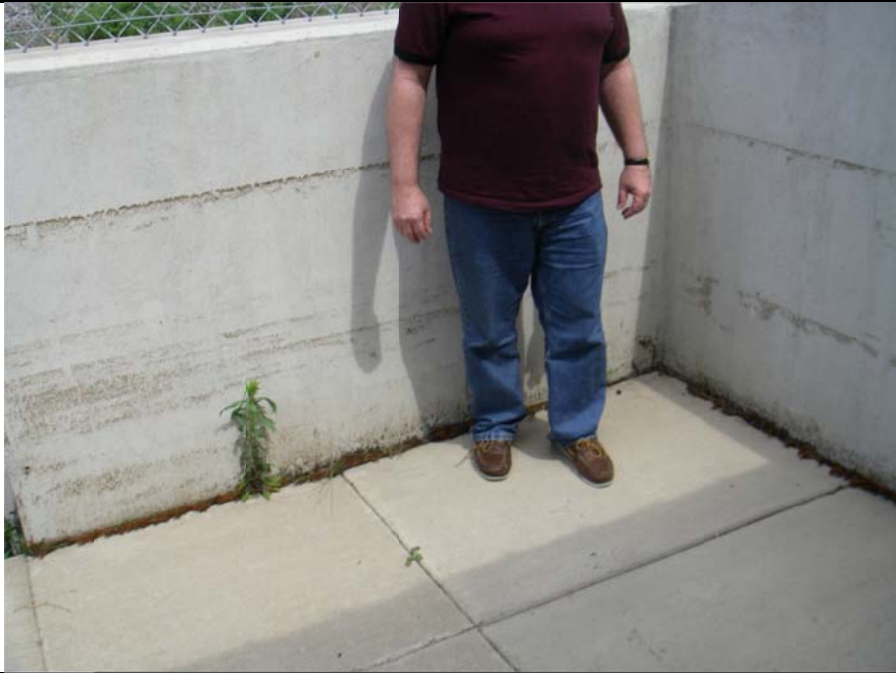
<b>Photographer:</b>	Dennis Benson			<b>Witness:</b>	None		
<b>Photo #</b>	2	<b>Of</b>	2	<b>Date:</b>	2/15/11	<b>Time:</b>	11:02 am
<b>Description:</b>	Staining on wall shows height of water in this area of the outfall. This is on a stair landing between outfall and stream. Stream back-up was this high..
