ARKANSAS
Department of Environmental Quality

RE: City of Marion, Wastewater Treatment Plant

AFIN: 18-00110 NPDES Permit No.: AR0021971

NPDES Compliance Inspection Report

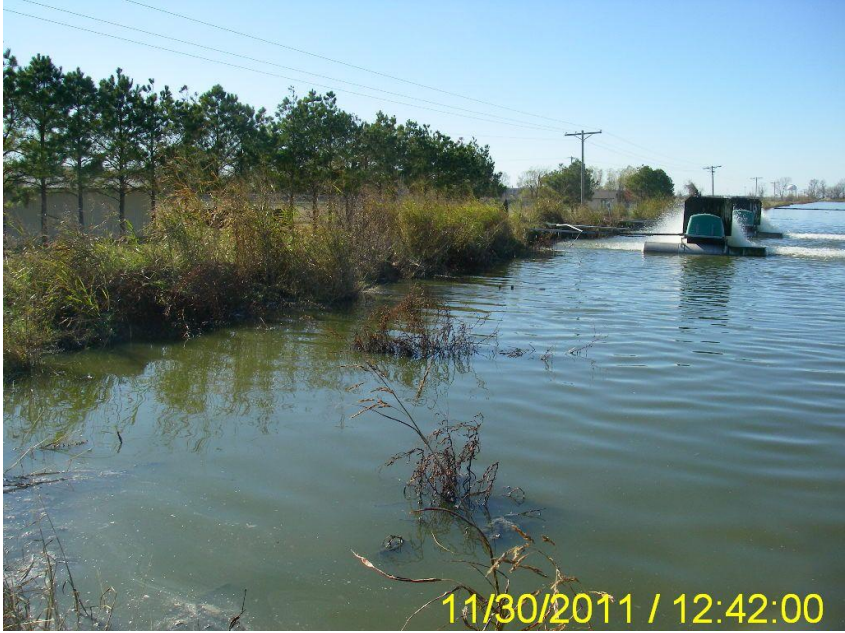
Location:	City of Marion WWTP						
Photographer:	Michael Greenway			Witness:	Brent Walker		
Photo #	1	Of	12	Date:	11/30/2011	Time:	12:42
Description:	The southeast corner of the primary treatment pond, influent is pumped into the pond in this area. Also shown is excessive growth of vegetation on the levee.

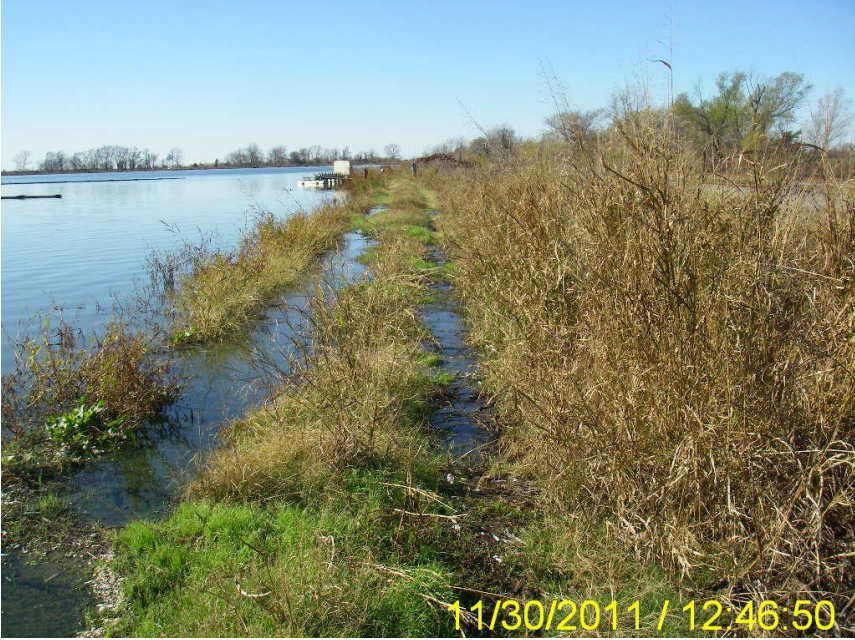
1. On November 30, 2011, partially treated wastewater was flowing over the top of the north levee from the primary (East) treatment pond. This is an unpermitted discharge in violation of the Arkansas Water and Air Pollution Control Act- A.C.A. §8-4-217 (b)(1).

- a) The treatment ponds did not have adequate freeboard and an overflow of partially treated wastewater was observed on the northeast levee of the primary treatment pond. Arkansas Pollution Control and Ecology Commission Minute Order # 80-21 and Regulation 6.202 (B) require that the basic design criteria for wastewater treatment plants be based on the latest edition of the "Recommended Standards for Sewage Works," published by the Great Lakes- Upper Mississippi Board of State Sanitary Engineers known as 10 States Standards. 10 States Standards - 93.415 specifies minimum freeboard shall be 3 feet, except that for small systems 2 feet may be acceptable.

Photographer:	Michael Greenway			Witness:	Brent Walker		
Photo #	2	Of	12	Date:	11/30/2011	Time:	12:46
Description:	Partially treated wastewater is shown flowing over the northeast levee of the primary treatment pond. Also note the excessive growth of vegetation on the levee.

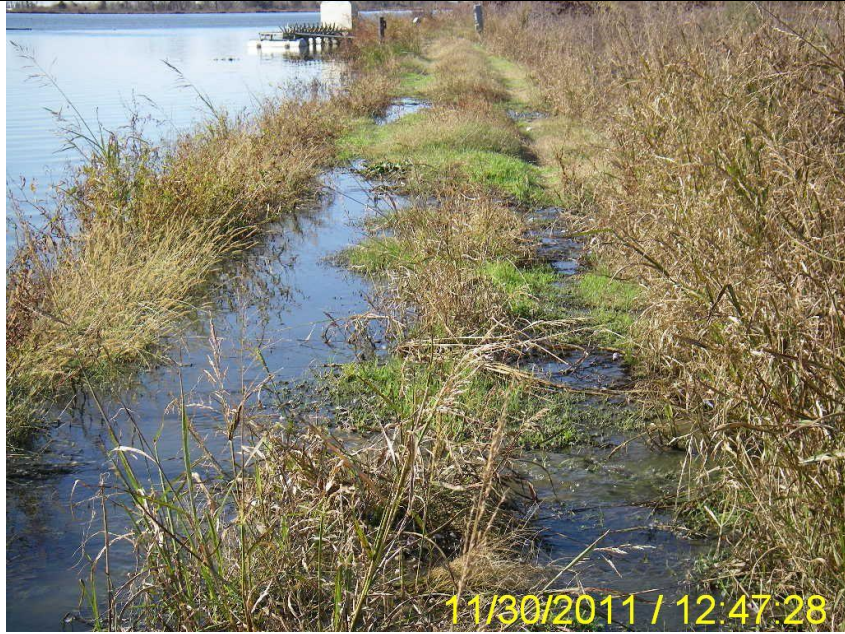
Location:	City of Marion WWTP						
Photographer:	Michael Greenway			Witness:	Brent Walker		
Photo #	3	Of	12	Date:	11/30/2011	Time:	12:47
Description:	Partially treated wastewater flowing over the levee of the primary treatment pond.

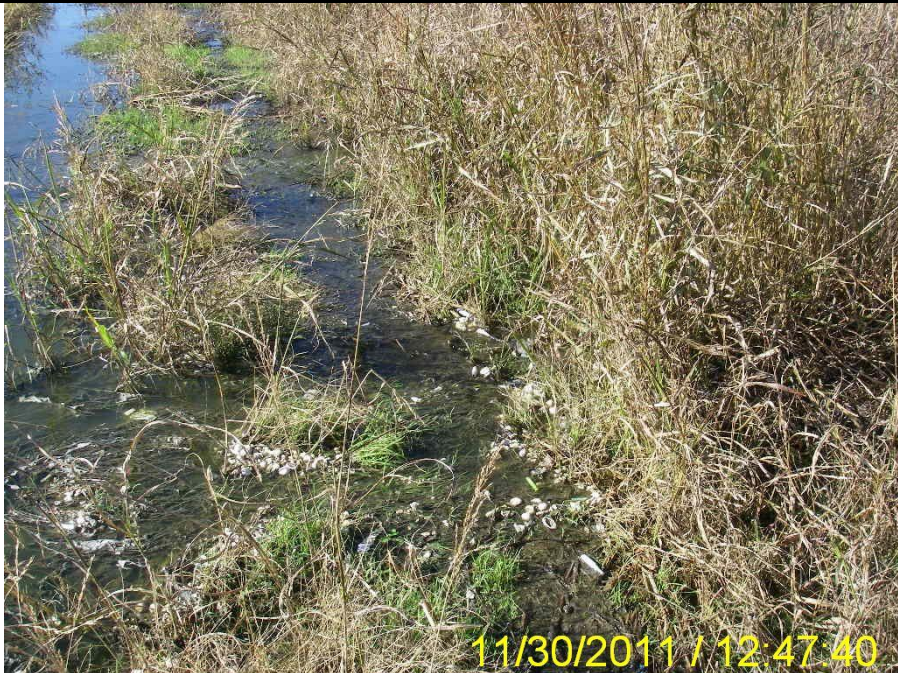
Photographer:	Michael Greenway			Witness:	Brent Walker		
Photo #	4	Of	12	Date:	11/30/2011	Time:	12:47
Description:	Partially treated wastewater flowing over the levee of the primary treatment pond.

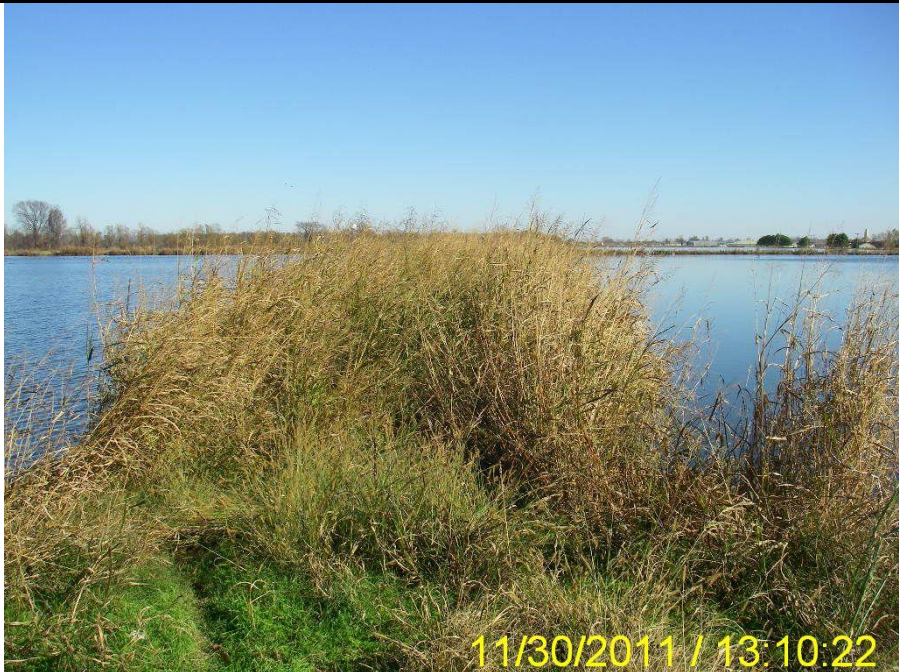
Location:	City of Marion WWTP						
Photographer:	Michael Greenway			Witness:	Brent Walker		
Photo #	5	Of	12	Date:	11/30/2011	Time:	13:10
Description:	Excessive growth of vegetation on the levee that divides the two western treatment ponds.

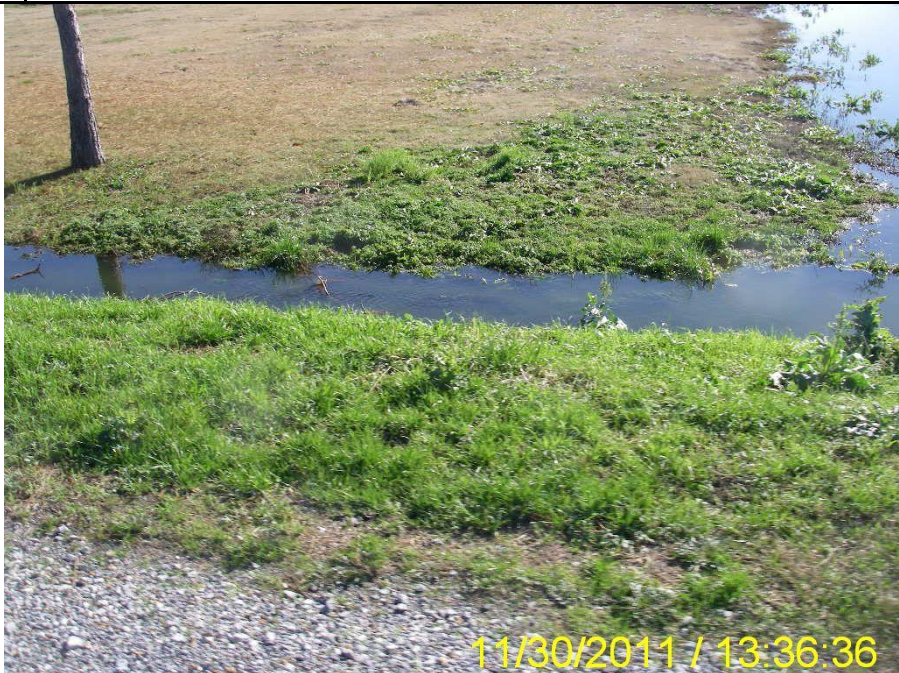
Photographer:	Michael Greenway			Witness:	Brent Walker		
Photo #	6	Of	12	Date:	11/30/2011	Time:	13:36
Description:	The wastewater from the overflow was traveling along Hardin Rd.

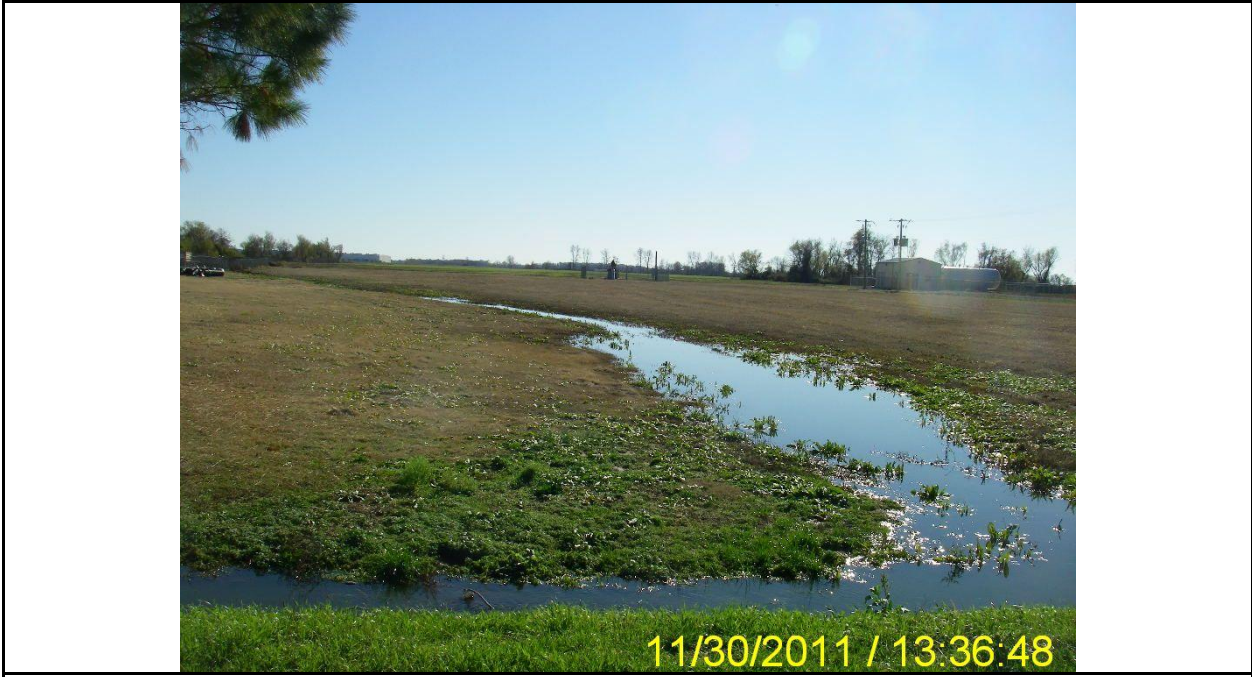
Photo #	7	Of	12	Date:	11/30/2011	Time:	13:36
----------------	---	-----------	----	--------------	------------	--------------	-------

Description:	The wastewater from the overflow traveled near what appeared to be a well and a water treatment facility.
---------------------	---

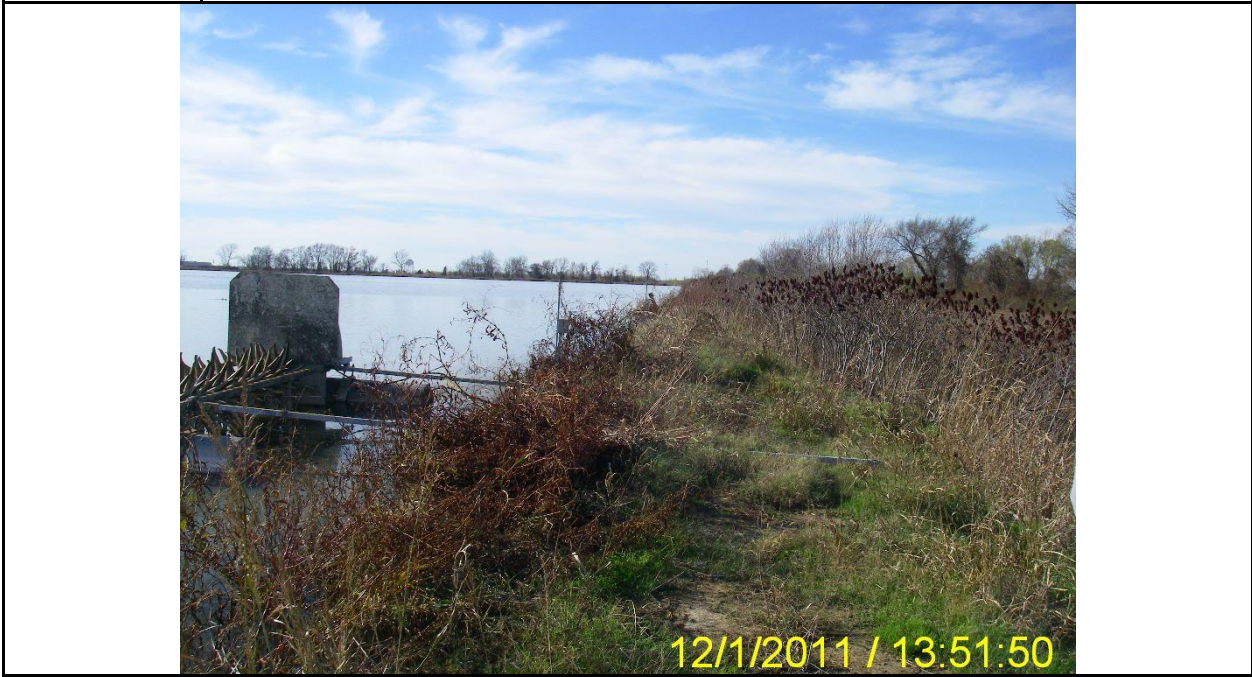
Photo #	8	Of	12	Date:	12/01/2011	Time:	13:51
----------------	---	-----------	----	--------------	------------	--------------	-------

Description:	Excessive growth of vegetation on the north levee of the primary treatment pond.
---------------------	--

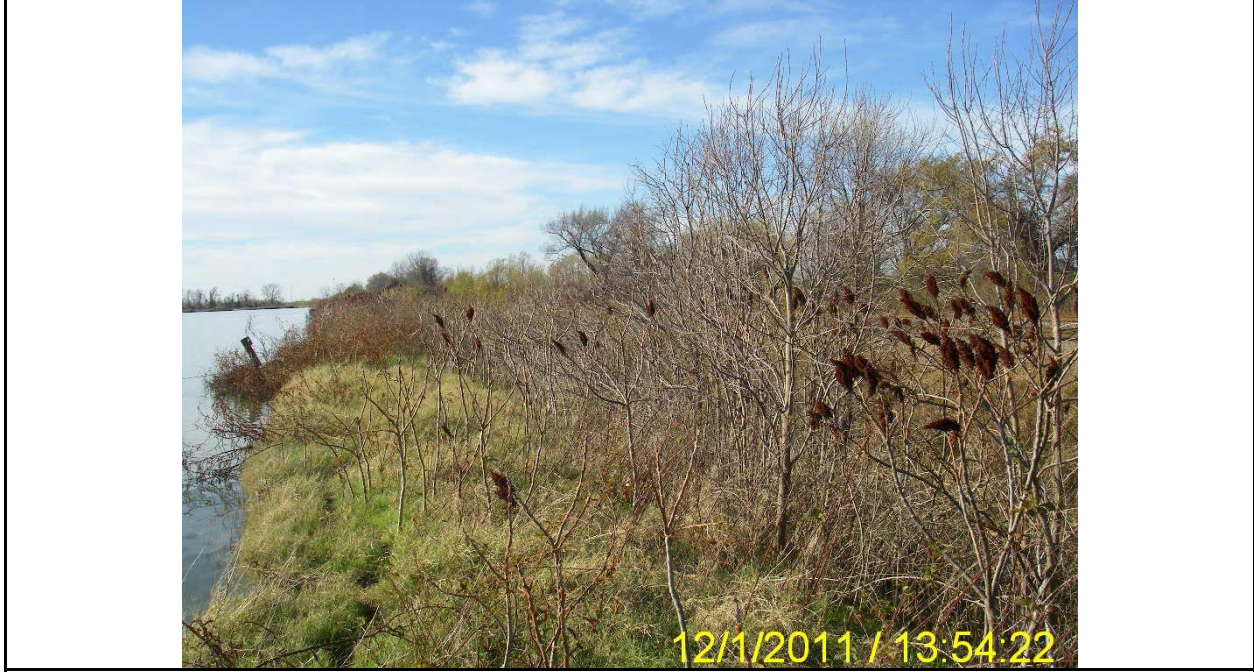
Photo #	9	Of	12	Date:	12/01/2011	Time:	13:54
----------------	---	-----------	----	--------------	------------	--------------	-------

Description:	Excessive growth of vegetation on the north levee of the primary treatment pond.						
---------------------	--	--	--	--	--	--	--

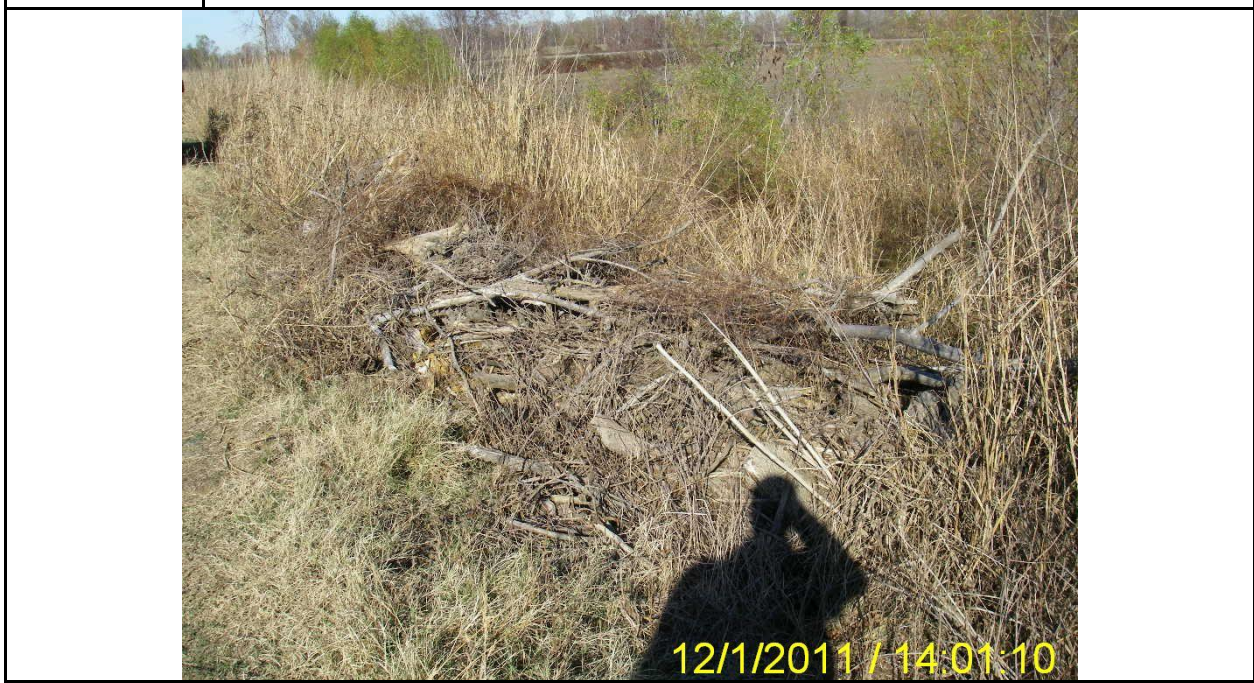
Photo #	10	Of	12	Date:	12/01/2011	Time:	14:01
----------------	----	-----------	----	--------------	------------	--------------	-------

Description:	Excessive growth of vegetation and woody debris on the east levee of the primary treatment pond.						
---------------------	--	--	--	--	--	--	--

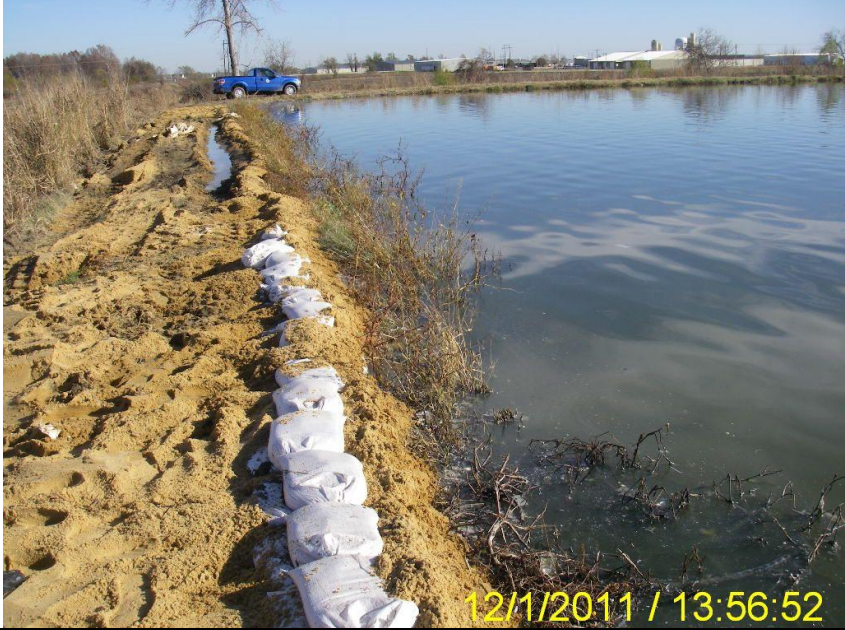
Photo #	11	Of	12	Date:	12/01/2011	Time:	13:56
----------------	----	-----------	----	--------------	------------	--------------	-------

Description:	Sandbags were used to stop the overflow on the northeast levee of the primary treatment pond.						
---------------------	---	--	--	--	--	--	--

As reported by Mr. Walker and Mr. Greenway we did stop this overflow with sandbags and a portable 4" pump. We have worked diligently to lower our lagoon system after these abnormal rainfalls. We currently have achieved about 18" to 24" of freeboard on our lagoons. On January 10th we started shoring up our levees with rip-rap stored in our 3rd lagoon. We also are preparing to bush-hog the excessive growth issue as weather permits.

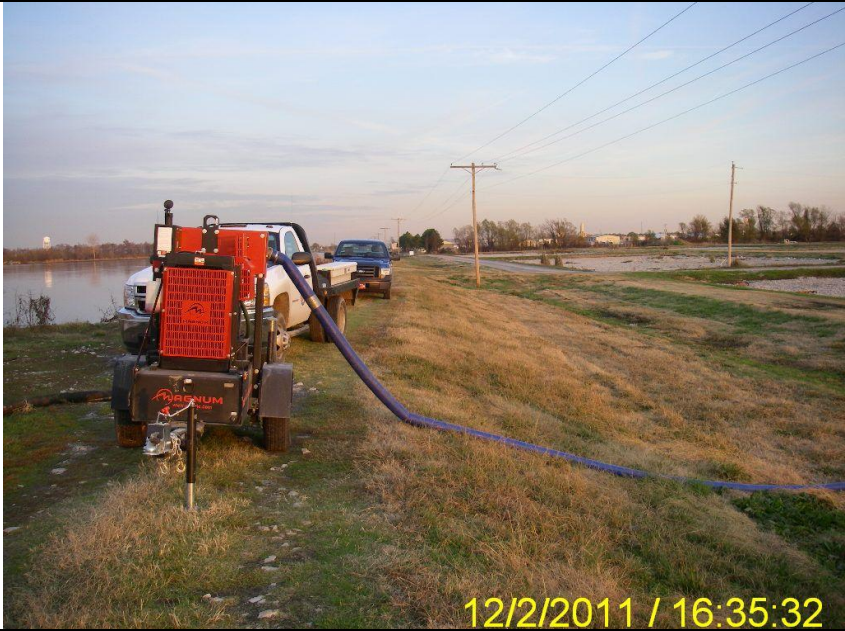
Photo #	12	Of	12	Date:	12/02/2011	Time:	16:35
----------------	----	-----------	----	--------------	------------	--------------	-------

Description:	This portable pump was used to assist in lowering the level of water in the treatment ponds. This unit pumped wastewater from the final treatment pond, directly into one of the rock reed filters.						
---------------------	---	--	--	--	--	--	--

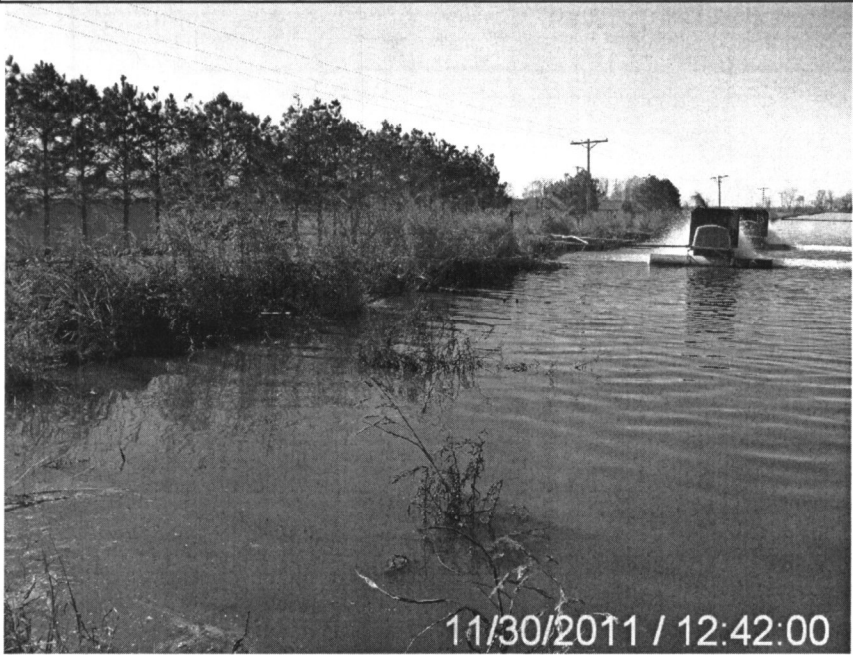
Photo #	1	Of	12	Date:	11/30/2011	Time:	12:42
----------------	---	-----------	----	--------------	------------	--------------	-------

Description:	The southeast corner of the primary treatment pond, influent is pumped into the pond in this area. Also shown is excessive growth of vegetation on the levee.
---------------------	---

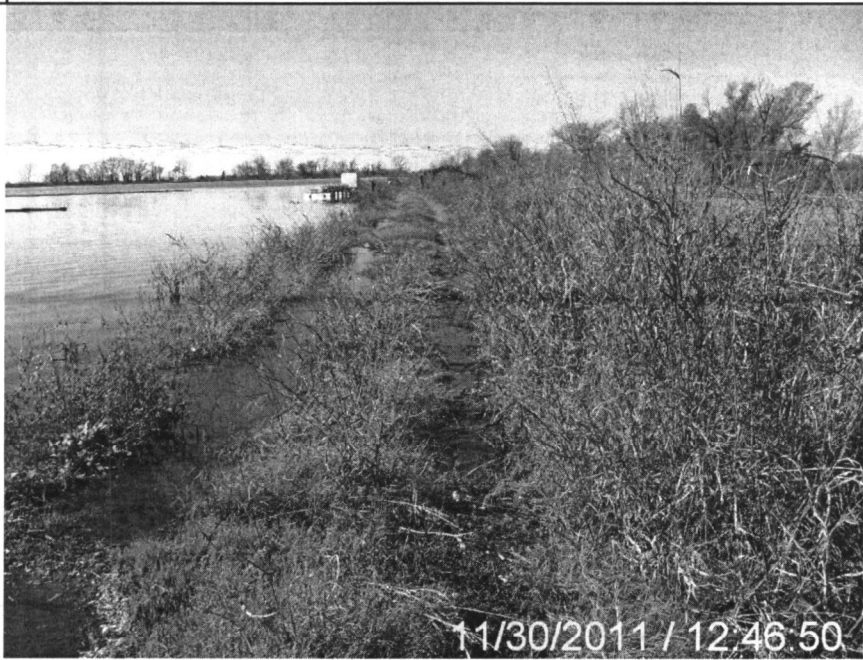
Photo #	2	Of	12	Date:	11/30/2011	Time:	12:46
----------------	---	-----------	----	--------------	------------	--------------	-------

Description:	Partially treated wastewater is shown flowing over the northeast levee of the primary treatment pond. Also note the excessive growth of vegetation on the levee.
---------------------	--

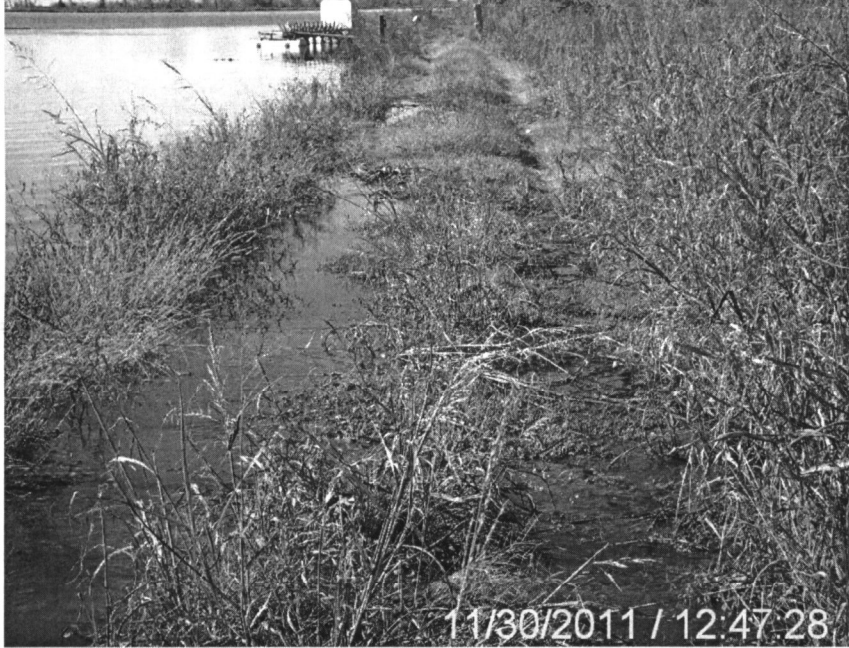
Location:	City of Marion WWTP						
Photographer:	Michael Greenway			Witness:	Brent Walker		
Photo #	3	Of	12	Date:	11/30/2011	Time:	12:47
Description:	Partially treated wastewater flowing over the levee of the primary treatment pond.

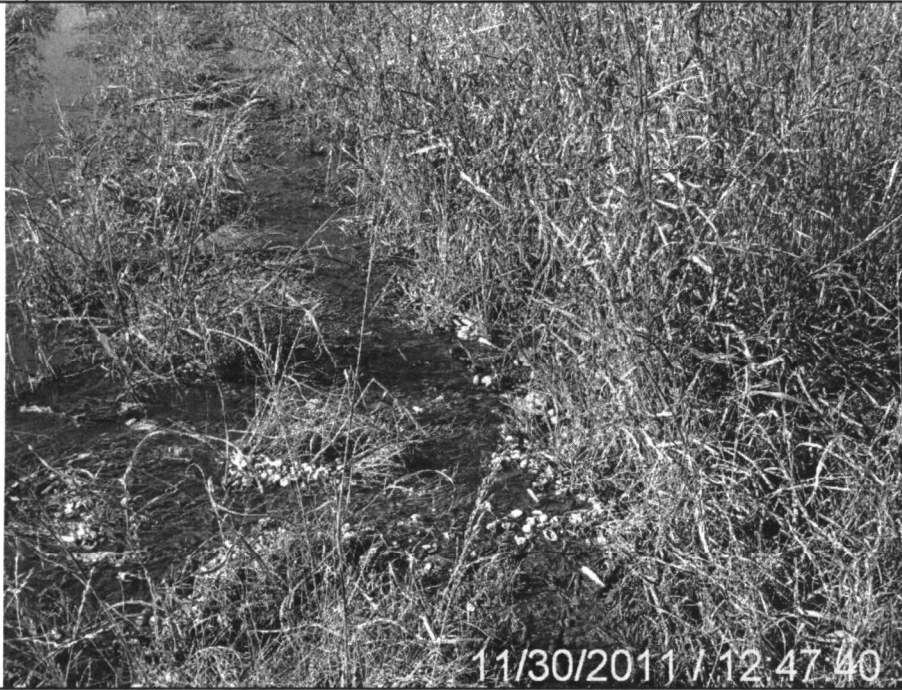
Photographer:	Michael Greenway			Witness:	Brent Walker		
Photo #	4	Of	12	Date:	11/30/2011	Time:	12:47
Description:	Partially treated wastewater flowing over the levee of the primary treatment pond.

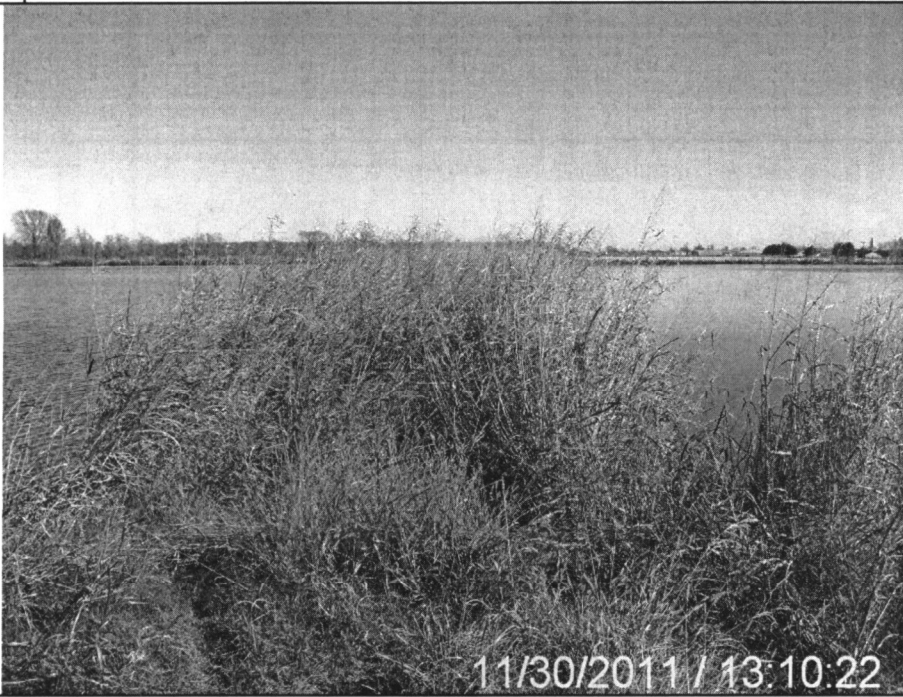
Location:	City of Marion WWTP						
Photographer:	Michael Greenway			Witness:	Brent Walker		
Photo #	5	Of	12	Date:	11/30/2011	Time:	13:10
Description:	Excessive growth of vegetation on the levee that divides the two western treatment ponds.

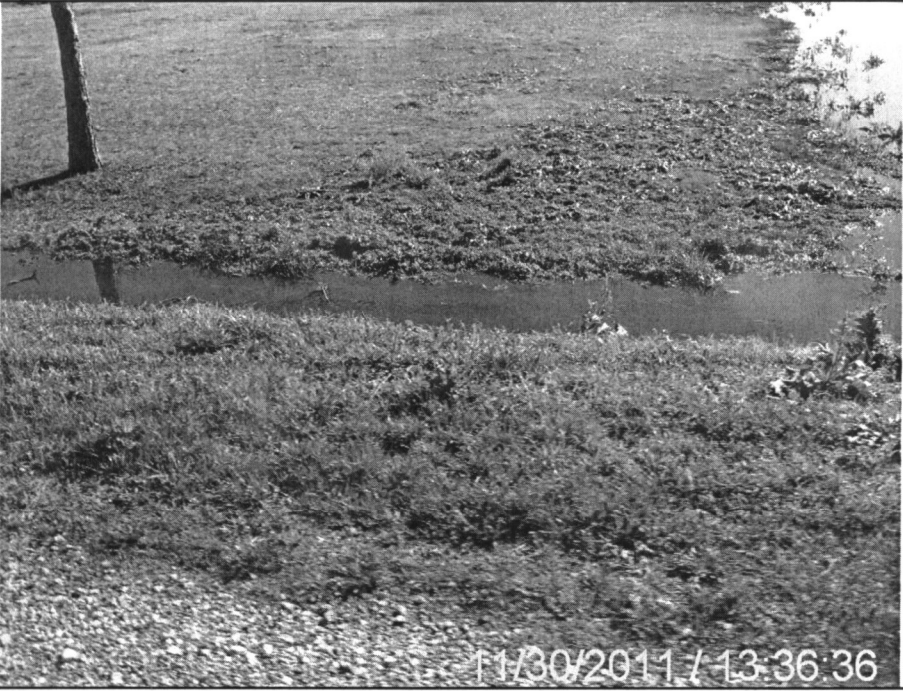
Photographer:	Michael Greenway			Witness:	Brent Walker		
Photo #	6	Of	12	Date:	11/30/2011	Time:	13:36
Description:	The wastewater from the overflow was traveling along Hardin Rd.

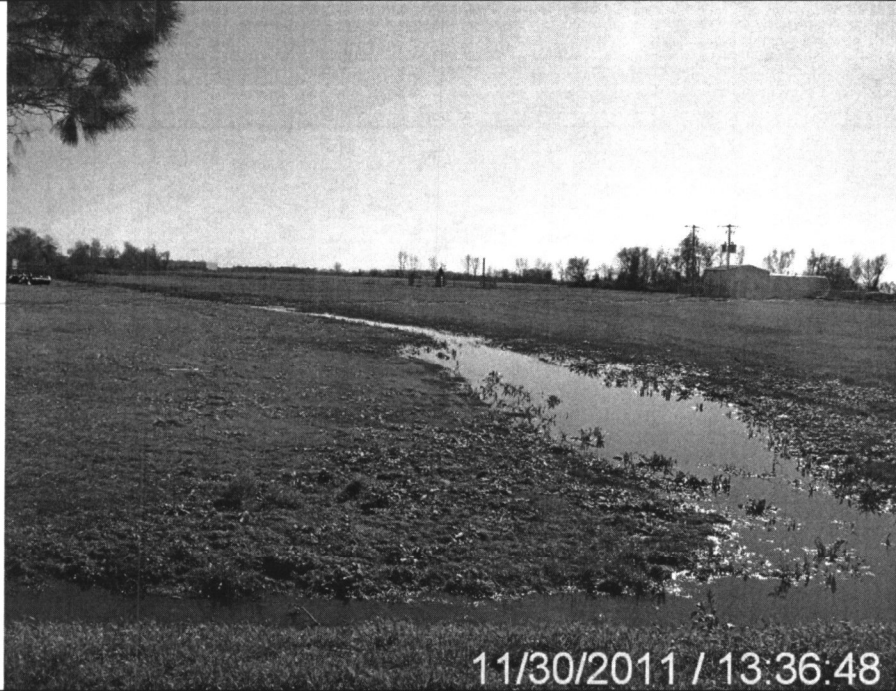
Location:	City of Marion WWTP						
Photographer:	Michael Greenway			Witness:	Brent Walker		
Photo #	7	Of	12	Date:	11/30/2011	Time:	13:36
Description:	The wastewater from the overflow traveled near what appeared to be a well and a water treatment facility.

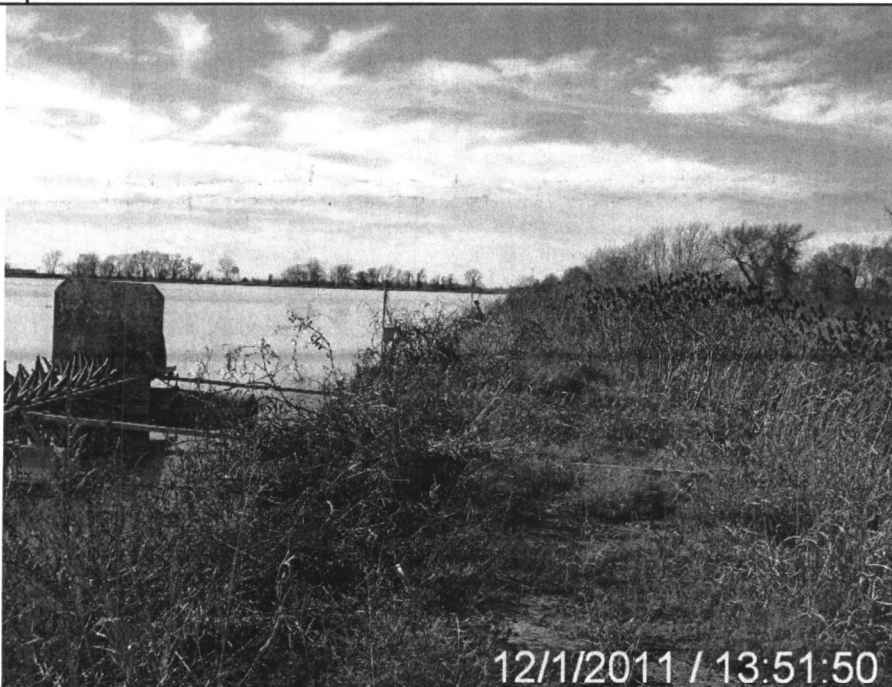
Photographer:	Michael Greenway			Witness:	Brent Walker		
Photo #	8	Of	12	Date:	12/01/2011	Time:	13:51
Description:	Excessive growth of vegetation on the north levee of the primary treatment pond.

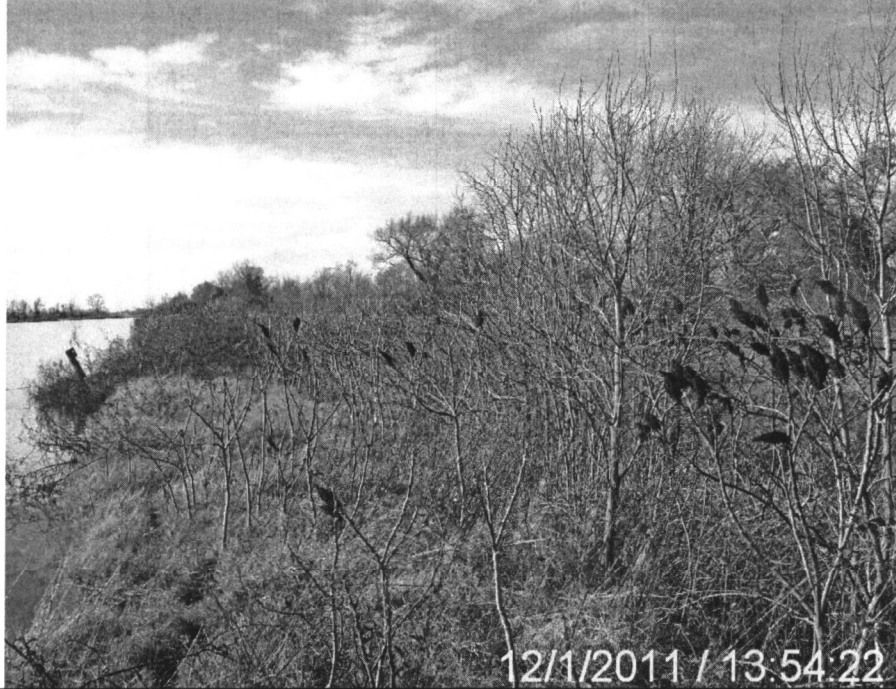
Location:	City of Marion WWTP						
Photographer:	Michael Greenway			Witness:	Brent Walker		
Photo #	9	Of	12	Date:	12/01/2011	Time:	13:54
Description:	Excessive growth of vegetation on the north levee of the primary treatment pond.

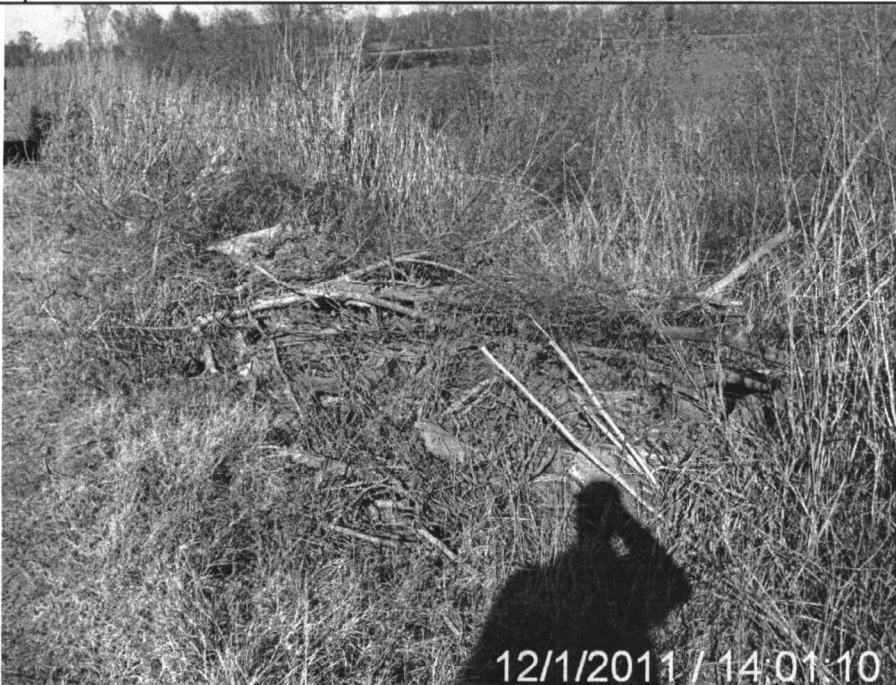
Photographer:	Michael Greenway			Witness:	Brent Walker		
Photo #	10	Of	12	Date:	12/01/2011	Time:	14:01
Description:	Excessive growth of vegetation and woody debris on the east levee of the primary treatment pond.

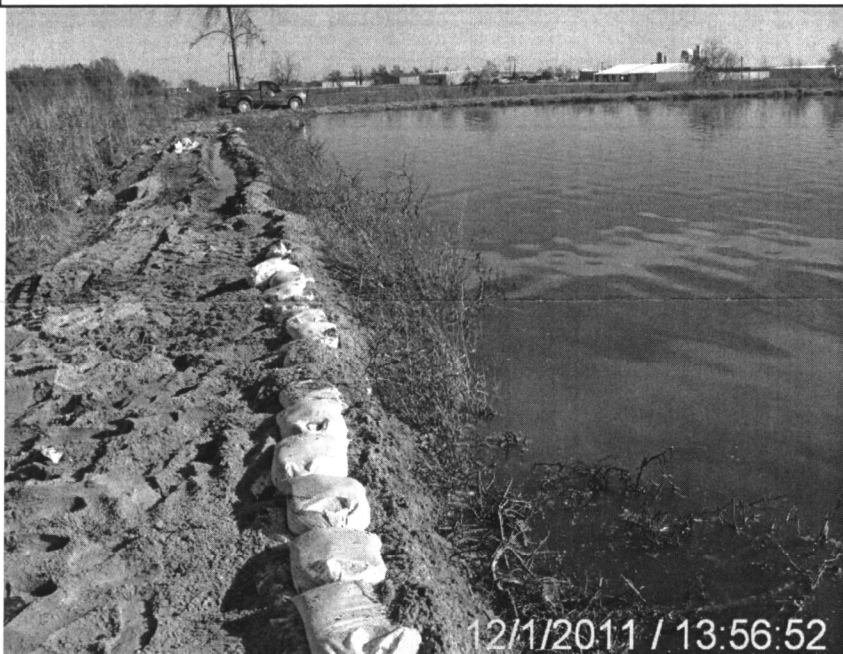
Location:	City of Marion WWTP						
Photographer:	Michael Greenway			Witness:	Brent Walker		
Photo #	11	Of	12	Date:	12/01/2011	Time:	13:56
Description:	Sandbags were used to stop the overflow on the northeast levee of the primary treatment pond.

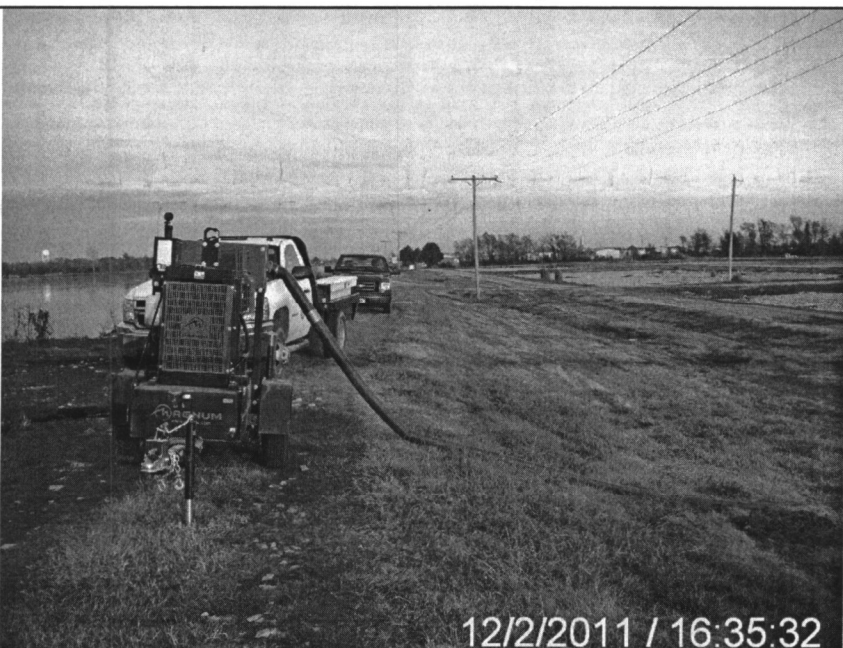
Photographer:	Michael Greenway			Witness:	Brent Walker		
Photo #	12	Of	12	Date:	12/02/2011	Time:	16:35
Description:	This portable pump was used to assist in lowering the level of water in the treatment ponds. This unit pumped wastewater from the final treatment pond, directly into one of the rock reed filters.
