RE: Reconnaissance Inspection

AFIN: 29-00034 NPDES Permit No.: AR0038466

ADEQ Water NPDES Inspection	AFIN: 29-00034	Permit #: AR0038466

Water Division NPDES Photographic Evidence Sheet

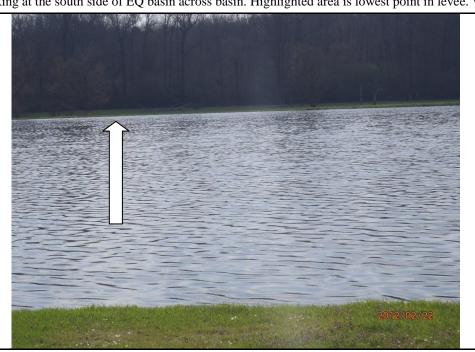
Photo# 1 Of 1 Date: 2-22-2012 Time: 12:41

- 1. The Equalization Basin was overflowing. This is considered an un-permitted discharge.
- 2. 10 States Standards 93.415 states "Minimum freeboard shall be 3 feet (0.9 m.), except that for small systems 2 feet (0.6 m.) may be acceptable". At the time of the inspection your pond did not have any freeboard.

Description: Looking at the south side of EQ basin across basin. Highlighted area is lowest point in levee. Water was over the top.

We applied for and received a \$252,000 grant from the Arkansas Department of Economic Development that will be used to place an additional gravity flow line from the EQ pond to the influent station, hopefully aiding in restoring freeboard at that plant in a more timely fashion. We will also use part of that grant for repairs of 50 manholes and a major line repair on West 3rd Street.

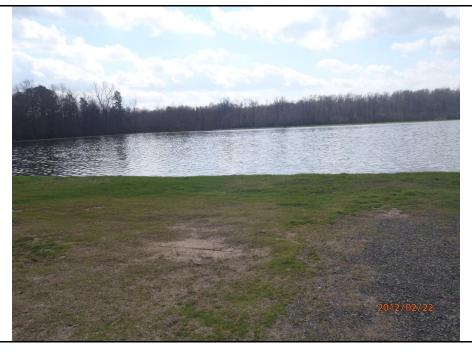
Photographer:	Red Smi	th	Witness:	None		
Photo # 2	Of	2	Date:	2-22-2012	Time:	12:41

Description: Another view of Basin.
