ARKANSAS
Department of Environmental Quality

RE: Compliance Inspection, Marion Wastewater Treatment Plant
AFIN: 18-00110 Permit No.: AR0021971, AR0021971C and ARR000189

<h1 style="margin:0;">ADEQ</h1> <p style="margin:0; font-size: small;">A R K A N S A S Department of Environmental Quality</p>		WATER DIVISION INSPECTION REPORT			
		AFIN: 18-00110		PERMIT #: AR0021971	
COUNTY: 18 Crittenden		PDS #: 077287		MEDIA: WN	
GPS LOCATION: LAT: 35.190364 LONG: -90.228445					
<input type="checkbox"/> Outfall / <input type="checkbox"/> General Area / <input checked="" type="checkbox"/> Entrance / <input type="checkbox"/> Sample Point					
FACILITY INFORMATION			INSPECTION INFORMATION		
NAME: City of Marion WWTP			DATE(S):	3/18/2014	
LOCATION: West side of Hwy 118, South of the UP rail road.			ENTRY TIME:	10:30	
			EXIT TIME:	16:00	
CITY: Marion, AR			INSPECTION TYPE: Compliance Evaluation		
RESPONSIBLE OFFICIAL			INSPECTOR ID#: 86009 S - State		
CONTACTED DURING INSPECTION: Yes			FACILITY TYPE: 1 - Municipal		
NAME: Jim Shempert			PERMIT EFFECTIVE DATE: 12/1/2013		
TITLE: Water Utilities Director			PERMIT EXPIRATION DATE: 6/30/2017

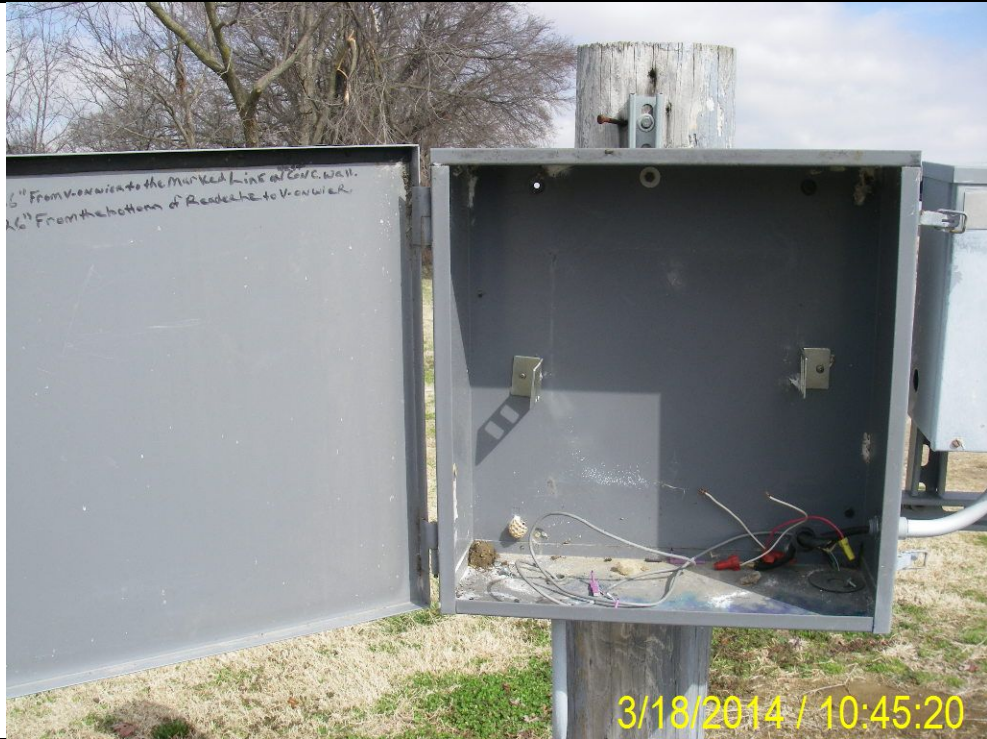
**	OTHER:				
SUMMARY OF FINDINGS					
<p>This routine compliance inspection revealed the following violations:</p> <ol style="list-style-type: none"> 1. The totalizing meter for flow measurements was not maintained (Photo 1). Instantaneous flow measurements were taken daily at the crest of the weir. This violates Part I, Section A, and Part III, Section B, Item 1A of the Permit. 2. The facility did not perform influent sampling and calculate the CBOD5 and TSS removal rate annually. This violates Part II, Item 2 of the Permit. 3. There was excessive vegetation on the north and east levees of the lagoon (Photos 2-3). This violates Part III, Section B, Item 1A of the Permit. 4. Head was measured improperly at the crest of the weir for instantaneous flow measurements (Photo 4). This violates Part III, Section C, Item 2 of the Permit. A staff gauge should be installed at least 3 times the expected head upstream of the weir for accurate flow measurement. 5. The time and individual performing sampling/analysis was not recorded for DO monitoring. This violates Part III, Section C, Item 8 of the Permit. 6. At the time of inspection, flow was measured and calculated to be greater than 2.39 MGD. This exceeds the 1.6 MGD design flow of the facility. It appears the facility may experience significant infiltration and inflow problems. Auxiliary pumps were installed and running to establish/maintain adequate freeboard in the lagoons (Photo 5). 7. The Sanitary Sewer Overflow (SSO) inspection revealed excessive grease and solids in the wet well of the Vintage Veranda pump station. This violates Part III, Section B, Item 1A of the Permit.

Location:	City of Marion WWTP		
Photographer:	Michael Greenway	Date:	3/18/2014
Time:	10:45	Witness:	None
Photo #:	1	Description:	The box for the totalizing meter near the outfall. The flow measurement device was not maintained.

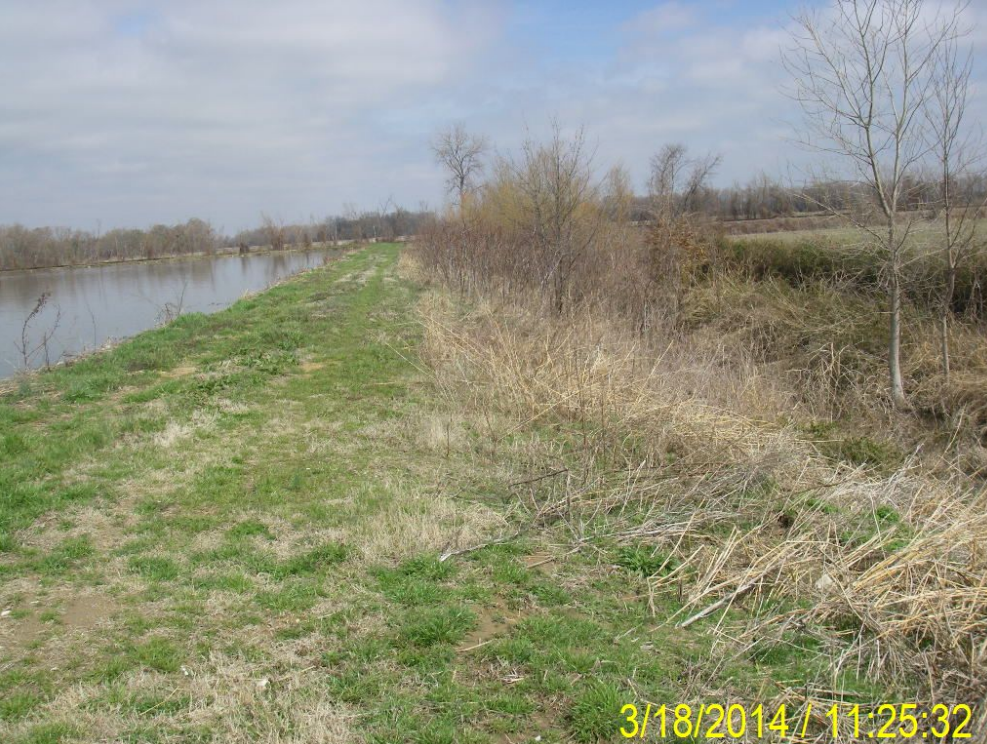
Photographer:	Michael Greenway	Date:	3/18/2014
Time:	11:25	Witness:	None
Photo #:	2	Description:	View of excessive vegetation on the outer slope of the east lagoon levee.

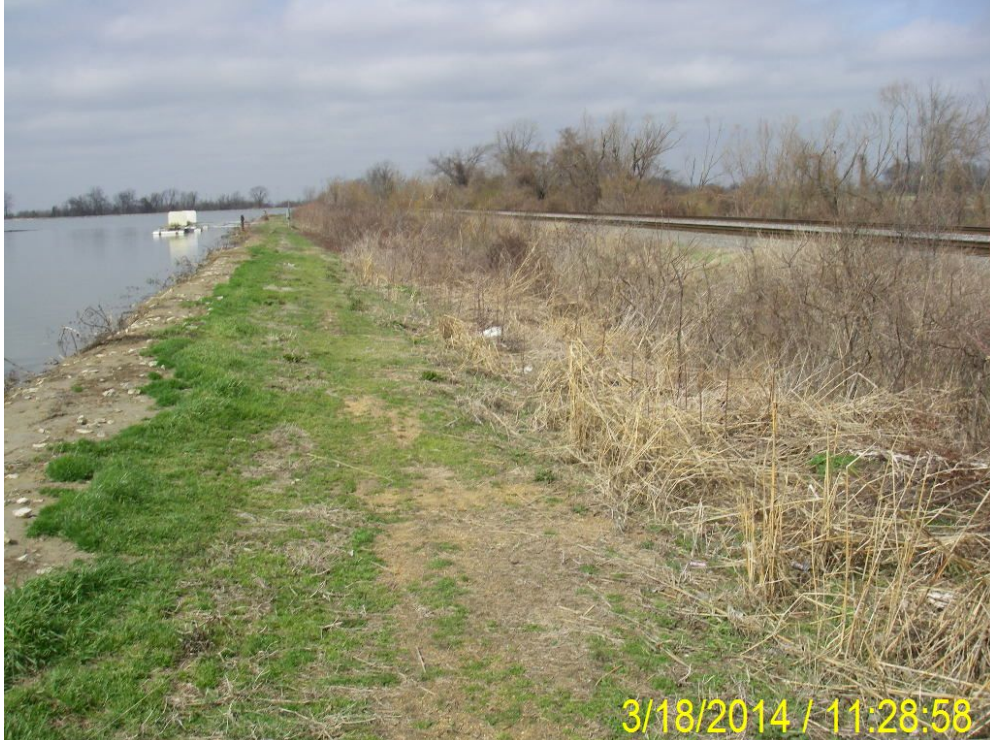
Location:	City of Marion WWTP		
Photographer:	Michael Greenway	Date:	3/18/2014
Time:	11:28	Witness:	None
Photo #:	3	Description:	View of excessive vegetation on the outer slope of the north lagoon levee.

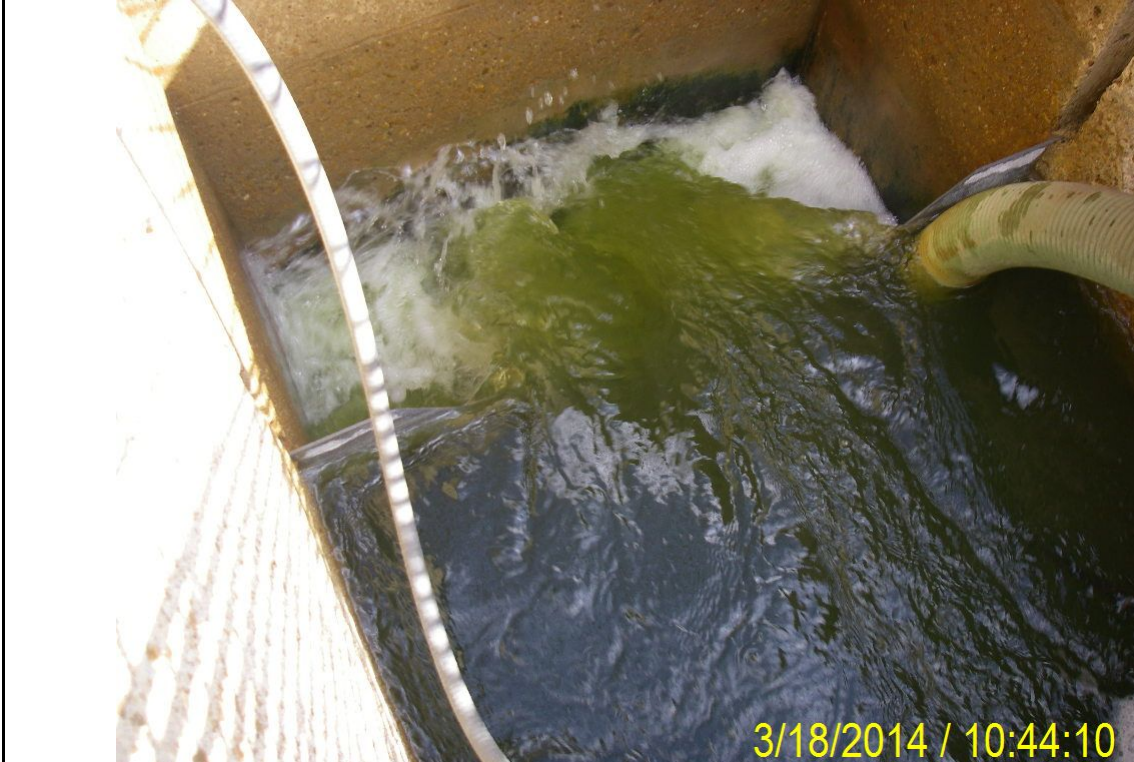
Photographer:	Michael Greenway	Date:	3/18/2014
Time:	10:44	Witness:	None
Photo #:	4	Description:	View of the outfall weir. Fourteen inches of head was measured over the crest of the 90 degree v-notch weir.
