Inspection Report: Pine Bluff Wastewater Utility, AFIN: 35-00149, Permit #: AR0033316

<b>VDEO</b>	WATER DIVISION INSPECTION REPORT									
AULU		AFIN: <b>35-00149</b> PERMIT #: <b>AR003331</b>			316		DATE: <b>6/18/2014</b>				
ARKANSAS			COUNTY: <b>35 Jefferson</b> PI			#: <b>078566</b>	MEDIA: WN				
Dep	partment of Environmental Quality	S LAT: <b>34.26602</b>	.266026 LONG: -92.018023 LOCATION: General Area								
	FACILITY INFORMAT		INSPECTION INFORMATION								
Pine Bluff Wastewater Utility LOCATION:				1 - Municipal INSPECTOR ID#: 26075 S - State							
1520 South Ohio Street			FACILITY EVALUATION RATING: INSPECTION TYPE:  1 - Unsatisfactory Reconnaissance

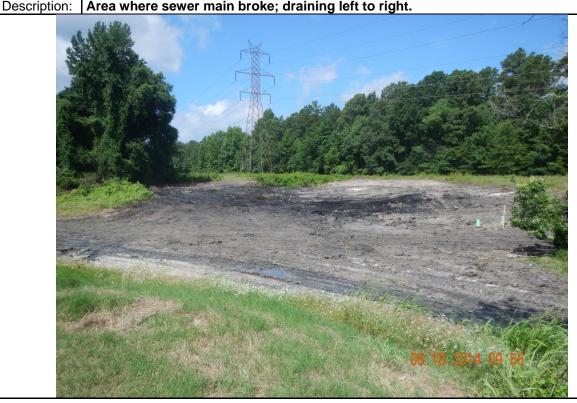
Water Division Photographic Evidence Sheet												
Location: Pine Bluff Wastewater Utility												
Photograph	er:	Steven L. Henderson		Date:	6/18/2014	Time:	09:58					
Witness: Amber Zajac, Graphic Flexible; Vincent Miles, PBWW Photo #: 1												
Description: Area where cower main brokes draining left to right

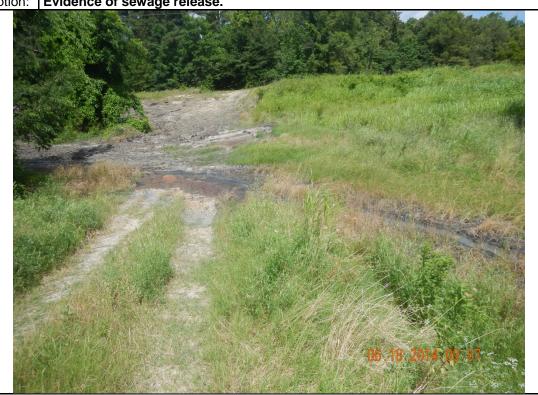
Photographer:Steven L. HendersonDate:6/18/2014Time:09:57Witness:Amber Zajac, Graphic Flexible; Vincent Miles, PBWWPhoto #:2Description:Evidence of sewage release.
