A R K A N S A S Department of Environmental Quality		WATER DIVISION INSPECTION REPORT							
		AFIN: 18-00110		PERMIT #: AR0021971		DATE: 9/24/2014			
		COUNTY: 18 Crittenden			PDS #: 080303		MEDIA: WN		
		GPS LAT: 35.190364 LONG: -90.228445 LOCATION: Entrance							
FACILITY INFORMATION				INSPECTION INFORMATION					
NAME: City of Marion WWTP LOCATION: West side of Hwy 118, South of the UP Rail Road. CITY: Marion, AR				FACILITY TYPE: 1 - Municipal		INSPECTOR ID#: 86009 S - State			
				FACILITY EVALUATION RATING: ***		INSPECTION TYPE: Reconnaissance			
				DATE(S): 9/24/2014		ENTRY TIME: 12:15		EXIT TIME: 12:50	
								PERMIT EFFECTIVE DATE: 12/1/2013 PERMIT EXPIRATION DATE: 6/30/2017	
RESPONSIBLE OFFICIAL				FAYETTEVILLE SHALE RELATED: N					
NAME / TITLE: Jim Shempert / Water Utilities Director COMPANY: City of Marion MAILING ADDRESS: P.O. Box 717 CITY, STATE, ZIP: Marion AR 72364 PHONE & EXT. / FAX: 870-739-5413 / EMAIL: N/A				FAYETTEVILLE SHALE VIOLATIONS: N

Water Division Photographic Evidence Sheet

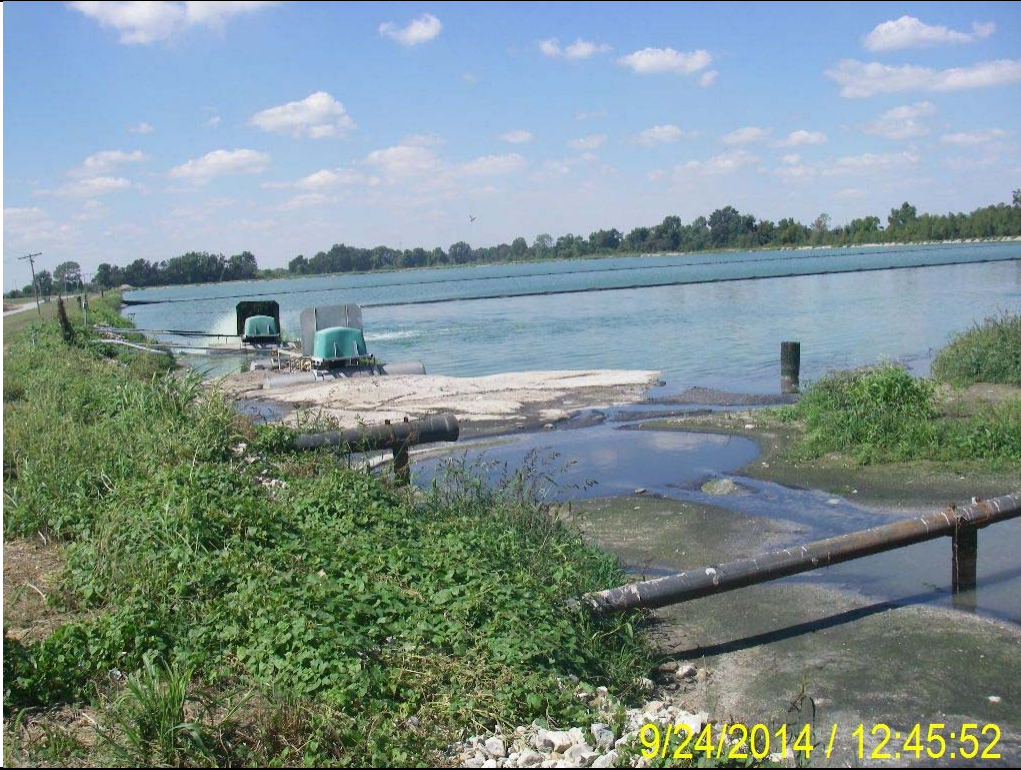
Location:	City of Marion WWTP		
Photographer:	Michael Greenway	Date:	9/24/2014
Time:	12:45		
Witness:	Brent Walker	Photo #:	1
Description:	View influent pipes and aerators in the primary lagoon. Note the accumulation of sludge.

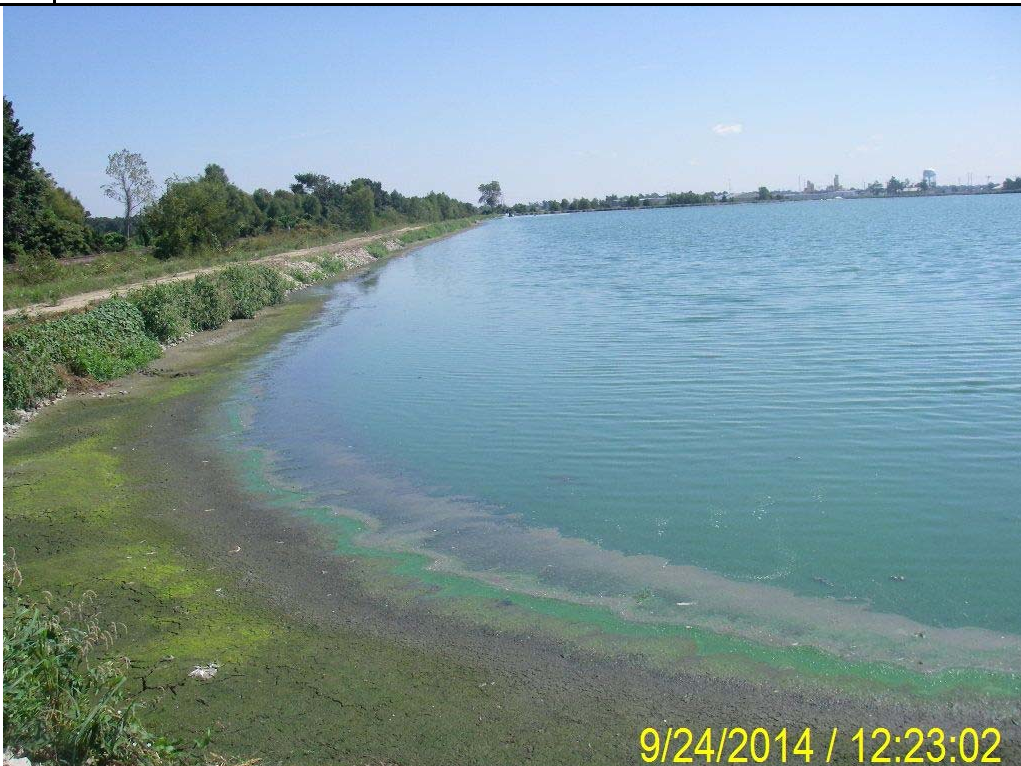
Photographer:	Michael Greenway	Date:	9/24/2014
Time:	12:23		
Witness:	Brent Walker	Photo #:	2
Description:	View of the NW corner of the primary lagoon. Note the sludge accumulation in bottom left.

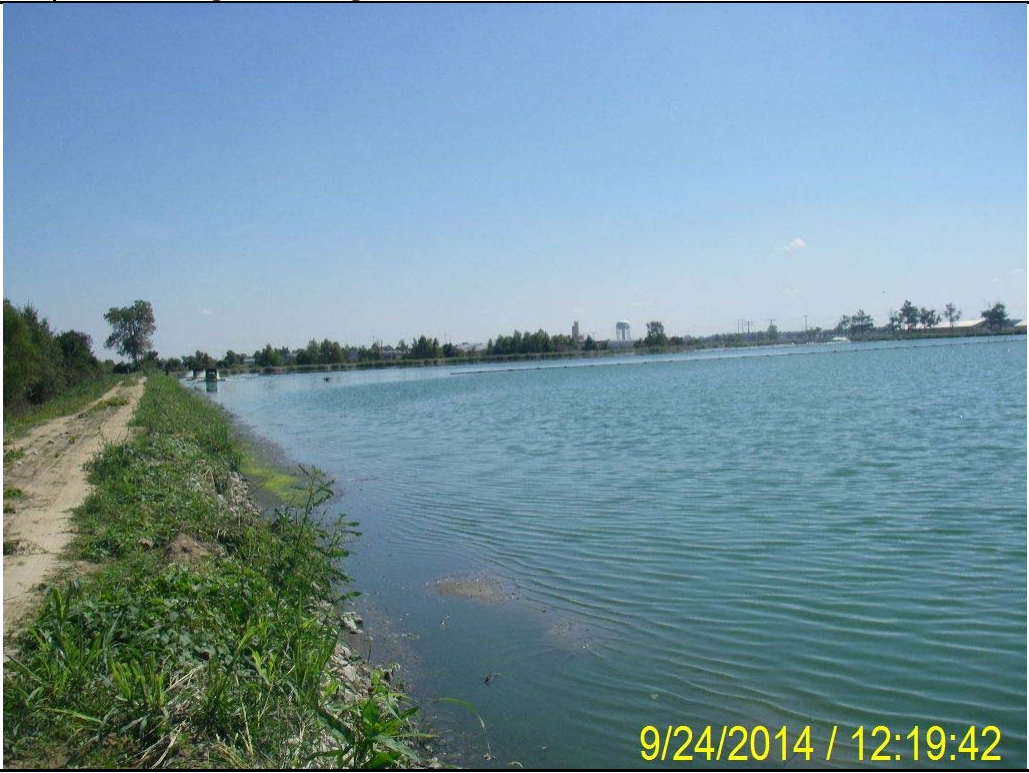
Location:	City of Marion WWTP		
Photographer:	Michael Greenway	Date:	9/24/2014
Witness:	Brent Walker	Time:	12:19
		Photo #:	3
Description:	View along the north levee of the primary lagoon. Note the depth of water and visible sludge in the lagoon near the levee.

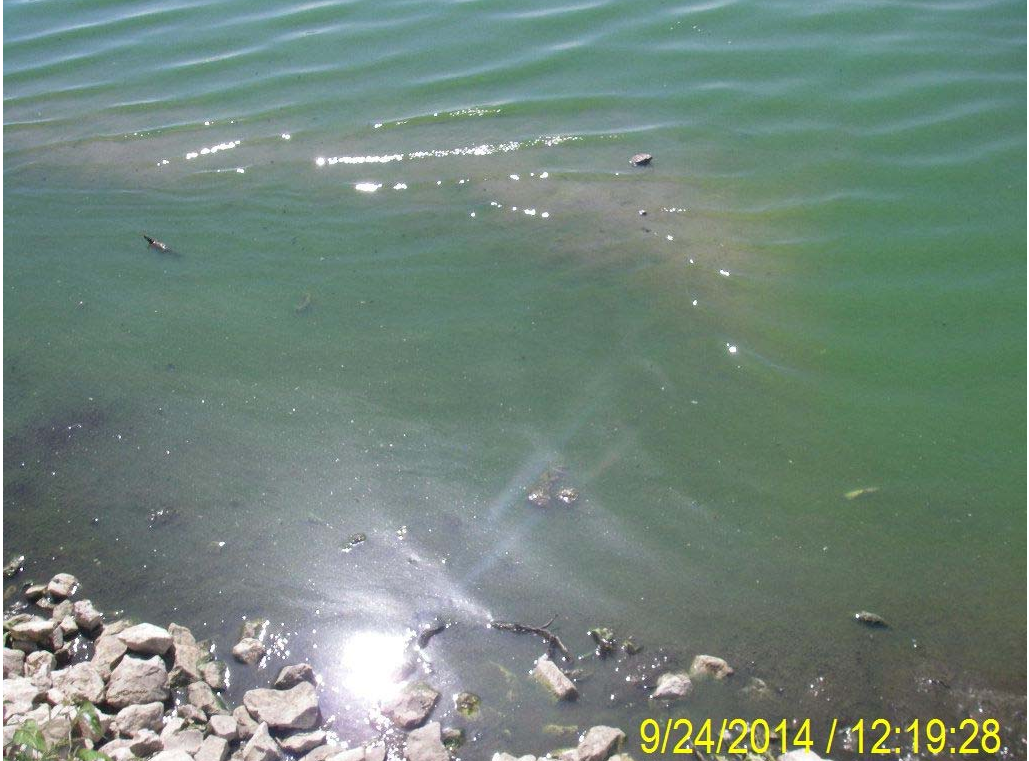
Photographer:	Michael Greenway	Date:	9/24/2014
Witness:	Brent Walker	Time:	12:19
		Photo #:	4
Description:	Closer view of sludge accumulation along the north levee of the primary lagoon.

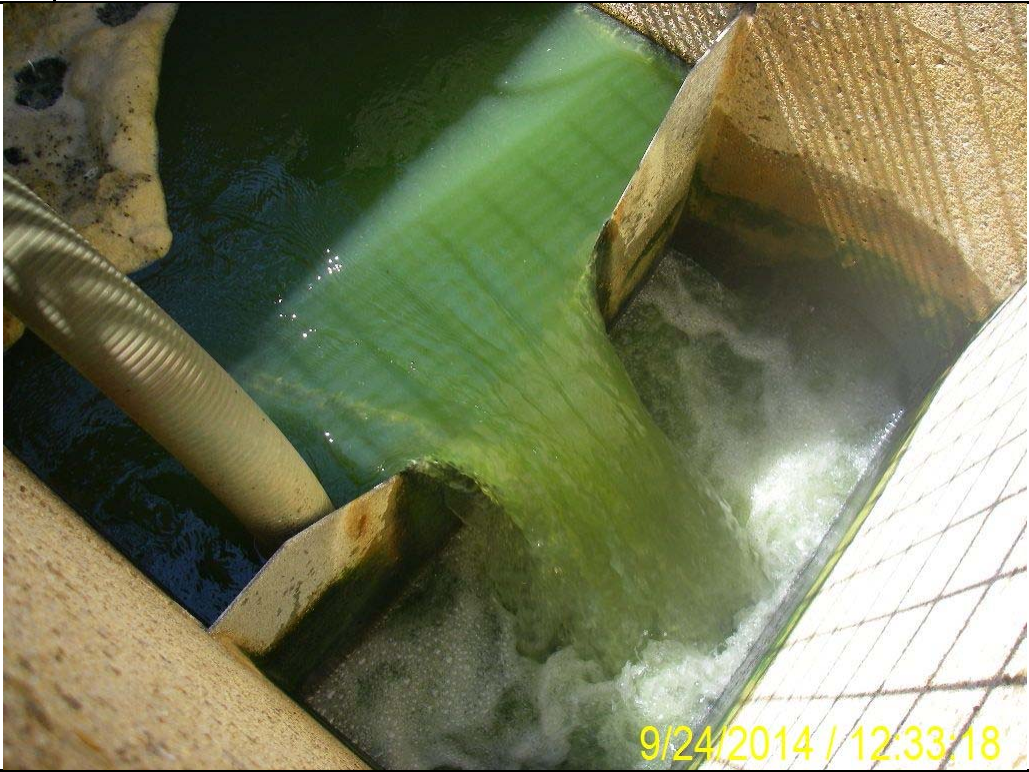
Water Division Photographic Evidence Sheet			
Location:	City of Marion WWTP		
Photographer:	Michael Greenway	Date:	9/24/2014
Time:	12:33	Witness:	Brent Walker
Photo #:	5	Description:	View of effluent and the outfall weir.

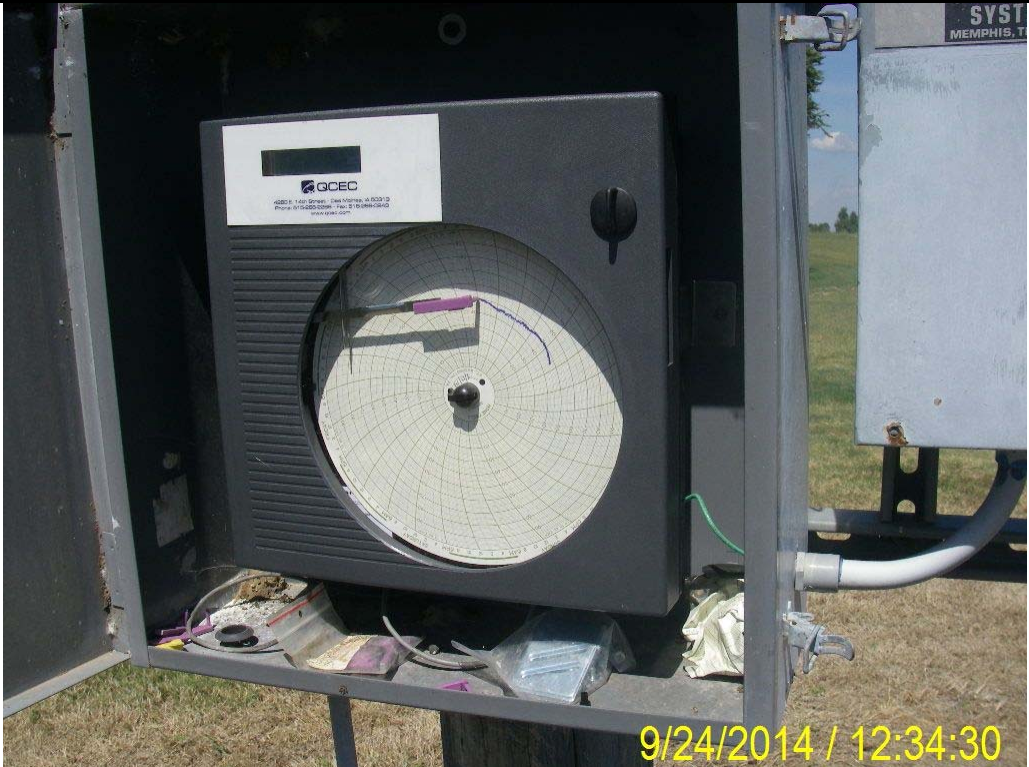
Photographer:	Michael Greenway	Date:	9/24/2014
Time:	12:34	Witness:	Brent Walker
Photo #:	6	Description:	View of flow measurement equipment.
