RE: Searcy WWTF Inspection AFIN: 73-00055 Permit No.: AR0021601

Inspection Report:	Searcy WWTF.	AFIN: 73-00055.	Permit #:	AR0021601

Issues and actions from ADEQ inspection of 10/8/2014

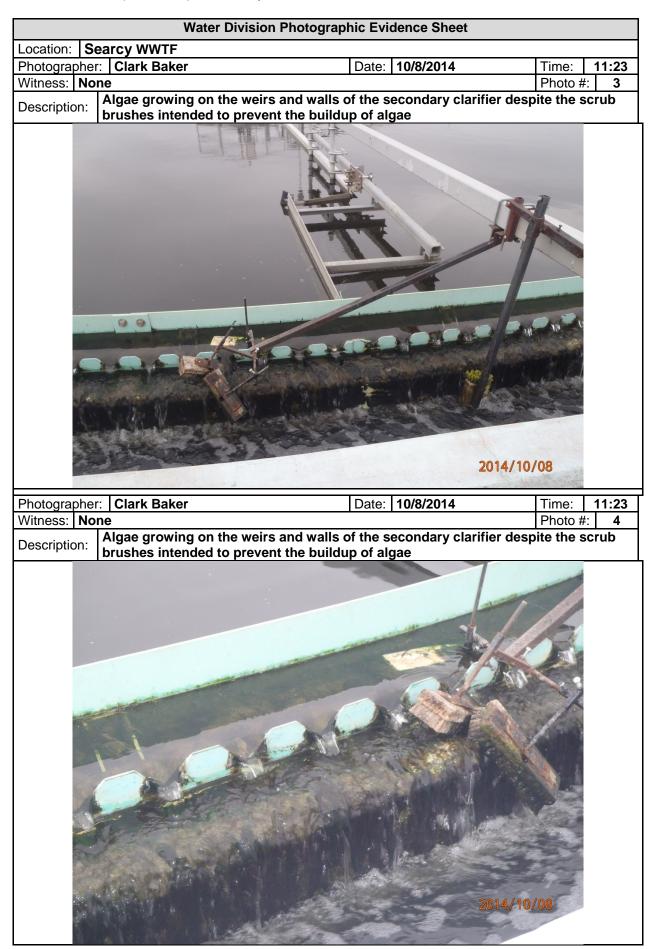
1. TREATMENT UNITS PROPERLY OPERATED:	Øs Om Ou Ona One
2. TREATMENT UNITS PROPERLY MAINTAINED: Vegetation in treatment units. Some algae on the weirs of the secondary clarifier, the brushes on the scraper used to prevent the buildup of algae may need to be replaced. There is evidence of algae and other solids recovered from the secondary clarifier being wasted on the ground instead of being properly disposed of.	⊡s Øm ⊡u ⊡na ⊡ne

Water Division Photogra	aphic Evidence Sheet	
	cy WWTF		
Photographer:	Clark Baker	Date: 10/8/2014	Time: 11:17
Witness: None Description: Ve	egetation growing in treatment unit	s of the system	Photo #: 1
Photographer:	Clark Baker	Date: 10/8/2014	Time: 11:15
Witness: None			Photo #: 2
	egetation growing in treatment unit	s of the system

Issue #1 Vegetation growing within treatment units.

Action taken: Vegetation on anoxic zone baffles and secondary clarifier weirs have been removed and disposed of properly. Cleaning scheduled frequency has been increased. Operators have been instructed concerning proper disposal of vegetation.
