ARKANSAS
Department of Environmental Quality

RE: Stuttgart WWT Facility Inspection (Arkansas Co)
AFIN: 01-00214 NPDES Permit No.: AR0034380

A R K A N S A S Department of Environmental Quality		WATER DIVISION INSPECTION REPORT				
		AFIN: 01-00214		PERMIT #: AR0034380		DATE: 3/11/2015
		COUNTY: 01 Arkansas		PDS #: 082569		MEDIA: WN
		GPS LAT: 34.493917 LONG: -91.564159 LOCATION: Entrance				
FACILITY INFORMATION			INSPECTION INFORMATION			
NAME: Stuttgart WWT Facility LOCATION: 1011 West 10th Street CITY: Stuttgart, AR 72160			FACILITY TYPE: 1 - Municipal			
			INSPECTOR ID#: 84022 S - State			
			FACILITY EVALUATION RATING: 1 - Unsatisfactory		INSPECTION TYPE: Reconnaissance	
			DATE(S): 3/11/2015	ENTRY TIME: 09:45	EXIT TIME: 11:15	
			PERMIT EFFECTIVE DATE:			
RESPONSIBLE OFFICIAL						
NAME / TITLE: JW Green / Mayor COMPANY: Stuttgart WWT Facility MAILING ADDRESS: 612 S. College CITY, STATE, ZIP: Stuttgart AR 72160 PHONE & EXT. / FAX: 8706733246 / EMAIL: stuttgartarwater@centurytel.net			PERMIT EXPIRATION DATE: FAYETTEVILLE SHALE RELATED: N FAYETTEVILLE SHALE VIOLATIONS: N

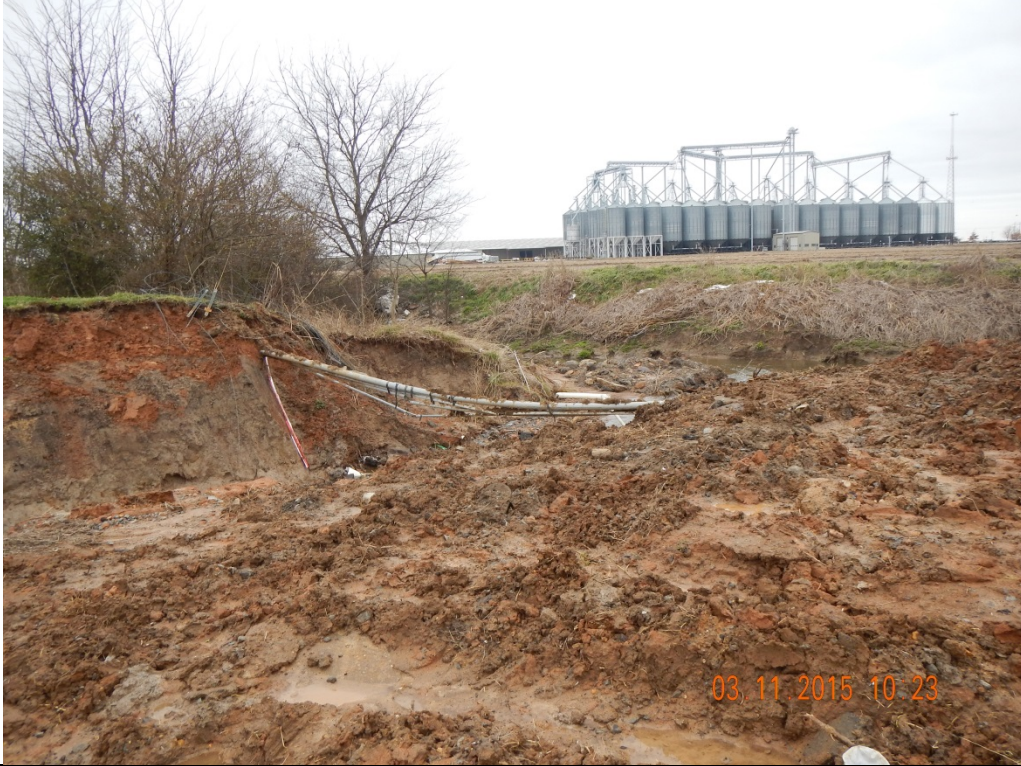
03, 11, 2015 10:23

**	OTHER:					
SUMMARY OF FINDINGS						
<p>The following violations were noted during the inspection:</p> <p>1.) A breach in the flow EQ basin was allowing the discharge of untreated wastewater into an unnamed irrigation ditch, thence to King Bayou, thence to Bayou Meto, and thence to the Arkansas River (Segment 3B). This is a violation of A.C.A. § 8-4-217 (a)(2), which states, "It shall be unlawful for any person to place or cause to be placed any sewage, industrial waste, or other wastes in a location where it is likely to cause pollution of any waters of this state."</p> <p>2.) This breach in the flow EQ basin resulted in an unpermitted discharge of untreated wastewater to the receiving stream (unnamed irrigation ditch). This is a violation of A.C.A. § 8-4-217 (b)(1)(E), which states, "It shall be unlawful for any person to engage in any of the following acts without having first obtained a written permit from the department to discharge sewage, industrial waste, or other wastes into any of the waters of this state."</p> <p>3.) A distinct debris line of grit and floatables was noted at the top of the flow EQ basin; indicating high-water levels in the basin. Adequate freeboard in ponds is a type of Best Management Practice (BMP) that protects pond levee integrity. Furthermore, the inner levee is not protected from wave action or burrowing animal activity (i.e., use of rip-rap). Lack of BMPs has resulted in a breach of the flow EQ basin. This is a violation of Part II, 6 of the permit.</p> <p>4.) The flow EQ basin levees have not been maintained. This lack of maintenance has resulted in a breach of the levee and an unpermitted discharge of untreated wastewater into the receiving stream (unnamed irrigation ditch). This is a violation of Part III, Section B, 1 of the permit.</p>

Location:	Stuttgart WWT Facility		
Photographer:	Kerri McCabe	Date:	March 11, 2015
Time:	1023	Witness:	District 6 Inspector Henderson
Photo #:	1	Description:	Breach in flow EQ basin at Stuttgart WWT Facility; facing away from flow EQ basin.

On March 11, 2015, Inspector Henderson and I arrived at the facility at approximately 0945. We were assisted by Operator Danny Wilson with Stuttgart WWT Facility. We went to the flow EQ basin levee breach, which was actively discharging untreated wastewater into waters of the State. This location is not the facility's permitted outfall, and the unpermitted discharge was occurring downstream of the permitted outfall in the receiving stream. It was noted that a distinct line of grit and floatables were present at the top of the flow EQ basin levees; indicating that the EQ basin had experienced high-water levels. Excessive high-water levels compromise levee integrity. The flow EQ basin inner levees are not protected with rip-rap or other structural controls to prevent wave action, burrowing, etc. The facility had made no attempts to slow the flow of the unpermitted discharge from the breached levee. They stated saturated conditions were making it difficult to get equipment to the location. When asked about a timeline for remediation, Mr. Wilson stated that they expected to cease the unpermitted discharge mid-April 2015 and have the levee repaired completely by early May 2015.

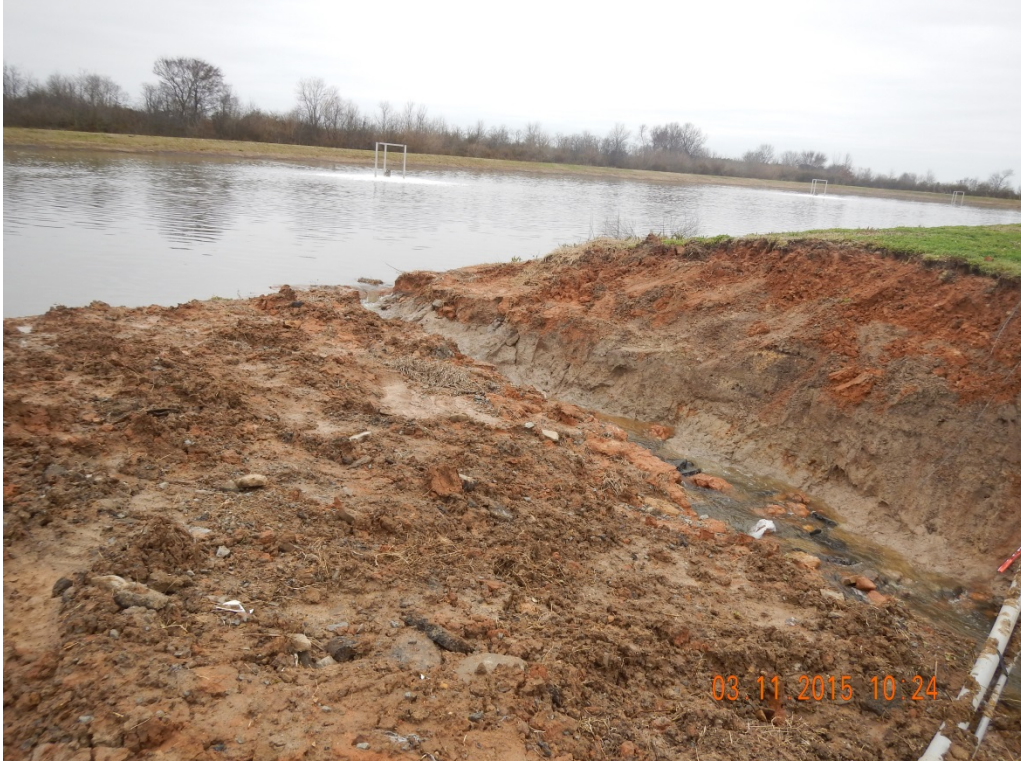
03, 11, 2015 10:24

Photographer:	Kerri McCabe	Date:	March 11, 2015
Time:	1024	Witness:	District 6 Inspector Henderson
Photo #:	2	Description:	Breach in flow EQ basin at Stuttgart WWT Facility; facing toward flow EQ basin.

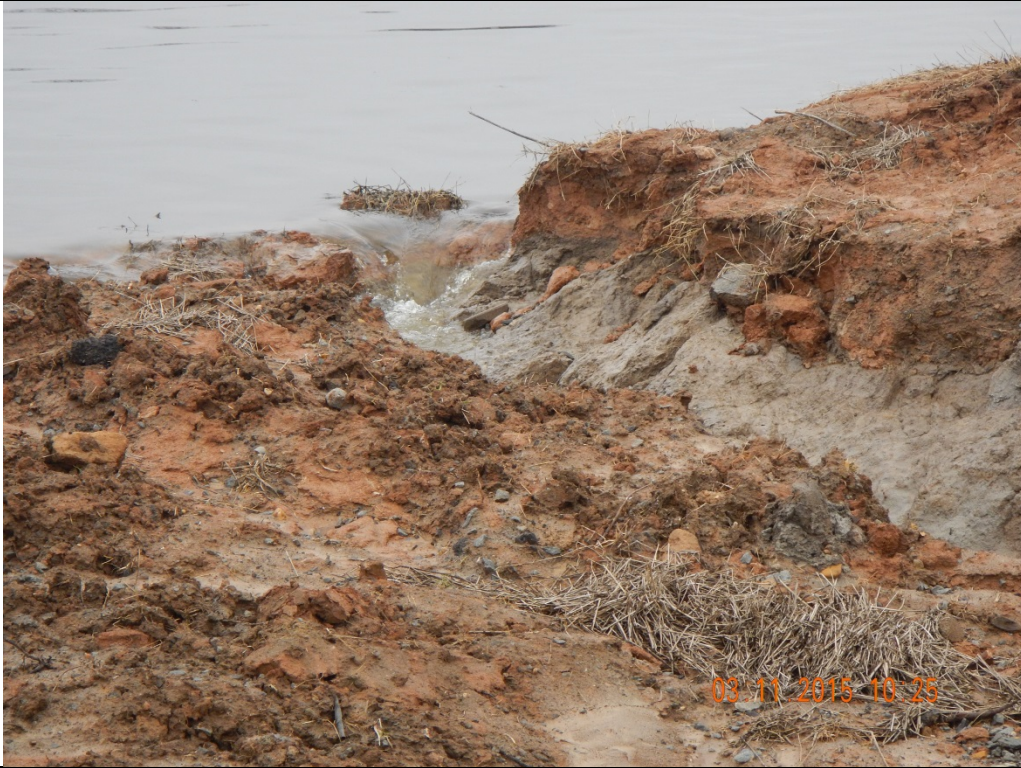
Location:	Stuttgart WWT Facility		
Photographer:	Kerri McCabe	Date:	March 11, 2015
Time:	1025	Witness:	District 6 Inspector Henderson
Photo #:	3	Description:	Close-up of breach in flow EQ basin levee with flow of untreated wastewater.

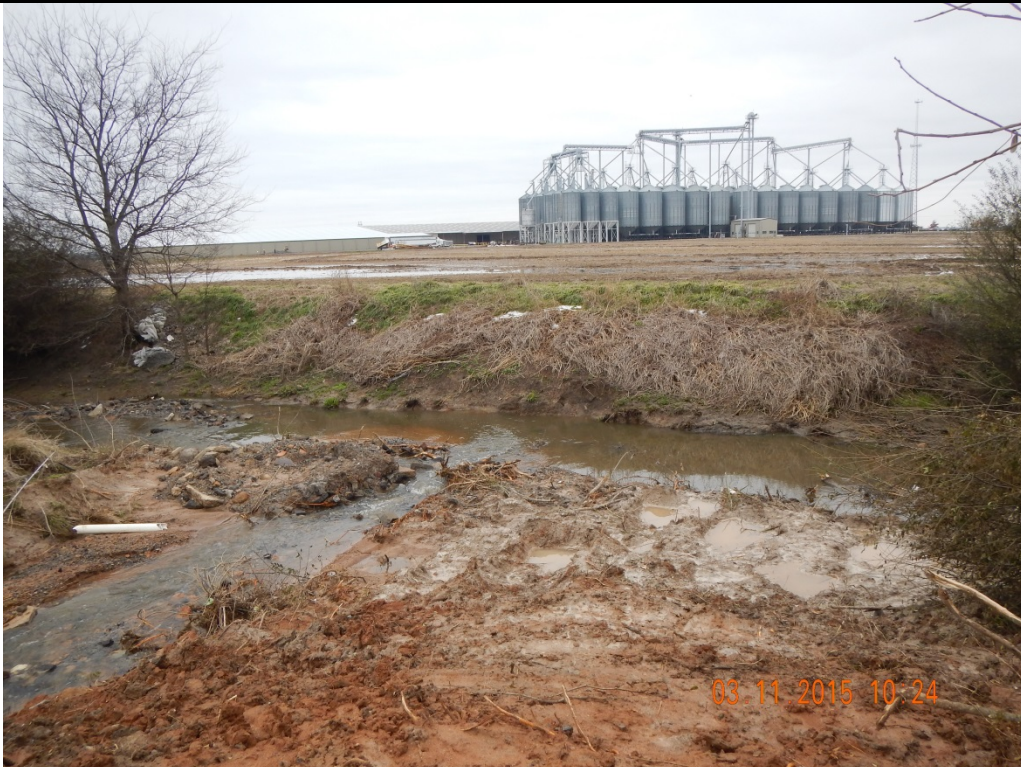
Photographer:	Kerri McCabe	Date:	March 11, 2015
Time:	1024	Witness:	District 6 Inspector Henderson
Photo #:	4	Description:	Unpermitted discharge of untreated wastewater into receiving stream; downstream (left) and upstream (right).

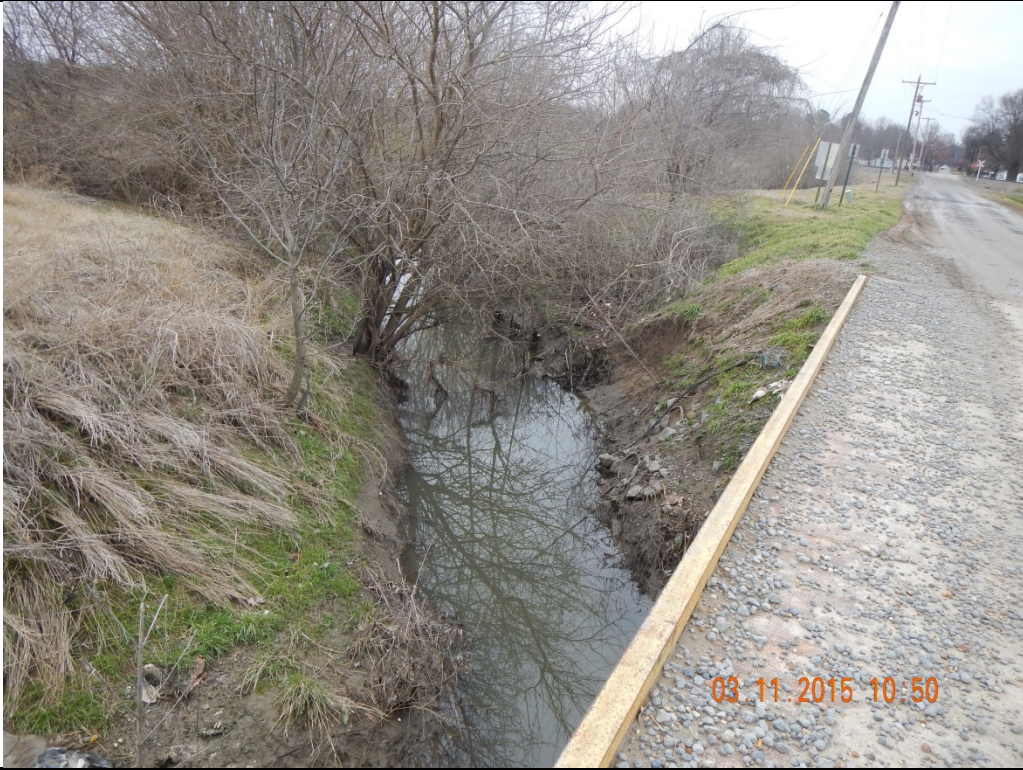
Location:	Stuttgart WWT Facility		
Photographer:	Kerri McCabe	Date:	March 11, 2015
Time:	1050	Witness:	District 6 Inspector Henderson
Photo #:	5	Description:	Upstream sample location; facing upstream of the receiving stream and away from WWTP.

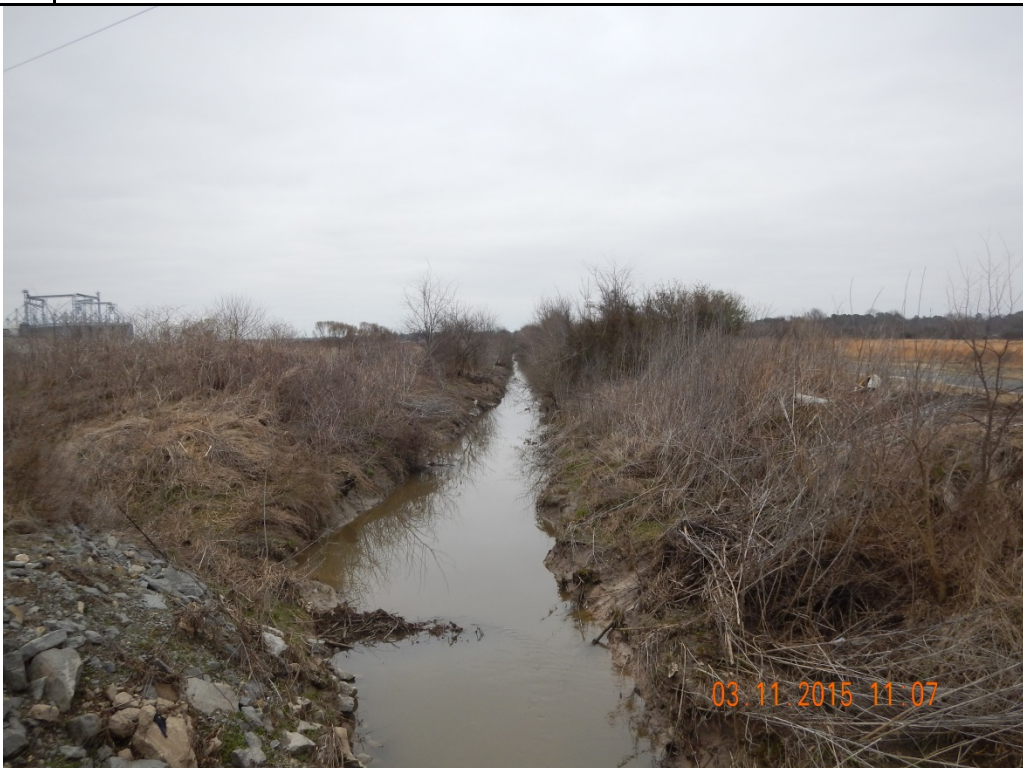
Photographer:	Kerri McCabe	Date:	March 11, 2015
Time:	1107	Witness:	District 6 Inspector Henderson
Photo #:	6	Description:	Downstream sample location; facing upstream of receiving stream and toward WWTP.
