## WATER DIVISION INSPECTION REPORT

AFIN: 18-00110	PERMIT #: AR0021971	DATE: 3/12/2015
COUNTY: 18 Crittenden	PDS #: 084342	MEDIA: WN
GPS LAT: 35.19036 LONG: -90.22844 LOCATION: Entrance

FACILITY INFORMATION	INSPECTION INFORMATION	
NAME: <b>City of Marion STP</b> LOCATION: <b>5054 Hardin Rd.</b> CITY: <b>Marion</b>	FACILITY TYPE: <b>1 - Municipal</b> INSPECTOR ID#: <b>52138 S - State</b> FACILITY EVALUATION RATING: <b>N</b> INSPECTION TYPE: <b>Reconnaissance</b> DATE(S): <b>3/12/2015</b> ENTRY TIME: <b>12:50</b> EXIT TIME: <b>13:20</b> PERMIT EFFECTIVE DATE: <b>12/1/2013</b> PERMIT EXPIRATION DATE: <b>6/30/2017</b>	
RESPONSIBLE OFFICIAL	FAYETTEVILLE SHALE RELATED: <b>N</b> FAYETTEVILLE SHALE VIOLATIONS: <b>N</b> <b>INSPECTION PARTICIPANTS</b> NAME/TITLE/PHONE/FAX/EMAIL/ETC.: <b>None</b>	
NAME / TITLE: <b>Frank Fogleman / Mayor</b> COMPANY: <b>City of Marion</b> MAILING ADDRESS: <b>14 Military Rd.</b> CITY, STATE, ZIP: <b>Marion AR 72364</b> PHONE & EXT. / FAX: <b>870-739-5410 /</b> EMAIL:		
CONTACTED DURING INSPECTION: <b>No</b>		
<b>AREA EVALUATIONS</b> (S=Satisfactory, M=Marginal, U=Unsatisfactory, N=Not Applicable/Evaluated)

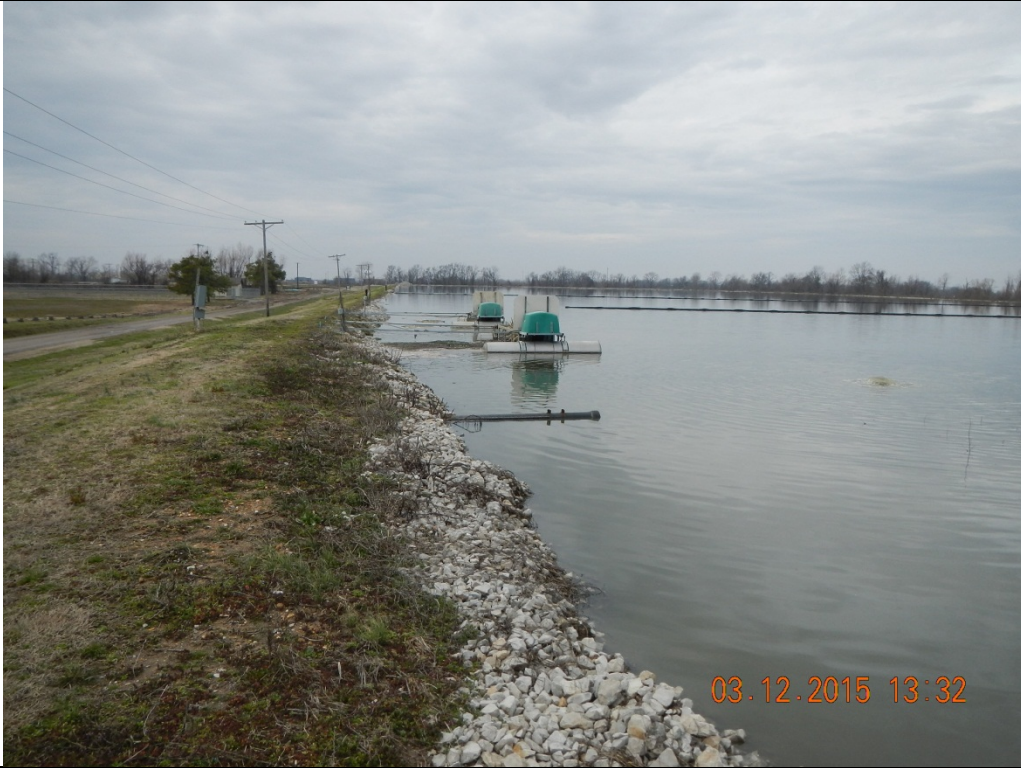
Location:	<b>City of Marion STP</b>		
Photographer:	<b>Brent Walker</b>	Date:	<b>3/12/2015</b>
Witness:	<b>None</b>	Time:	<b>1332</b>
		Photo #:	<b>1</b>
Description:	<b>Lagoon with minimal freeboard.</b>

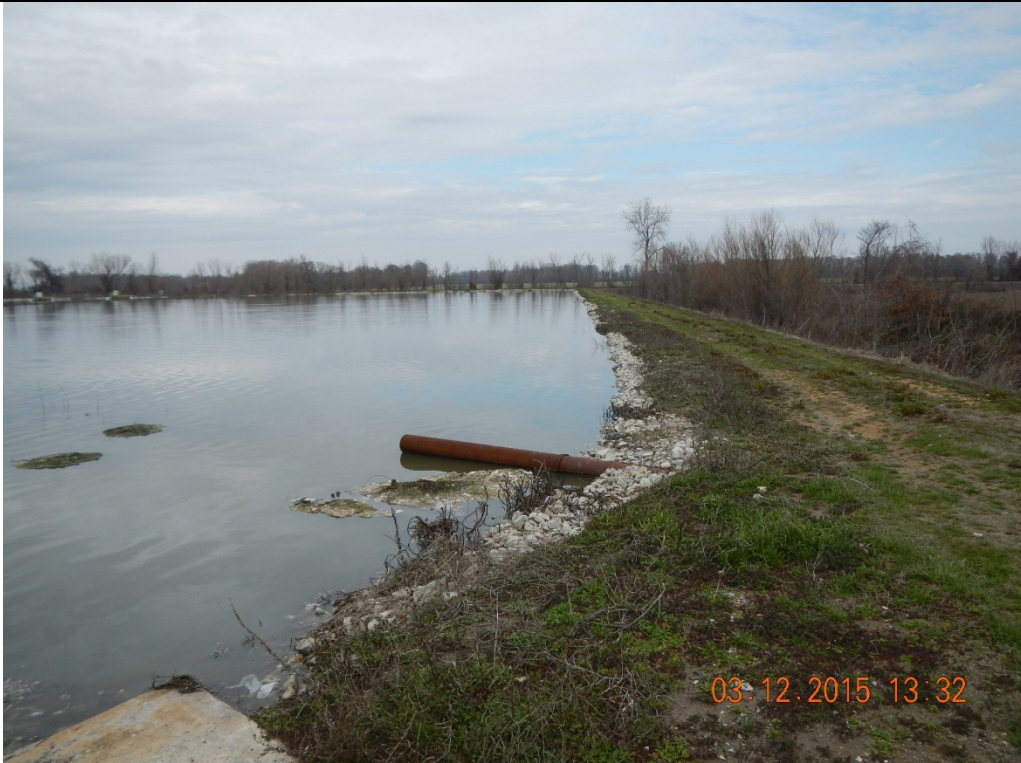
Photographer:	<b>Brent Walker</b>	Date:	<b>3/12/2015</b>
Witness:	<b>None</b>	Time:	<b>1332</b>
		Photo #:	<b>2</b>
Description:	<b>Lagoon with minimal freeboard.</b>

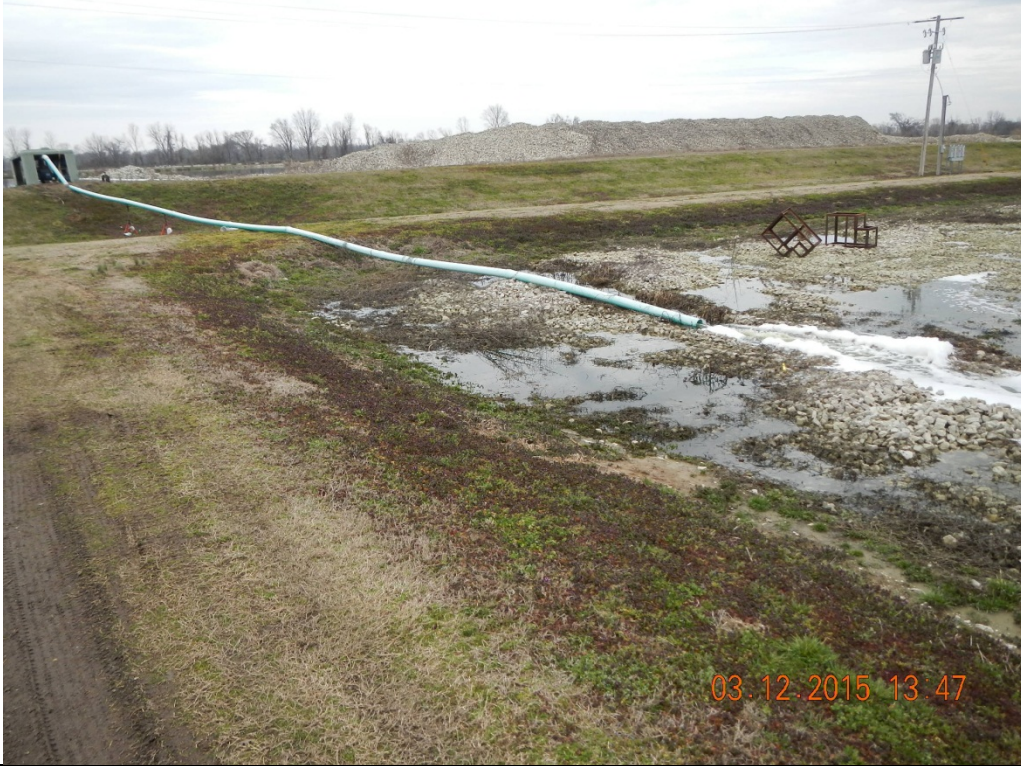
A temporary pump was being used to pump from the third lagoon to the northwest rock reed filter. This filter was hydraulically overloaded resulting in a bypass across the surface of the filter. Flow from the third lagoon was being diverted to the old concrete outfall structure located between the lagoon and the rock reed filter.

Location:	<b>City of Marion STP</b>				
Photographer:	<b>Brent Walker</b>	Date:	<b>3/12/2015</b>	Time:	<b>1347</b>
Witness:	<b>None</b>	Photo #:	<b>3</b>		
Description:	<b>Pump discharging to flooded northwest rock reed filter.</b>

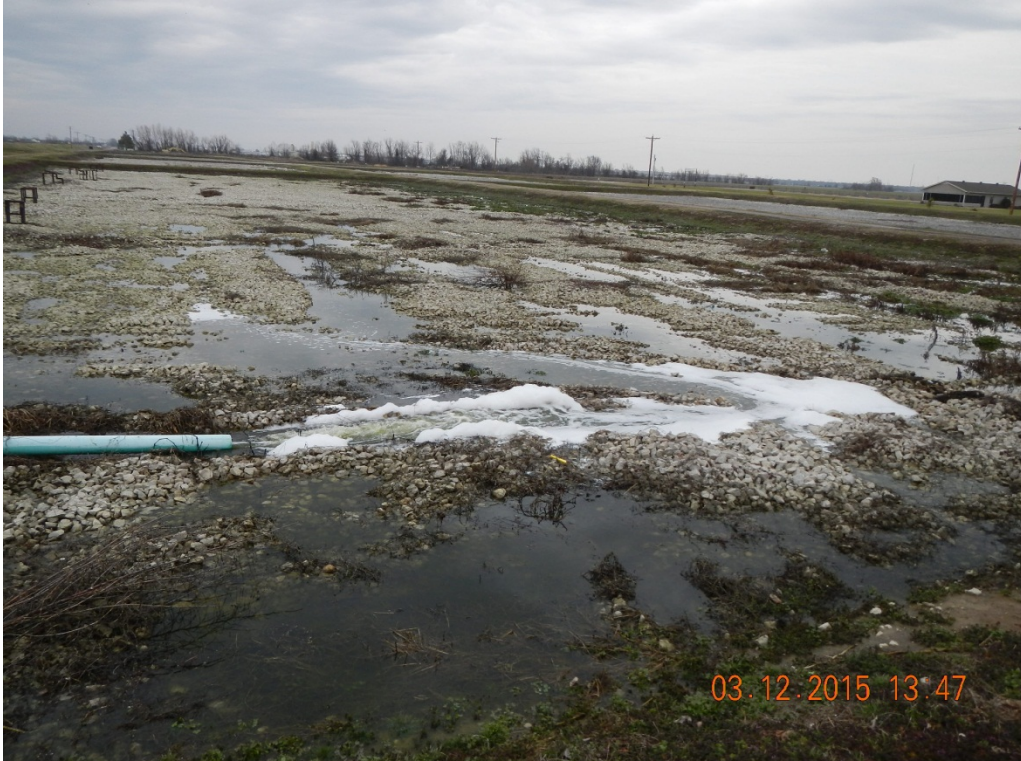
Photographer:	<b>Brent Walker</b>	Date:	<b>3/12/2015</b>	Time:	<b>1347</b>
Witness:	<b>None</b>	Photo #:	<b>4</b>		
Description:	<b>Pump discharging to flooded northwest rock reed filter.</b>

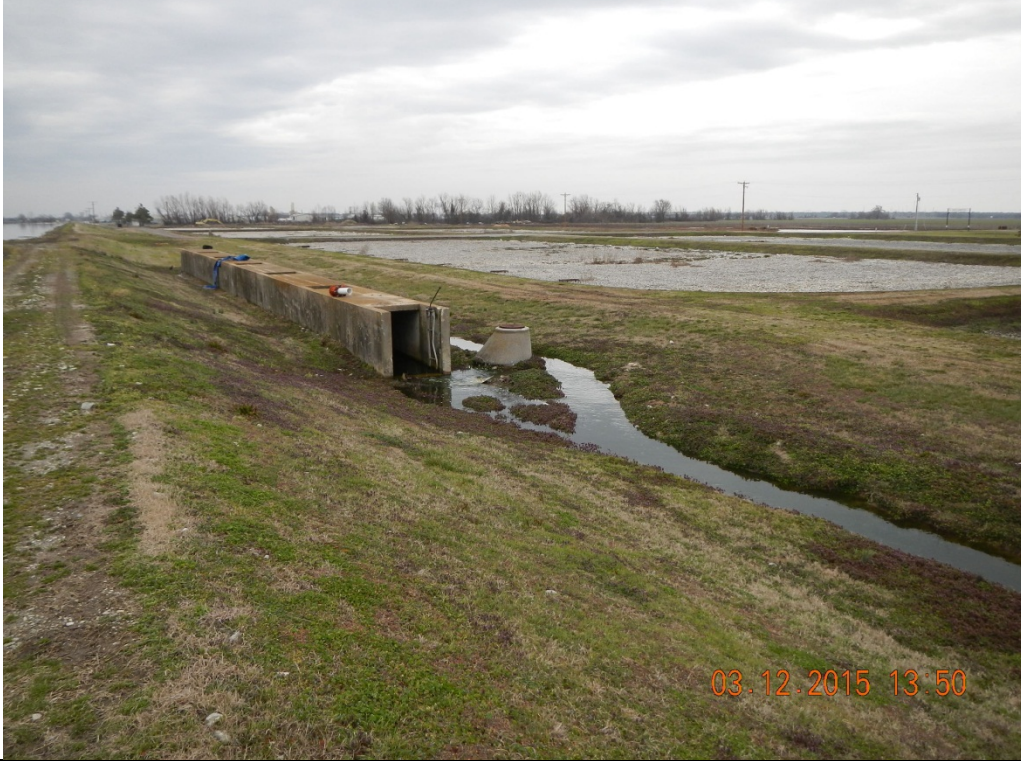
The old concrete outfall structure was discharging in two locations thus resulting in two unpermitted discharges.

Location:	<b>City of Marion STP</b>		
Photographer:	<b>Brent Walker</b>	Date:	<b>3/12/2015</b>
Witness:	<b>None</b>	Time:	<b>1350</b>
		Photo #:	<b>5</b>
Description:	<b>Overflow from old concrete outfall structure.</b>

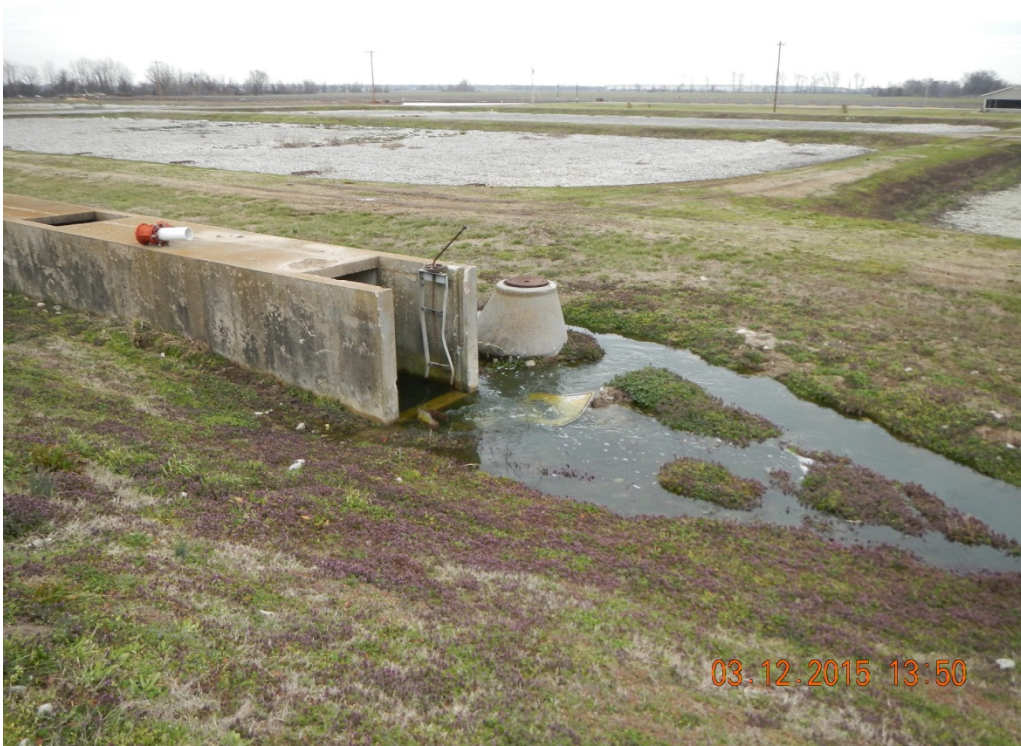
Photographer:	<b>Brent Walker</b>	Date:	<b>3/12/2015</b>
Witness:	<b>None</b>	Time:	<b>1350</b>
		Photo #:	<b>6</b>
Description:	<b>Overflow from old concrete outfall structure.</b>

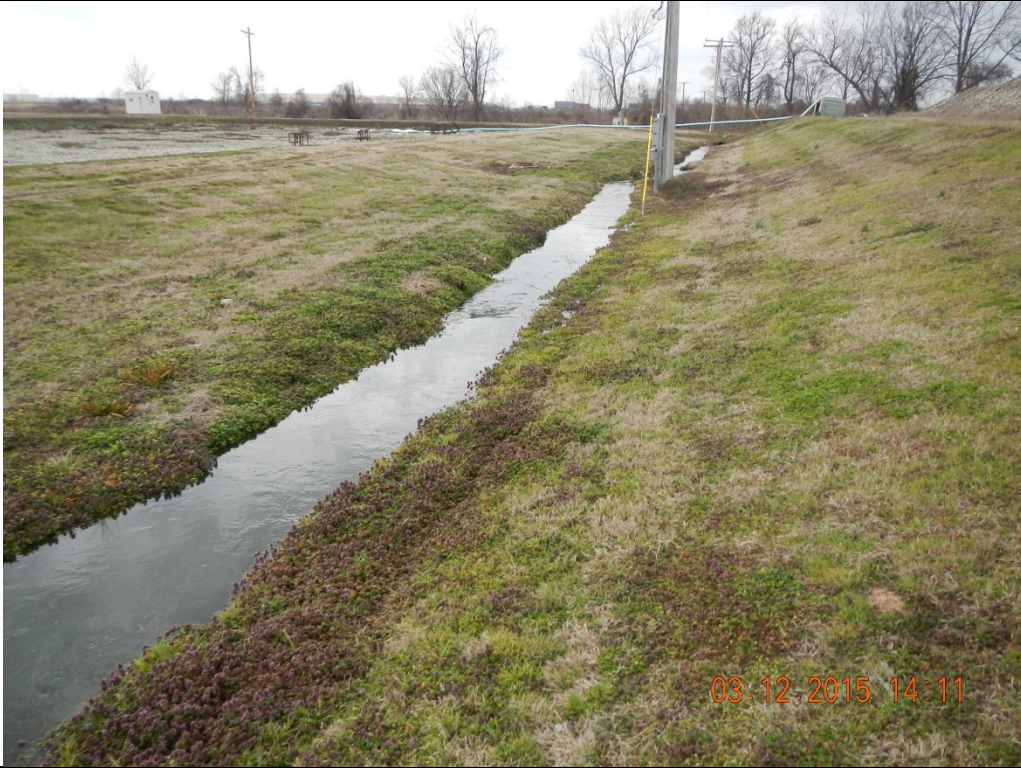
1. The structure was overflowing to the surface of the ground and flowing down a ditch to a corrugated plastic culvert where it flowed into the receiving stream.
2. The structure was also discharging directly to the receiving stream via the old underground discharge pipe.

Location:	<b>City of Marion STP</b>		
Photographer:	<b>Brent Walker</b>	Date:	<b>3/12/2015</b>
Witness:	<b>None</b>	Time:	<b>1411</b>
		Photo #:	<b>7</b>
Description:	<b>Overflow from old concrete outfall structure flowing toward receiving stream.</b>

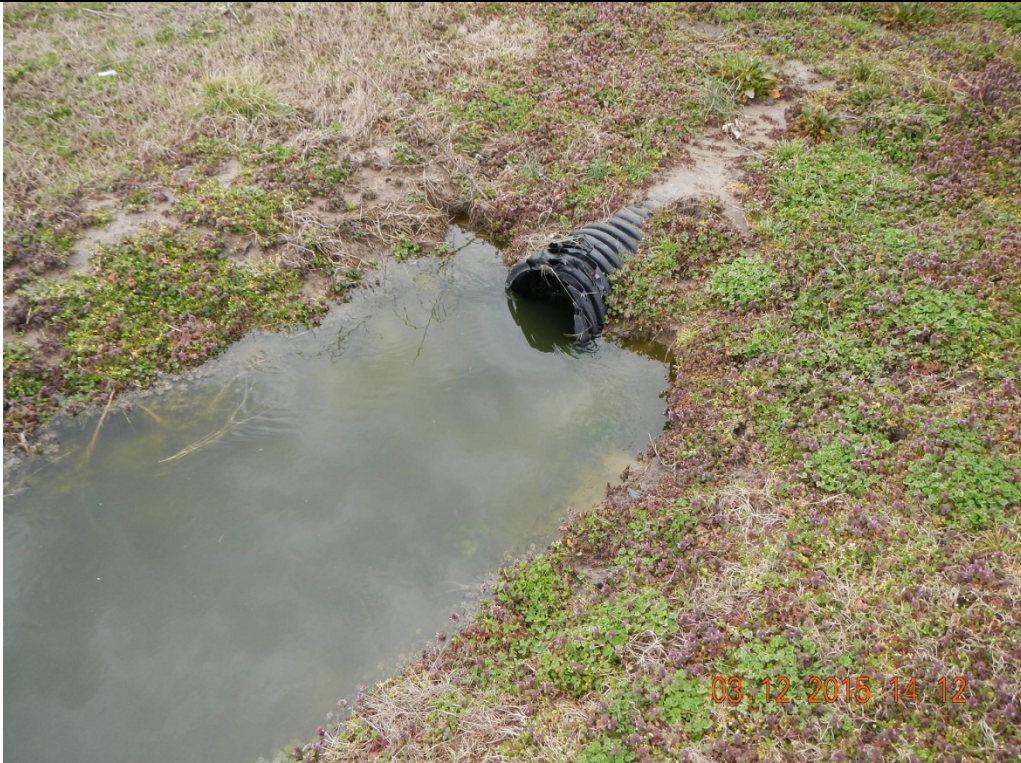
Photographer:	<b>Brent Walker</b>	Date:	<b>3/12/2015</b>
Witness:	<b>None</b>	Time:	<b>1412</b>
		Photo #:	<b>8</b>
Description:	<b>Overflow from old concrete outfall structure entering plastic corrugated culvert.</b>

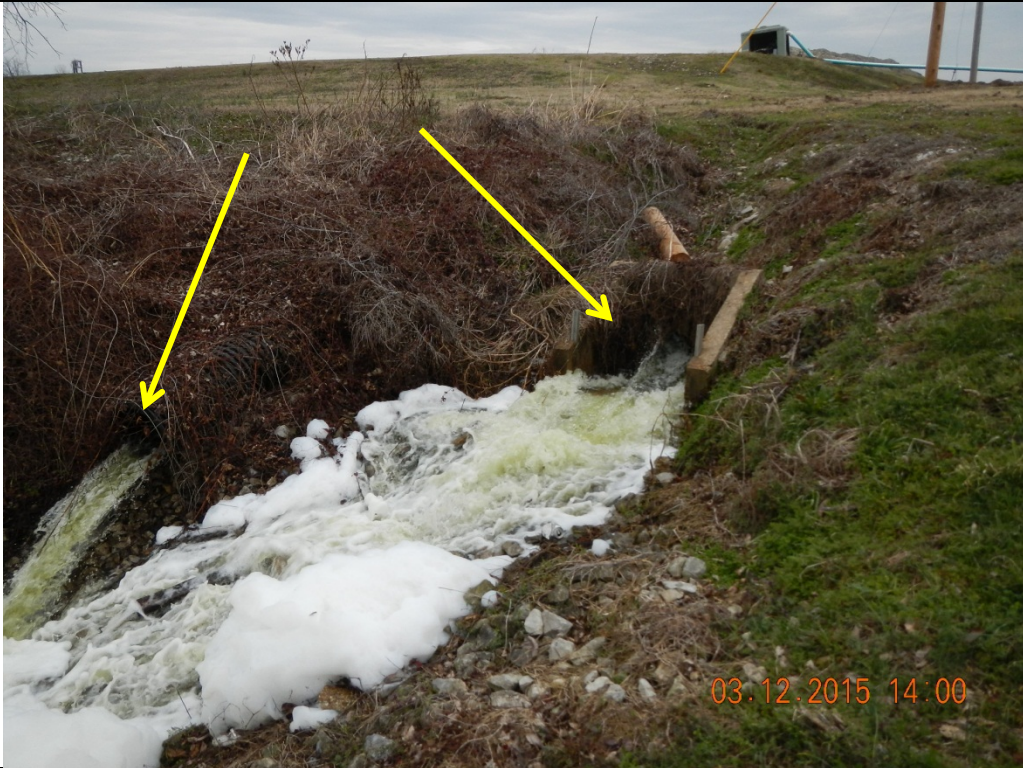
Location:	<b>City of Marion STP</b>		
Photographer:	<b>Brent Walker</b>	Date:	<b>3/12/2015</b>
Witness:	<b>None</b>	Time:	<b>1400</b>
		Photo #:	<b>9</b>
Description:	<b>Unpermitted discharges directly from old concrete outfall structure (right) and via plastic corrugated culvert (left).</b>

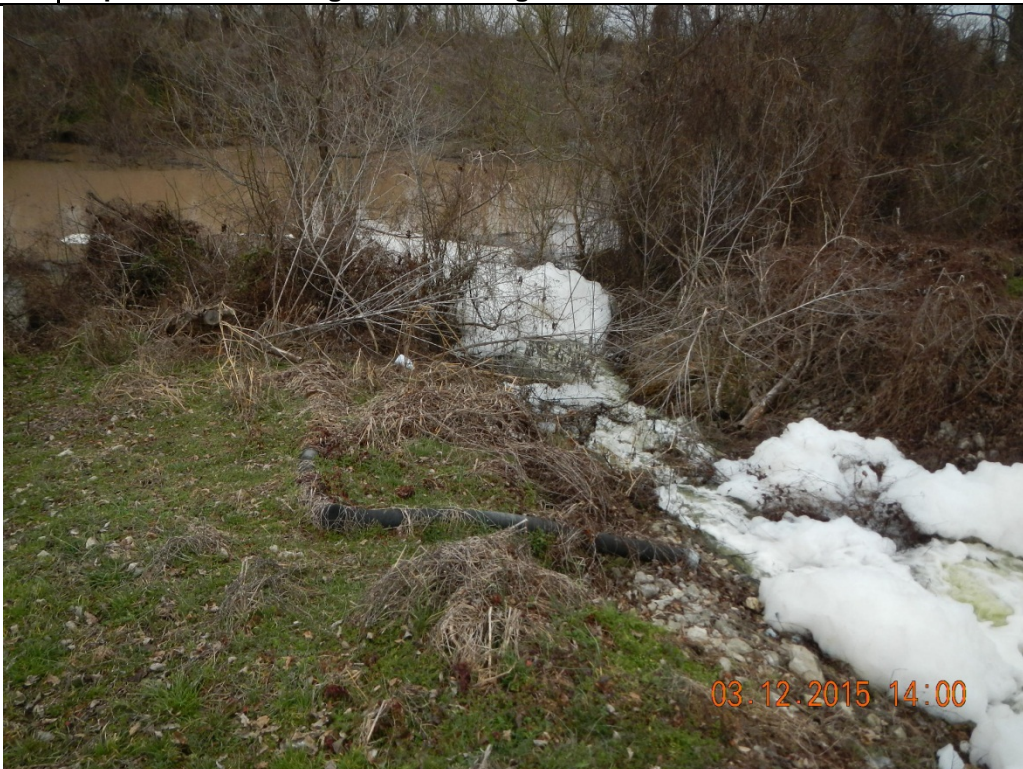
Photographer:	<b>Brent Walker</b>	Date:	<b>3/12/2015</b>
Witness:	<b>None</b>	Time:	<b>1400</b>
		Photo #:	<b>10</b>
Description:	<b>Unpermitted discharges to receiving stream.</b>
