## WATER DIVISION INSPECTION REPORT

AFIN: 18-00110	PERMIT #: AR0021971	DATE: 3/20/2015
COUNTY: 18 Crittenden	PDS #: 084343	MEDIA: WN
GPS LAT: 35.19036 LONG: -90.22844 LOCATION: Entrance

FACILITY INFORMATION	INSPECTION INFORMATION
NAME: <b>City of Marion STP</b> LOCATION: <b>5054 Hardin Rd.</b> CITY: <b>Marion</b>	FACILITY TYPE: <b>1 - Municipal</b> INSPECTOR ID#: <b>52138 S - State</b> FACILITY EVALUATION RATING: <b>N</b> INSPECTION TYPE: <b>Reconnaissance</b>
	DATE(S): <b>3/20/2015</b> ENTRY TIME: <b>12:50</b> EXIT TIME: <b>13:20</b> PERMIT EFFECTIVE DATE: <b>7/1/2014</b> PERMIT EXPIRATION DATE: <b>6/30/2019</b>
RESPONSIBLE OFFICIAL	
NAME / TITLE: <b>Frank Fogleman / Mayor</b> COMPANY: <b>City of Marion</b> MAILING ADDRESS: <b>14 Military Rd.</b> CITY, STATE, ZIP: <b>Marion AR 72364</b> PHONE & EXT. / FAX: <b>870-739-5410 /</b> EMAIL:	FAYETTEVILLE SHALE RELATED: <b>N</b> FAYETTEVILLE SHALE VIOLATIONS: <b>N</b>
CONTACTED DURING INSPECTION: <b>No</b>	INSPECTION PARTICIPANTS
	NAME/TITLE/PHONE/FAX/EMAIL/ETC.:

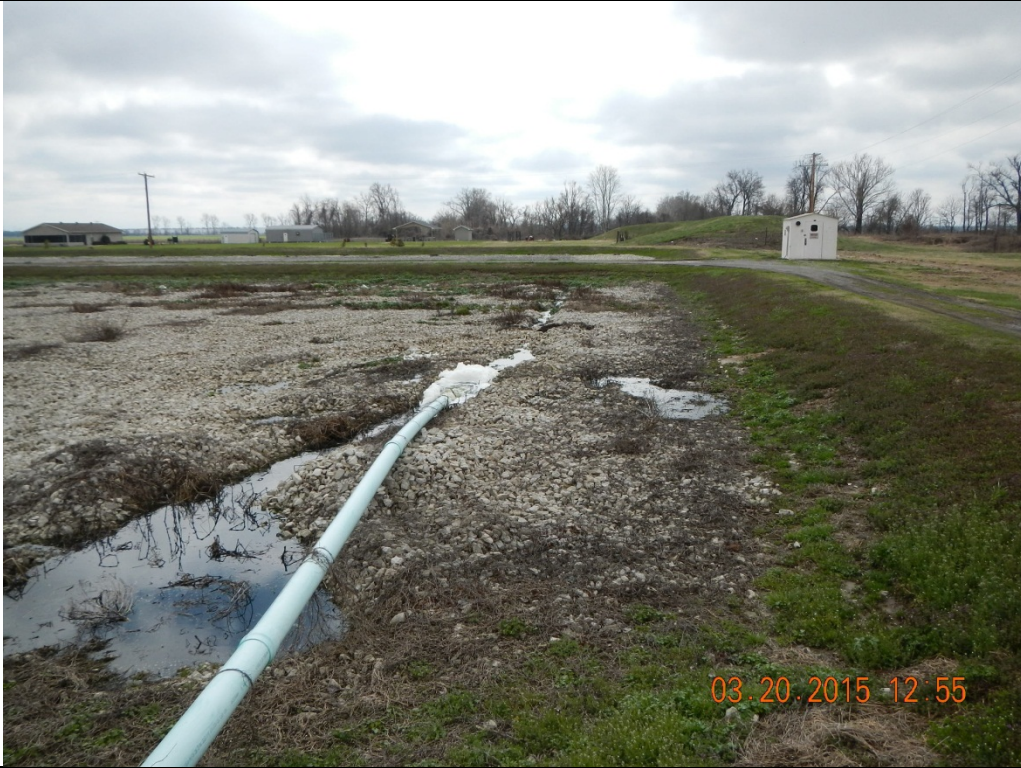
*A temporary pump was being used to pump from the third lagoon to the northwest rock reed filter. This filter was hydraulically overloaded resulting in a bypass across the surface of the filter.*

Location:	<b>City of Marion STP</b>		
Photographer:	<b>Brent Walker</b>	Date:	<b>3/20/2015</b>
Witness:	<b>None</b>	Time:	<b>1255</b>
		Photo #:	<b>1</b>
Description:	<b>Pump discharging to flooded northwest rock reed filter.</b>

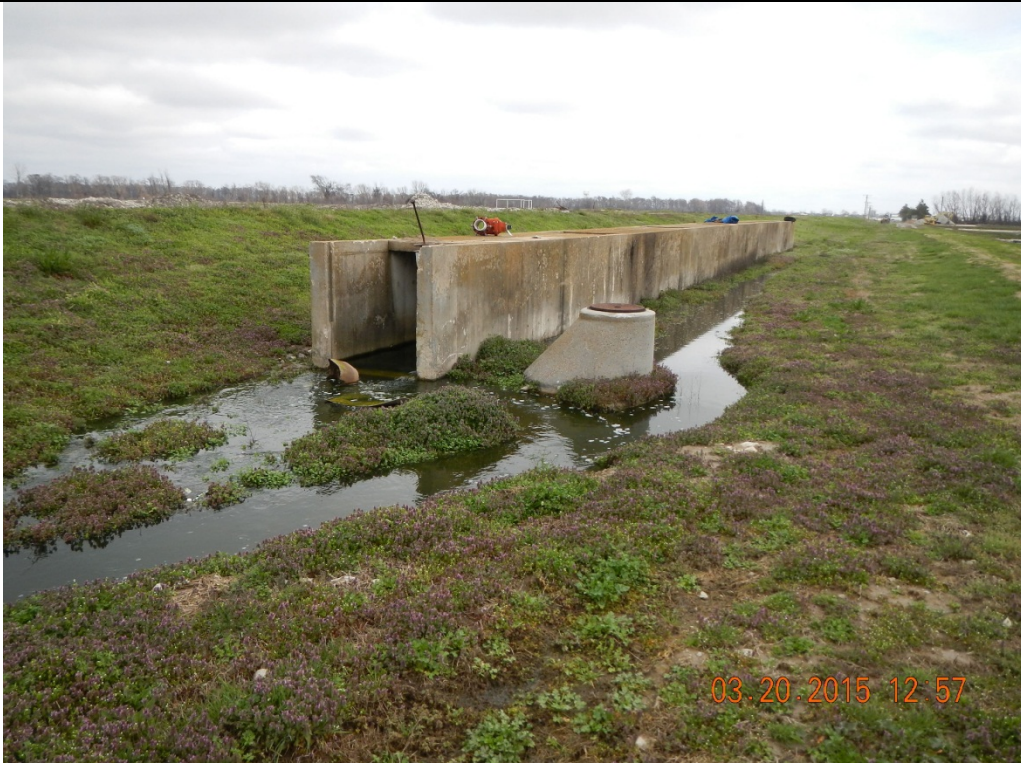
*The old concrete outfall structure was discharging in two locations thus resulting in two unpermitted discharges.*

Photographer:	<b>Brent Walker</b>	Date:	<b>3/20/2015</b>
Witness:	<b>None</b>	Time:	<b>1257</b>
		Photo #:	<b>2</b>
Description:	<b>Overflow from old concrete outfall structure.</b>

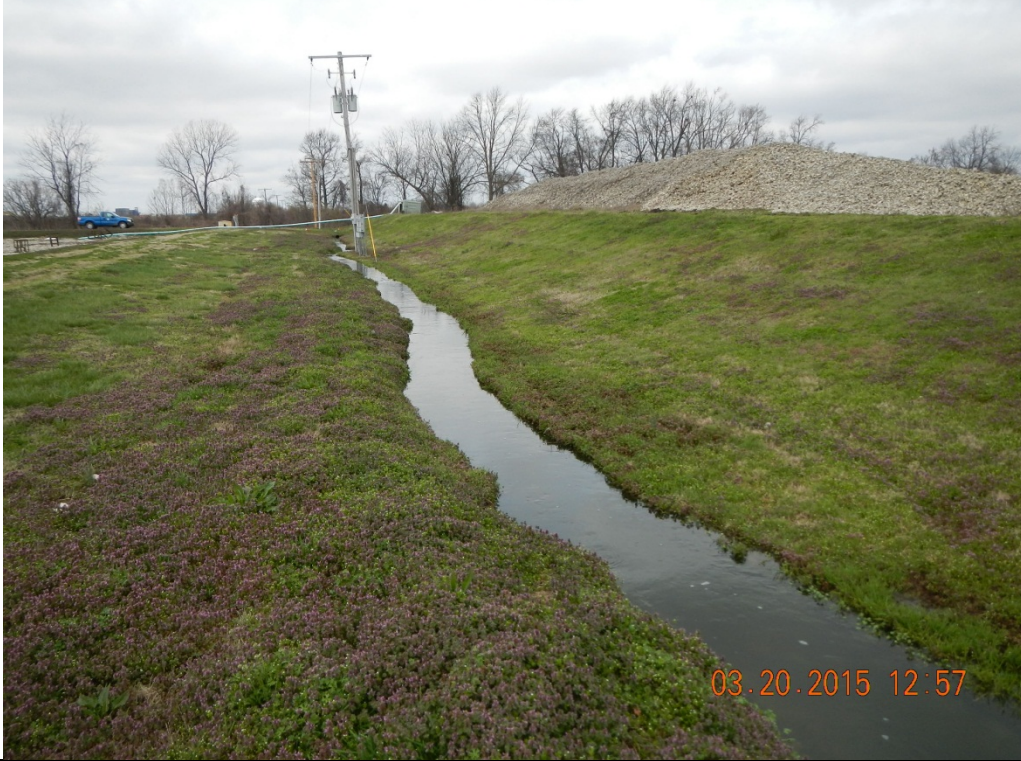
Location:	<b>City of Marion STP</b>		
Photographer:	<b>Brent Walker</b>	Date:	<b>3/20/2015</b>
Witness:	<b>None</b>	Time:	<b>1257</b>
		Photo #:	<b>3</b>
Description:	<b>Overflow from old concrete outfall structure flowing toward receiving stream.</b>

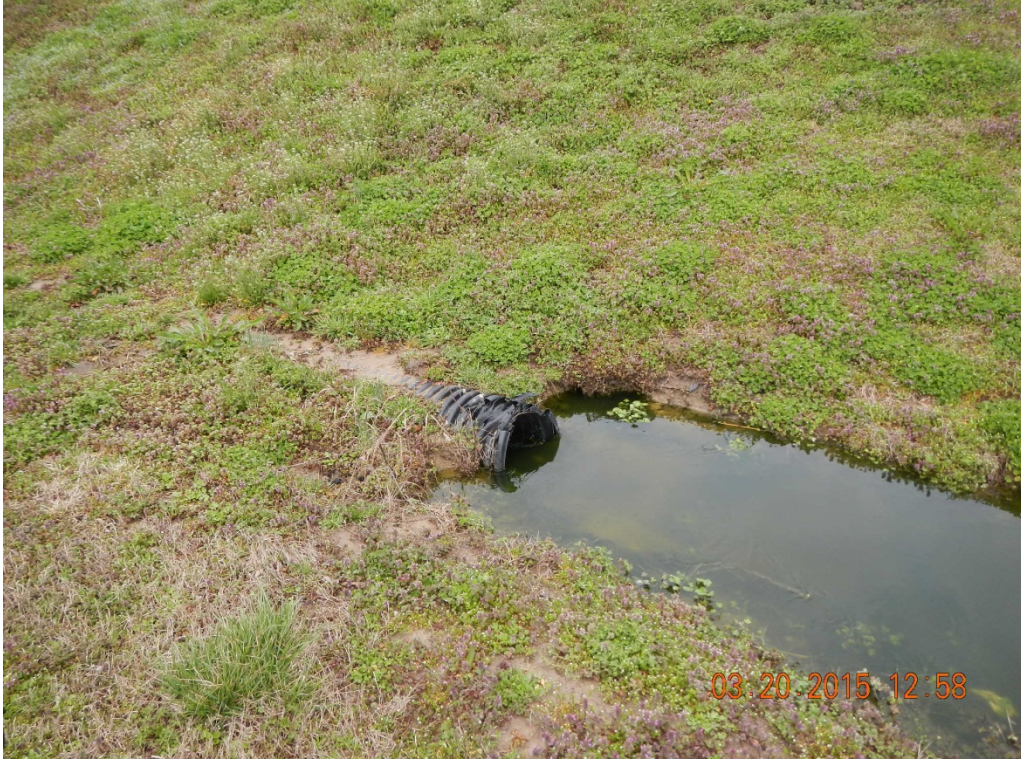
- 1. The structure was overflowing to the surface of the ground and flowing down a ditch to a corrugated plastic culvert where it flowed into the receiving stream.*
- 2. The structure was also discharging directly to the receiving stream via the old underground discharge pipe.*

Photographer:	<b>Brent Walker</b>	Date:	<b>3/20/2015</b>
Witness:	<b>None</b>	Time:	<b>1258</b>
		Photo #:	<b>4</b>
Description:	<b>Overflow from old concrete outfall structure entering plastic corrugated culvert.</b>

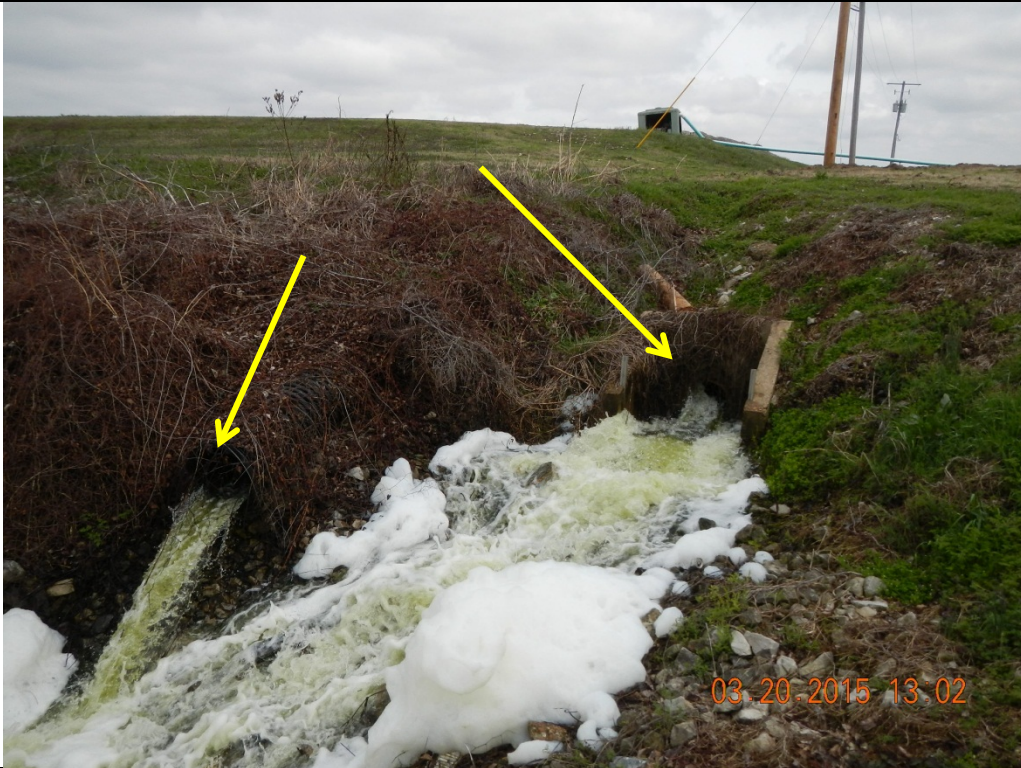
Location:	<b>City of Marion STP</b>		
Photographer:	<b>Brent Walker</b>	Date:	<b>3/20/2015</b>
Witness:	<b>None</b>	Time:	<b>1302</b>
		Photo #:	<b>5</b>
Description:	<b>Unpermitted discharges directly from old concrete outfall structure (right) and via plastic corrugated culvert (left).</b>

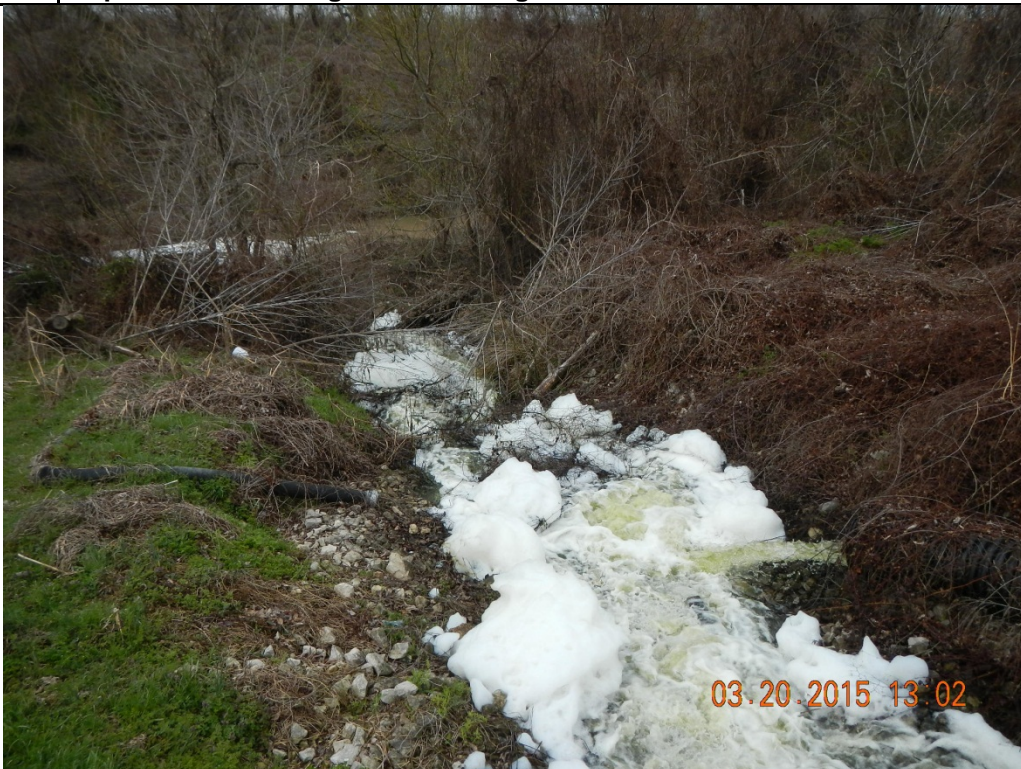
Photographer:	<b>Brent Walker</b>	Date:	<b>3/20/2015</b>
Witness:	<b>None</b>	Time:	<b>1302</b>
		Photo #:	<b>6</b>
Description:	<b>Unpermitted discharges to receiving stream.</b>
