**RE: El Dorado Water Utilities - South Plant Inspection (Union Co)**  
**AFIN: 70-00341 NPDES Permit No.: AR0033723**

## WATER DIVISION INSPECTION REPORT

**Industrial Site Visit**

**Name of Industry: Duckwater Services, LLC**

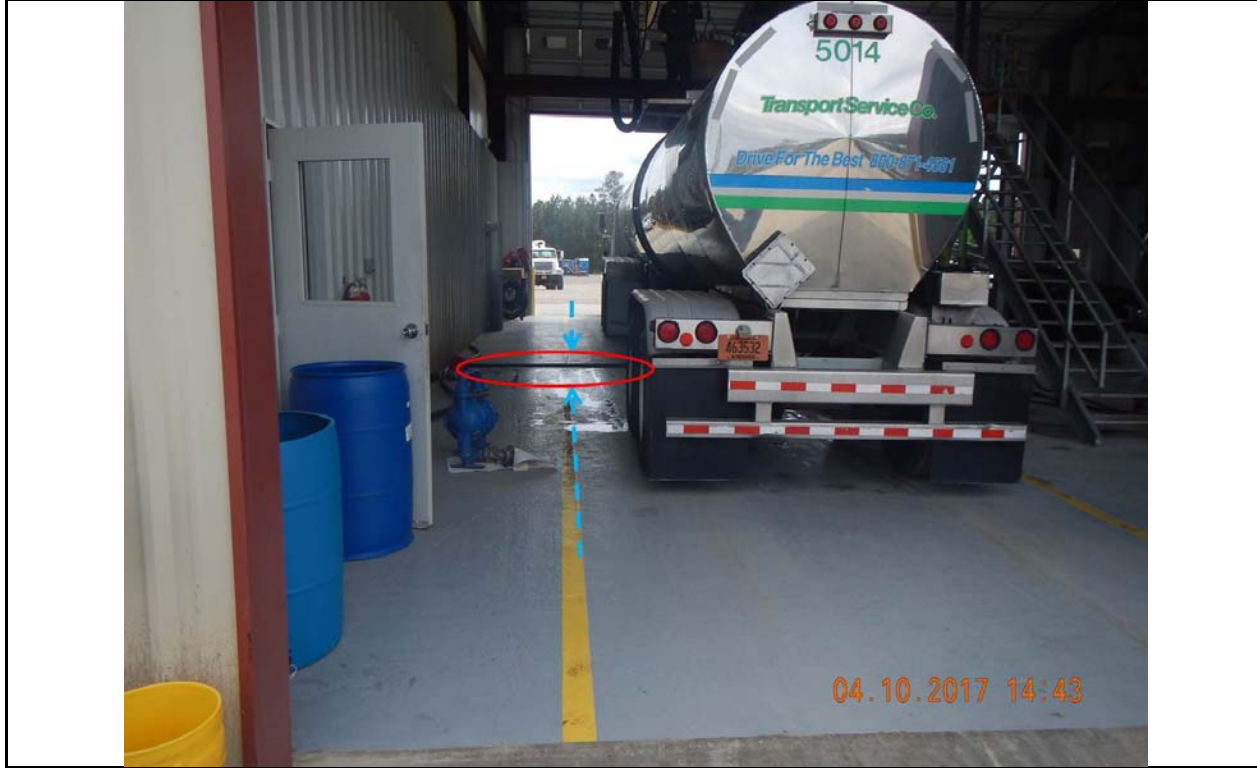
Location:	<b>El Dorado Water Utilities - South Plant</b>		
Photographer:	<b>Michael Young</b>	Date:	<b>04/10/2017</b>
Witness:	<b>Jay Honeycutt; Clark Burton</b>	Time:	<b>14:43</b>
		Photo #:	<b>1</b>
Description:	<b>Floor drain circled in red. Floor is built to flow to central drainage.</b>

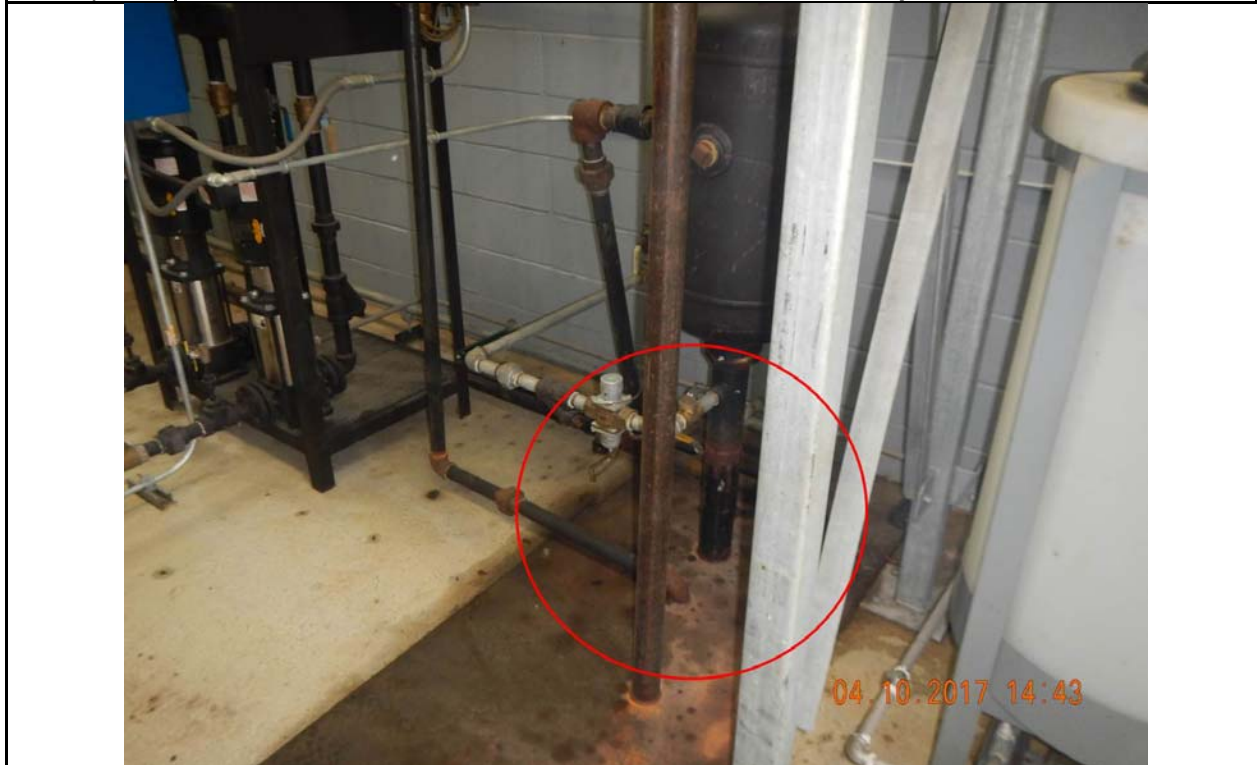
Photographer:	<b>Michael Young</b>	Date:	<b>04/10/2017</b>
Witness:	<b>Jay Honeycutt; Clark Burton</b>	Time:	<b>14:43</b>
		Photo #:	<b>2</b>
Description:	<b>Boiler blowdown is also released to central drain and to pretreatment unit.</b>

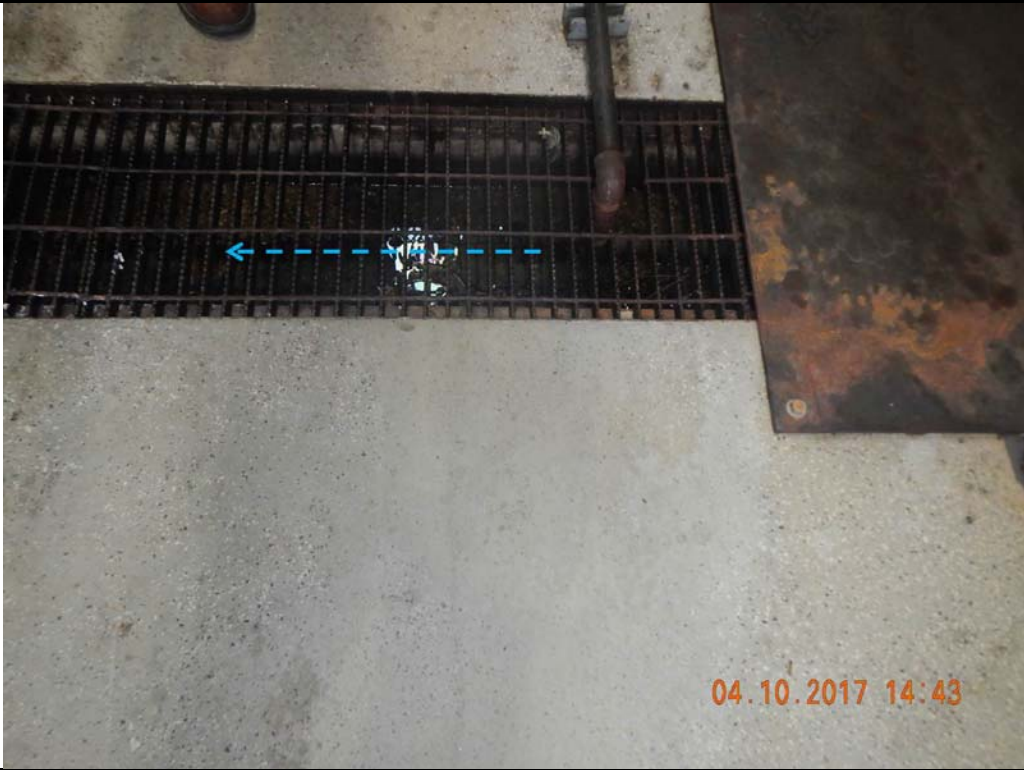
Water Division Photographic Evidence Sheet			
Location:	El Dorado Water Utilities - South Plant		
Photographer:	Michael Young	Date:	04/10/2017
Time:	14:43	Witness:	Jay Honeycutt; Clark Burton
Photo #:	3	Description:	Central drain and flow direction.

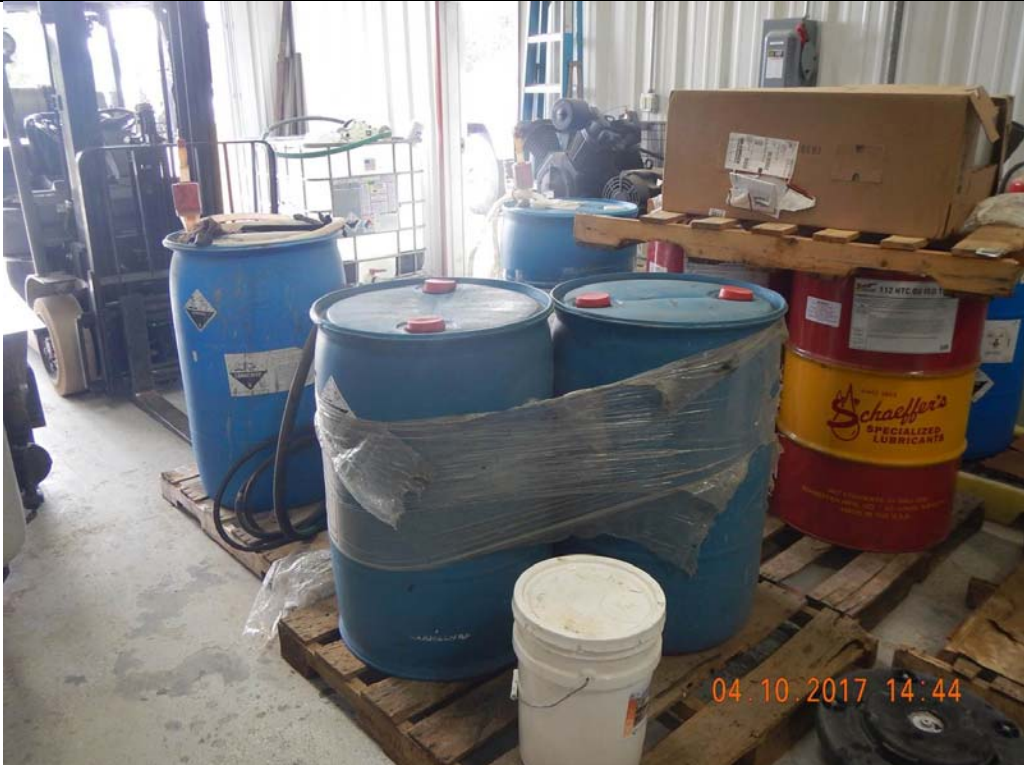
Photographer:	Michael Young	Date:	04/10/2017
Time:	14:44	Witness:	Jay Honeycutt; Clark Burton
Photo #:	4	Description:	Chemicals used for cleaning and repair. Spills would drain to central floor drain.

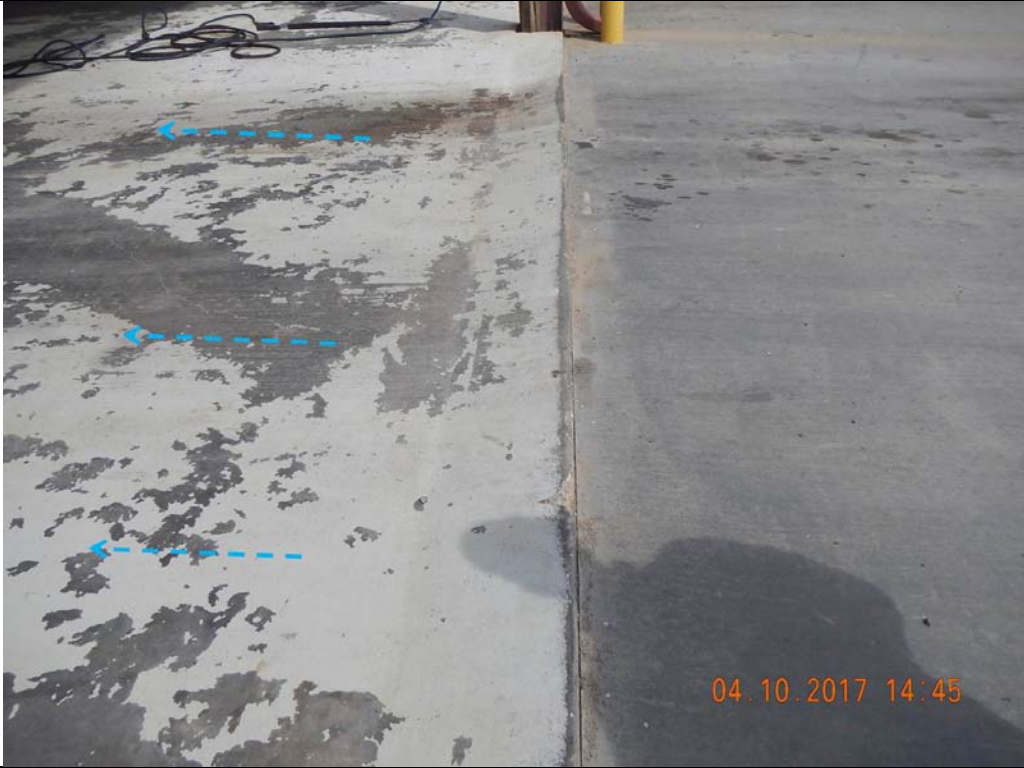
Location:	<b>El Dorado Water Utilities - South Plant</b>		
Photographer:	<b>Michael Young</b>	Date:	<b>04/10/2017</b>
Witness:	<b>Jay Honeycutt; Clark Burton</b>	Time:	<b>14:45</b>
		Photo #:	<b>5</b>
Description:	<b>Floor is sloped to direct water to central floor drain in both wash bays.</b>

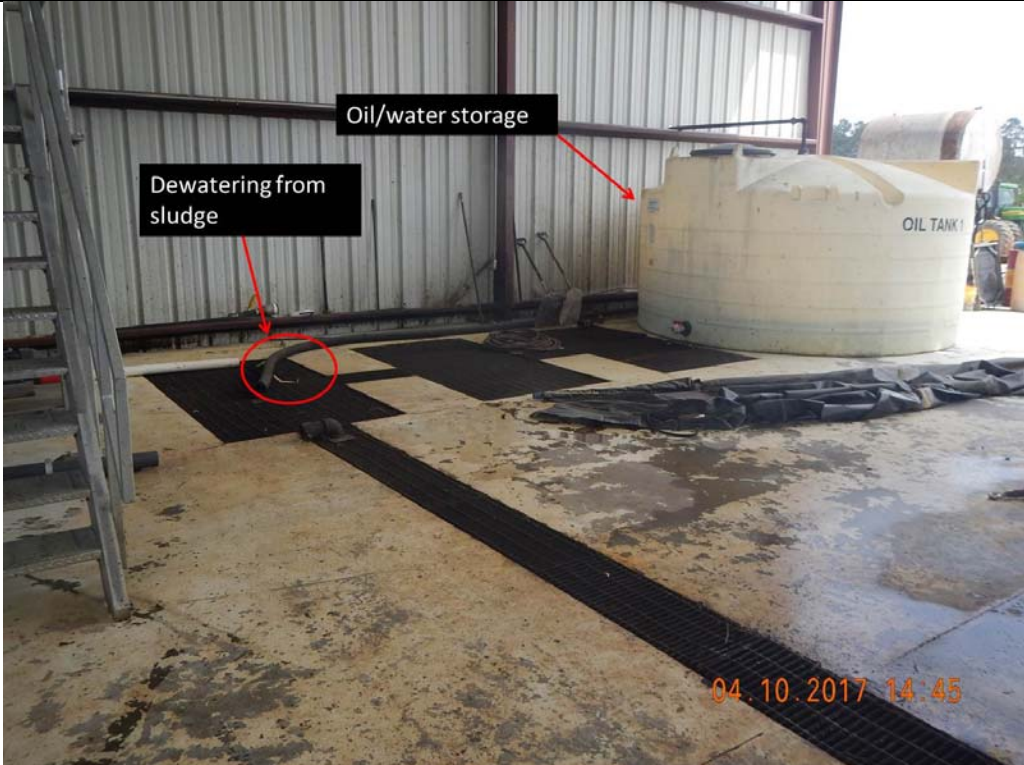
Photographer:	<b>Michael Young</b>	Date:	<b>04/10/2017</b>
Witness:	<b>Jay Honeycutt; Clark Burton</b>	Time:	<b>14:45</b>
		Photo #:	<b>6</b>
Description:	<b>Sludge is dewatered and water is returned to treatment unit.</b>

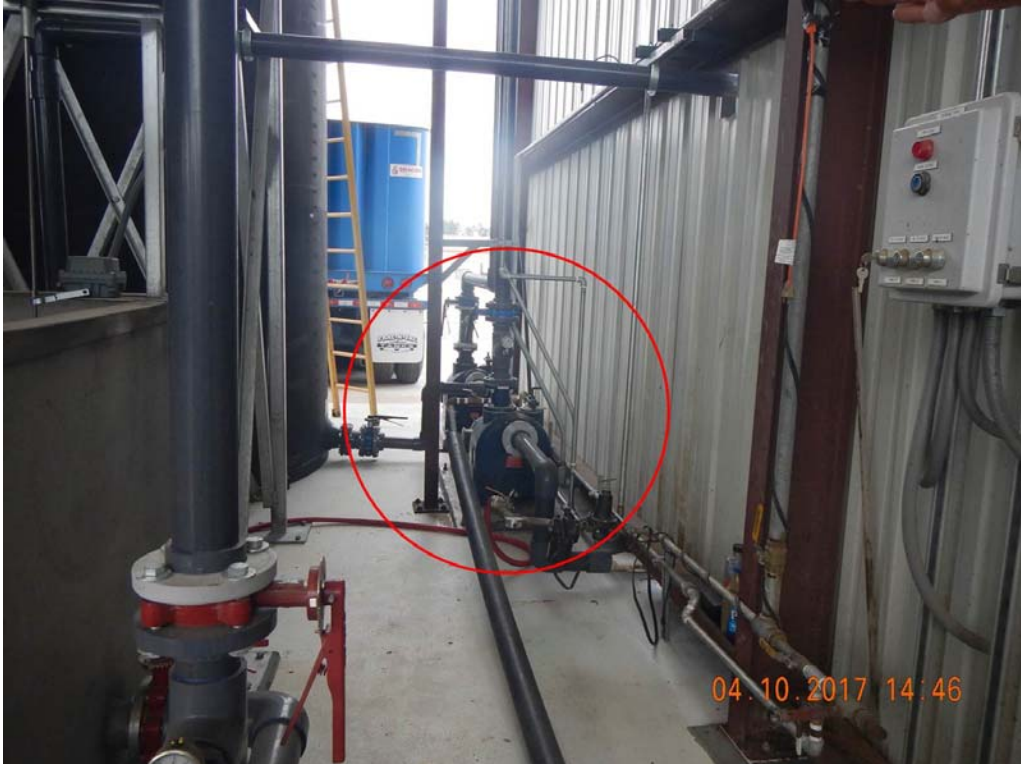
Location:	<b>El Dorado Water Utilities - So</b>		
Photographer:	<b>Michael Young</b>	Date:	<b>04/10/2017</b>
Time:	<b>14:46</b>	Witness:	<b>Jay Honeycutt; Clark Burton</b>
Photo #:	<b>7</b>	Description:	<b>Pump used to transfer wastewater to holding tank.</b>

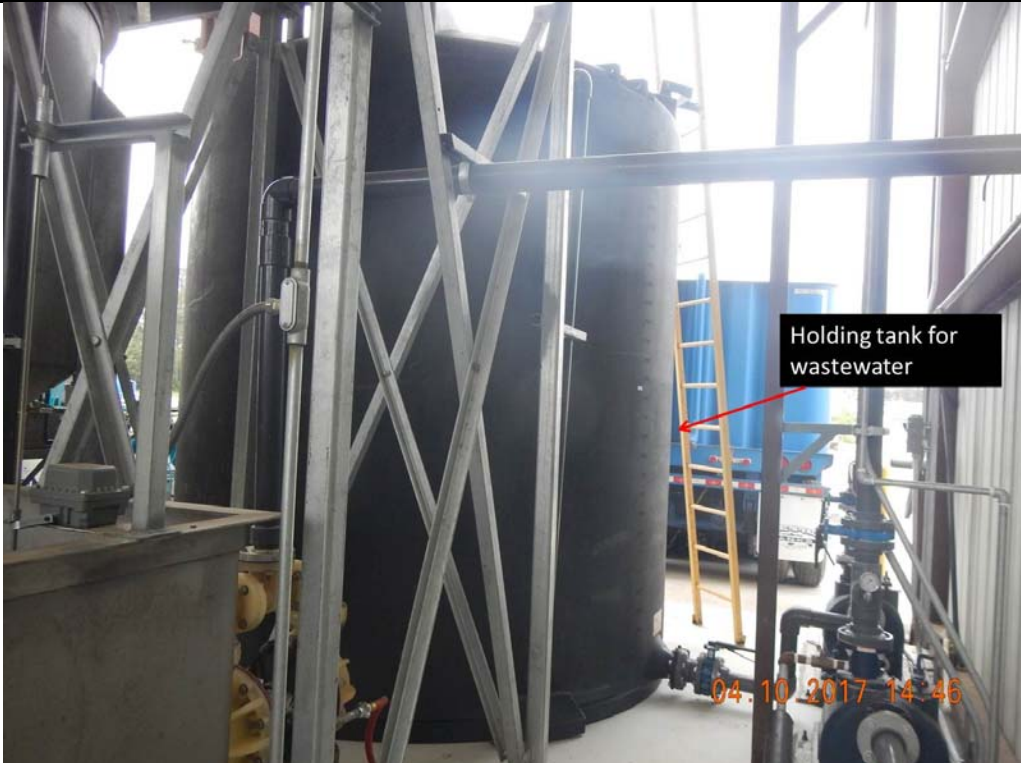
Photographer:	<b>Michael Young</b>	Date:	<b>04/10/2017</b>
Time:	<b>14:46</b>	Witness:	<b>Jay Honeycutt; Clark Burton</b>
Photo #:	<b>8</b>	Description:	<b>Wastewater holding tank.</b>

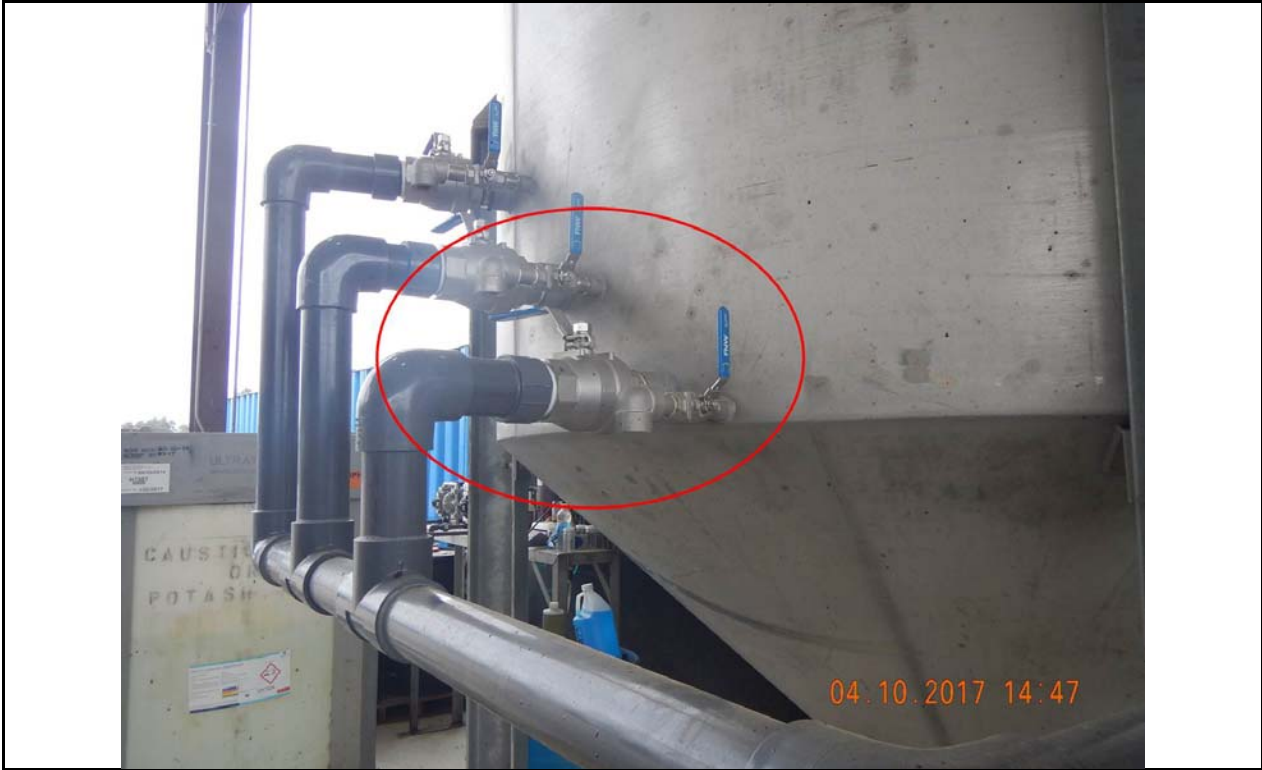
Location:	<b>El Dorado Water Utilities - South Plant</b>		
Photographer:	<b>Michael Young</b>	Date:	<b>04/10/2017</b>
Time:	<b>14:47</b>	Witness:	<b>Jay Honeycutt; Clark Burton</b>
Photo #:	<b>9</b>	Description:	<b>Valve to take quality control samples for treatment indications.</b>

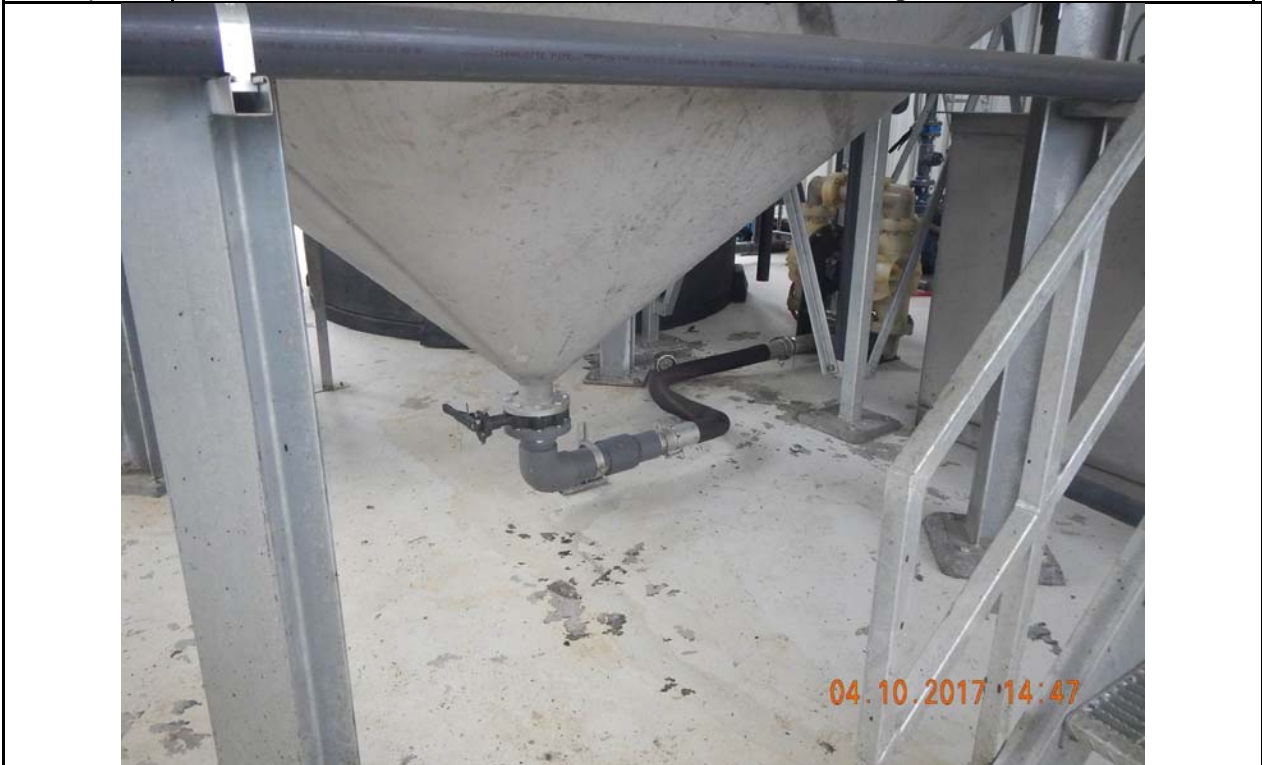
Photographer:	<b>Michael Young</b>	Date:	<b>04/10/2017</b>
Time:	<b>14:47</b>	Witness:	<b>Jay Honeycutt; Clark Burton</b>
Photo #:	<b>10</b>	Description:	<b>Release from batch reactor to treated wastewater holding tank.</b>

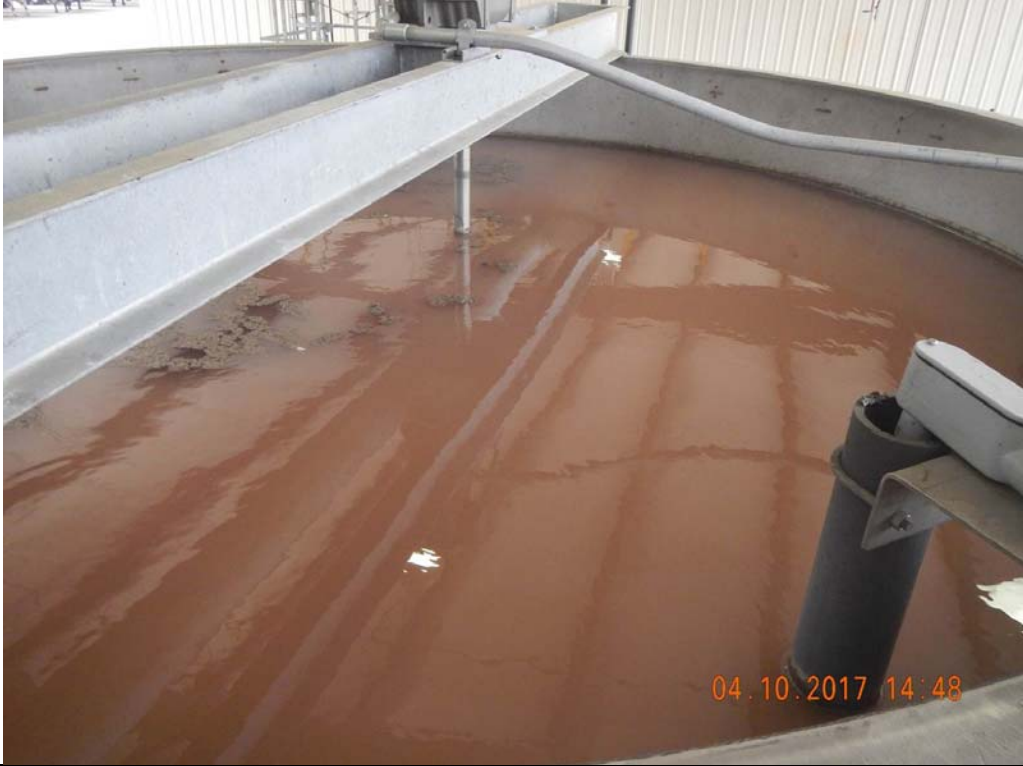
Location:	<b>El Dorado Water Utilities - South Plant</b>		
Photographer:	<b>Michael Young</b>	Date:	<b>04/10/2017</b>
Time:	<b>14:48</b>	Witness:	<b>Jay Honeycutt; Clark Burton</b>
Photo #:	<b>11</b>	Description:	<b>Wastewater was settling during inspection. Red tint product of red resin washout.</b>

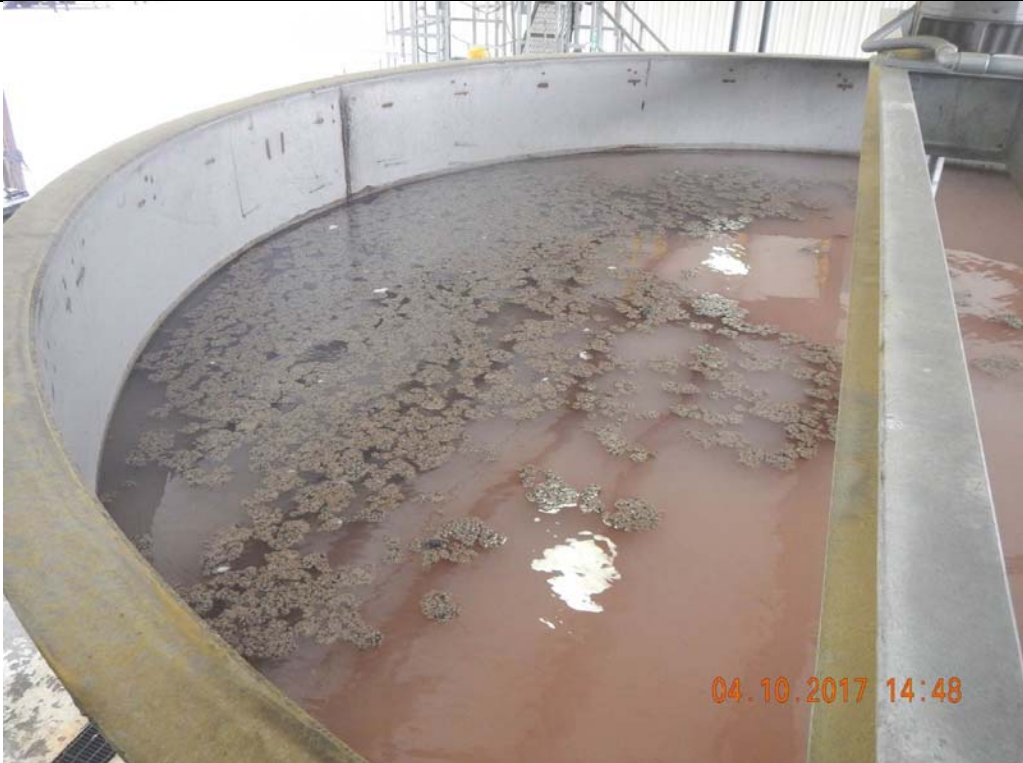
Photographer:	<b>Michael Young</b>	Date:	<b>04/10/2017</b>
Time:	<b>14:48</b>	Witness:	<b>Jay Honeycutt; Clark Burton</b>
Photo #:	<b>12</b>	Description:	<b>Flocculation of waste materials that will eventually settle.</b>

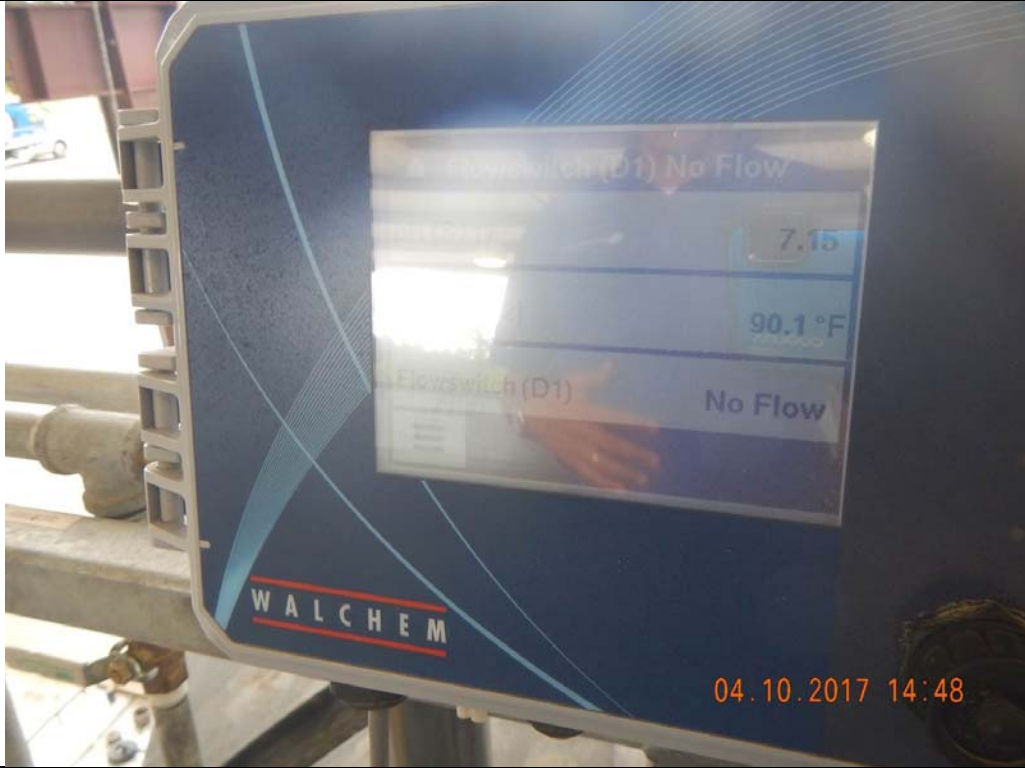
Location:	<b>El Dorado Water Utilities - South Plant</b>		
Photographer:	<b>Michael Young</b>	Date:	<b>04/10/2017</b>
Witness:	<b>Jay Honeycutt; Clark Burton</b>	Time:	<b>14:48</b>
Description:	<b>pH monitor for wastewater.</b>	Photo #:	<b>13</b>

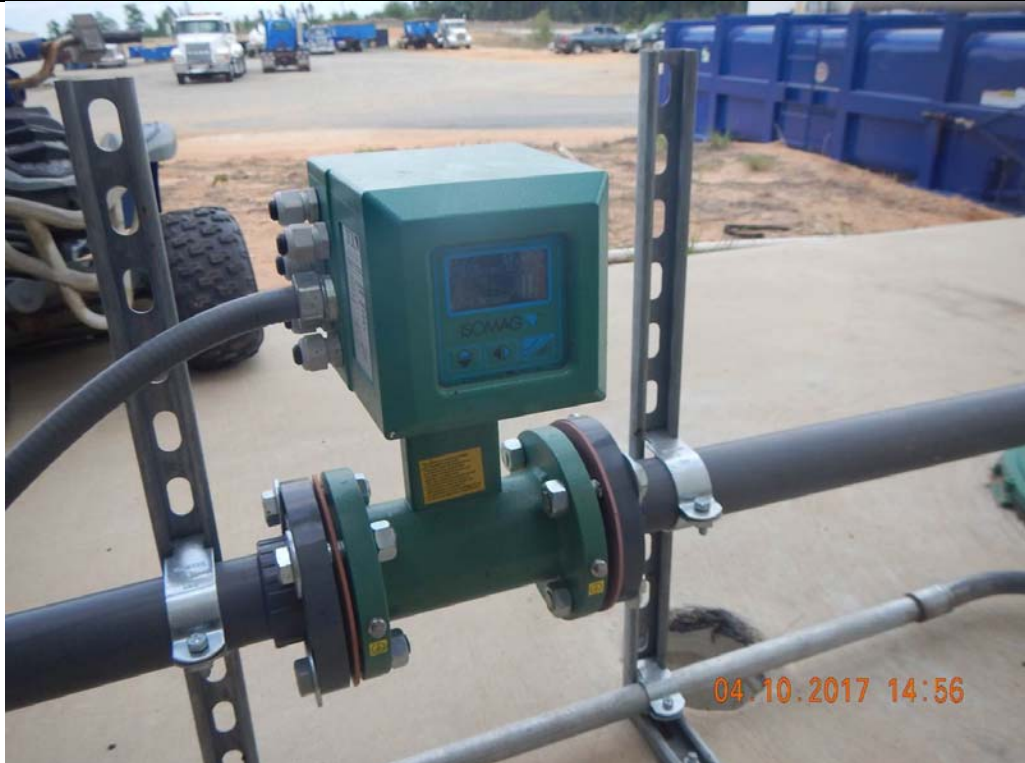
Photographer:	<b>Michael Young</b>	Date:	<b>04/10/2017</b>
Witness:	<b>Jay Honeycutt; Clark Burton</b>	Time:	<b>14:56</b>
Description:	<b>Flow device prior to EWU monitoring location and discharge to sanitary sewer.</b>	Photo #:	<b>14</b>

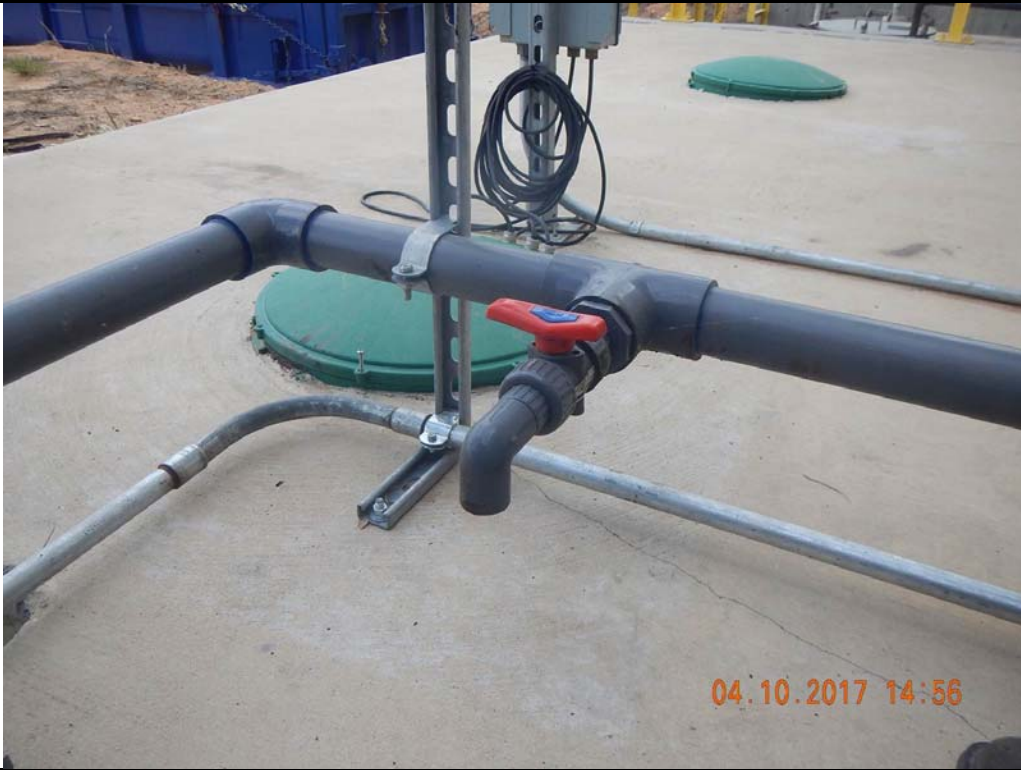
<b>Water Division Photographic Evidence Sheet</b>				
Location:	<b>El Dorado Water Utilities - South Plant</b>			
Photographer:	<b>Michael Young</b>	Date:	<b>04/10/2017</b>	
Witness:	<b>Jay Honeycutt; Clark Burton</b>	Time:	<b>14:56</b>	
Description:	<b>EWU monitoring location.</b>		Photo #:	<b>15</b>

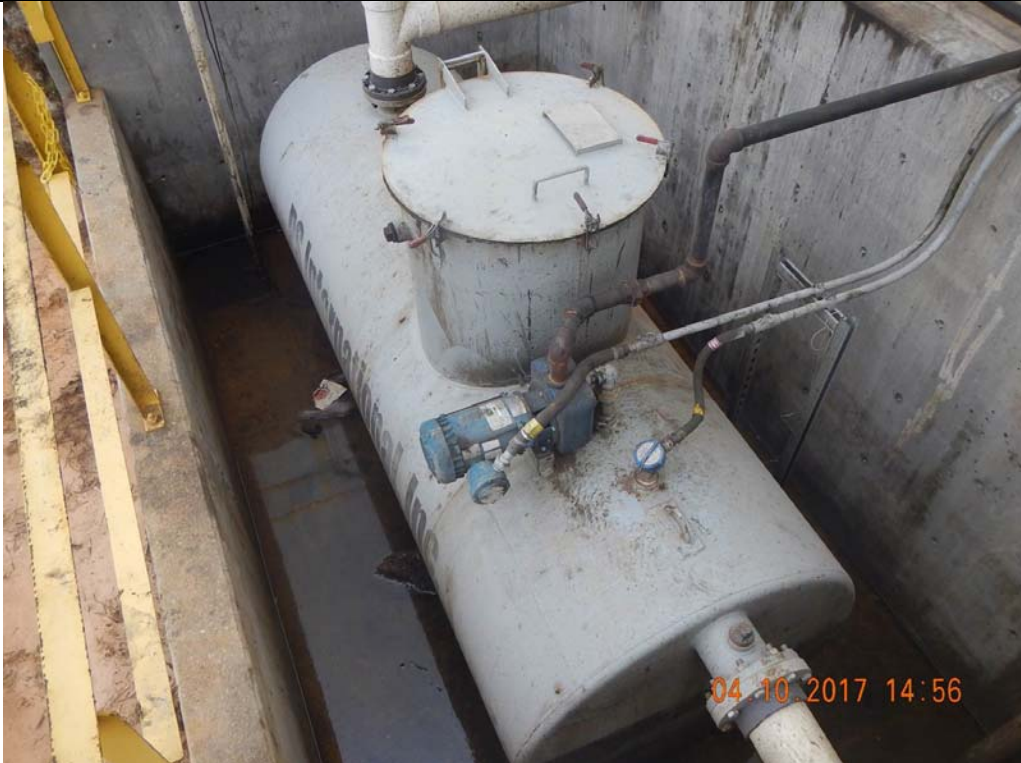
Photographer:	<b>Michael Young</b>	Date:	<b>04/10/2017</b>	Time:	<b>14:56</b>
Witness:	<b>Jay Honeycutt; Clark Burton</b>	Photo #:	<b>16</b>		
Description:	<b>Oil water separator. Stormwater is returned to the treatment unit.</b>
