WATER DIVISION INSPECTION REPORT

AFIN: 52-00073	PERMIT #: AR0022365	DATE: 4/25/2017
COUNTY: 52 Ouachita	PDS #: 097257	MEDIA: WN
GPS LAT: 33.563066 LONG: -92.816983 LOCATION: General Area

NAME:
Camden WWTP

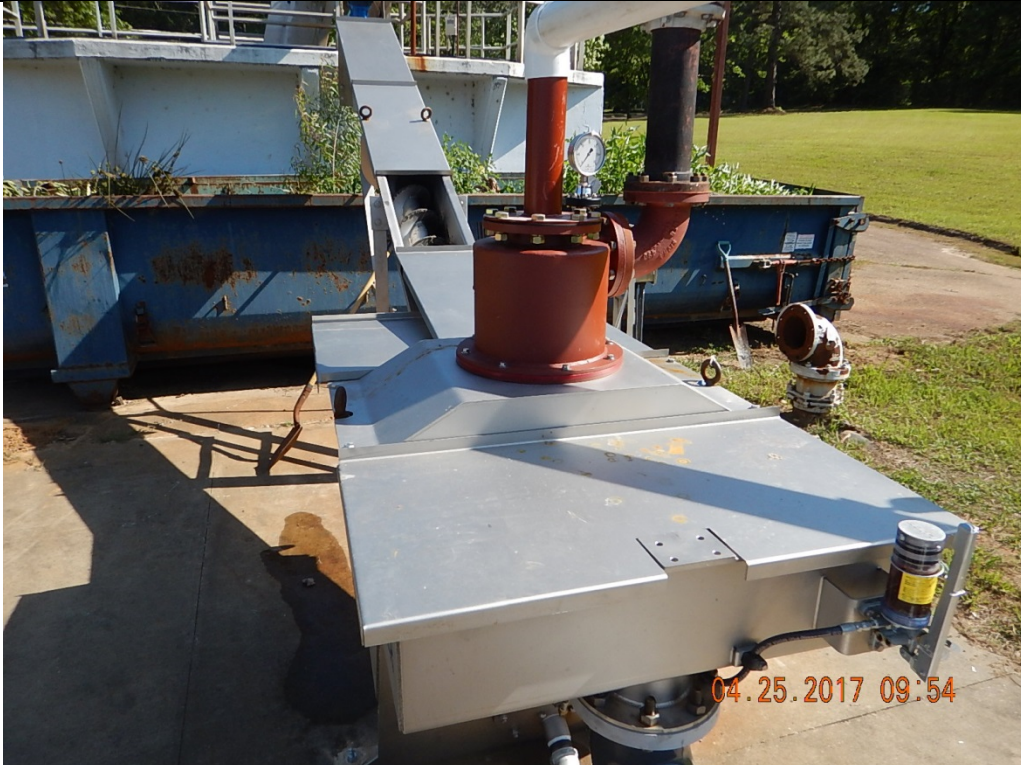
The treatment system consists of bar screens, grit separator, activated sludge, secondary clarifier, chlorine disinfection, and dechlorination. Mr. Ballard stated that a new auger had recently been installed at the grit separator (Photo 1). The aeration basin was observed (Photo 2) and was in good operating condition. Both clarifiers (Photos 3-4) were functional. A small leak was noted on the sludge thickener in an inspection performed on May 25, 2016 by ADEQ District 8 Inspector Michael Young. This patched leak (Photo 5) was observed and appeared to be adequate.

Location:	Camden WWTP				
Photographer:	Tobin Fulmer	Date:	4/25/2017	Time:	9:54
Witness:	Keith Ballard, Jessica Temple			Photo #:	1
Description:	Grit separator with recently installed auger.

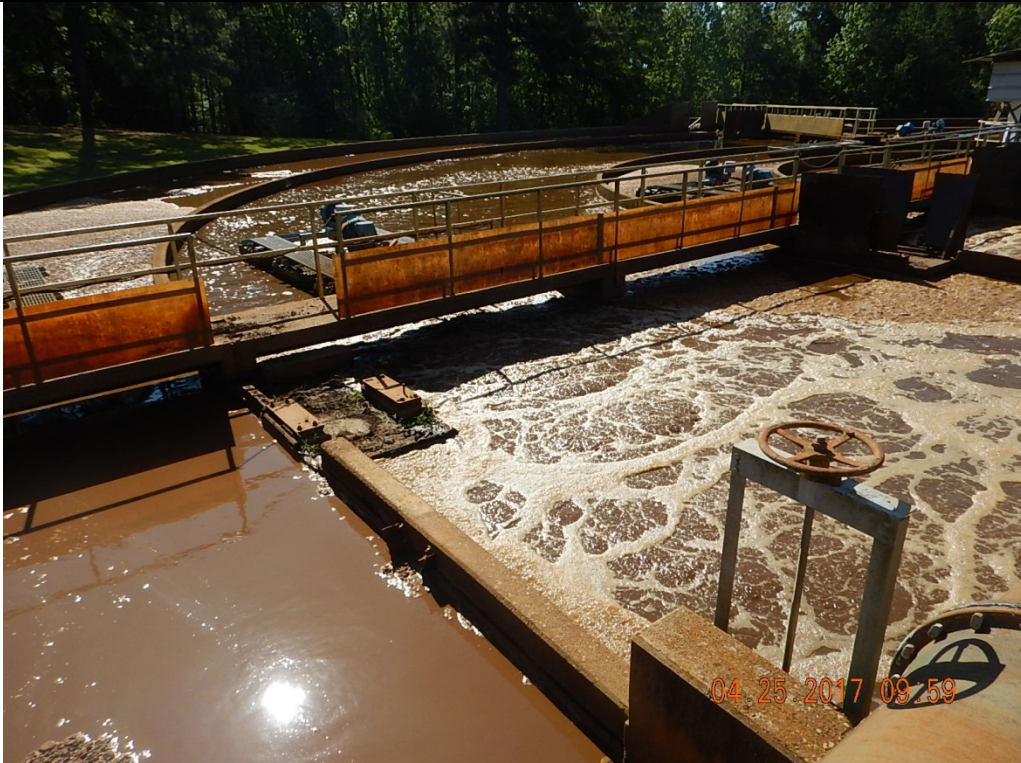
Photographer:	Tobin Fulmer	Date:	4/25/2017	Time:	9:59
Witness:	Keith Ballard, Jessica Temple			Photo #:	2
Description:	Aeriation basin

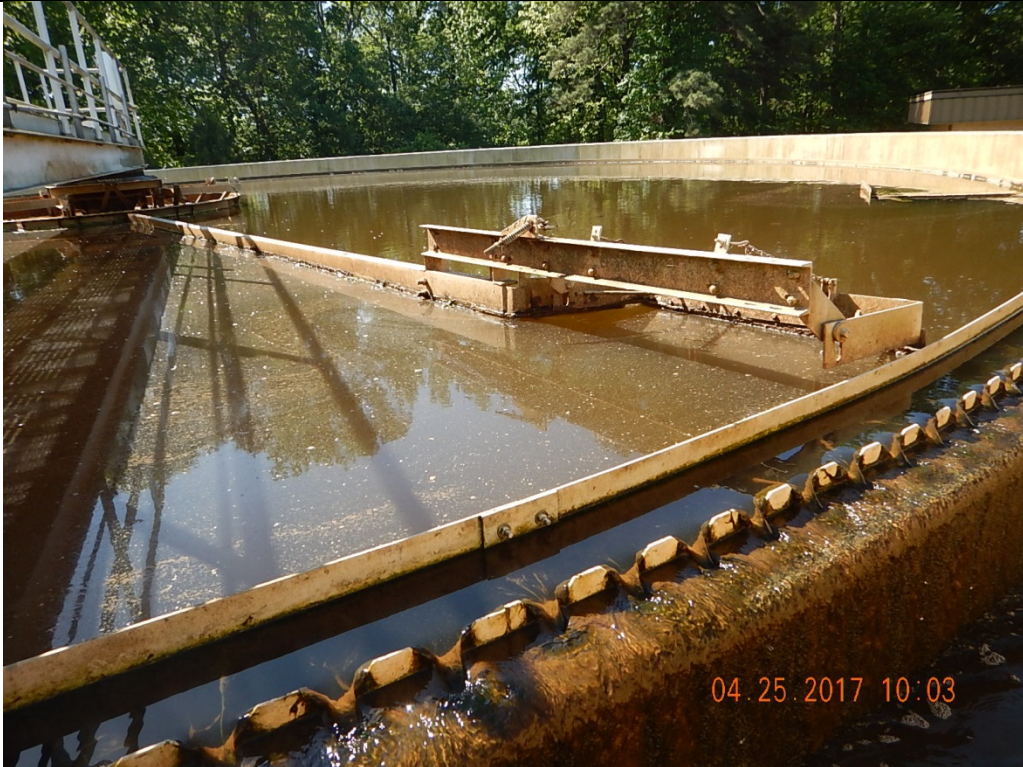
Location:	Camden WWTP				
Photographer:	Tobin Fulmer	Date:	4/25/2017	Time:	10:03
Witness:	Keith Ballard, Jessica Temple			Photo #:	3
Description:	East clarifier

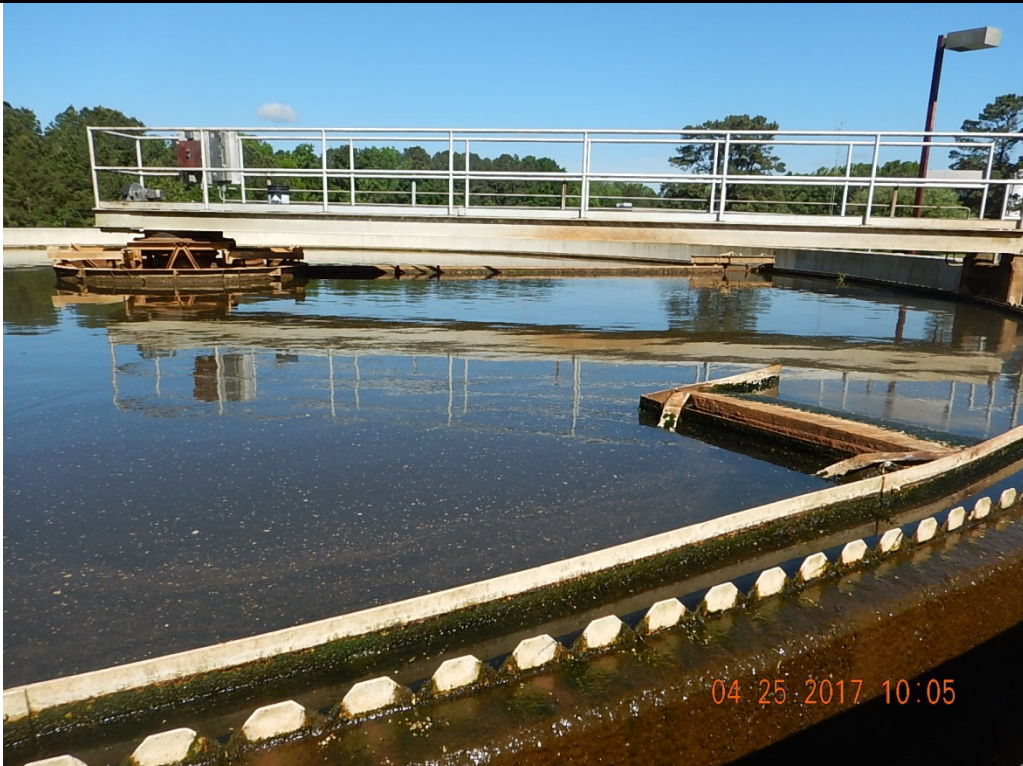
Photographer:	Tobin Fulmer	Date:	4/25/2017	Time:	10:06
Witness:	Keith Ballard, Jessica Temple			Photo #:	4
Description:	West clarifier

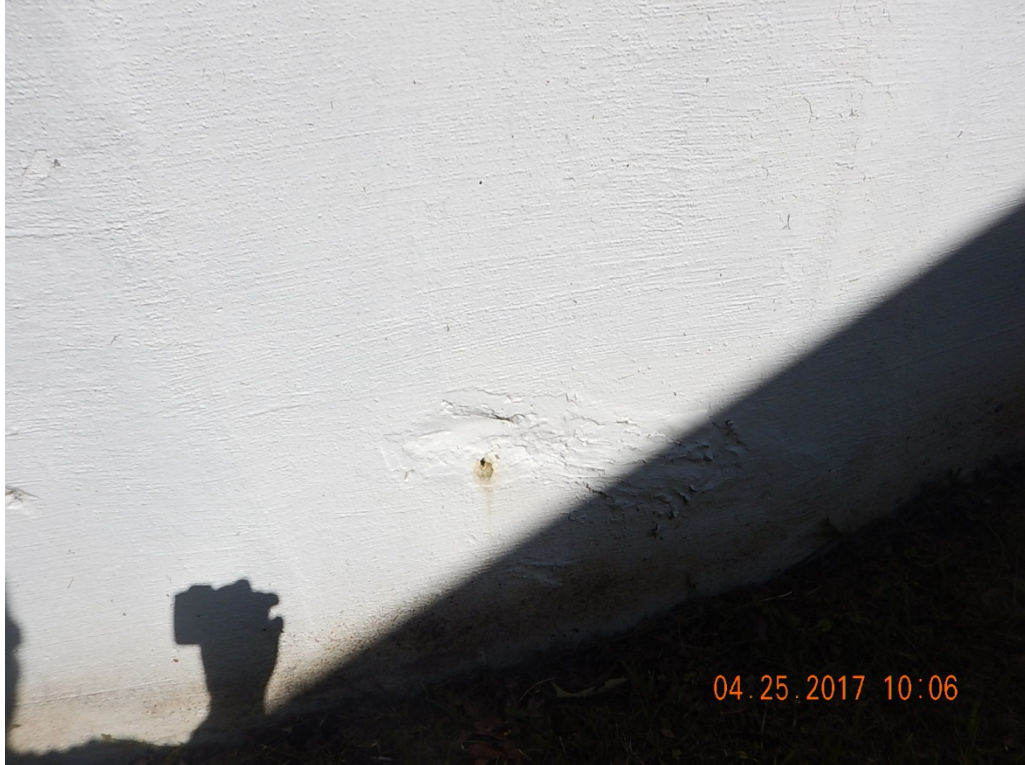
Location:	Camden WWTP				
Photographer:	Tobin Fulmer	Date:	4/25/2017	Time:	10:06
Witness:	Keith Ballard, Jessica Temple			Photo #:	5
Description:	Patched leak on the sludge thickener.

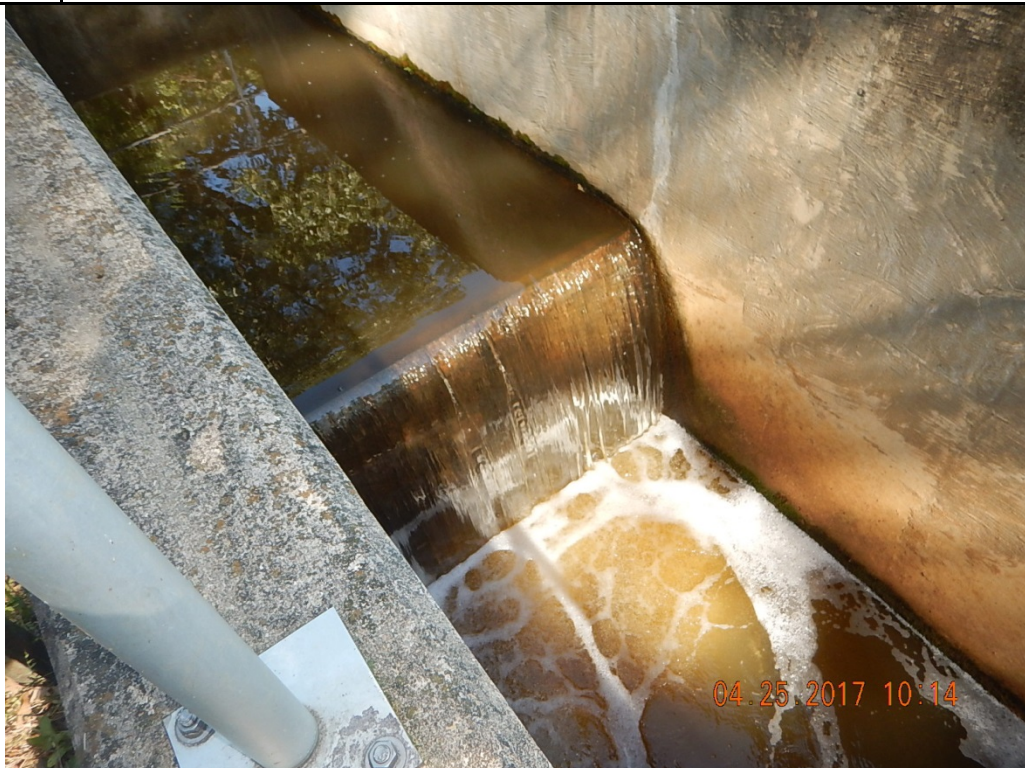
Photographer:	Tobin Fulmer	Date:	4/25/2017	Time:	10:10
Witness:	Keith Ballard, Jessica Temple			Photo #:	6
Description:	Effluent
