RE: City of Benton WWTP Inspection

AFIN: 63-00063 Permit No.: AR0036498

inspection Report: (	∍ity	of Benton WV	/V I F	, AFIN: 63-00063	, Pern	111 #: <i>P</i>	KUUS	0498	
	<u>VDEO</u>		WATER	RI	DIVISION I	NSP	PECI	ΓΙΟΙ	N RE	PORT
	ADLQ	AF	IN: <b>63-00063</b>	PE	RMIT #: <b>AR003</b> 6	498			DATE: 7	7/23/2019
A	RKANSAS	CC	DUNTY: <b>63 Sa</b> l	line		PDS 7	#: <b>108</b> 9	906		MEDIA: WN
Dep	partment of Environmental Quality	GF	'S LAT: <b>34.55</b> 1	167	2 LONG: -92.593	<b>291</b> L	OCATI	ON: (	Outfall	
	FACILITY INFORMAT	TION				SPEC	TION II	NFOR	MATIO	N
Cit	y of Benton WWTP				FACILITY TYPE:  1 - Municipal		OR ID#:	State		
	6 W. Hazel St.				4 - Satisfactory			Com	rion type: pliance	Evaluation
	nton				(-)	TRY TIME: 9:00	EXIT T			FECTIVE DATE:
	RESPONSIBLE OFFIC	CIAL			1720/2010			00	9/30/2 PERMIT EX	ZUUS XPIRATION DATE:
	: / TITLE								9/30/2	2013
COMF	David Vondran / General Mana	ger			FAYETTEVILLE	SHAL	E REL	ATED	): N	
	y of Benton			-	FAYETTEVILLE					
	ng address: 27 Dale Avenue			ŀ					CIPANT	S

**RE: Response to City of Benton WWTP Inspection** NPDES: AR0036498

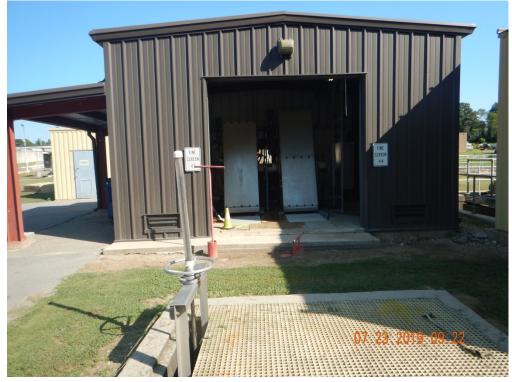
## Water Division Photographic Evidence Sheet Location: City of Benton WWTP Photographer: Jason Bolenbaugh Date: 7/23/2019 Time: 09:22 Witness: Photo #: 1

Description: Fine Screen #1 and #2 building.

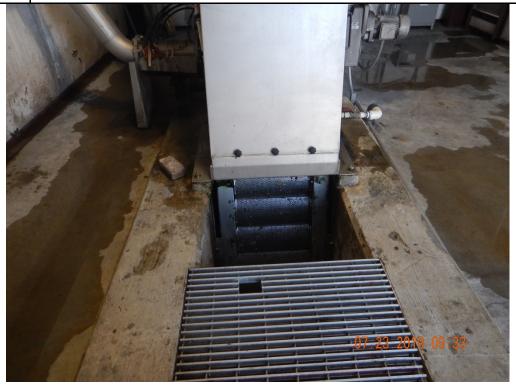
Photographer:	Jason Bolenbaugh	Date:	7/23/2019	Time:	09:33
Witness:				Photo #:	2

Description: Fine Screen #3.

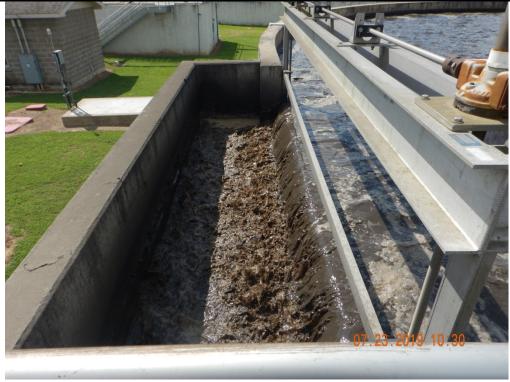
## Water Division Photographic Evidence Sheet Location: City of Benton WWTP Photographer: Jason Bolenbaugh Date: 7/23/2019 Time: 10:30 Witness: Photo #: 7

Description: Oxidation Ditch #1 spillway to the Secondary Clarifier.

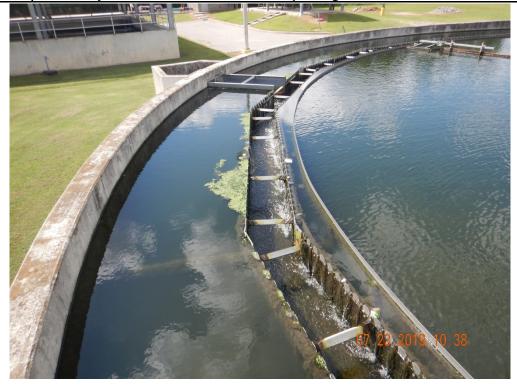
Photographer:	Jason Bolenbaugh	Date:	7/23/2019	Time:	10:38
Witness:				Photo #:	8

1. TREATMENT UNITS PROPERLY OPERATED:	☑S ☐M ☐U ☐NA ☐NE
2. TREATMENT UNITS PROPERLY MAINTAINED: Facility battles normal buildup of algae in clarifiers	☑S ☐M ☐U ☐NA ☐NE

Description: Secondary Clarifier #2 with minor buildup of algae.

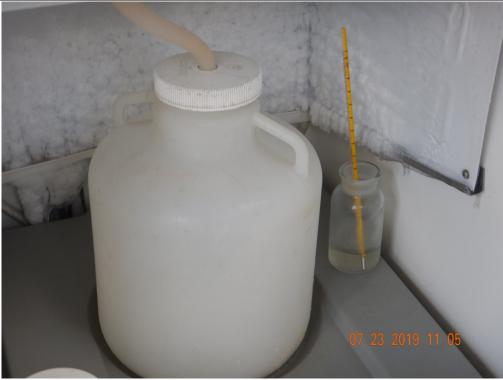
a. SAMPLES REFRIGERATED DURING COMPOSITING: Composite sampler was at 0°C when checked	⊠y □n □na □ne
b. PROPER PRESERVATION TECHNIQUES USED:	Øy □n □na □ne

Description: Composite sampler bottle and thermometer measuring 0°C.

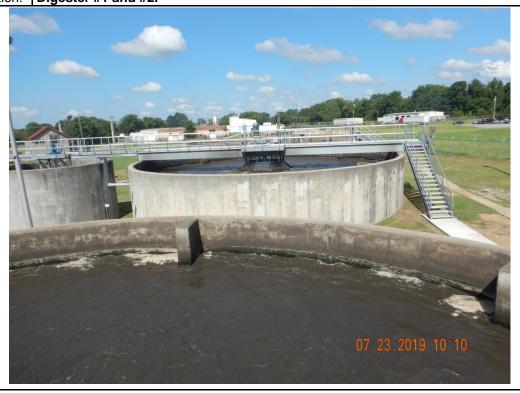
Witness:	Photo #:	16

Description: Digester #1 and #2.

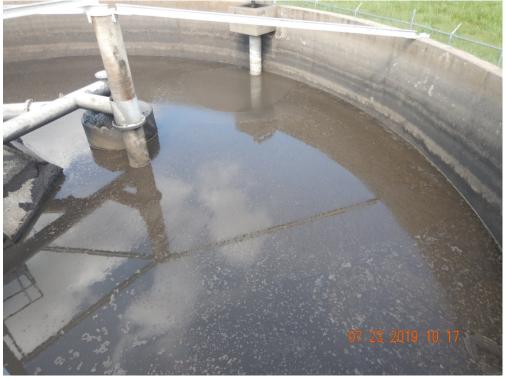
Water Division Photographic Evidence Sheet									
Location:	City	of Benton WWTP							
Photograp	her:	Jason Bolenbaugh	Date:	7/23/2019	Time:	10:17			
Witness:					Photo #:	19			
Dagariatia		N' ( #0 ' d ( b

Description: Digester #3 in decant phase.

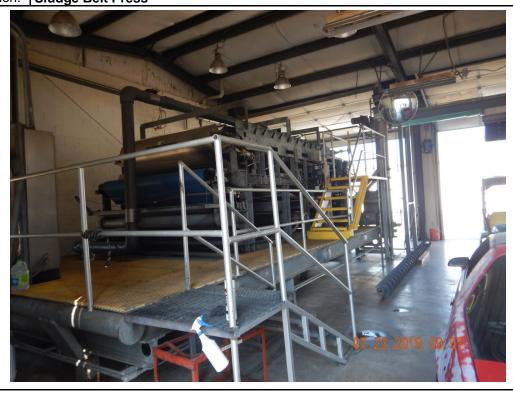
Water Division Photographic Evidence Sheet									
Location:	City	of Benton WWTP							
Photograph	Photographer: Jason Bolenbaugh Date: 7/23/2019 Time: 09:57								
Witness:	Witness: Photo #: 21								
Description	n: S	ludge Belt Press

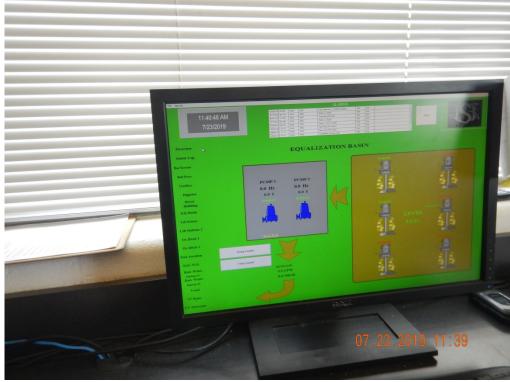
Description: | SCADA view of activities at the Equalization Basin.

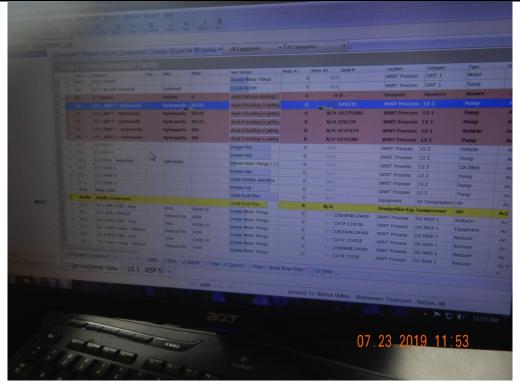
Photographer: Jason Bolenbaugh Date: 7/23/2019 Time: 11:53
Witness: Photo #: 22

Description: Screen view of the Maintenance Pro 7.0 program the facility uses.

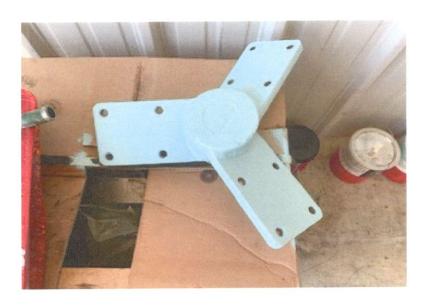
Location:	Wastewater Plant 616 W Hazel						
Photographer:	Jonathan	Buf	f	Witness:			
Photo #	5 0	f	14	Date:	08/20/2019 - Tue	Time:	10:26am
Description:	Anaerobi	c m	ixer collar hub painted	with epoxy.
