OFFICE OF WATER QUALITY INSPECTION REPORT

AFIN: 17-00062	PERMIT #: AR0021482	DATE: 8/14/2019
COUNTY: 17 Crawford	PDS #: 109239	MEDIA: WN
GPS LAT: 35.437918 LONG: -94.330428 LOCATION: Entrance

FACILITY INFORMATION	INSPECTION INFORMATION
<small>NAME:</small> B&W Plating <small>LOCATION:</small> 11 North 27th St. <small>CITY:</small> Van Buren	<small>FACILITY TYPE:</small> 2 - Industrial <small>INSPECTOR ID#:</small> 71330 S - State <small>FACILITY EVALUATION RATING:</small> 2 - Marginal <small>INSPECTION TYPE:</small> Industrial User <small>DATE(S):</small> <small>ENTRY TIME:</small> <small>EXIT TIME:</small> <small>PERMIT EFFECTIVE DATE:</small> 8/14/2019 10:30 11:05 1/1/2015 <small>PERMIT EXPIRATION DATE:</small> 12/31/2019
RESPONSIBLE OFFICIAL	<small>FAYETTEVILLE SHALE RELATED:</small> N <small>FAYETTEVILLE SHALE VIOLATIONS:</small> N
<small>NAME: / TITLE</small> Steve Dufresne / <small>COMPANY:</small> Van Buren Municipal Utilities <small>MAILING ADDRESS:</small> PO Drawer 1269 <small>CITY, STATE, ZIP:</small> Van Buren AR 72956 <small>PHONE & EXT: / FAX:</small> 479-474-5067 / <small>EMAIL:</small> steve@vbmua.arcoxml.com <small>CONTACTED DURING INSPECTION:</small> No	INSPECTI

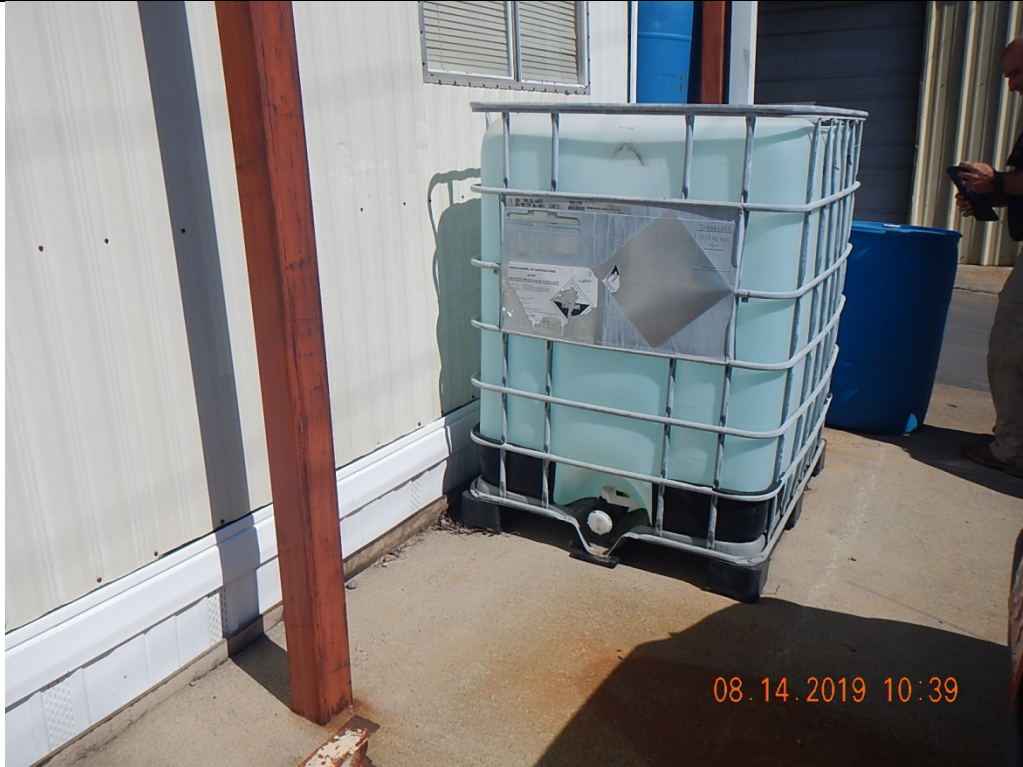
Excessive buildup was noted on the evaporator components. Increased maintenance is recommended. I observed empty waste barrels staged near the door. Per the Plating Manager, these were awaiting pickup. A 275-gal, white tote tank of sodium hydroxide was staged adjacent to the front door in the parking area. This tote was not on a spill pallet nor was any other containment available nearby in the event of a spill. Additional training on spill prevention and response is recommended.

Location:	B&W Plating		
Photographer:	Dannielle Gray	Date:	8/14/2019
Witness:	None	Time:	1039
Description:	Tote of sodium hydroxide staged in parking lot.

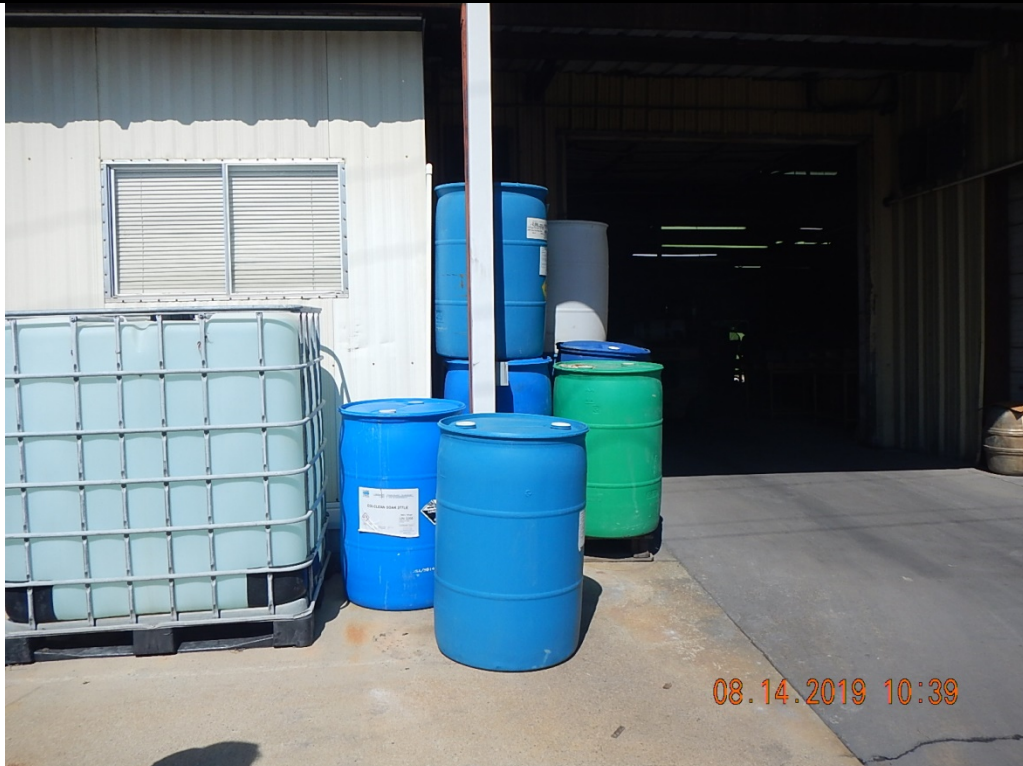
Photographer:	Dannielle Gray	Date:	8/14/2019
Witness:	None	Time:	1039
Description:	Tote and empty barrels in parking lot.

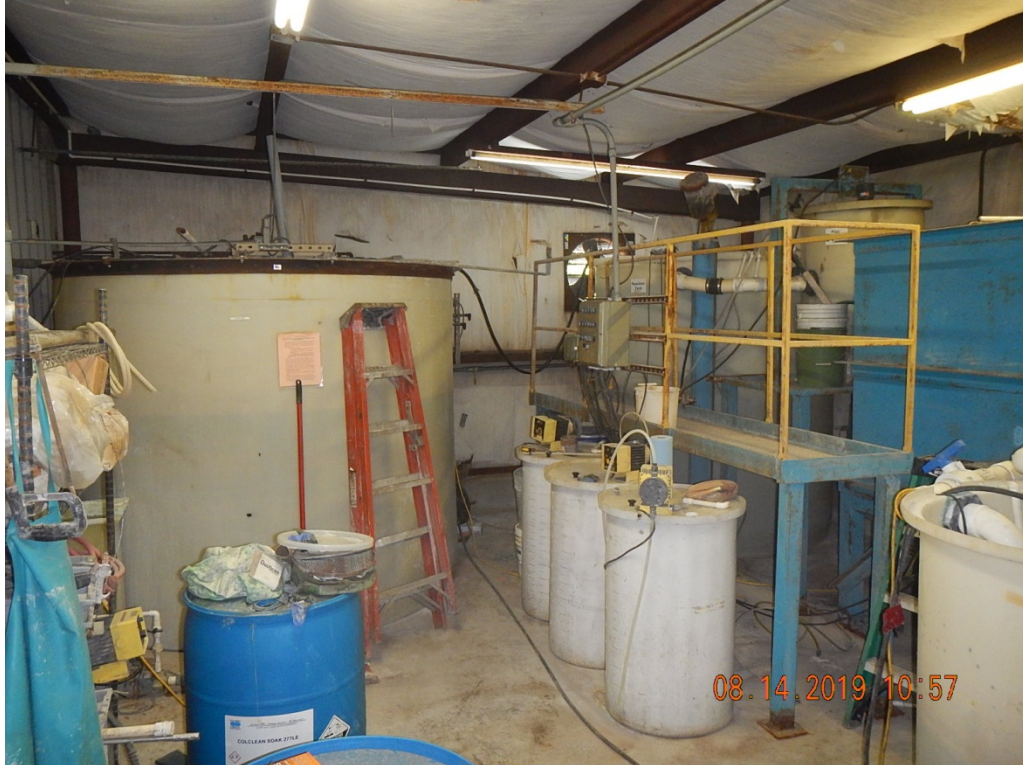
Location:	B&W Plating		
Photographer:	Dannielle Gray	Date:	8/14/2019
Witness:	None	Time:	1057
		Photo #:	3
Description:	Overview of pretreatment (photo right) and waste storage (tank photo left).

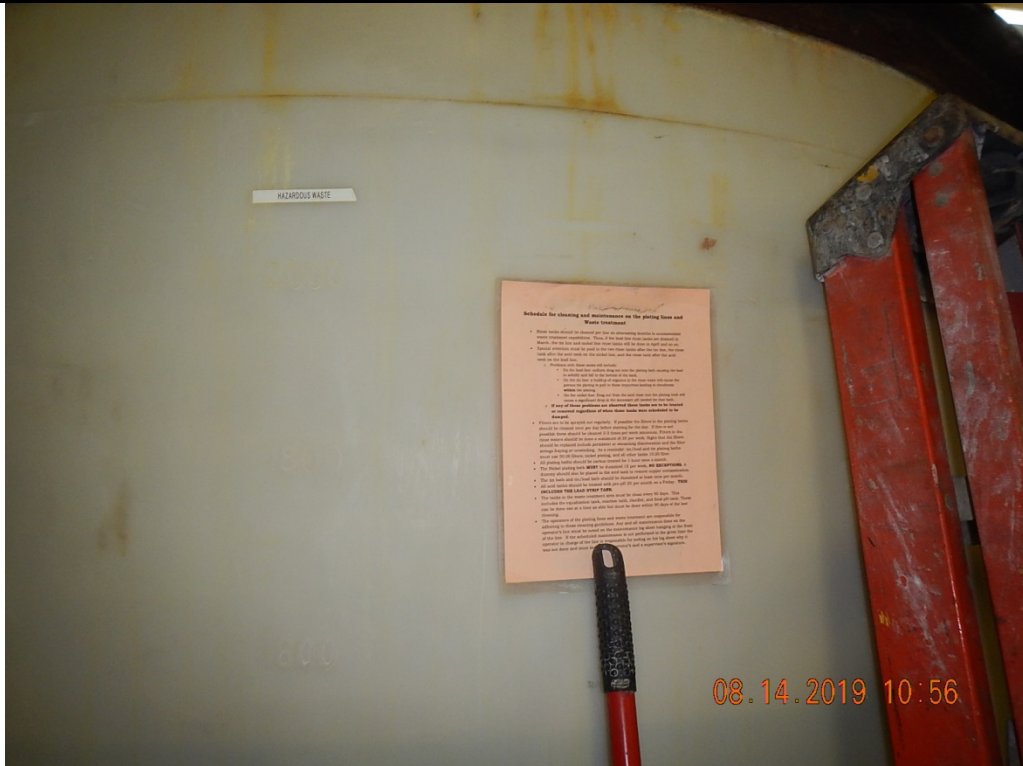
Photographer:	Dannielle Gray	Date:	8/14/2019
Witness:	None	Time:	1056
		Photo #:	4
Description:	Hazardous waste storage container near pretreatment plant.

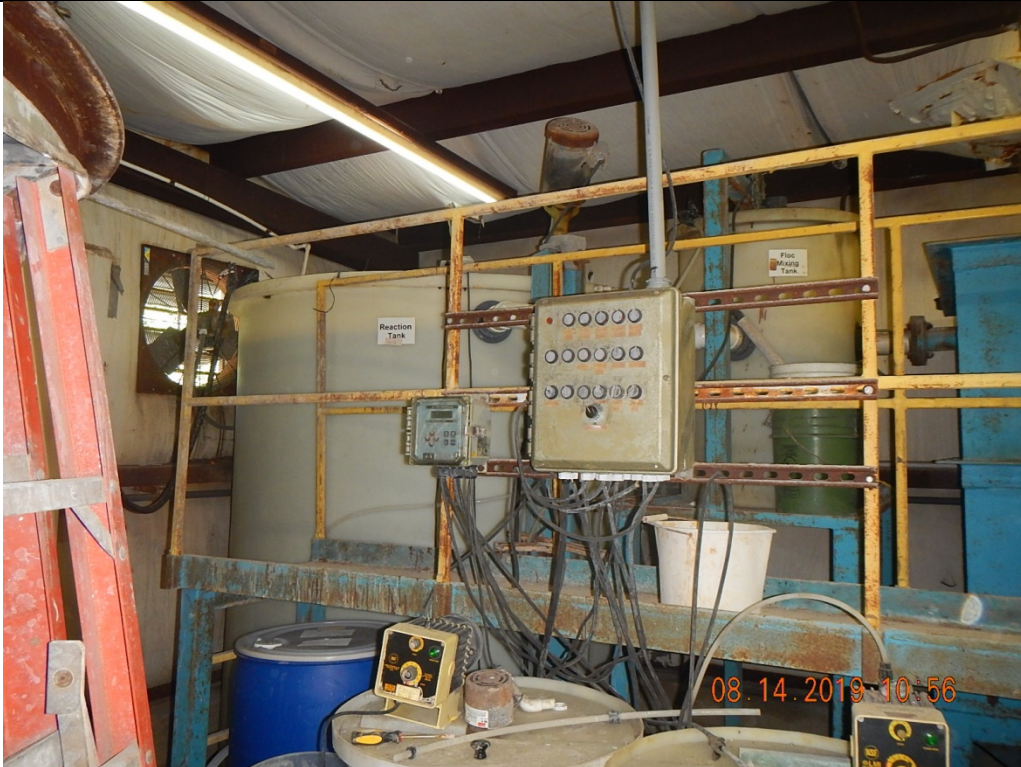
Location:	B&W Plating		
Photographer:	Dannielle Gray	Date:	8/14/2019
Witness:	None	Time:	1056
Description:	Reaction tank and mixing tank components.

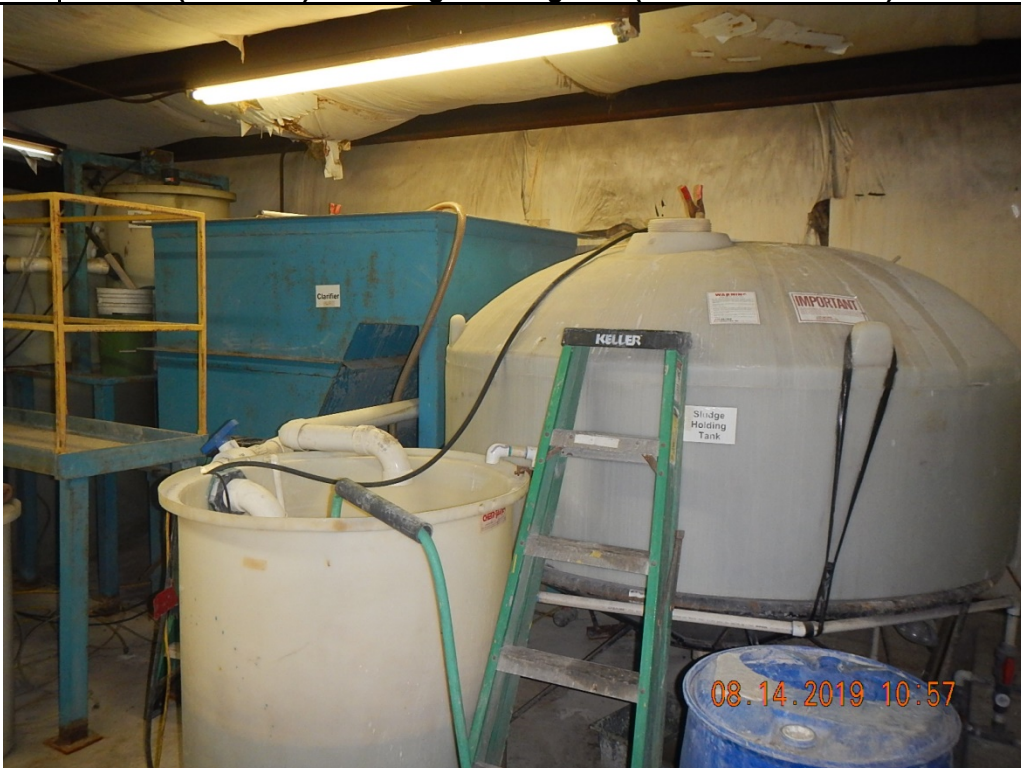
Photographer:	Dannielle Gray	Date:	8/14/2019
Witness:	None	Time:	1057
Description:	Clarifier (blue tank) and sludge holding tank (white rounded tank).

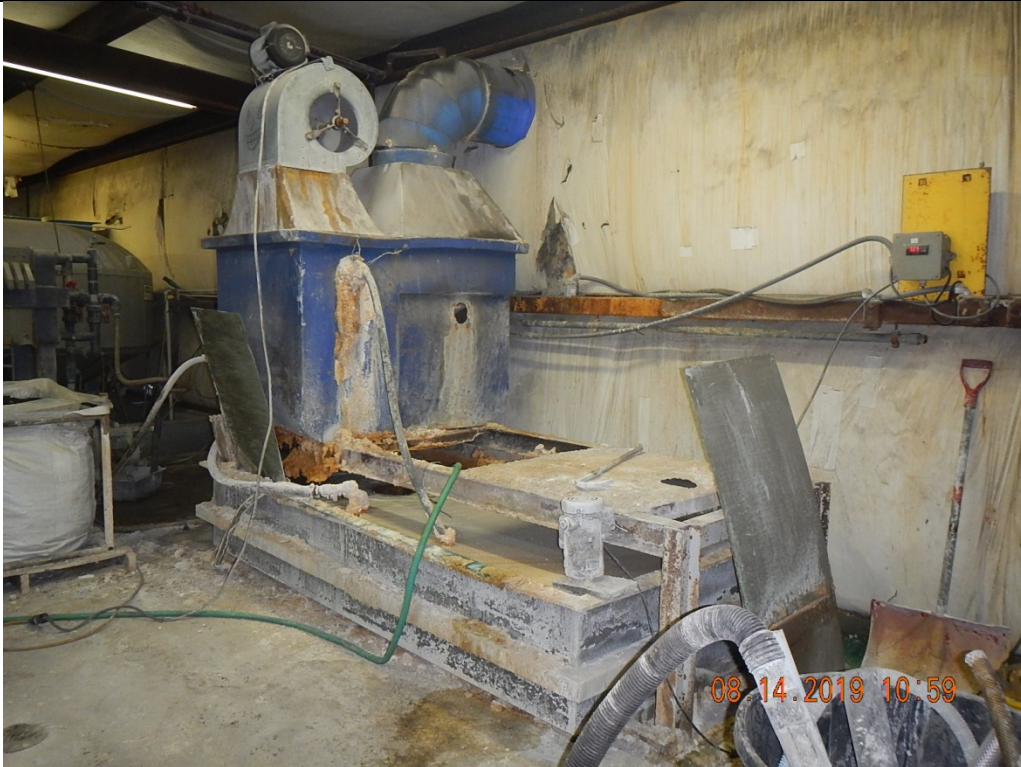
Location:	B&W Plating		
Photographer:	Dannielle Gray	Date:	8/14/2019
Witness:	None	Time:	1059
		Photo #:	7
Description:	Evaporation tank; note buildup and scaling on components.

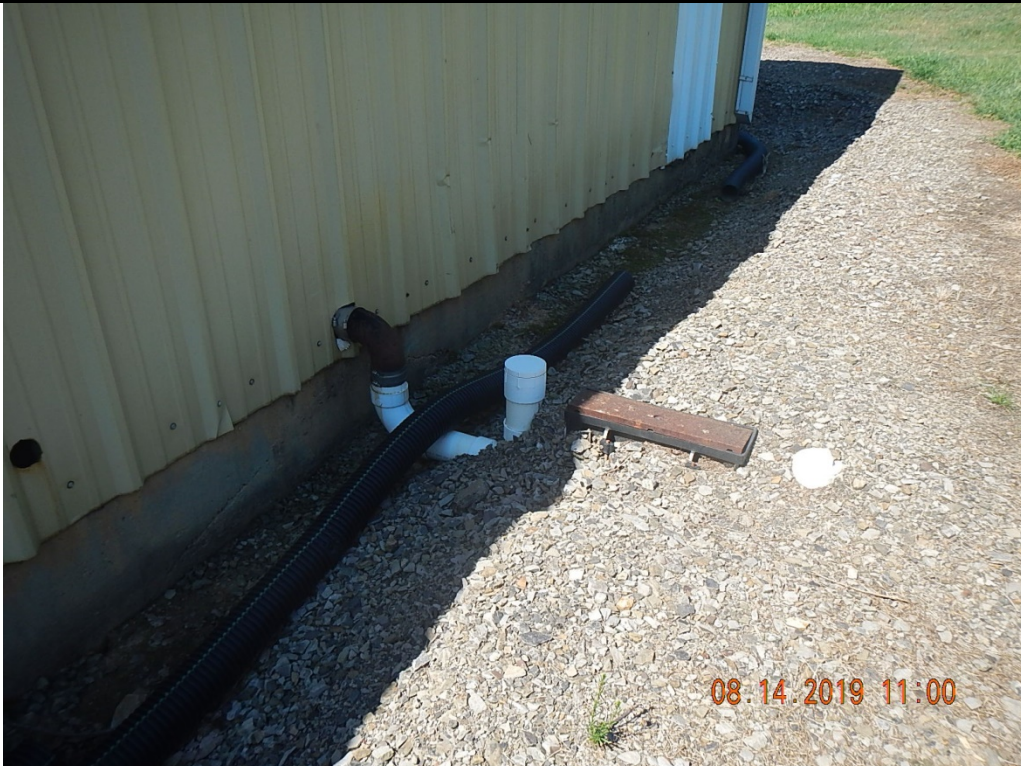
This facility has a no discharge permit through the POTW. The sewer at the facility has been capped and removed, and the industry has no means of discharging to the city sewer line. This was the result of numerous non-compliance issues in the past.

Photographer:	Dannielle Gray	Date:	8/14/2019
Witness:	None	Time:	1100
		Photo #:	8
Description:	Capped sample location.
