OFFICE OF WATER QUALITY INSPECTION REPORT

AFIN: 17-00062	PERMIT #: AR0021482	DATE: 8/14/2019
COUNTY: 17 Crawford	PDS #: 109240	MEDIA: WN
GPS LAT: 35.430056 LONG: -94.951260 LOCATION: Entrance

FACILITY INFORMATION	INSPECTION INFORMATION
NAME: River City Coatings, Inc. LOCATION: 306 Sycamore St. CITY: Van Buren	FACILITY TYPE: 2 - Industrial INSPECTOR ID#: 71330 S - State FACILITY EVALUATION RATING: 3 - Satisfactory INSPECTION TYPE: Industrial User DATE(S): 8/14/2019 ENTRY TIME: 12:00 EXIT TIME: 12:30 PERMIT EFFECTIVE DATE: 1/1/2015 PERMIT EXPIRATION DATE: 12/31/2019
RESPONSIBLE OFFICIAL NAME: / TITLE Steve Dufresne / COMPANY: Van Buren Municipal Utilities MAILING ADDRESS: PO Drawer 1269 CITY, STATE, ZIP: Van Buren AR 72959 PHONE & EXT: / FAX: 479-474-5067 / EMAIL: steve@vbmua.arcoxml.com CONTACTED DURING INSPECTION: No	FAYETTEVILLE SHALE RELATED: N FAYETTEVILLE SHALE VIOLATIONS: N INSPECTION PARTICIPANTS NAME/TITLE/PHONE/FAX/EMAIL/ETC.: James Dunn/City of Van Buren Chief Plant Operator/479.474.5067/james@vbmua.arcoxml.com Kim Redo/City of Van Buren Environmental Coordinator/479.474.0941/kim@vbmua.arcoxml.com Tony Jester/Plant Manager/479-471-7675/tony@rivercitycoatings.com

Industr

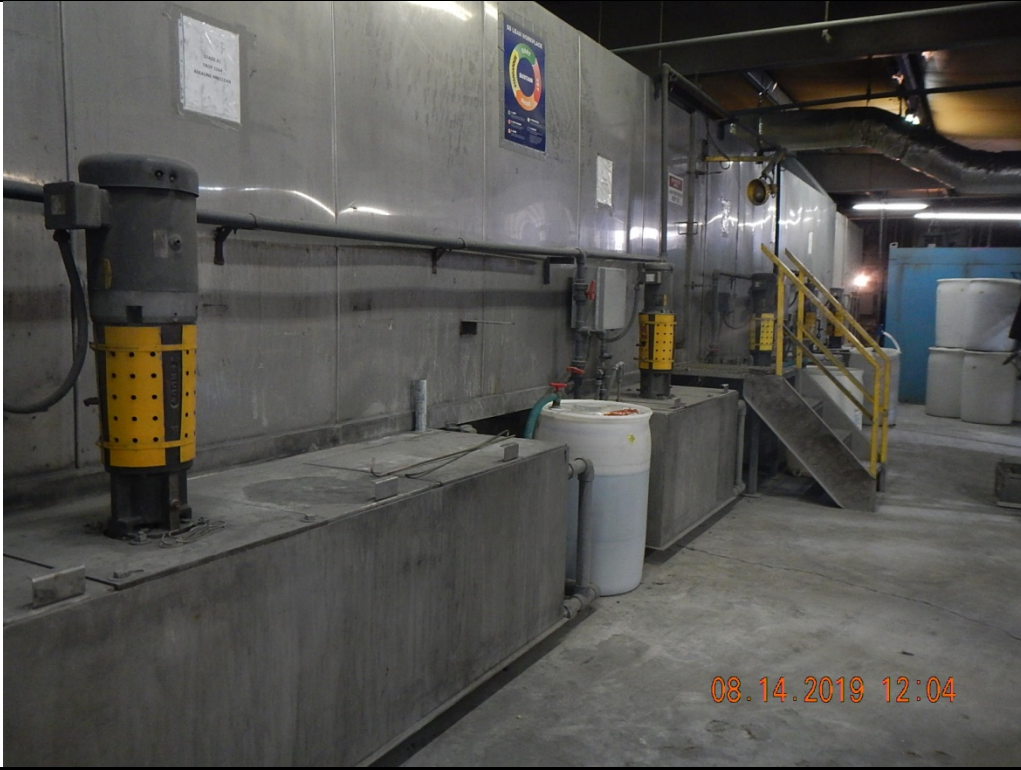
Location:	River City Coatings, Inc.		
Photographer:	Dannielle Gray	Date:	8/14/2019
Witness:	None	Time:	1204
		Photo #:	1
Description:	5-stage wash tank system.

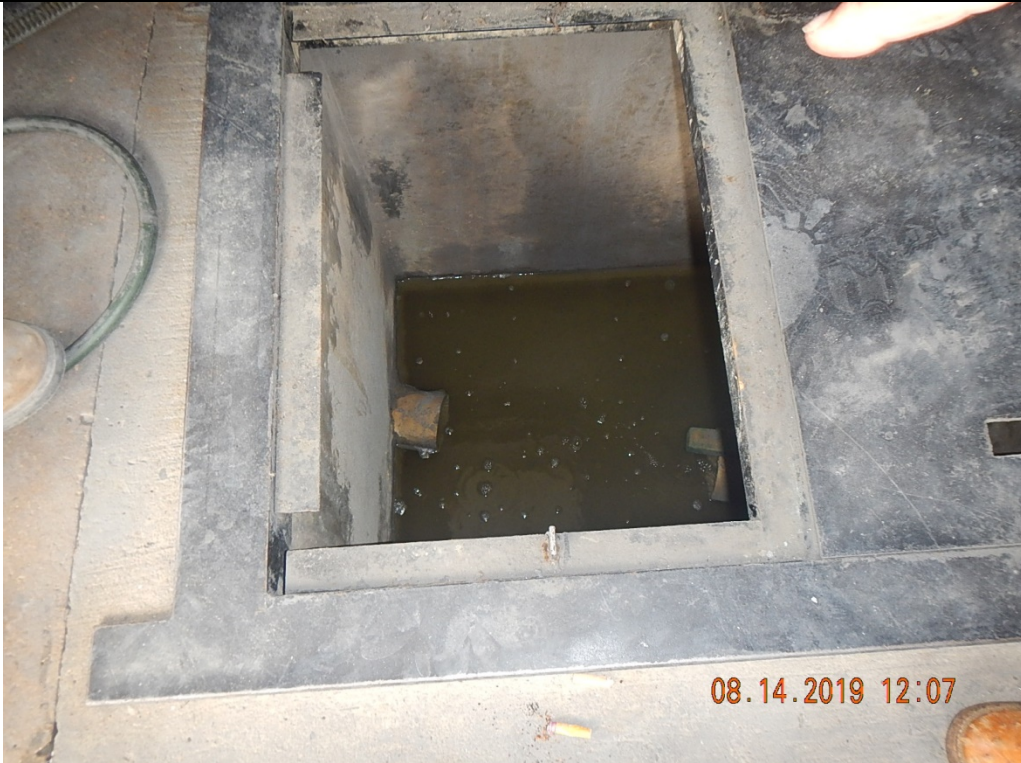
Photographer:	Dannielle Gray	Date:	8/14/2019
Witness:	None	Time:	1207
		Photo #:	2
Description:	Sampling location.

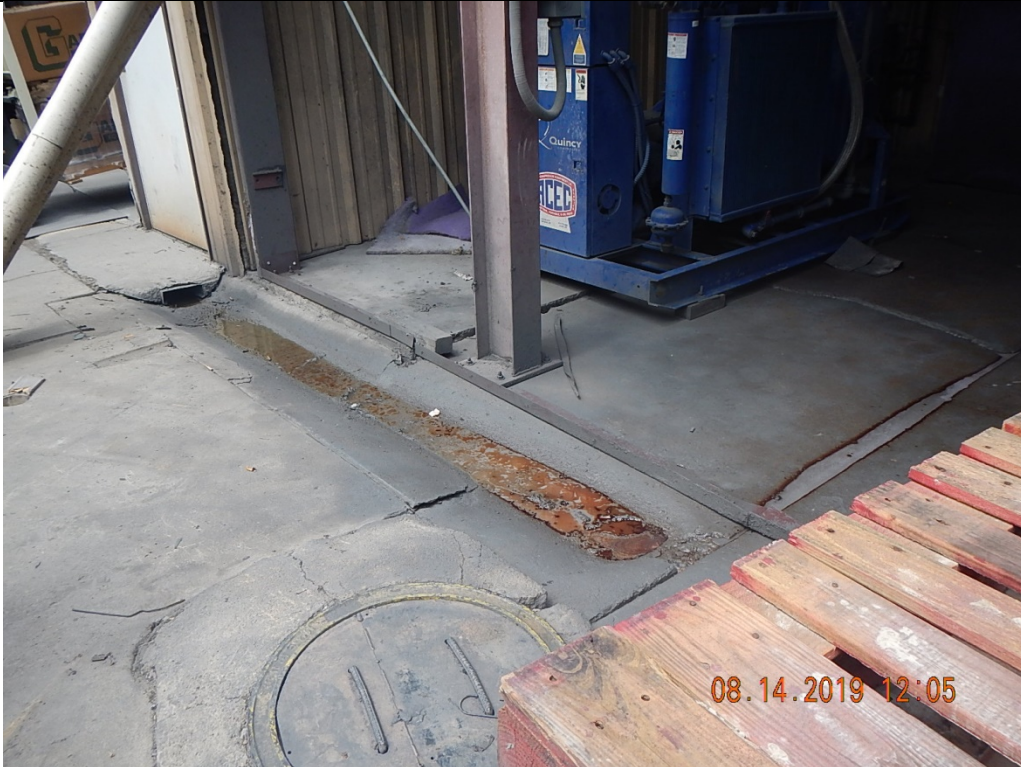
The pretreatment components and processing line were clean, operational, and well-maintained. Staff interviewed was familiar with both the pretreatment system and the permit and permit requirements through the city. A small quantity of hazardous waste is stored onsite, but it is labeled and stored properly. Spill kits were staged in obvious locations. Oil from equipment was observed leaking into a stormwater drainage feature during inspection. Prior to inspection completion, the Plant Manager had staff responded with absorbent and informed that the equipment would be serviced and the absorbent would be swept up and disposed of properly. Oil was not observed in a nearby stormwater drainage ditch.

| 9. Adequate spill prevention? | <u> </u> | Yes | <u> X </u> | No | <u> </u> | NA |

Location:	River City Coatings, Inc.		
Photographer:	Dannielle Gray	Date:	8/14/2019
Witness:	None	Time:	1205
		Photo #:	3
Description:	Oil leaking into stormwater drainage observed near sampling location.

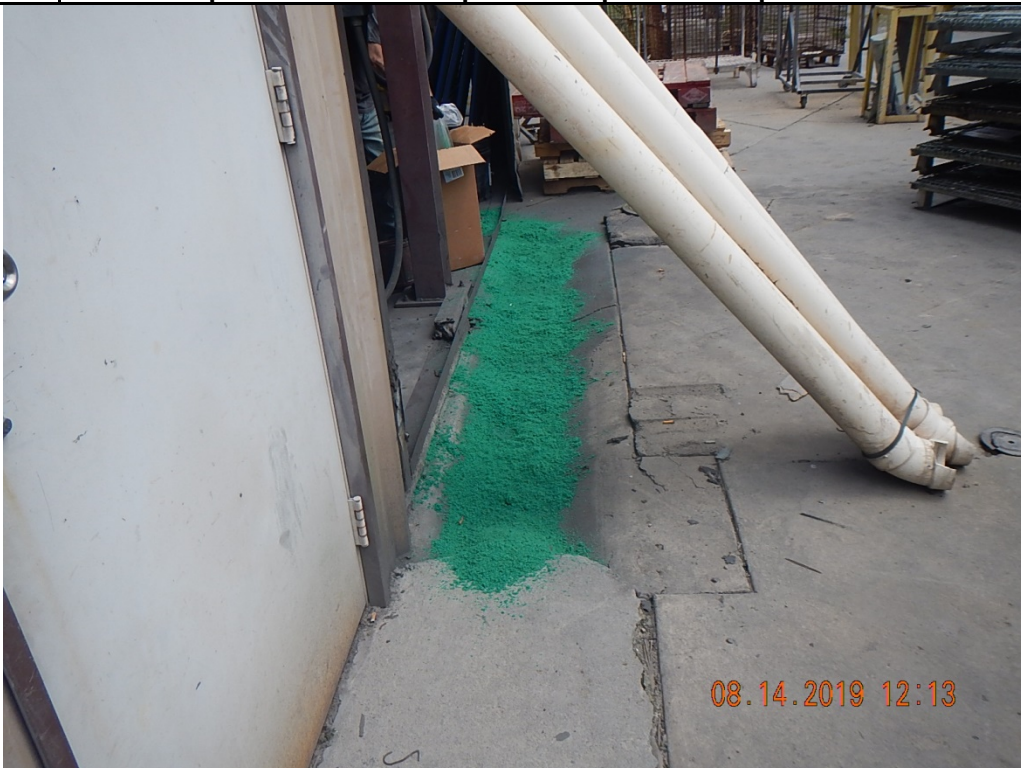
Photographer:	Dannielle Gray	Date:	8/14/2019
Witness:	None	Time:	1213
		Photo #:	4
Description:	Absorbent placed over oil leak prior to inspection completion.
