OFFICE OF WATER QUALITY INSPECTION REPORT

AFIN: 17-00062	PERMIT #: AR0021482	DATE: 8/14/2019
COUNTY: 17 Crawford	PDS #: 109242	MEDIA: WN
GPS LAT: 35.425702 LONG: -94.331594 LOCATION: Entrance

FACILITY INFORMATION	INSPECTION INFORMATION
NAME: Tate & Lyle LOCATION: 610 South 28 th St CITY: Van Buren	FACILITY TYPE: 2 - Industrial INSPECTOR ID#: 71330 S - State FACILITY EVALUATION RATING: 3 - Satisfactory INSPECTION TYPE: Industrial User DATE(S): 8/14/2019 ENTRY TIME: 11:15 EXIT TIME: 11:50 PERMIT EFFECTIVE DATE: 1/1/2015 PERMIT EXPIRATION DATE: 12/31/2019
RESPONSIBLE OFFICIAL NAME: / TITLE Steve Dufresne / COMPANY: Van Buren Municipal Utilities MAILING ADDRESS: PO Drawer 1269 CITY, STATE, ZIP: Van Buren AR 72956 PHONE & EXT: / FAX: 479-474-5067 / EMAIL: steve@vbmua.arcoxml.com CONTACTED DURING INSPECTION: No	FAYETTEVILLE SHALE RELATED: N FAYETTEVILLE SHALE VIOLATIONS: N INSPECTION PARTICIPANTS NAME/TITLE/PHONE/FAX/EMAIL/ETC.: James Dunn/City of Van Buren Chief Plant Operator/479.474.5067/james@vbmua.arcoxml.com Kim Redo/City of Van Buren Environmental Coordinator/479.474.0941/kim@vbmua.arcoxml.com Erik Boggs/Production Manager/479-410-6011 Bobby Campbell/EHS Manager/479-410-6102 Jef

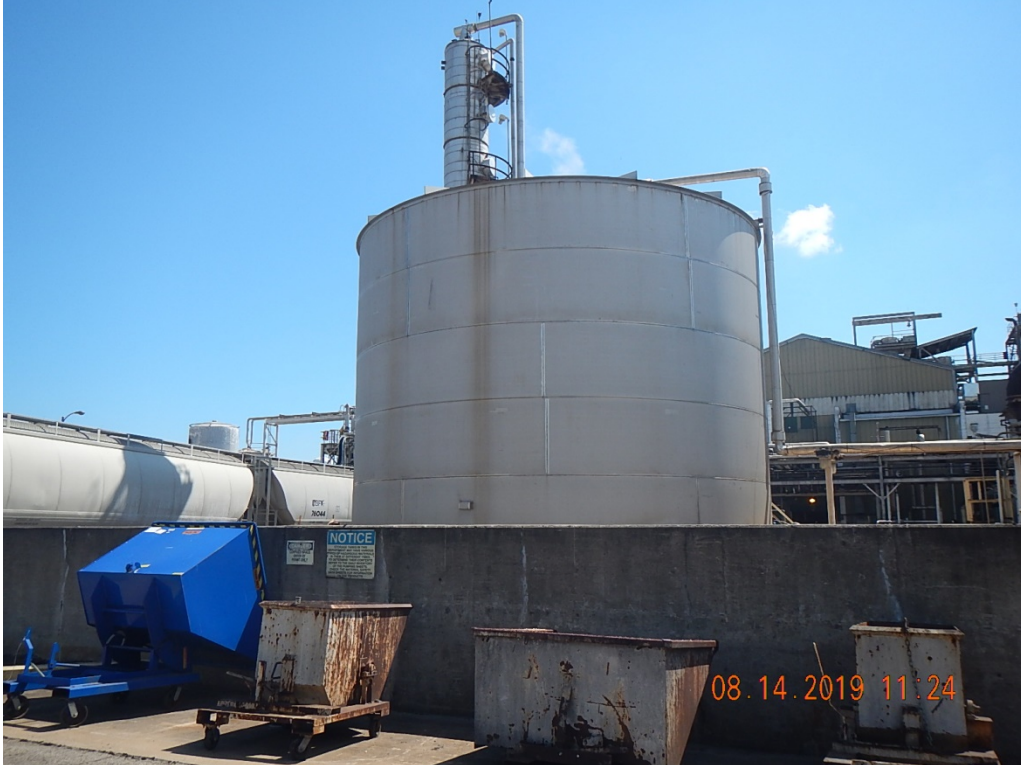
Location:	Tate & Lyle		
Photographer:	Dannielle Gray	Date:	8/14/2019
Witness:	None	Time:	1124
		Photo #:	1
Description:	Surge tank in secondary containment.

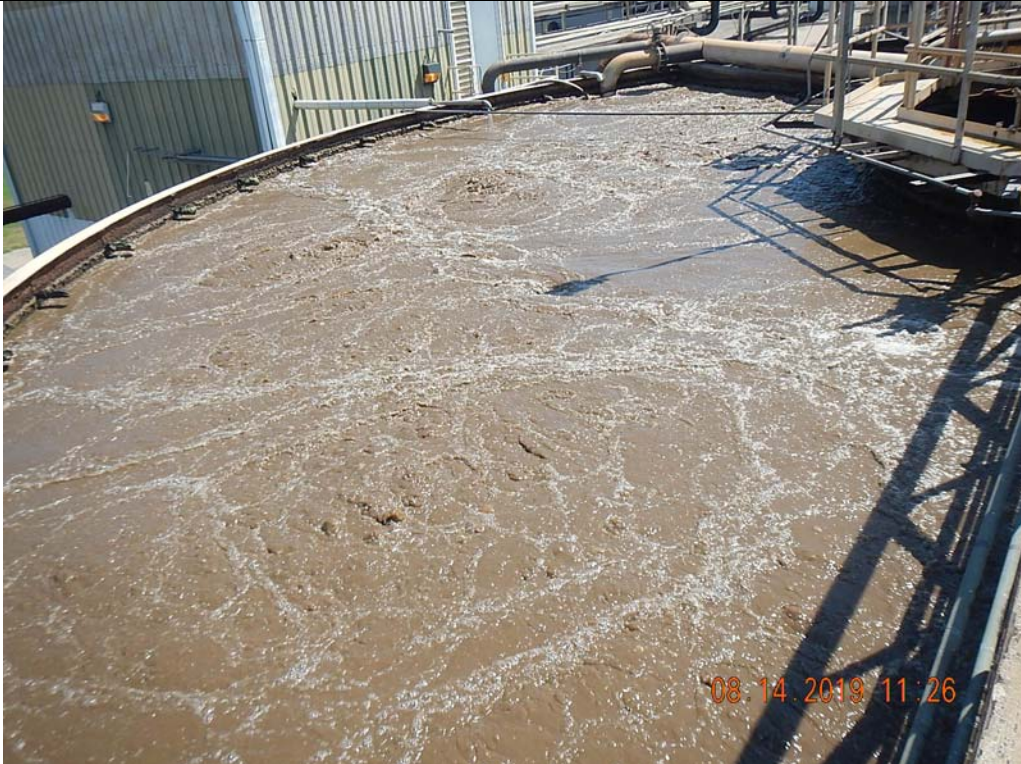
Photographer:	Dannielle Gray	Date:	8/14/2019
Witness:	None	Time:	1126
		Photo #:	2
Description:	Activated sludge chamber in package wastewater treatment plant.

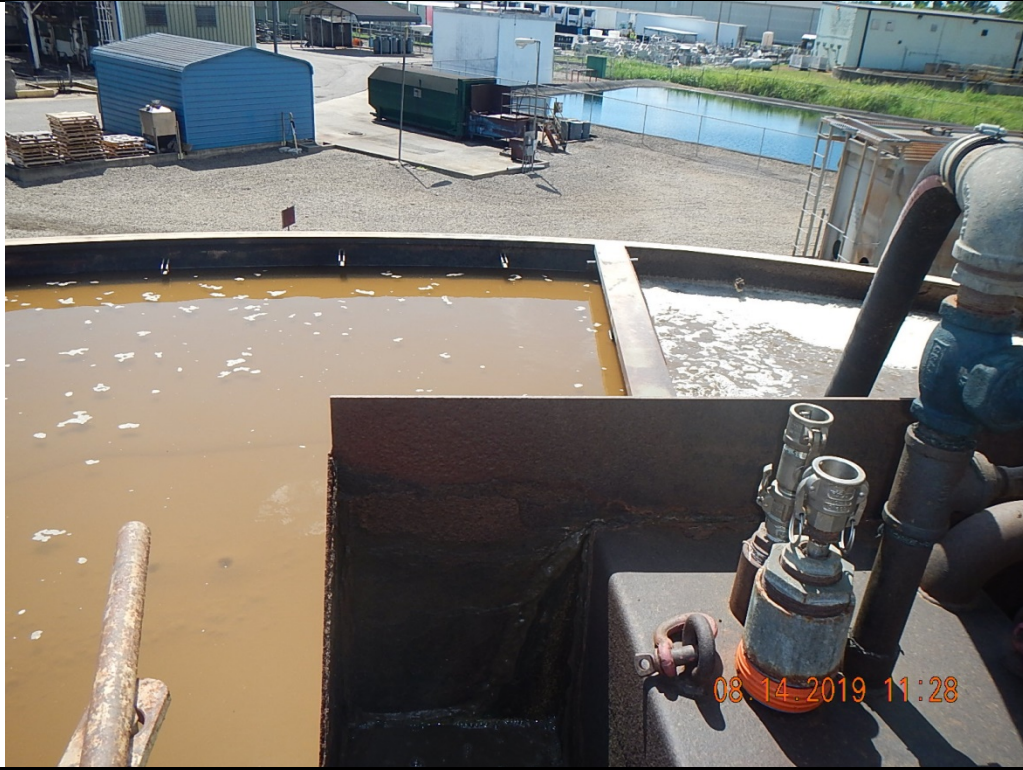
Location:	Tate & Lyle		
Photographer:	Dannielle Gray	Date:	8/14/2019
Witness:	None	Time:	1128
		Photo #:	3
Description:	WAS chamber (photo left), activated sludge chamber (photo right), and RAS box (photo right center) of package wastewater treatment plant.

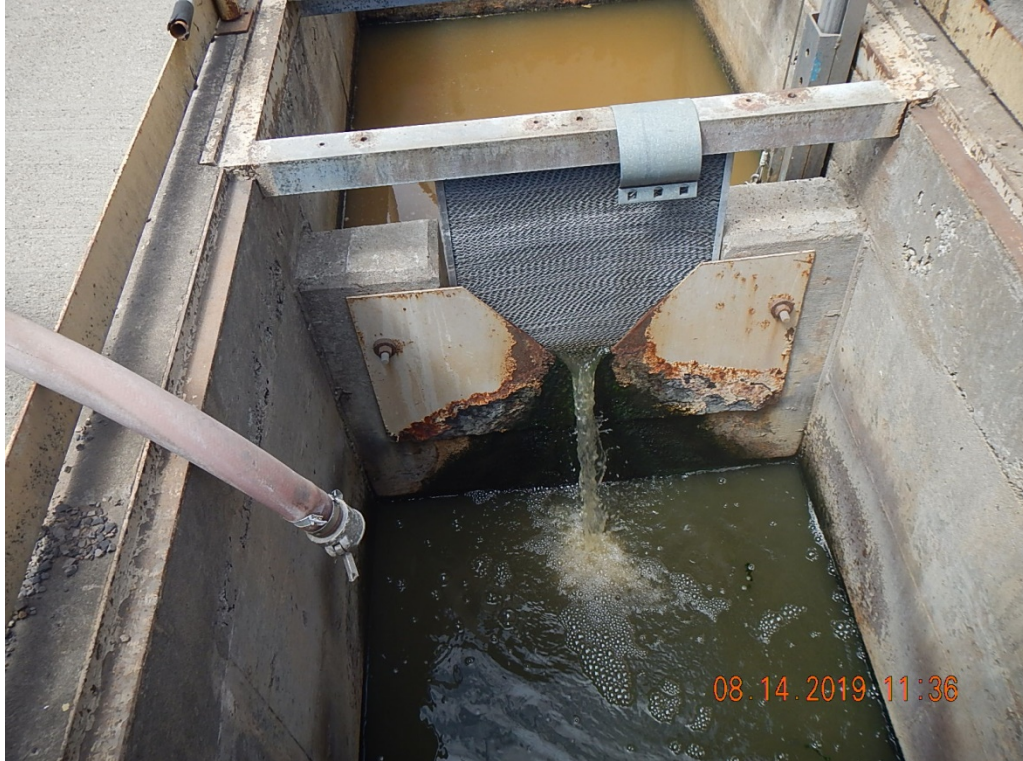
Photographer:	Dannielle Gray	Date:	8/14/2019
Witness:	None	Time:	1136
		Photo #:	4
Description:	Effluent exiting package plant towards city sewer.

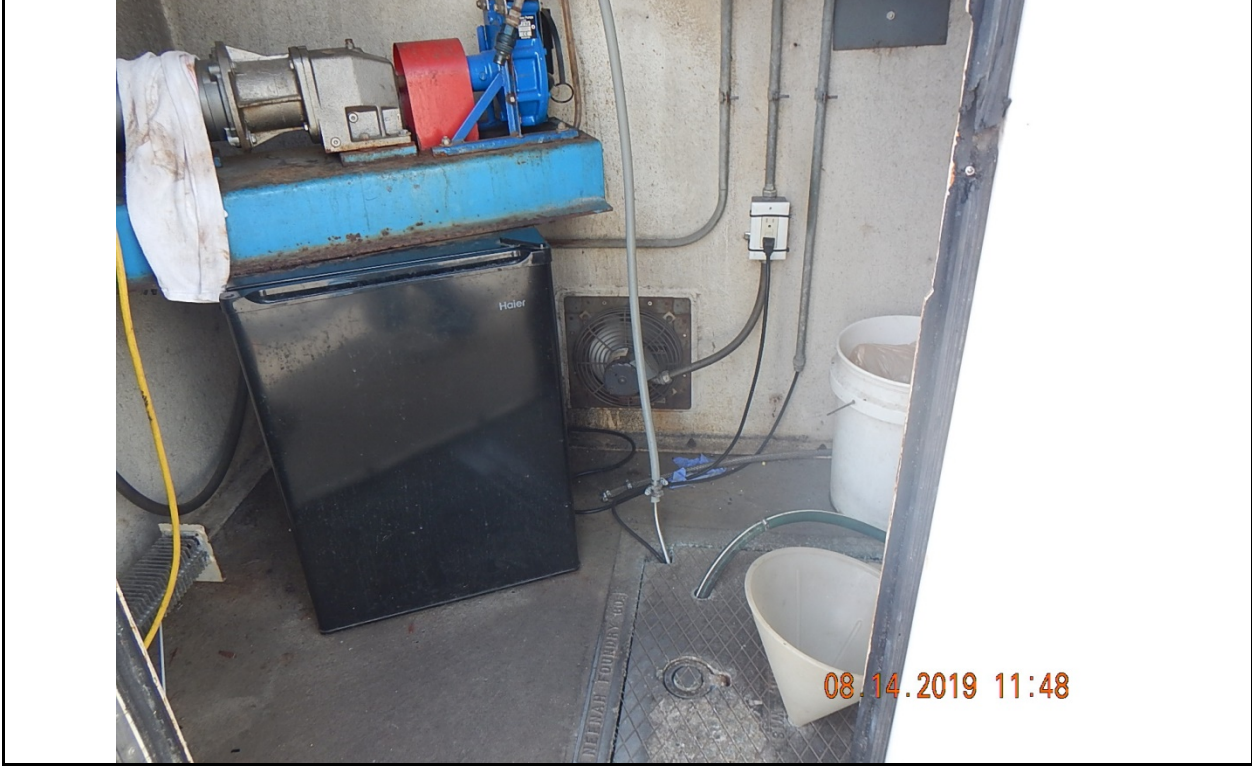
Location: **Tate & Lyle**
Photographer: **Dannielle Gray** Date: **8/14/2019** Time: **1148**
Witness: **None** Photo #: **5**

Description: **Sampling shed and well prior to entering city sewer. Funnel (bottom right) is on top of sampling well. City and facility samples are collected here.**
