<h1 style="margin:0;">ADEQ</h1> <p style="margin:0;">ARKANSAS Department of Environmental Quality</p>	WATER DIVISION INSPECTION REPORT		
	AFIN: 04-00106	PERMIT #: AR0020273	DATE: 8/20/2019
	COUNTY: 04 Benton	PDS #: 109287	MEDIA: WN
	GPS LAT:	LONG:	LOCATION: *****
FACILITY INFORMATION		INSPECTION INFORMATION	
NAME: City of Siloam Springs PCI LOCATION: 975 Anderson Road CITY: Siloam Springs		FACILITY TYPE: ***** INSPECTOR ID#: 83321 S - State FACILITY EVALUATION RATING: *** INSPECTION TYPE: Industrial User DATE(S): 8/20/2019 ENTRY TIME: 14:00 EXIT TIME: 15:00 PERMIT EFFECTIVE DATE: 10/1/2007 PERMIT EXPIRATION DATE: 9/30/2012	
RESPONSIBLE OFFICIAL		INSPECTION PARTICIPANTS	
NAME / TITLE: Mr. Andy Brashear / Environmental Manager COMPANY: Simmons Food, Inc. MAILING ADDRESS: P.O. Box 430 CITY, STATE, ZIP: Siloam Springs AR 72761 PHONE & EXT: / FAX: / EMAIL:		NAME/TITLE/PHONE/FAX/EMAIL/ETC.: Cole Southerland, Field Inspector, ADEQ Tom Meyers, WW Superintendent, Siloam Springs Tony Brown, Class III WW Operator, Siloam Springs Andy Brashear, Env. Manager, Simmons Food Bill Paczowski, WW Superintendent, Simmons Food

POTW Pretreatment Program

Industrial Site Visit

Name of Industry: SIMMONS

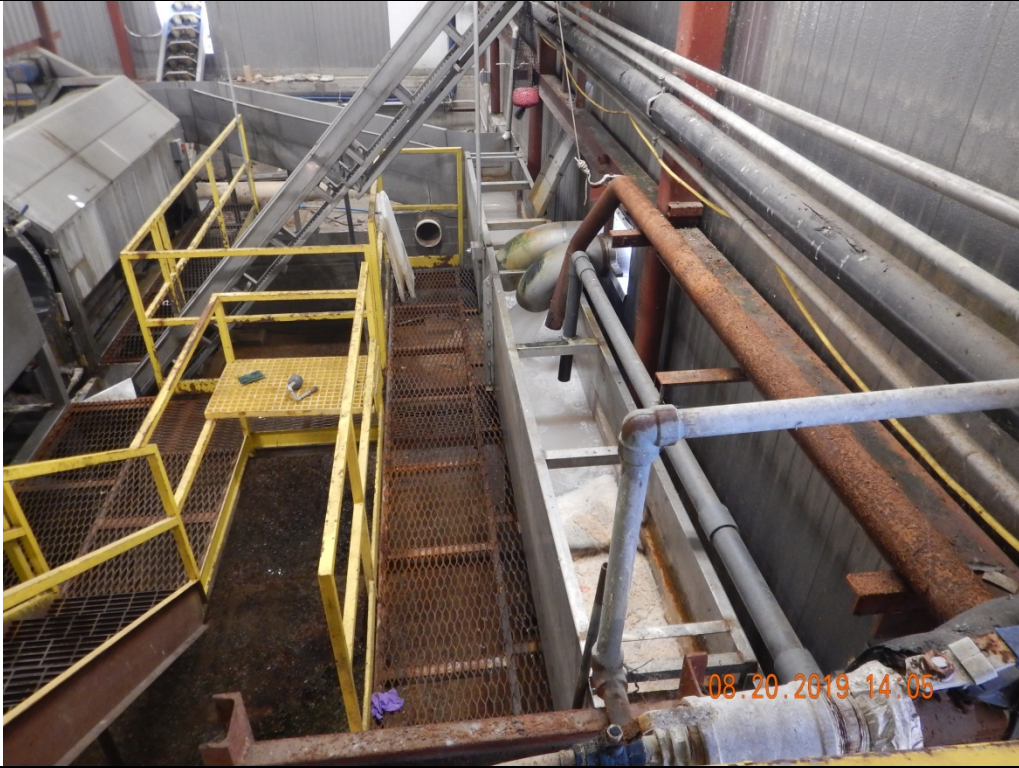
Location:	City of Siloam Springs PCI				
Photographer:	Jason Bolenbaugh	Date:	8/20/2019	Time:	14:05
Witness:				Photo #:	1
Description:	Wastewater flowing into the pretreatment unit.

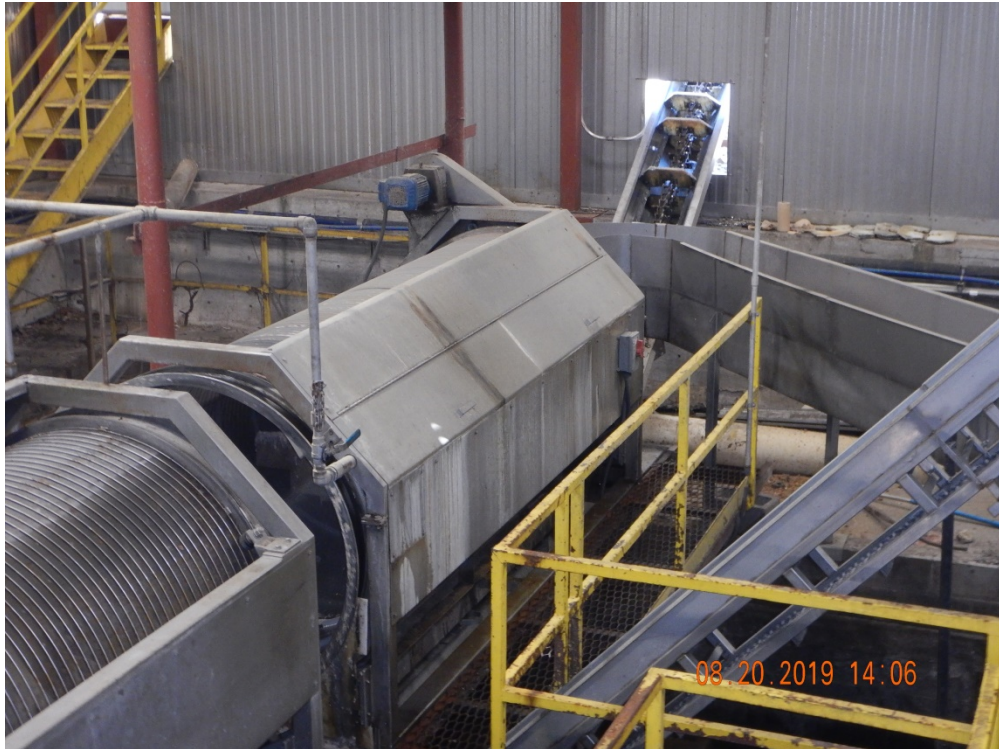
Photographer:	Jason Bolenbaugh	Date:	8/20/2019	Time:	14:06
Witness:				Photo #:	2
Description:	Screening equipment.

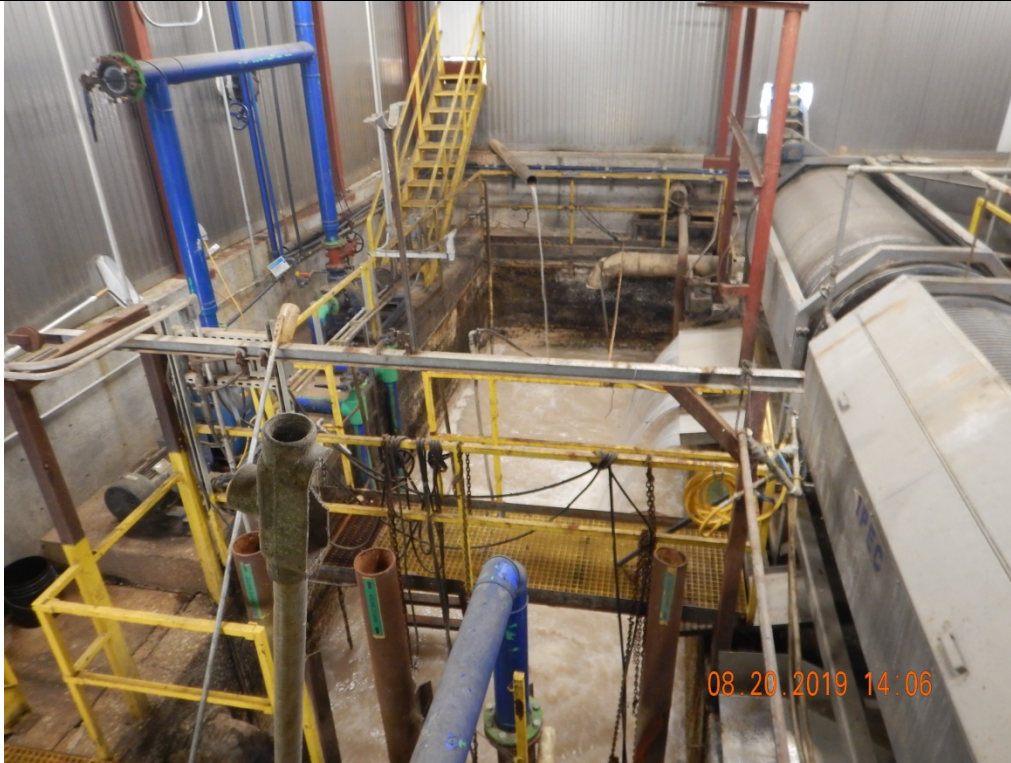
Location:	City of Siloam Springs PCI		
Photographer:	Jason Bolenbaugh	Date:	8/20/2019
Witness:		Time:	14:06
		Photo #:	3
Description:	View of 18ft deep pit wastewater flows into following screening.

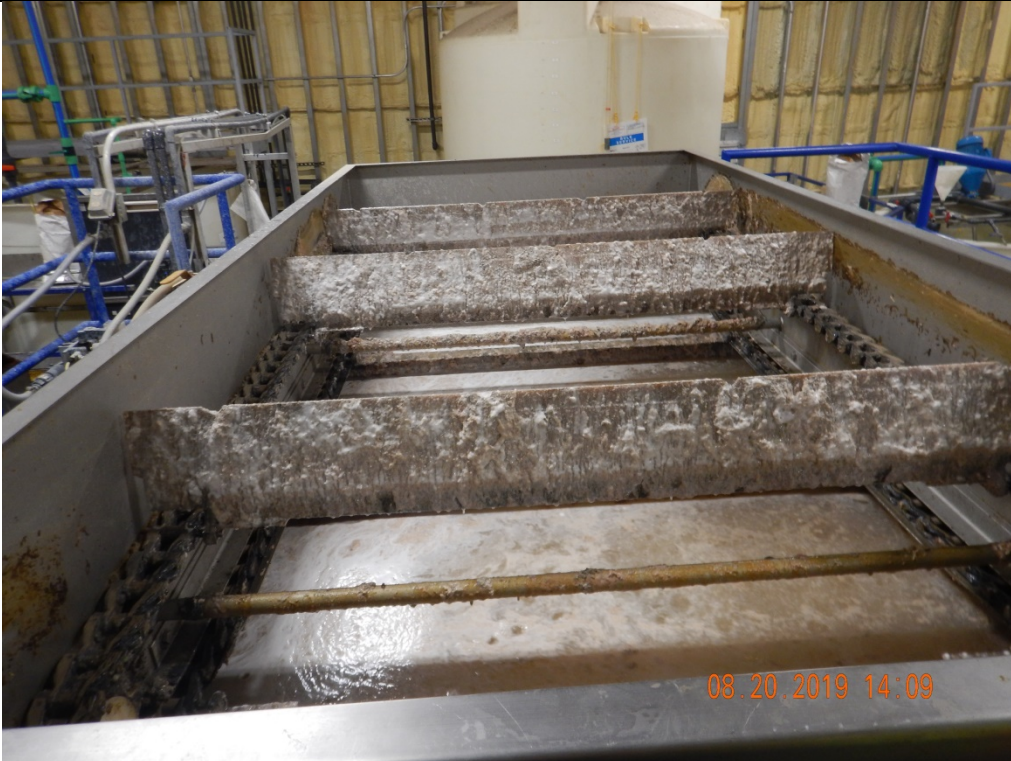
Photographer:	Jason Bolenbaugh	Date:	8/20/2019
Witness:		Time:	14:09
		Photo #:	4
Description:	First Dissolved Air Floatation (DAF/SAF) unit.

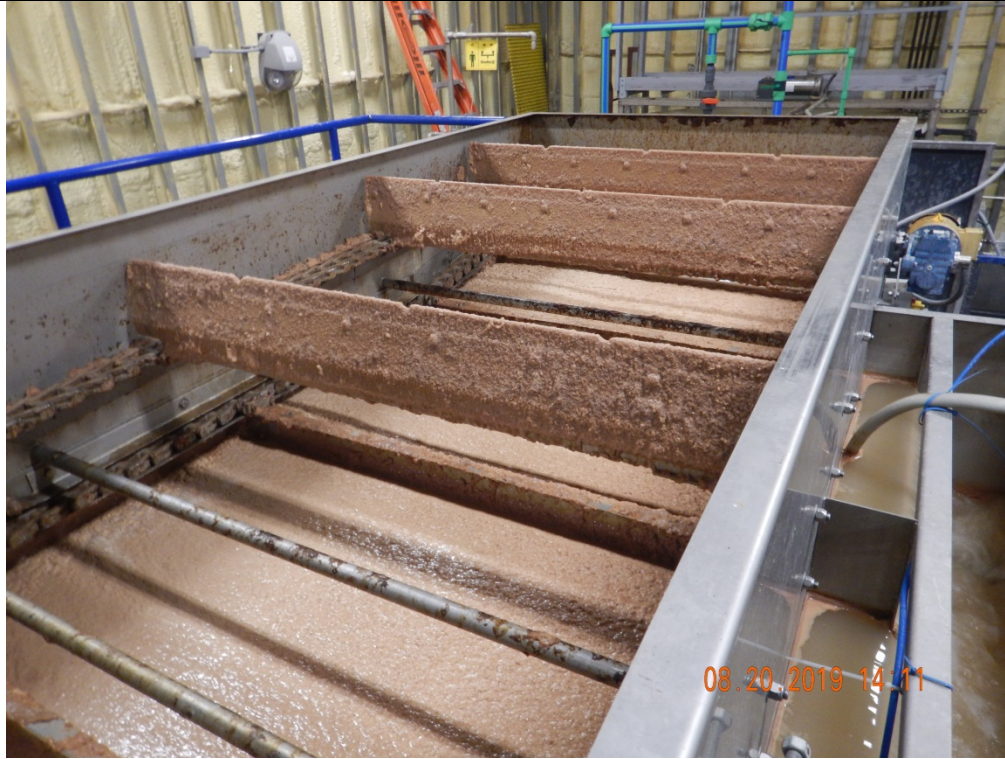
Location:	City of Siloam Springs PCI		
Photographer:	Jason Bolenbaugh	Date:	8/20/2019
Witness:		Time:	14:11
		Photo #:	5
Description:	Second Dissolved Air Floatation unit.

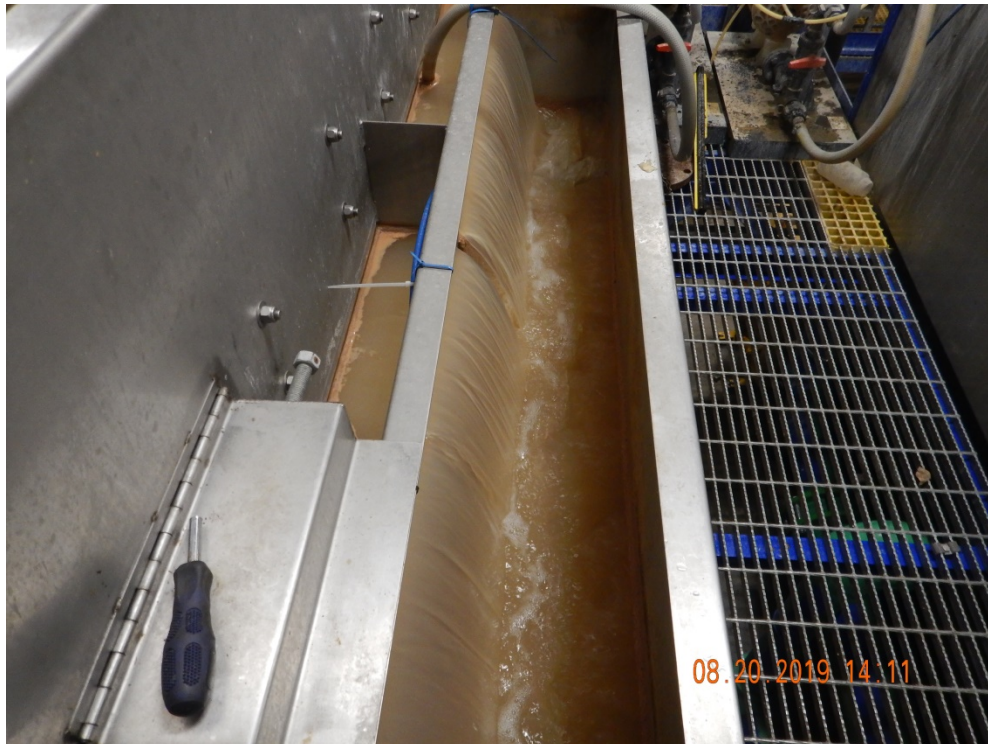
Photographer:	Jason Bolenbaugh	Date:	8/20/2019
Witness:		Time:	14:11
		Photo #:	6
Description:	Discharge from the second DAF unit.
