A R K A N S A S Department of Environmental Quality		WATER DIVISION INSPECTION REPORT					
		AFIN: 70-00341		PERMIT #: AR0033723		DATE: 8/20/2019	
		COUNTY: 70 Union		PDS #: 109385		MEDIA: WN	
		GPS LAT: 33.245102 LONG: -92.664519 LOCATION: Entrance					
FACILITY INFORMATION			INSPECTION INFORMATION				
NAME: Miller Transporters, Inc. LOCATION: 2811 North West Ave. CITY: El Dorado, AR 71730			FACILITY TYPE: 2 - Industrial	INSPECTOR ID#: 101531 S - State			
			FACILITY EVALUATION RATING: 5 - Satisfactory		INSPECTION TYPE: Industrial User		
			DATE(S): 8/20/2019	ENTRY TIME: 11:12	EXIT TIME: 11:28	PERMIT EFFECTIVE DATE: 1/1/2015	
					PERMIT EXPIRATION DATE: 12/31/2019		
RESPONSIBLE OFFICIAL			FAYETTEVILLE SHALE RELATED: N				
NAME / TITLE: Ed Matlege / Director of Environmental Affairs COMPANY: Miller Transporters Inc. MAILING ADDRESS: P.O. Box 1392 CITY, STATE, ZIP: El Dorado AR 71730 PHONE & EXT. / FAX: 870-862-5541 / EMAIL: RFREELAND@MILLERT.COM			FAYETTEVILLE SHALE VIOLATIONS: N

POTW Pretreatment Program

Industrial Site Visit

Name of Industry: Miller Transporters Inc.

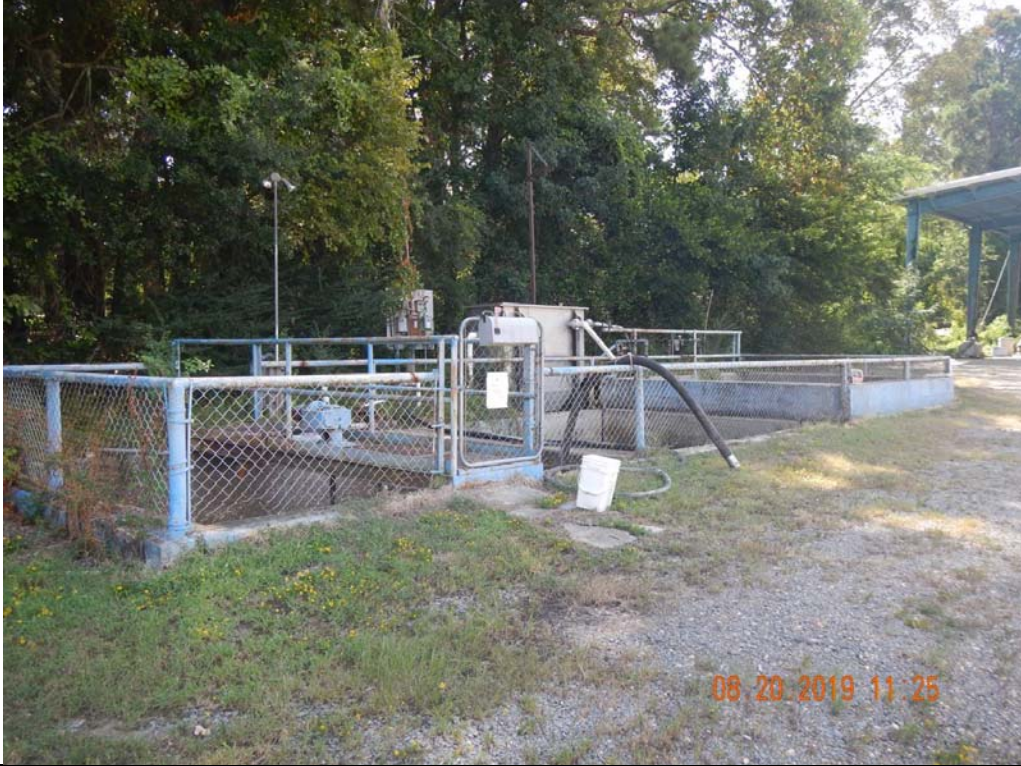
Location:	Miller Transporters, Inc.				
Photographer:	Michael Young	Date:	08/20/2019	Time:	11:25
Witness:				Photo #:	1
Description:	Pretreatment device has not been utilized in two years with no tank washing.

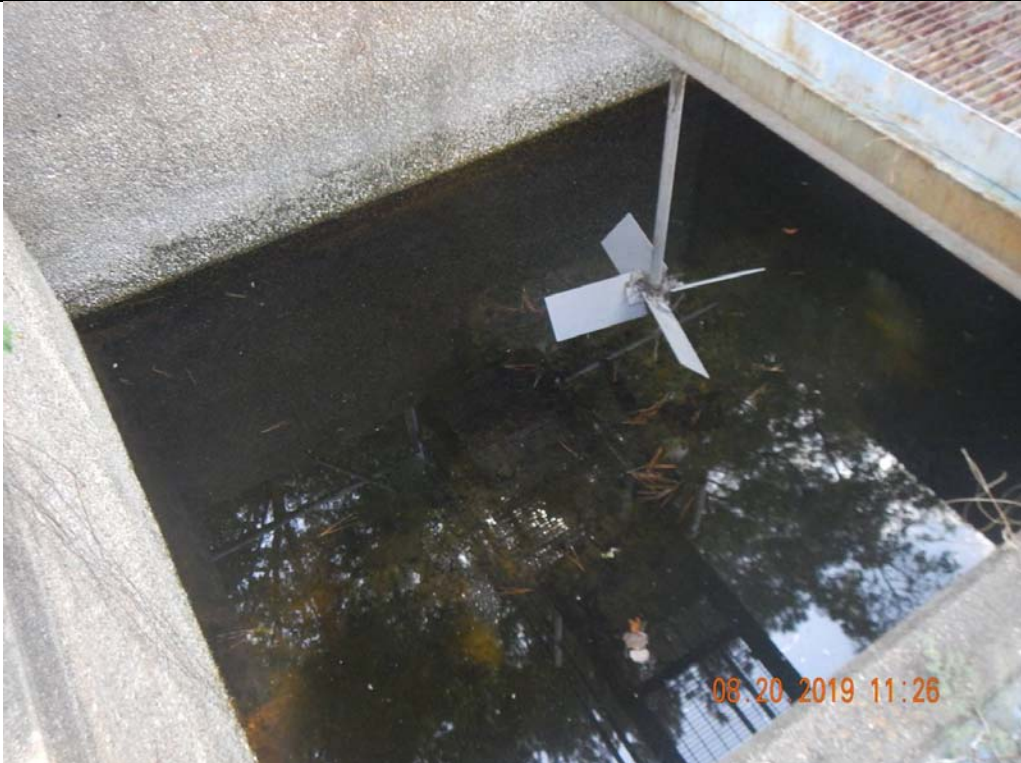
Photographer:	Michael Young	Date:	08/20/2019	Time:	11:26
Witness:				Photo #:	2
Description:	Chemical mixer in pretreatment unit.

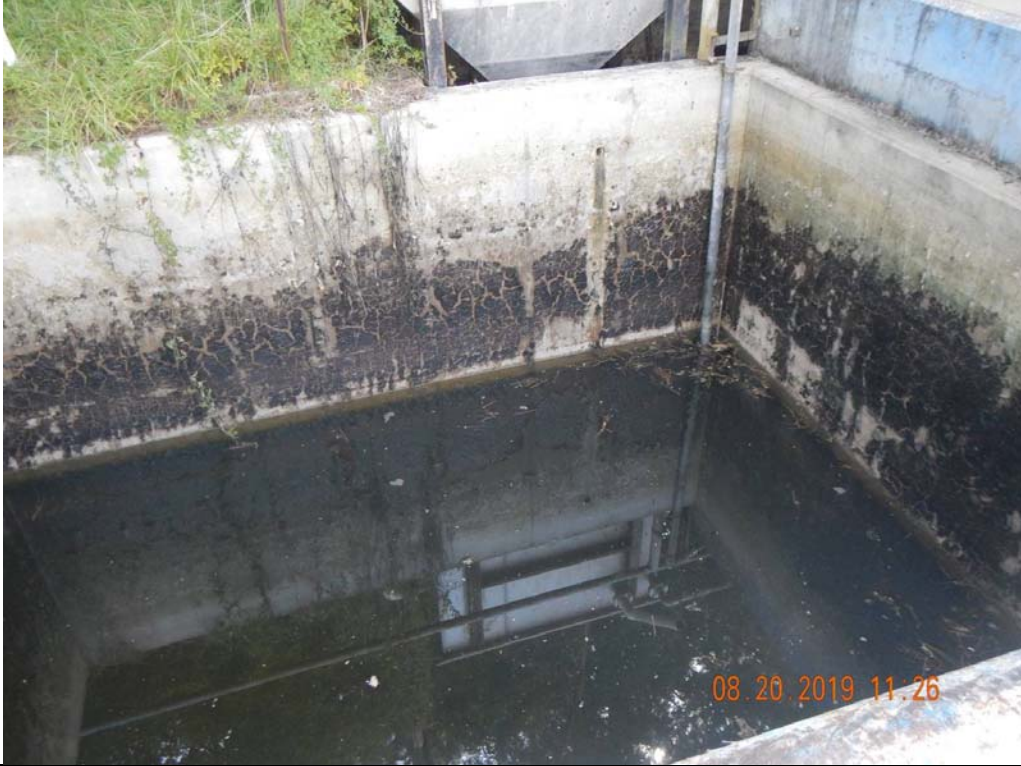
Location:	Miller Transporters, Inc.		
Photographer:	Michael Young	Date:	08/20/2019
Witness:		Time:	11:26
		Photo #:	3
Description:	Pretreatment device with very little water and no discharge from tank washing.

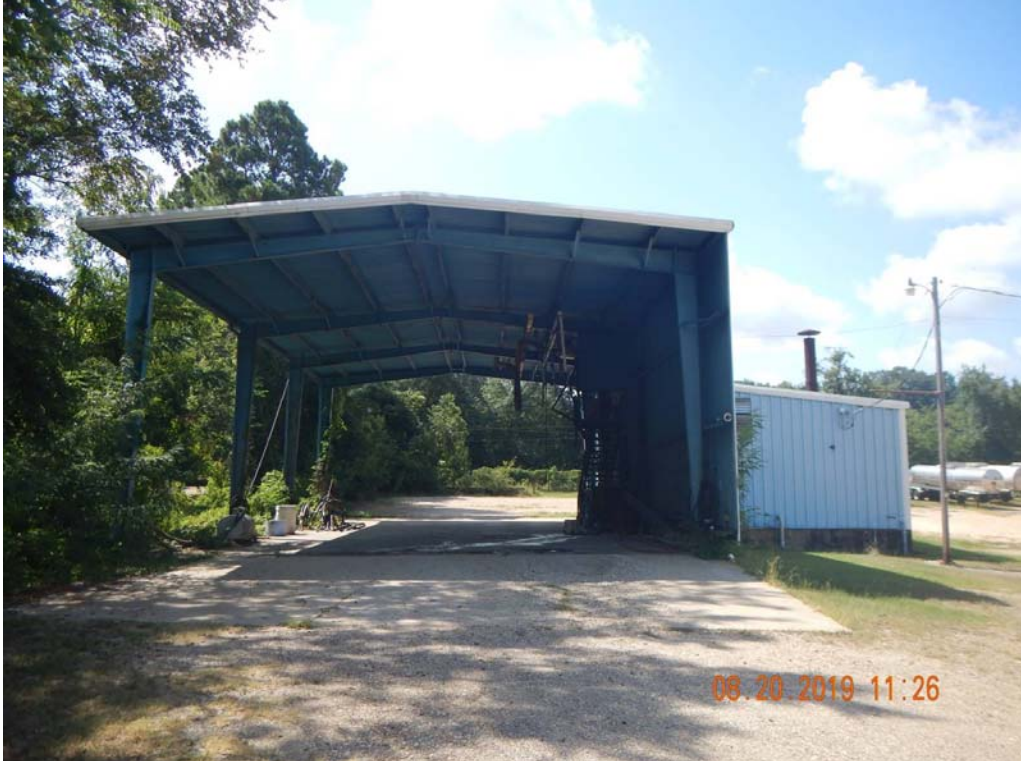
Photographer:	Michael Young	Date:	08/20/2019
Witness:		Time:	11:26
		Photo #:	4
Description:	Interior tank washing building.

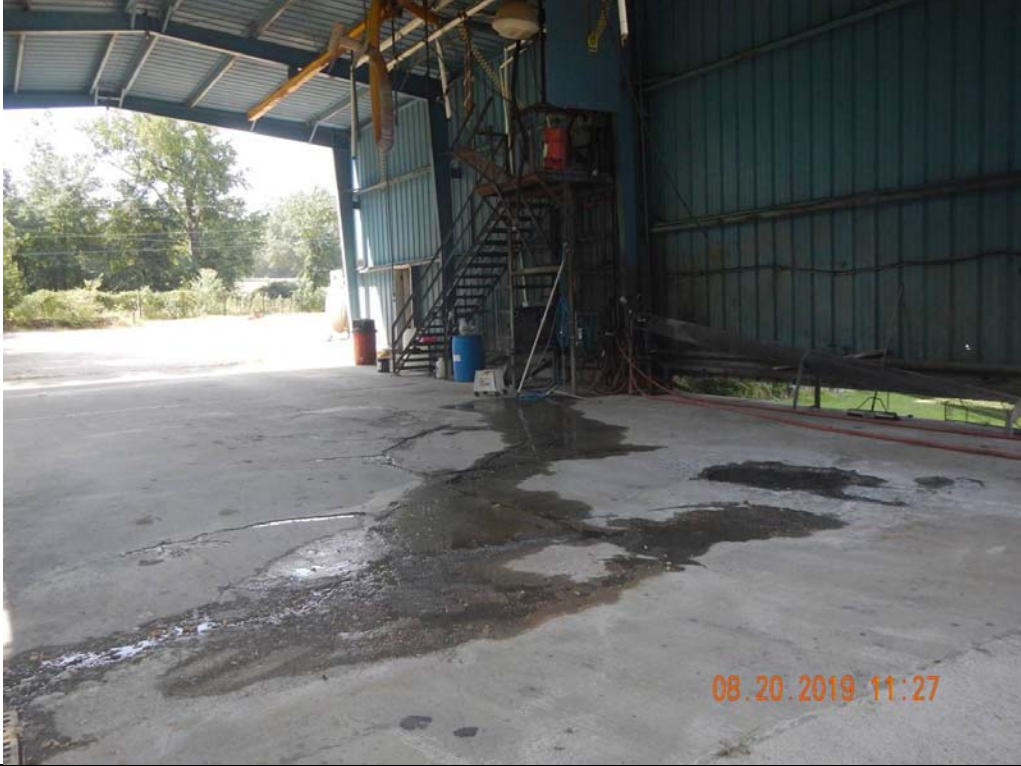
Location:	Miller Transporters, Inc.				
Photographer:	Michael Young	Date:	08/20/2019	Time:	11:27
Witness:				Photo #:	5
Description:	Interior tank washing building. Water was potable water leak.
