<b>A R K A N S A S</b> Department of Environmental Quality		<b>WATER DIVISION INSPECTION REPORT</b>							
		AFIN: 70-00341		PERMIT #: AR0033723		DATE: 8/20/2019			
		COUNTY: 70 Union			PDS #: 109386		MEDIA: WN		
		GPS LAT: 33.198770 LONG: -92.608510 LOCATION: Entrance							
<b>FACILITY INFORMATION</b>				<b>INSPECTION INFORMATION</b>					
NAME: <b>Prescolite - Reflector Plant</b> LOCATION: <b>216 Mims Drive</b> CITY: <b>El Dorado, AR 71730</b>				FACILITY TYPE: <b>2 - Industrial</b>		INSPECTOR ID#: <b>101531 S - State</b>			
				FACILITY EVALUATION RATING: <b>5 - Satisfactory</b>		INSPECTION TYPE: <b>Industrial User</b>			
				DATE(S): <b>8/20/2019</b>		ENTRY TIME: <b>11:12</b>		EXIT TIME: <b>11:28</b>	
								PERMIT EFFECTIVE DATE: <b>1/1/2015</b>	
				PERMIT EXPIRATION DATE: <b>12/31/2019</b>					
<b>RESPONSIBLE OFFICIAL</b>				FAYETTEVILLE SHALE RELATED: <b>N</b>					
NAME / TITLE: <b>Michael L. Phillips / Engineering Manager</b> COMPANY: <b>Hubbell Lighting, Inc.</b> MAILING ADDRESS: <b>216 Mims Drive</b> CITY, STATE, ZIP: <b>El Dorado AR 71730</b> PHONE & EXT. / FAX: <b>870-862-8181 /</b> EMAIL: <b>mphilips@prescolite.com</b>				FAYETTEVILLE SHALE VIOLATIONS: <b>N</b>

**PO

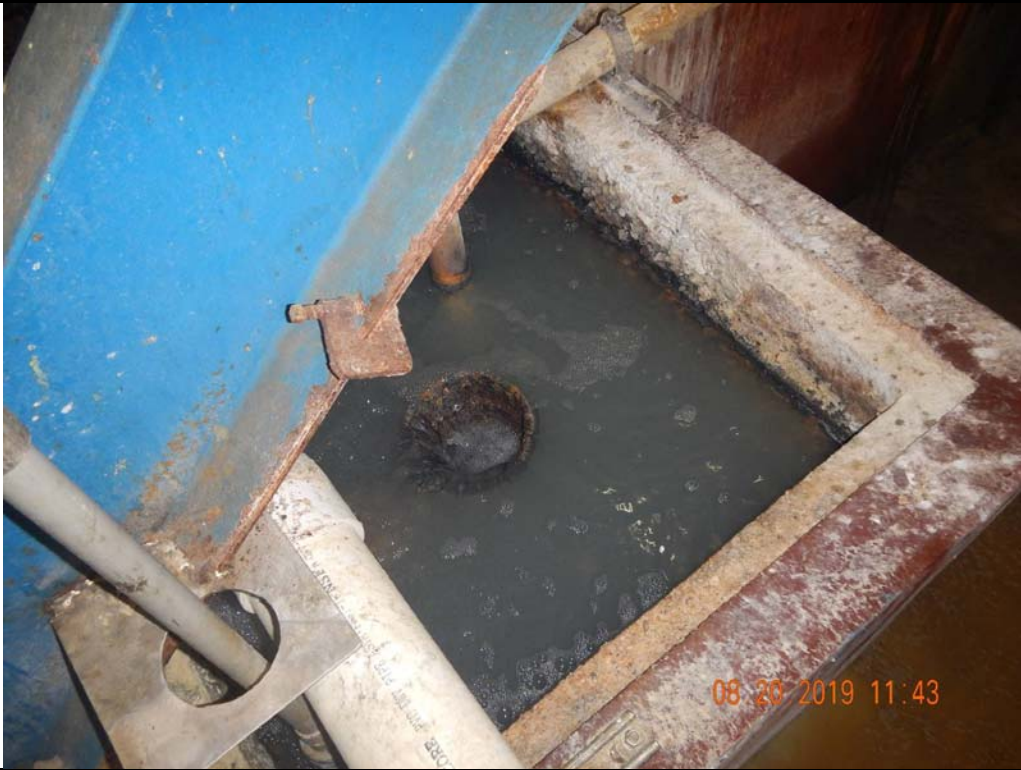
Location:	<b>Prescolite - Reflector Plant</b>		
Photographer:	<b>Michael Young</b>	Date:	<b>08/20/2019</b>
Witness:		Time:	<b>11:43</b>
		Photo #:	<b>1</b>
Description:	<b>Outfall to POTW. Slight discoloration to water with little to no foaming.</b>

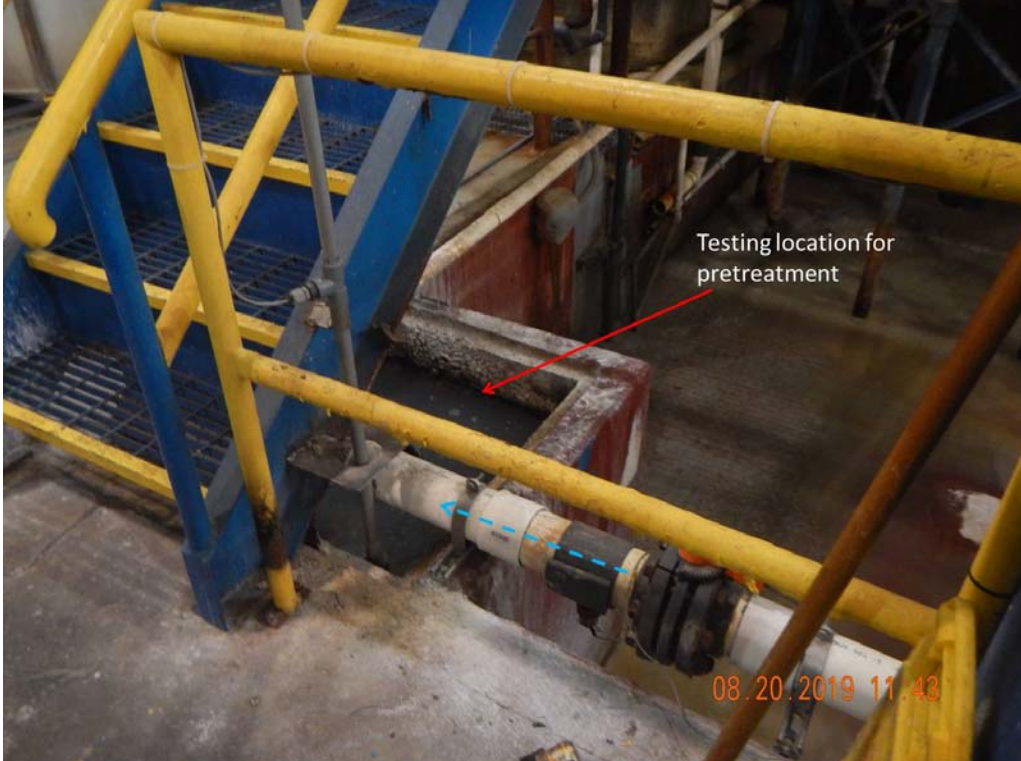
Photographer:	<b>Michael Young</b>	Date:	<b>08/20/2019</b>
Witness:		Time:	<b>11:43</b>
		Photo #:	<b>2</b>
Description:	<b>Testing location for pretreatment. City of El Dorado sets up composite sampler.</b>

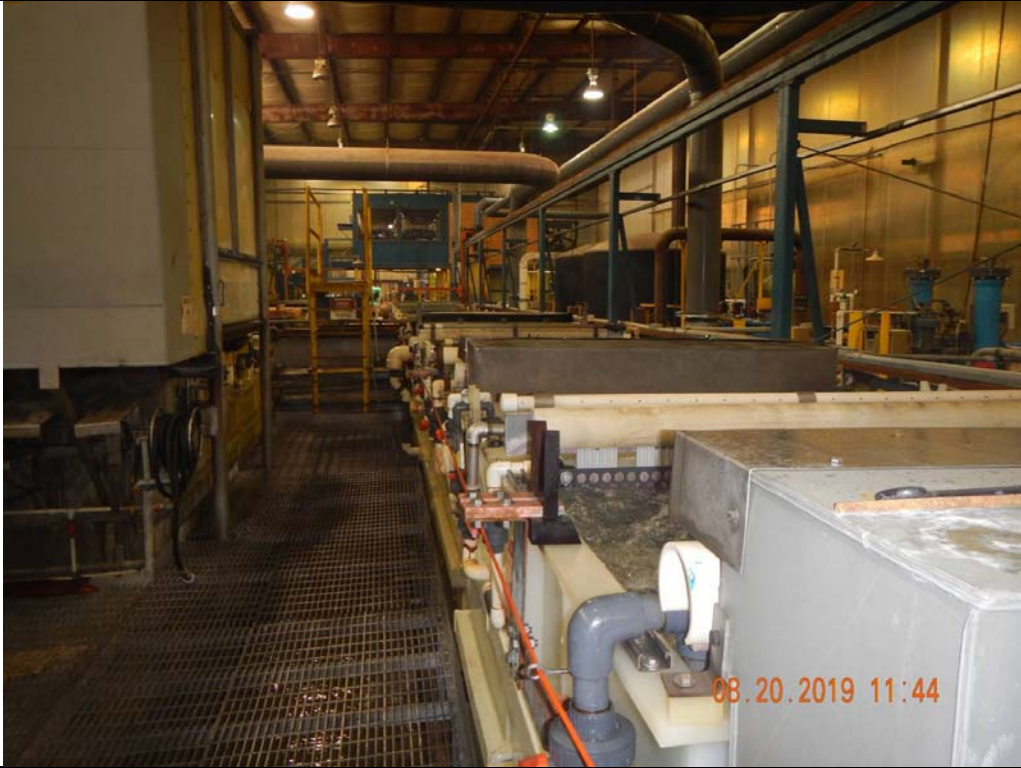
Location:	<b>Prescolite - Reflector Plant</b>		
Photographer:	<b>Michael Young</b>	Date:	<b>08/20/2019</b>
Witness:		Time:	<b>11:44</b>
		Photo #:	<b>3</b>
Description:	<b>Anodizing line consists of several tanks.</b>

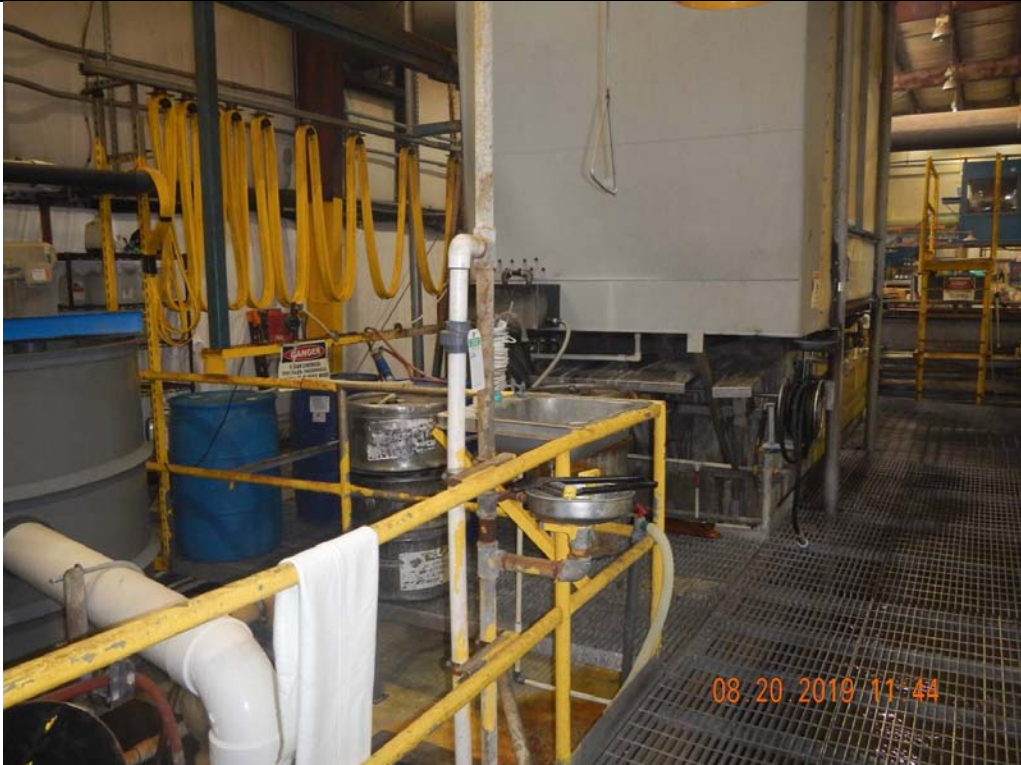
Photographer:	<b>Michael Young</b>	Date:	<b>08/20/2019</b>
Witness:		Time:	<b>11:44</b>
		Photo #:	<b>4</b>
Description:	<b>Chemical storage is over secondary containment that does not discharge to outfall.</b>

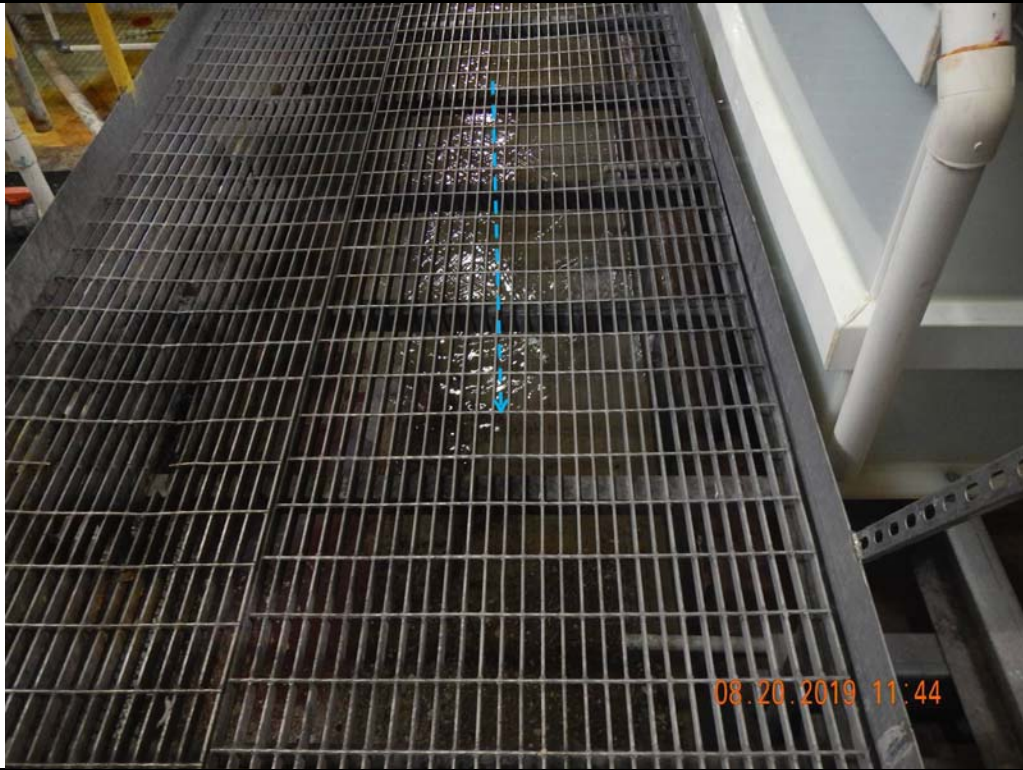
Location:	<b>Prescolite - Reflector Plant</b>				
Photographer:	<b>Michael Young</b>	Date:	<b>08/20/2019</b>	Time:	<b>11:44</b>
Witness:				Photo #:	<b>5</b>
Description:	<b>Discharge from anodizing line to the outfall.</b>
