RE: Stuttgart Municipal Water Works Inspections (Arkansas Co)
AFIN: 01-00214 NPDES Permit No.: AR0034380

On December 12, 2019, I performed a Compliance Evaluation Inspection, an SSO/Collection System Inspection, and an Industrial Stormwater Inspection of the above-referenced facility in accordance with the provisions of the Federal Clean Water Act, the Arkansas Water and Air Pollution Control Act, and the regulations promulgated thereunder. A copy of each of the inspection reports is enclosed for your records.

| ADEO | WATER | DIVISION I | NSPEC [*] | TIOI | N REF | PORT |

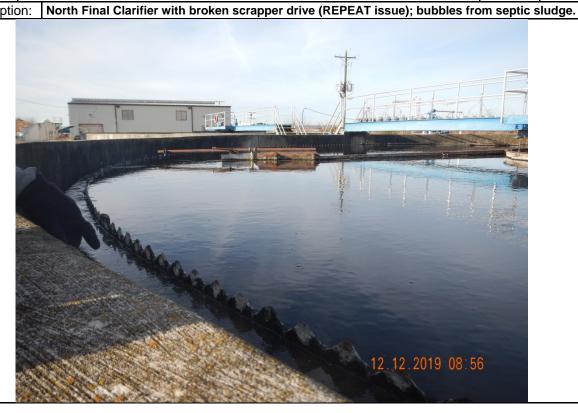
Witness:
 Photo #:
 14

- The influent flowmeter at the headworks is not in operation.
 - The scraper drive in the North Final Clarifier is not working, which allows sludge to sit on the bottom of the clarifier and to become septic. This is a REPEAT issue noted in past inspections.

| SECTION A: PERMIT VERIFICATION | |
|--|--|
| 2. TREATMENT UNITS PROPERLY MAINTAINED: Drive arm in North Final Clarifier is broken (REPEAT). | □S □M ☑U □NA □NE |

Description:
 North Final Clarifier with broken scrapper drive (REPEAT issue); bubbles from septic sludge.

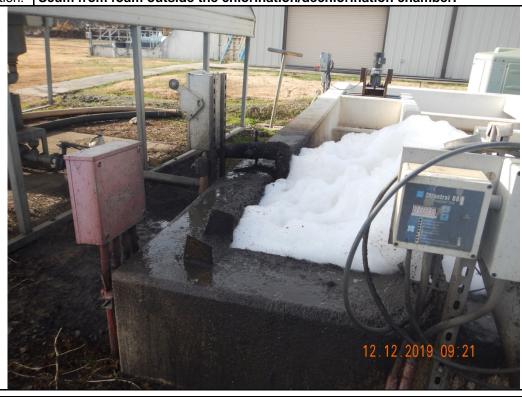
- Excessive foam at the chlorination/dechlorination chamber was bringing floating scum to the top of the chamber and depositing it on the outside of the chamber and on the ground.

| | Water Division Photographic Evidence Sheet | | | | |
|---|--|---|---|---|---|
| Description: | Scum from foam outside the c | hlorination/dec | hlorination chambe | er. | |

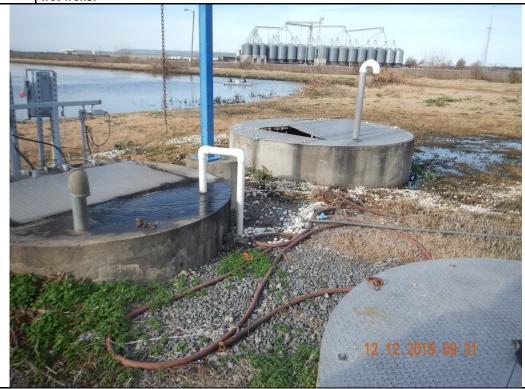
- Both the influent and effluent wet wells at the EQ basin had overflowed with sludge, solids, and grease deposited onto the ground.
- 4.) The following items violate Part III, Section B, 1, A of the permit:

- The EQ basin has excessive sludge/solids buildup at the front of the basin, which is causing overflows at the two wet wells as well as not allowing for design volume. This is a REPEAT

Description: Wet wells at EQ basin; photo right is to EQ and photo left is from EQ; note overflows at both wet wells.

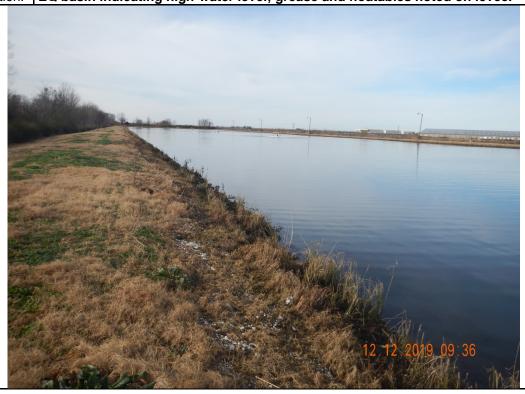
Overall, only minor issues with O&M were noted for the treatment plant (see "Summary of Findings"); however, some of these issues are ongoing and noted during past inspections as repeat violations. Most notably, the EQ basin continues to be an area of concern. Although pumps after preliminary that direct influent to either the treatment plant or EQ have been repaired, there were several years that one of the three influent pumps that route raw wastewater to the treatment system was offline. This caused the EQ pumps to route influent to the EQ during normal weather conditions resulting in an accumulation of sludge/solids in the front portion of the EQ basin. Due to the sludge/solids build-up at the front of the EQ, the wet wells at the EQ routinely overflow and the contents of the EQ cannot be pumped back to the headworks from the wet well. The operator has to route EQ contents via portable pumps/hosing to a nearby manhole, which is routed back to the influent wet well prior to the headworks.

| Water Division Photographic Evidence Sheet | | | | | | | | | |
|--|---|---|---|--|---|---|---|---|---|
| Description: EQ basin indicating high-water level; grease and floatables noted on levee. | | | | | | | | | |

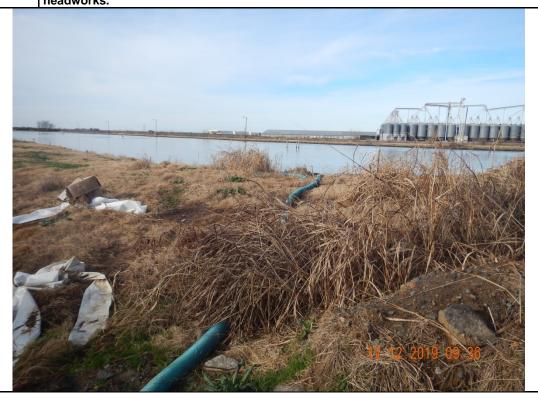
Description: Hosing used to divert EQ contents to manhole due to overflows at wet wells; routed to headworks.

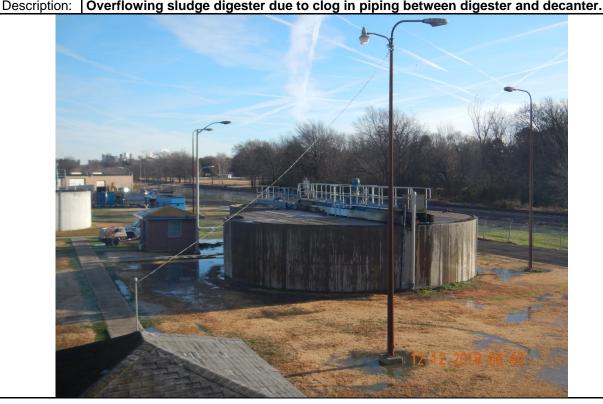
- 3.) The following items violate Part II, Condition 6 of the permit:
 - The West Digester was overflowing onto the facility grounds during the inspection. Supernatant and sludge must be remediated appropriately.

| Water Division Photographic Evidence Sheet | | | | | | | |
|--|---|---|---|---|---|--|--|
| Description: | Overflowing cludge digester | dua ta alaa in ni | aina batwaan digas | tor and door | ntor | | |

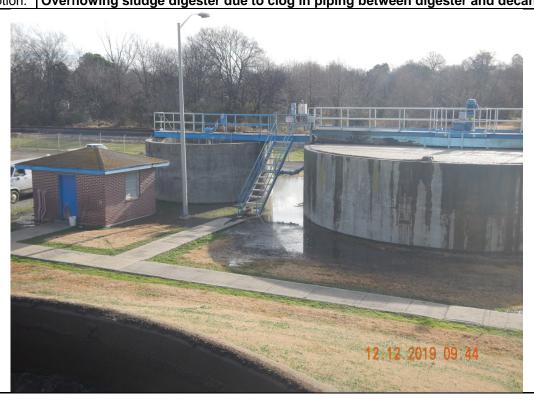
Description:
 Overflowing sludge digester due to clog in piping between digester and decanter.

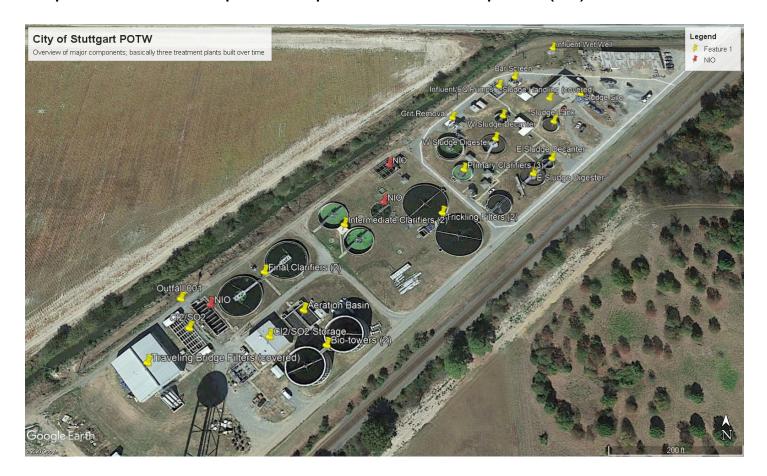
Figure 2. Google Earth image dated Oct 14, 2015 depicting the City of Stuttgart POTW with major components identified. Red pins are components that are not in operation (NIO).
