V DEO	WATER	<b>DIVISION I</b>	NSF	ECTI	ON	REI	PORT	
	ADLQ	AF	IN: <b>01-00214</b> F	PERMIT #: AR0034	1380		DA	ATE: <b>1</b>	2/12/2019
Δ	RKANSAS	CC	OUNTY: 01 Arkaı	nsas	PDS	#: <b>11142</b>	6		MEDIA: WN
Dep	partment of Environmental Quality	GF	S LAT: L	ONG: LOC	OITA	1: <b>N/A</b>		•	
	FACILITY INFORMAT	ION		IN	SPEC	TION INF	FORM	ATION	
	: uttgart Collection System			FACILITY TYPE:  1 - Municipal	8402	ror id#: 22 S - Sta			
	11 W 10th Street			FACILITY EVALUATION RATING  2 - Marginal		S			on System
Stu	uttgart, AR			(-/	TRY TIME:	12:00	<b>,</b>   '		FECTIVE DATE:
	RESPONSIBLE OFFIC	CIAL		12,12,2013	0.10	12.00		<b>2/1/20</b> PERMIT EXI	15 PIRATION DATE:
	: / TITLE						1/31/2	020	
	mmy Lawson / Manager			FAYETTEVILLE	SHAI	F RFI AT	TED: N	J	
	uttgart Municipal Water Works			FAYETTEVILLE					
	NG ADDRESS:								•
	2 S College Street PO Box 130 STATE, ZIP:			NAME/TITLE/PHONE/FAX/EMA		TION PA	KIICII	PANIS	•
	uttgart AR 72160			Danny Wilson (

On Thurs, Dec 12, 2019, an inspection was conducted of the City of Stuttgart collection system.

The inspection consisted of an assessment of the system's lift stations and a record review of the reported SSO information.

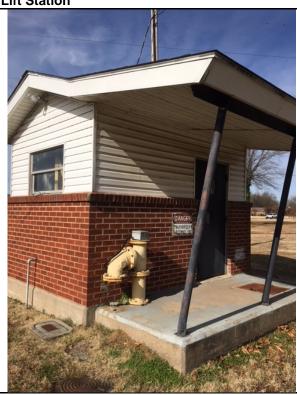
Description: Visual alarm at McCracken Lift Station.

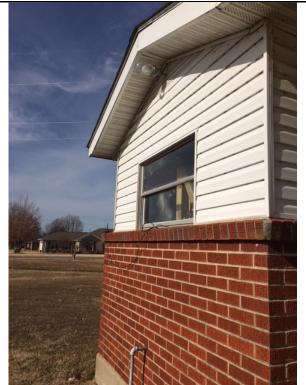
Water Division Pho	tographic Evi	dence Sheet		
Location: \$	Stut	tgart Collection System				
Photographo	er:	Kerri McCabe	Date:	Dec 12, 2019	Time:	1126
Witness:					Photo #	: 9

Description: Control panel (water level/pump run hours) for McCracken Lift Station.
