RE: Benton Utilities - WTP Inspection

AFIN: 63-00063 Permit No.: AR0036498

OFFICE OF WATER QUALITY INSPECTION REPORT

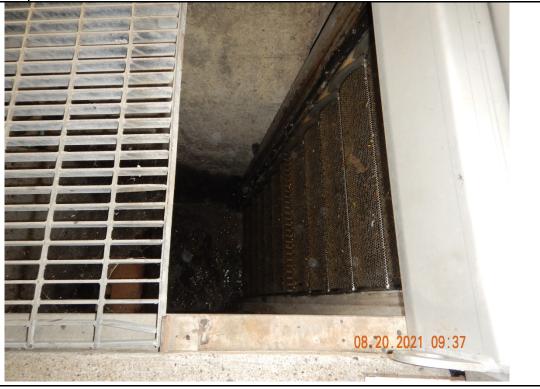
Coation: Benton Utilities - WTP Photographer: Jason Bolenbaugh Witness: Date: 8/20/2021 Date: 8/20/2021 Time: 09:37 Photo #: 3

Description: DSCN3112: Fine Screen #2.

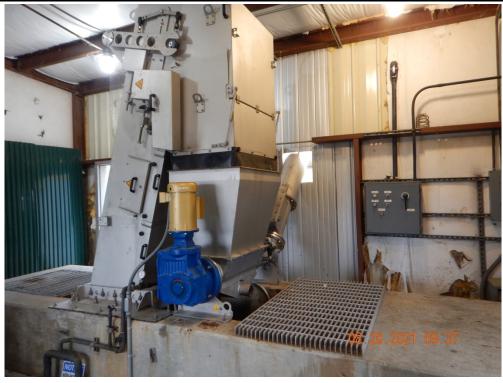
Photographer:	Jason Bolenbaugh	Date:	8/20/2021	Time:	09:37
Witness:				Photo #:	4

Description: DSCN3113: Fine Screen #2.

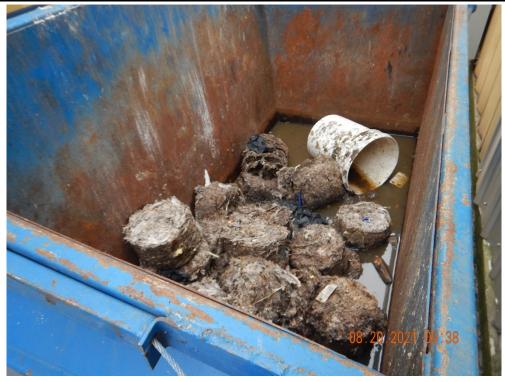
Office of Water Quality Photographic Evidence Sheet								
Location:	Ben	ton Utilities - WTP						
Photographer: Jason		Jason Bolenbaugh	Date:	8/20/2021	Time:	09:38		
Witness:				•	Photo #:	5

Description: DSCN3114: Fine Screen #2 waste removed during treatment.

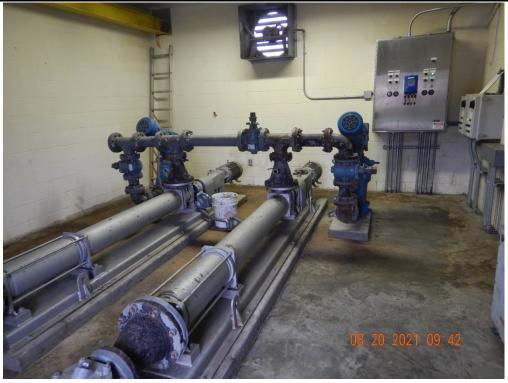
Photographer: Jason Bolenbaugh	Date:	8/20/2021	Time:	09:42
Witness:			Photo #	: 6

- In the near future the permittee intends to replace both Waste Activated Sludge pumps as one pump currently can only be controlled manually.

Description: DSCN3117: Waste Activated Sludge pumps to be replaced.

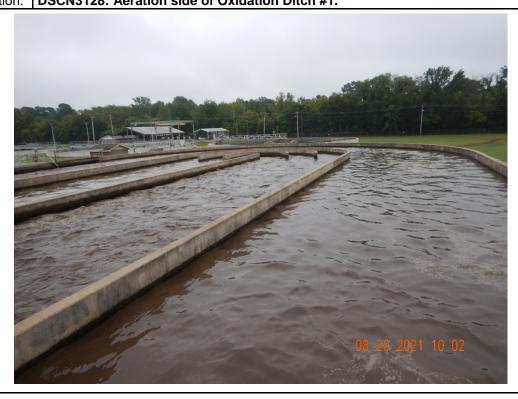
- During the July 23, 2019 inspection the permittee was required to repair an impeller within an anaerobic
 zone of Oxidation Ditch #1. The permittee completed the project in a timely manner but a letter was not sent
 closing the inspection. All impellers were fully operational during this inspection and therefore the violation
 noted in the previous inspection is resolved.

Office of Water Quality Photographic Evidence Sheet					
Location: E	Benton Utilities - WTP					
Photographe	er: Jason Bolenbaugh	Date:	8/20/2021	Time:	10:02	
Witness:				Photo #	[‡] : 9	
Description:	DSCN3128: Aeration side of 0	Oxidation Ditch #	1.

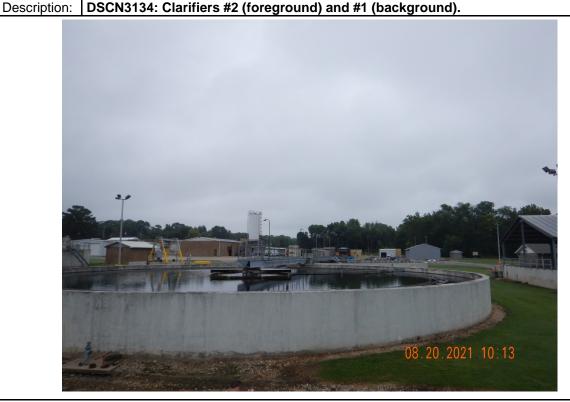
Office of Water Quali	ty Photographic	Evidence Sheet		
Location: I	Ben	ton Utilities - WTP				
Photograph	er:	Jason Bolenbaugh	Date:	8/20/2021	Time:	10:13
Witness:					Photo #	: 13
Docorintion	. [SCN2124, Clarifiana #2 /fara	around) and #1 /	(background)	<u> </u>

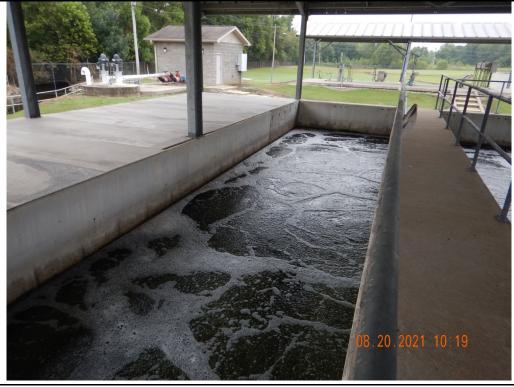
Office of Wate	r Quality Photographic	Evidence Sheet		
Location:	Ben	ton Utilities - WTP				
Photograph	ner:	Jason Bolenbaugh	Date:	8/20/2021	Time:	10:19
Witness:					Photo #	: 15

Description: DSCN3141: Post aeration basin.

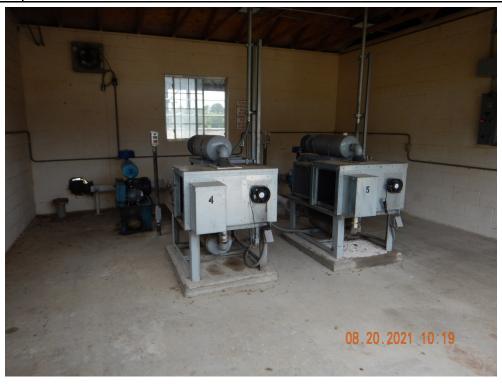
Photographer: Jason Bolenbaugh	Date:	8/20/2021	Time:	10:19
Witness:			Photo #	: 16

Description: **DSCN3144: Post aeration blowers.**

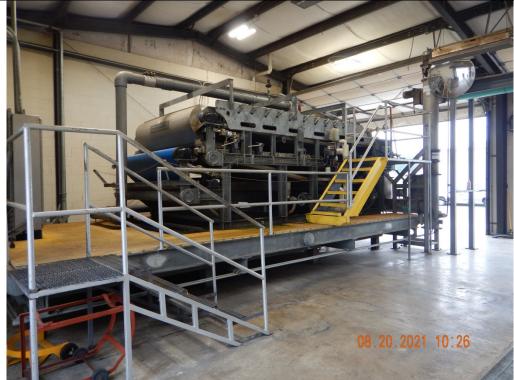
Office of Water Quality Photographic Evidence Sheet							
Location:	Ben	ton Utilities - WTP					
Photograp	her:	Jason Bolenbaugh	Date:	8/20/2021	Time:	10:26	
Witness:					Photo #:	21

Description: DSCN3155: Sludge Press.

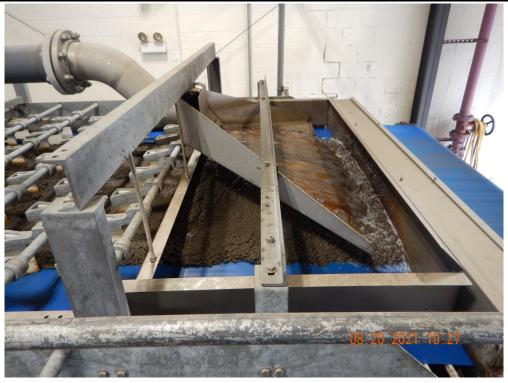
Photographer:	Jason Bolenbaugh	Date:	8/20/2021	Time:	10:27
Witness:				Photo #	: 22

Description: DSCN3157: Top of the sludge press where dewatering begins.

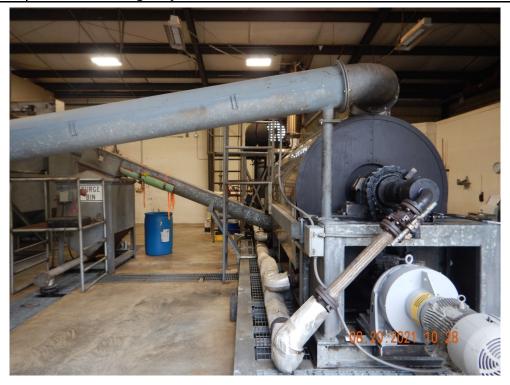
Photographer:	Jason Bolenbaugh	Date:	8/20/2021	Time:	10:28
Witness:				Photo #	: 24

Description: **DSCN3160: Sludge Dryer.**
