<p>ENVIRONMENTAL QUALITY</p>	OFFICE OF WATER QUALITY				
	INSPECTION REPORT				
	AFIN: 63-00063	PERMIT #: AR0036498	DATE: 8/20/2021		
	COUNTY: 63 Saline	PDS #: 118170	MEDIA: WN		
GPS LAT: 34.614652 LONG: -92.529425 LOCATION: Entrance					
FACILITY INFORMATION		INSPECTION INFORMATION			
NAME: Benton Utilities LOCATION: 616 W. Hazel St. CITY: Benton		FACILITY TYPE: 1 - Municipal INSPECTOR ID#: 83321 S - State FACILITY EVALUATION RATING: 4 - Satisfactory INSPECTION TYPE: SSO/Collection System			
RESPONSIBLE OFFICIAL		DATE(S): 8/20/2021 ENTRY TIME: 09:00 EXIT TIME: 11:45 PERMIT EFFECTIVE DATE: 4/1/2021 PERMIT EXPIRATION DATE: 3/31/2026			
NAME: / TITLE Mr. David Vondran / General Manager COMPANY: Benton Utilities MAILING ADDRESS: 1827 Dale Ave. CITY, STATE, ZIP: Benton AR 72015 PHONE & EXT: / FAX: 501-776-5984 / EMAIL: dvondran@bentonutilities.com		FAYETTEVILLE SHALE RELATED: N			
CONTACTED DURING INSPECTION: No		FAYETTEVILLE SHALE VIOLATIONS: N

Office of Water Quality Photographic Evidence Sheet

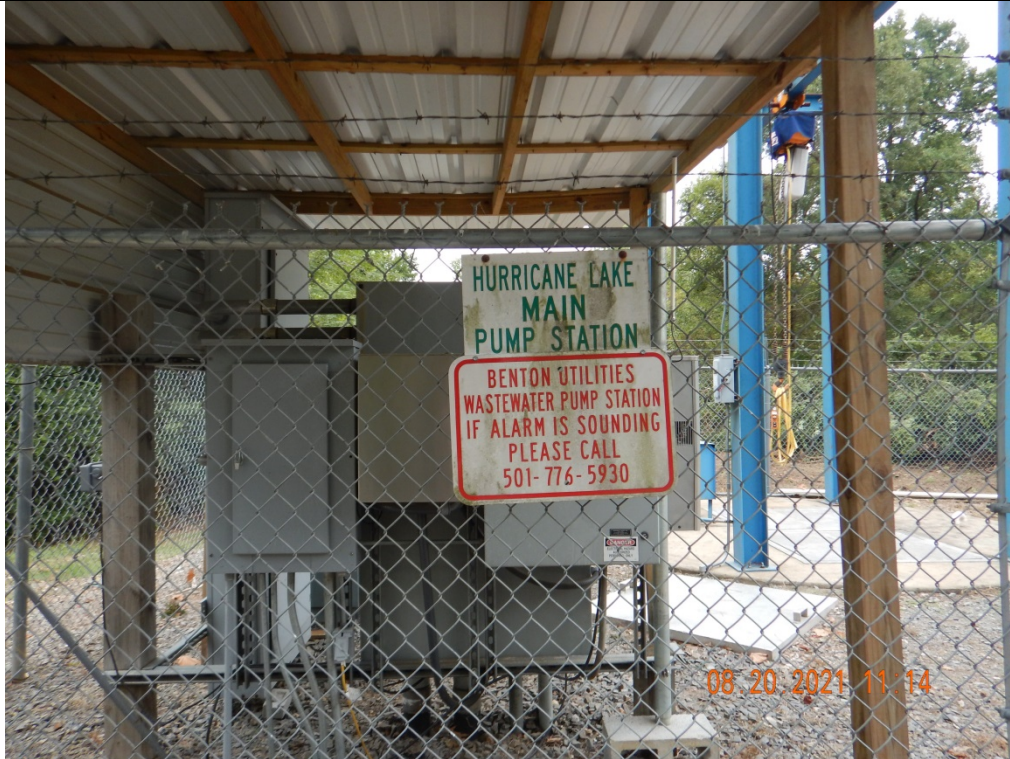
Location:	Benton Utilities		
Photographer:	Jason Bolenbaugh	Date:	8/20/2021
Witness:		Time:	11:14
		Photo #:	1
Description:	DSCN3169: Emergency contact information at the Hurricane Lake Main station.

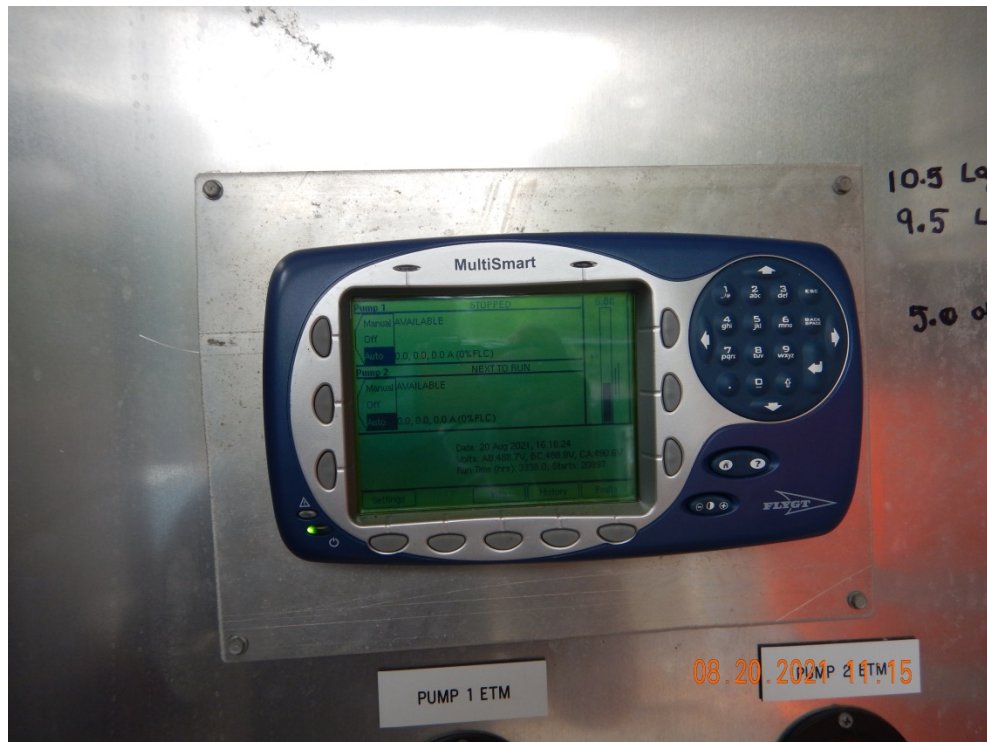
Photographer:	Jason Bolenbaugh	Date:	8/20/2021
Witness:		Time:	11:15
		Photo #:	2
Description:	DSCN3170: Flygt MultiSmart control monitor.

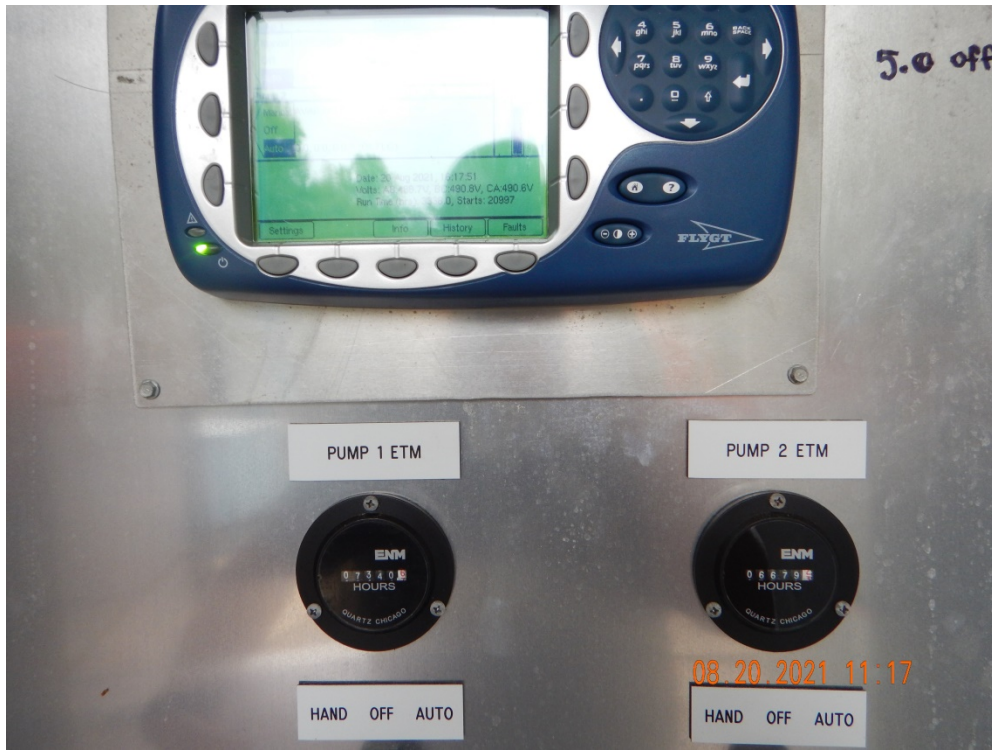
Location:	Benton Utilities		
Photographer:	Jason Bolenbaugh	Date:	8/20/2021
Witness:		Time:	11:17
		Photo #:	3
Description:	DSCN3172: Pumps 1 (07340.6 hours) and 2 (06679.2 hours) run times.

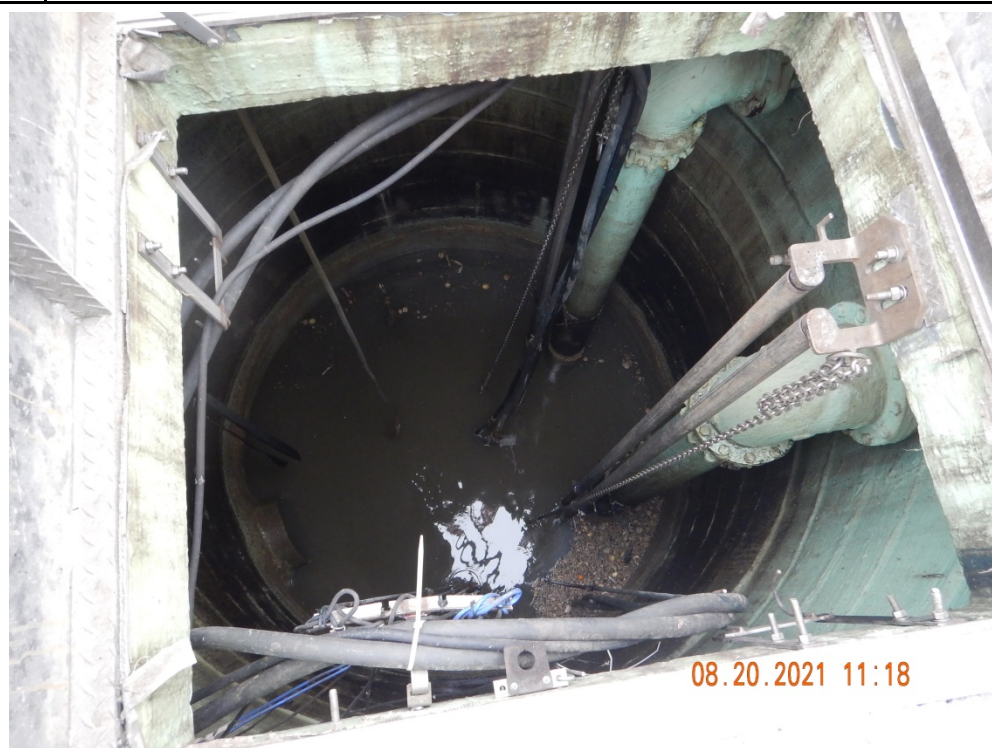
Photographer:	Jason Bolenbaugh	Date:	8/20/2021
Witness:		Time:	11:18
		Photo #:	4
Description:	DSCN3173: Wet well with minimal solids and no evidence the water level neared overflow conditions.

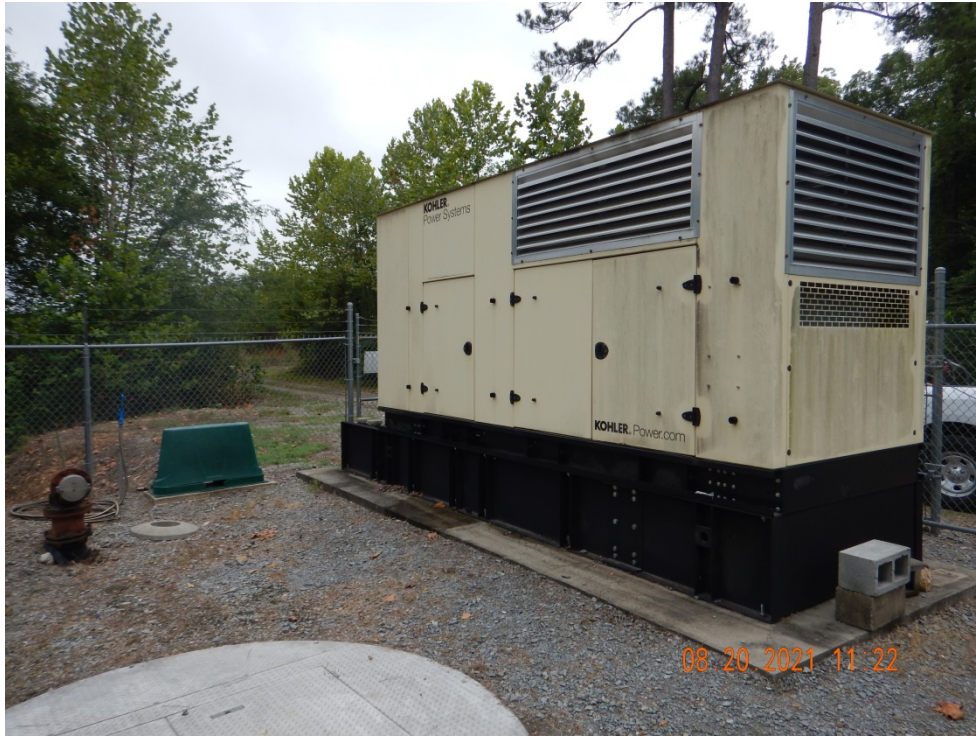
Location:	Benton Utilities		
Photographer:	Jason Bolenbaugh	Date:	8/20/2021
Witness:		Time:	11:22
		Photo #:	5
Description:	DSCN3175: Permanent generator and bypass hookup.

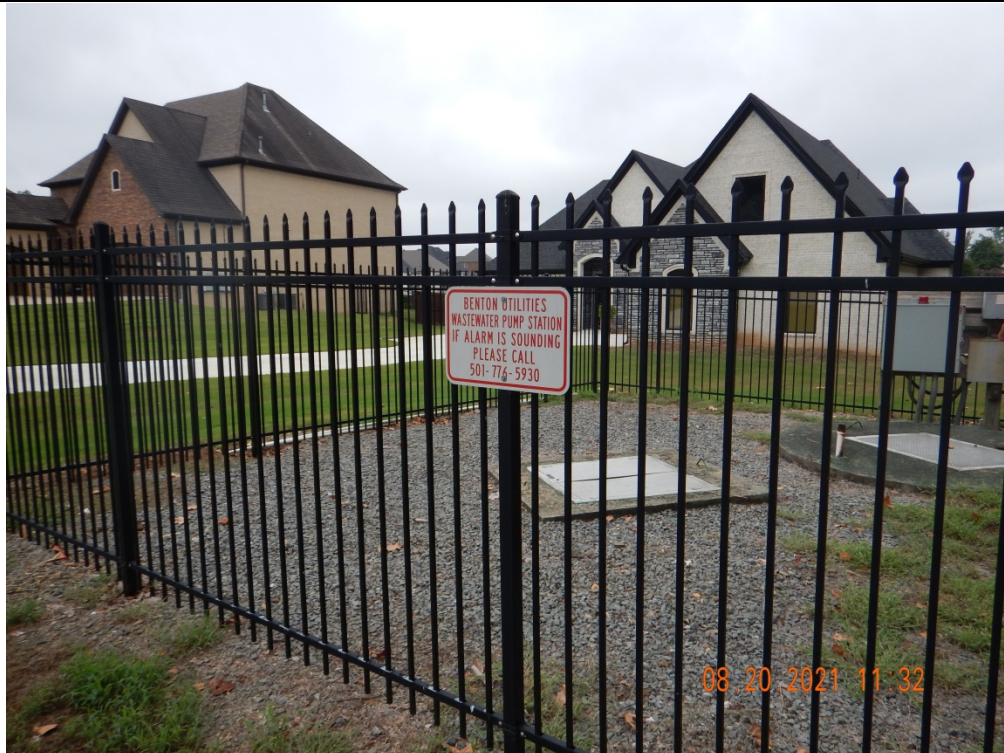
Photographer:	Jason Bolenbaugh	Date:	8/20/2021
Witness:		Time:	11:32
		Photo #:	6
Description:	DSCN3176: Emergency contact information and lift station.

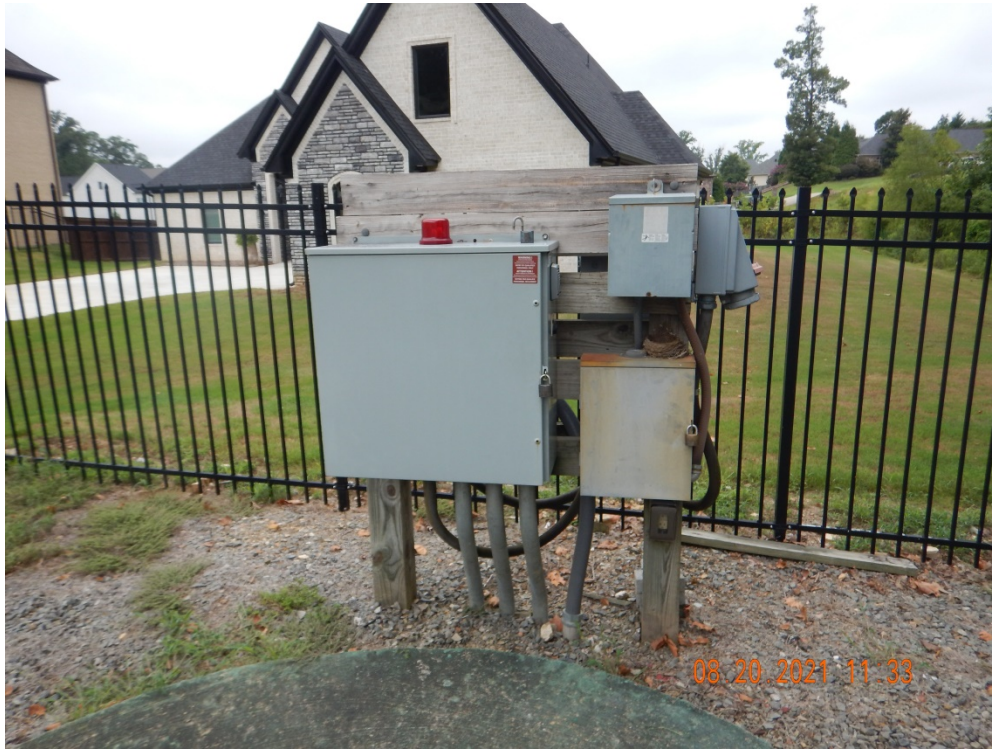
Location:	Benton Utilities		
Photographer:	Jason Bolenbaugh	Date:	8/20/2021
Witness:		Time:	11:33
		Photo #:	7
Description:	DSCN3177: Lift station control panel with generator hookup.

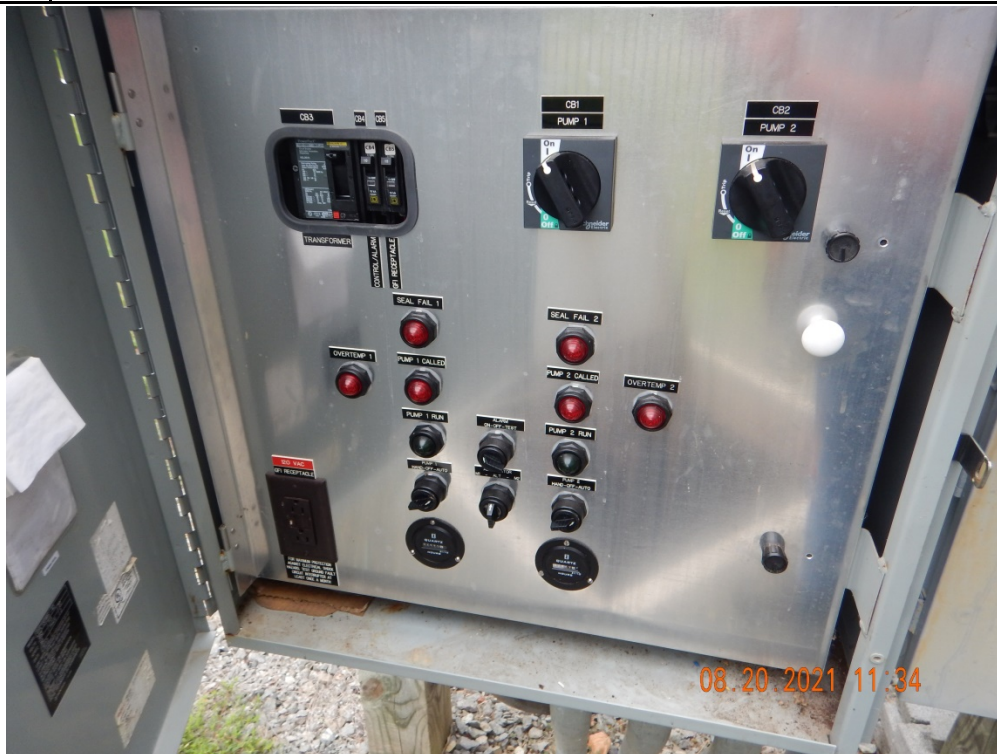
Photographer:	Jason Bolenbaugh	Date:	8/20/2021
Witness:		Time:	11:34
		Photo #:	8
Description:	DSCN3180: Lift station control panel. Pumps 1 (02095.9 hours) and 2 (02429.3 hours) runs times.

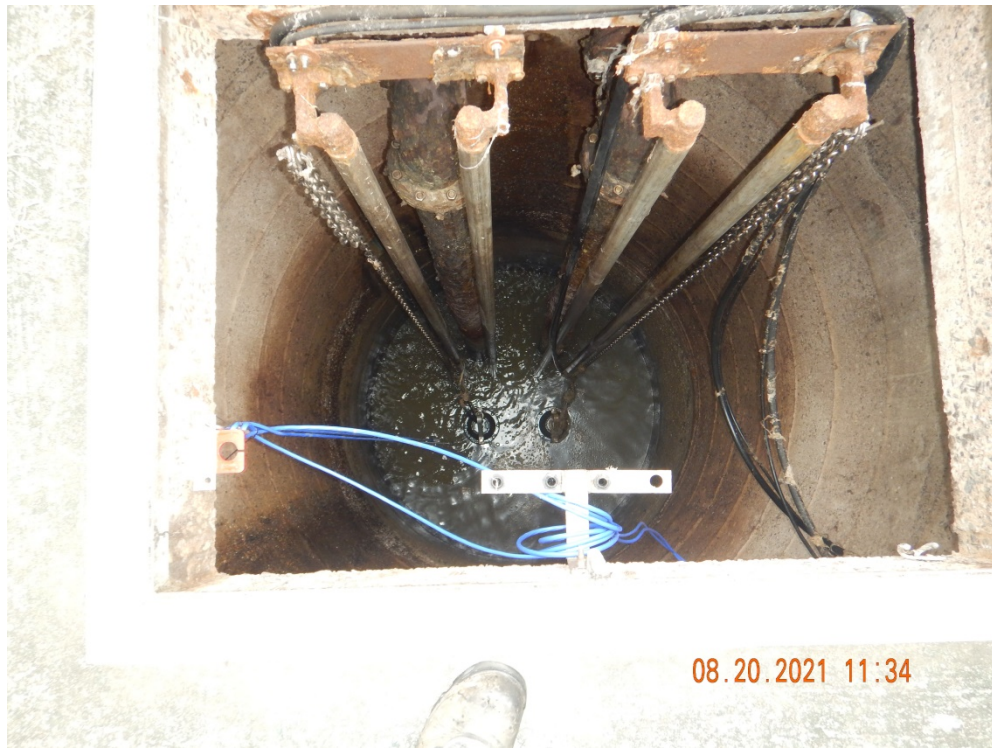
Location:	Benton Utilities		
Photographer:	Jason Bolenbaugh	Date:	8/20/2021
Witness:		Time:	11:34
		Photo #:	9
Description:	DSCN3179: Wet well with no solids and no evidence the water level neared overflow conditions.

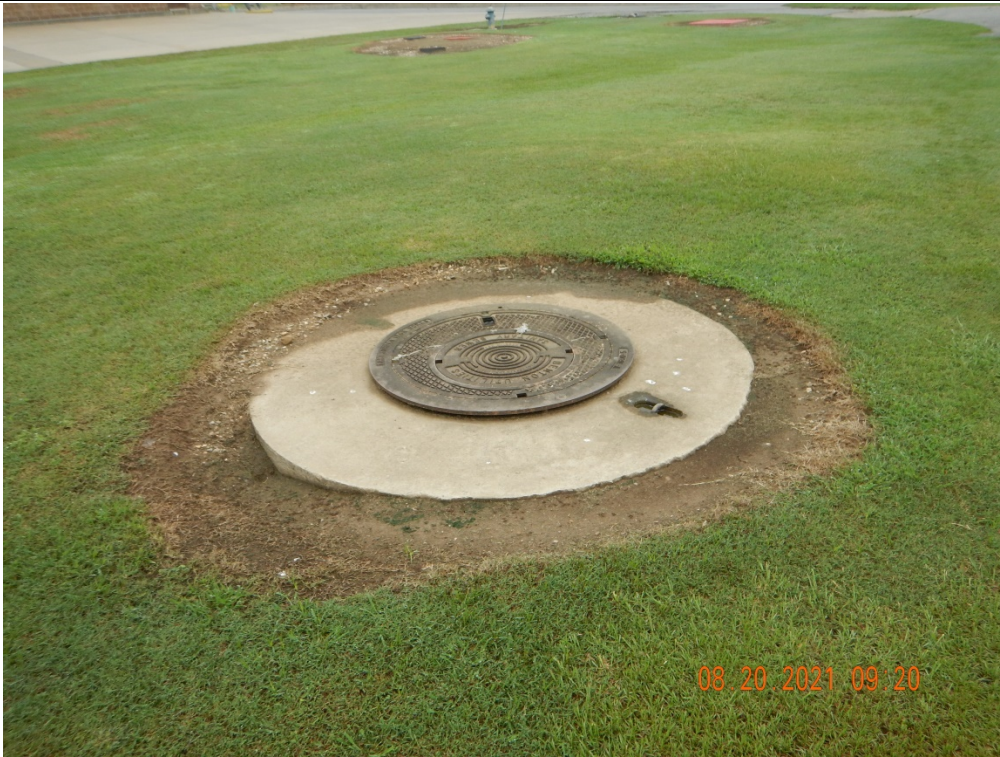
Location:	Benton Utilities				
Photographer:	Jason Bolenbaugh	Date:	8/20/2021	Time:	09:20
Witness:				Photo #:	10
Description:	DSCN3099: Manhole #14 to the east of Oxidation Ditch #2.

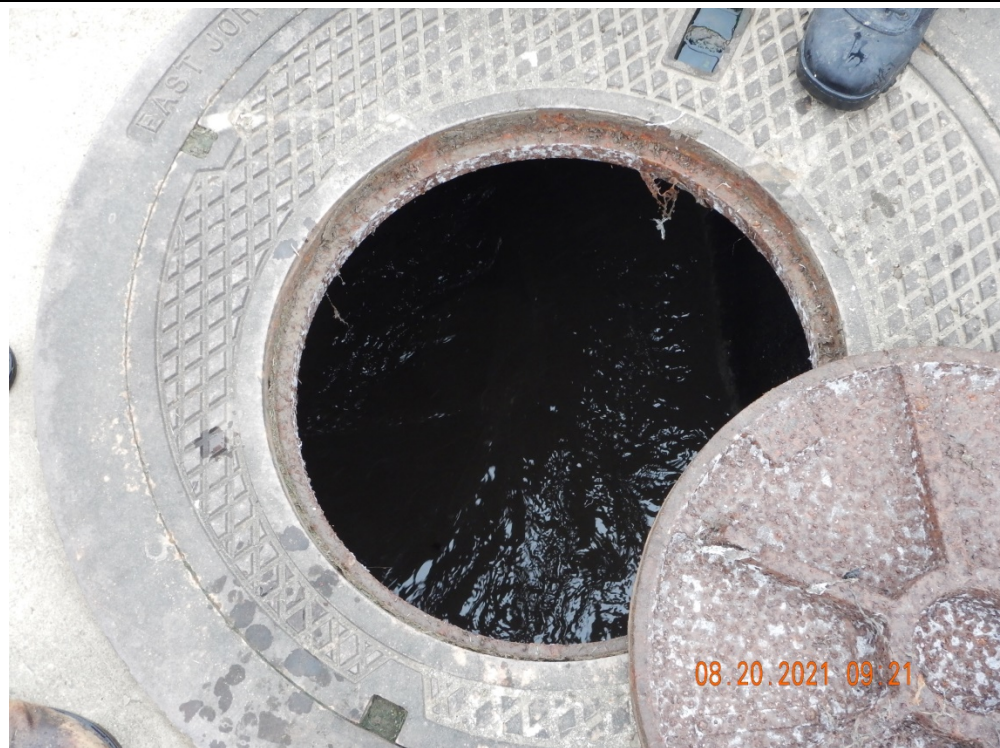
Photographer:	Jason Bolenbaugh	Date:	8/20/2021	Time:	09:21
Witness:				Photo #:	11
Description:	DSCN3100: Inside of Manhole #14 at the Benton Utilities treatment plant.

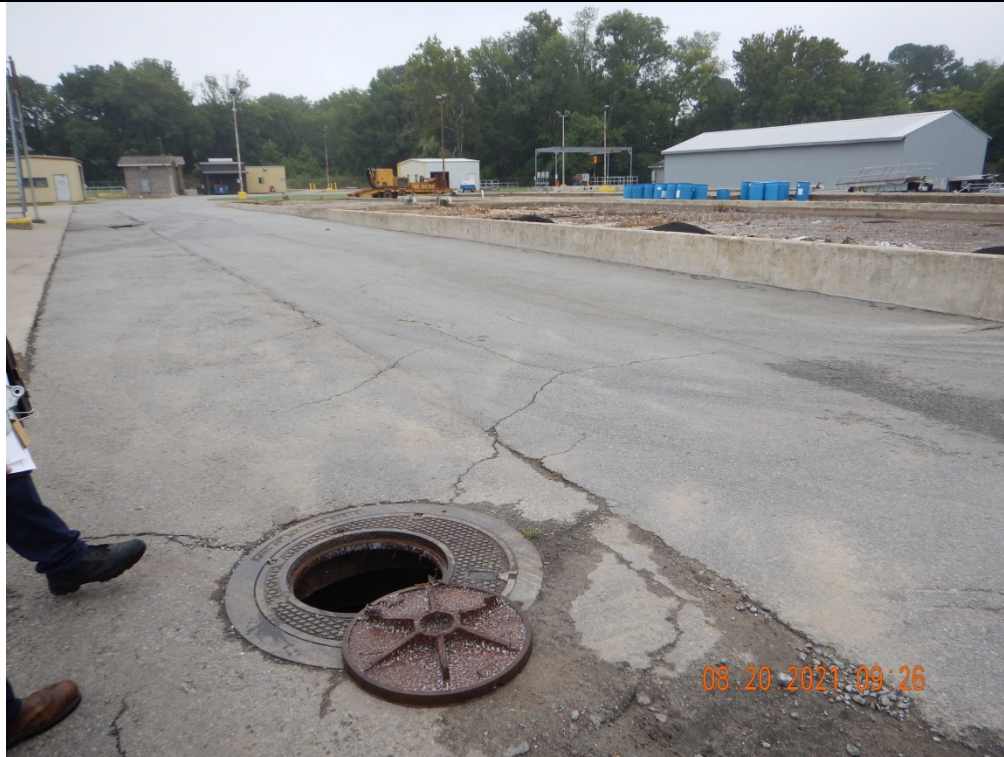
Location:	Benton Utilities		
Photographer:	Jason Bolenbaugh	Date:	8/20/2021
Witness:		Time:	09:26
		Photo #:	10
Description:	DSCN3101: Manhole #15 at the Benton Utilities treatment plant adjacent to the former sand filter beds.

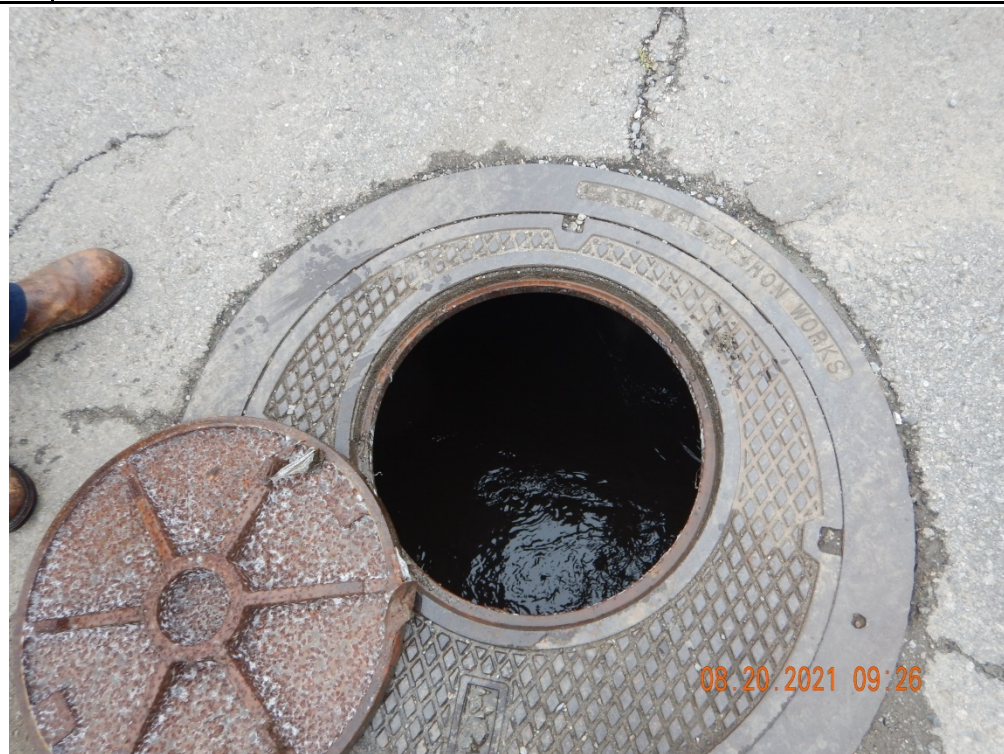
Photographer:	Jason Bolenbaugh	Date:	8/20/2021
Witness:		Time:	09:26
		Photo #:	13
Description:	DSCN3102: Inside of Manhole #15 at the Benton Utilities treatment plant.
