RE: Camden WWTP Inspection (Ouachita Co)

AFIN: 52-00073 NPDES Permit No.: AR0022365

OFFICE OF WATER QUALITY INSPECTION REPORT

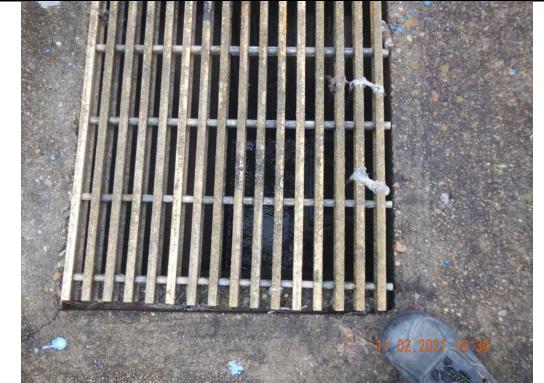
Office of Water Quality Photographic Evidence Sheet Location: Camden WWTP Photographer: Michael Young Date: 11/02/2021 Time: 10:30 Witness: Photo #: 3

Description: Automatic bar screen was not in operation at time of inspection.

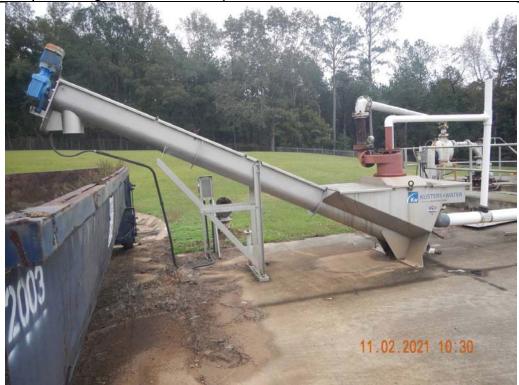
Photographer: Michael Young	Date:	11/02/2021	Time:	10:30
Witness:			Photo #:	4

Description: Screenings from influent are placed in a container.

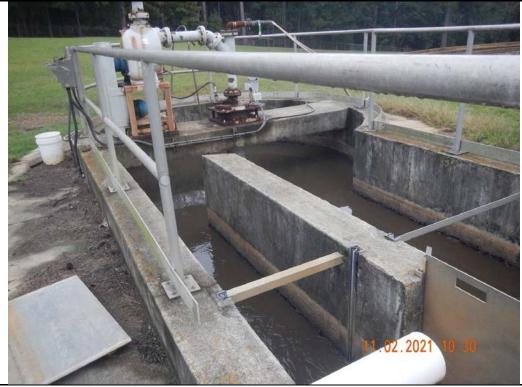
Office of Water Quality Photographic Evidence Sheet Location: Camden WWTP Photographer: Michael Young Date: 11/02/2021 Time: 10:30 Witness: Photo #: 5

Description: Cyclonic grit screener in operation.

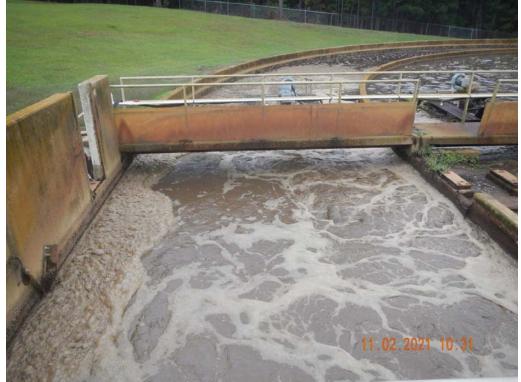
Office of Water Quality Photographic Evidence Sheet						
Location:	Can	nden WWTP				
Photograp	her:	Michael Young	Date:	11/02/2021	Time:	10:31
Witness:					Photo #:	7

Description: Aeration in oxidation ditch causing light foaming with no odors.

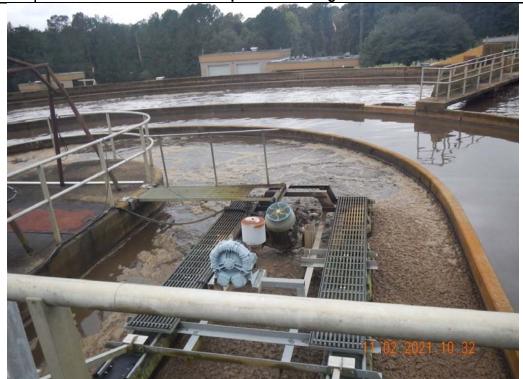
Photographer: Michael Young	Date: 11/02/2021	Time:	10:32
Witness:		Photo #	±: 10

Description: Aerator in oxidation ditch is a pontoon floating aerator.

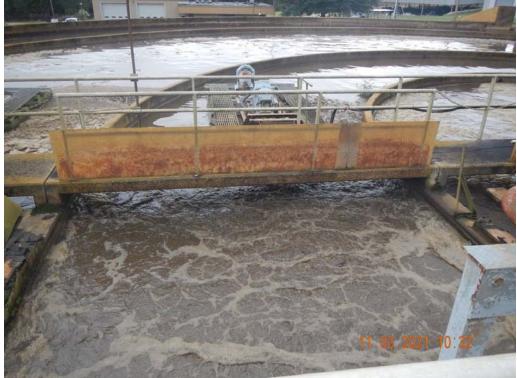
Office of Water Quality Photographic Evidence Sheet Location: Camden WWTP Photographer: Michael Young Date: 11/02/2021 Time: 10:32 Photo #: Witness: 11

Description: Aeration in oxidation ditch causing light foaming and no odors.

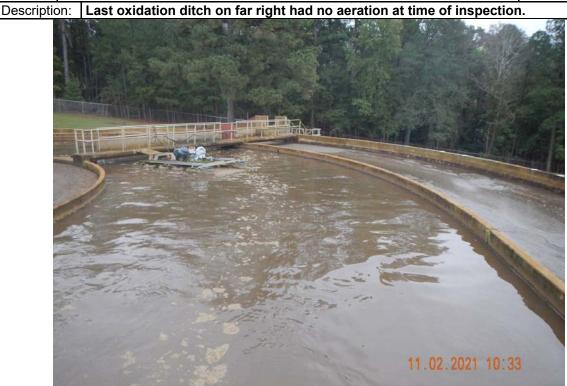
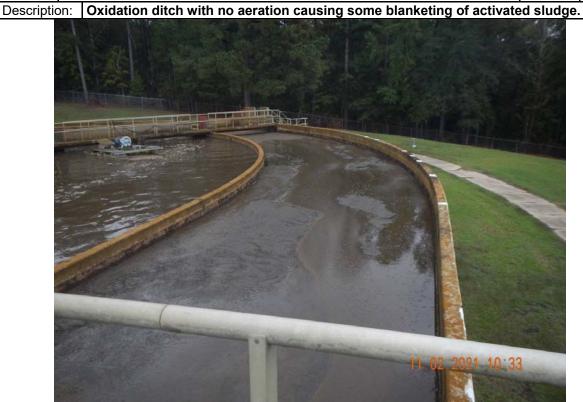
1.) At the time of inspection, the aerators in the outer ring of the oxidation ditch were not in operation (see Photos 12-14). This is a violation of permit condition Part III. (B.) (1.) (A.)

Description: Aerator not in operation at time of inspection.

Aerator not in operation at time of inspection.

During Mr. Young's inspection, he noted that the aerators in the outer ring of the oxidation ditch were not in operation. Two aerators were down waiting on parts during his inspection. Since his inspection the required maintenance has been done and aerators are back in operation. I have in closed pictures of the aerators in operation with movement in the outer ring of the oxidation ditch as requested by Mr. Young.

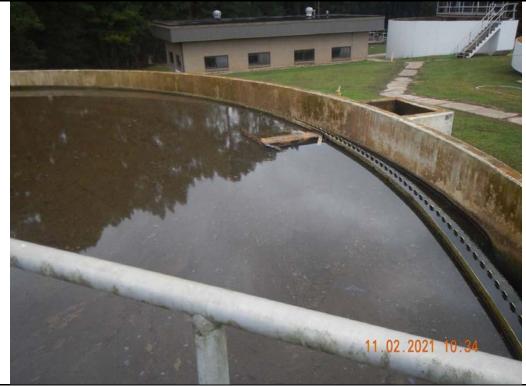
Office of Water Quality Photographic Evidence Sheet Location: Camden WWTP Photographer: Michael Young Date: 11/02/2021 Time: 10:34 Witness: Photo #: 15

Description: Clarifier with minor accumulations of oil and fats on surface.

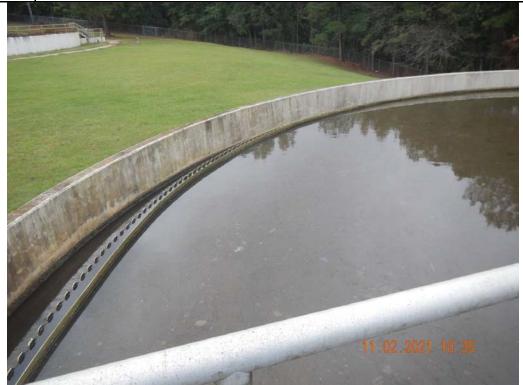
Photographer: Michael Young Date: 11/02/2021 Time: 10:35
Witness: Photo #: 16

Description: Clarifier with some accumulations of oils on surface.

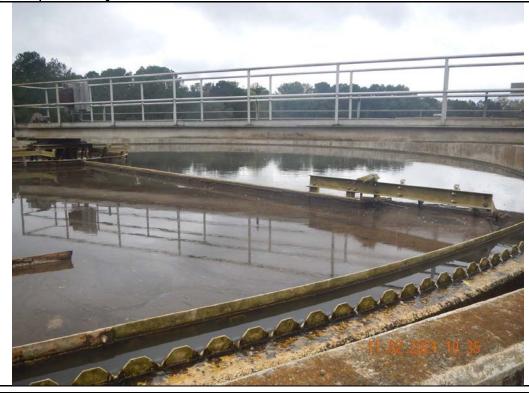
Office of Water Quality Photographic Evidence Sheet				
Location: C	amden WWTP			
Photographe	r: Michael Young	Date: 11/02/2021	Time: 10:35	
Witness:			Photo #: 17	
Description: Secondary clarifier with minor accumulations on surface and clean weir teeth.

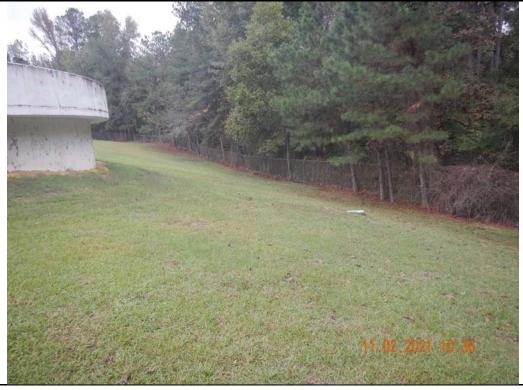
Office of Water Quality Photographic Evidence Sheet Location: Camden WWTP Photographer: Michael Young Date: 11/02/2021 Time: 10:36 Witness: Photo #: 19

Description: French drain installed after a groundwater issue under clarifier.
