RE: Stuttgart Municipal Water Works Inspection (Arkansas Co)

AFIN: 01-00214 NPDES Permit No.: AR0034380

OFFICE OF WATER QUALITY INSPECTION REPORT

AFIN: 01-00214 | PERMIT #: AR0034380 | DATE: 11/17/2021

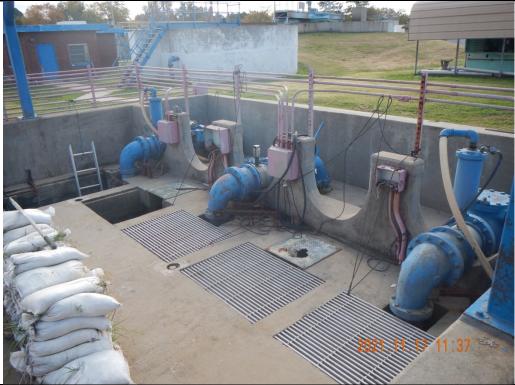
- Check valves in the primary headworks pumps ("A" pumps) are malfunctioning, causing
 influent to be diverted directly to the EQ basin outside of significant rain events via the EQ ("B")
 pumps.

- The "A1" & "B3" headworks pumps were inoperable at the time of inspection.

Description: "A" primary pumps at headwaters of facility; high-flow conditions trigger EQ pumps to divert influent to EQ basin; A1 pump (on left) inoperable at time of inspection

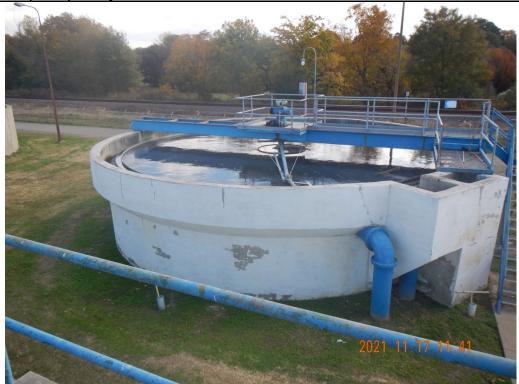
Photographer: Aaron Baggett Date: 11/17/2021 Time: 1141
Witness: Kerri McCabe Photo #: 2

Description: East primary clarifier

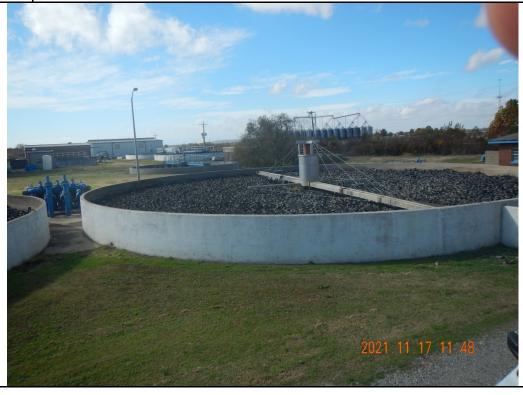
Photographer: Aaron Baggett	Date:	11/17/2021	Time:	1148
Witness: Kerri McCabe			Photo #:	4

- Distribution arms in both Trickle Filters were stationary at the time of inspection.
- Distribution arms in both Bio-Towers had significant vegetation growth at the time of inspection.

- The distribution arms in the trickle filters were not rotating, preventing the primary clarifier effluent from being spread on the filter media appropriately.
- Both intermediate clarifiers were showing signs of having gone septic, including dark color and bubbles at the surface. The west intermediate clarifier scraper drive is inoperable, which is allowing excess sludge to accumulate.
- Both sludge decanters were inoperable at the time of inspection.
- The East digester has not functioned in the past 1.5 years and has not been cleaned. As a result, significant vegetation is growing on the top of the sludge remaining in the digester.
- One of the Travelling Bridge Filters was inoperable at the time of inspection.

Description: West trickle filter below clarifiers; distribution arms were stationary in both of the trickle filters.

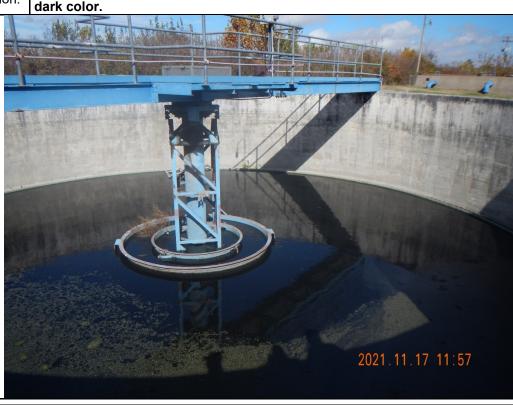
- The Belt Press was inoperable at the time of inspection.
- The scraper drive in north Intermediate Clarifier is not functioning, and the clarifier shows signs of having gone septic (dark color, bubbles); the south Intermediate Clarifier shows signs of having gone septic to a lesser degree than the north Intermediate Clarifier

Office of Water Quality Photographic Evidence Sheet							
Location: Stuttgart Municipal Water Works							
Photographer: Aaron Baggett Date: 11/17/2021 Time:				1157			
Witness: Kerri McCabe Photo #: 5						5	
Description: West intermediate clarifier showing signs of septic growth, including bubbles and

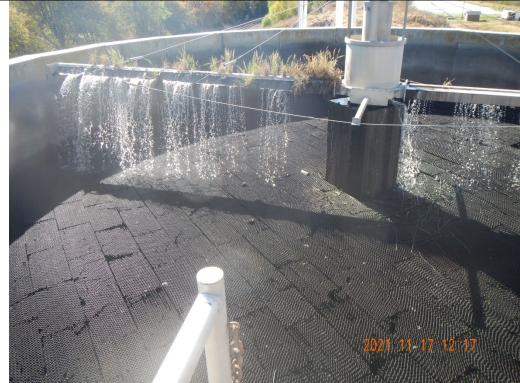
Photographer: Aaron Baggett Date: 11/17/2021 Time: 1217
Witness: Kerri McCabe Photo #: 6

Description: From top of southwest bio tower; distribution arms showing significant vegetation growth.

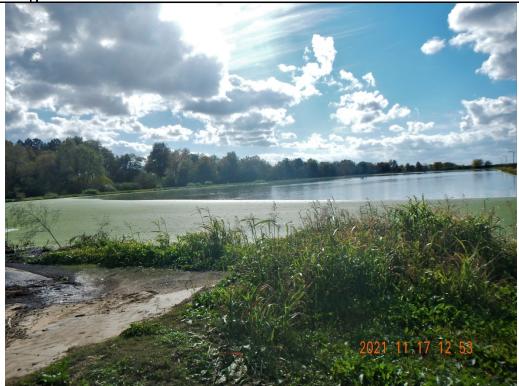
Photographer:Aaron BaggettDate:11/17/2021Time:1253Witness:Kerri McCabePhoto #:12

Description: EQ basin overview; facing southwest; corner of sludge drying pad in bottom left of photo.

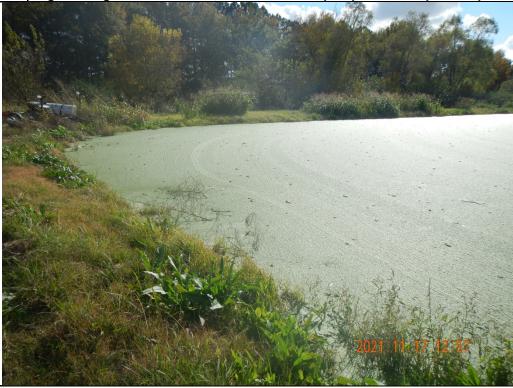
Office of Water Quality Photographic Evidence Sheet Location: Stuttgart Municipal Water Work Photographer: Aaron Baggett Date: 11/17/2021 Time: 1257 Witness: Kerri McCabe Photo #: 13

- The east Sludge Digester has been inoperable for approximately 1.5 years.
- Due to the redirection of influent outside of significant rain events, the EQ Basin has excessive accumulation of sludge. This accumulation has led to the basin being over design volume as well as overflows at EQ Basin wet wells. This is a REPEAT issue noted in past inspections.

Description: Sludge & water accumulation nearing the top of EQ Basin levee; significant vegetation growth at surface; trailer-mounted pump seen in top left of photo.

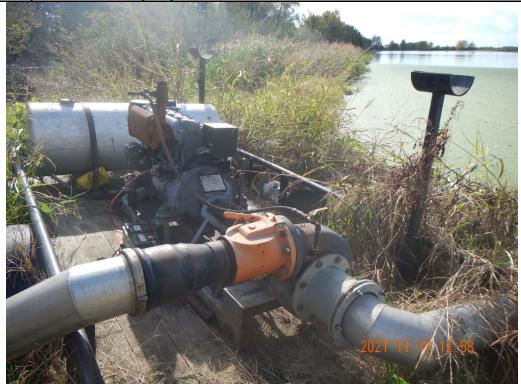
Photographer: Stuttgart Municipal Water Works Date: 11/17/2021 Time: 1256
Witness: Kerri McCabe Photo #: 14

- A trailer-mounted pump at the EQ basin intended to recirculate sludge to front of facility has discharged directly to the adjacent ditch due to broken pipes.

Multiple repeat O&M issues, including some ongoing issues, were noted for the treatment plant (see "Summary of Findings"), and the overall condition of the facility appears to have deteriorated since the previous inspection in December of 2019. Issues with the EQ basin noted in the 2019 inspection continue to be an area of concern. Influent has been routed to the EQ basin during normal weather conditions due to malfunctioning influent pump check valves and the "A1" influent pump being inoperable. This has led to the continued buildup of sludge/solids in the front portion of the GQ basin (a repeat issue), which now has significant vegetation growth at the surface (Photos 12-13). A temporary pump was placed at the EQ basin to recirculate sludge back to the front of the plant in an attempt to regulate sludge volume. However, the pipe below the pump was completely broken, and the flow patterns in the area showed that the pump had discharged directly into the adjacent ditch since the pipe had broken (Photos 14-16; area of complaint).

Description: Trailer-mounted pump intended to maintain EQ basin level.

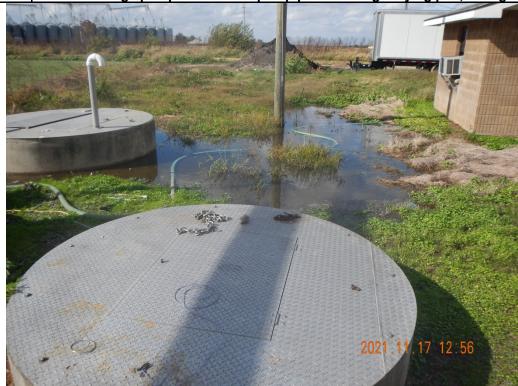
Photographer: Aaron Baggett Date: 11/17/2021 Time: 1256
Witness: Kerri McCabe Photo #: 18

Description: Water of uncertain origin pooling at northeast end of EQ basin; hose shown runs between sludge pump in EQ basin pump pit and sludge drying pad; facing west.

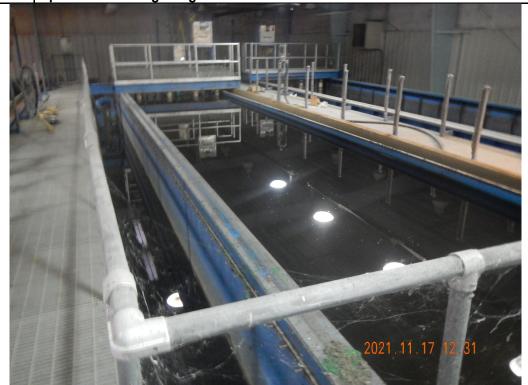
Photographer: Aaron Baggett Date: 11/17/2021 Time: 1231
Witness: Kerri McCabe Photo #: 22

Description: Operable travelling bridge filter.

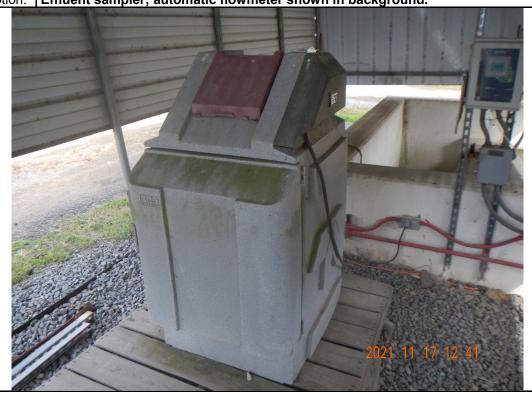
Cocation: Stuttgart Municipal Water Work Photographer: Aaron Baggett Date: 11/17/2021 Time: 1241 Witness: Kerri McCabe Photo #: 27 Description: Effluent sampler; automatic flowmeter shown in background.

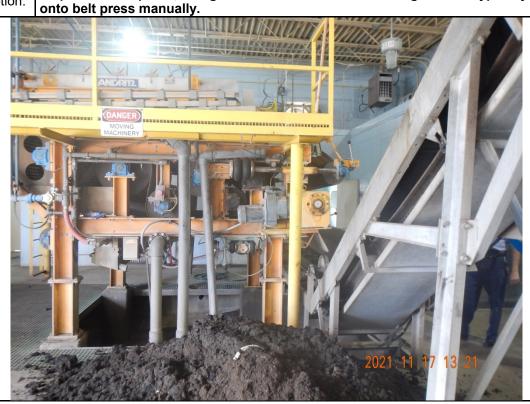
Office of Water Quality Photographic Evidence Sheet						
Location: Stuttgart Municipal Water Work						
Photographer:		Aaron Baggett	Date:	11/17/2021	Time:	1321
Witness: Kerri McCabe Photo #:						29
Description: Inoperable belt press; sludge from EQ basin shown in foreground is typically loaded
