RE: Boyd Point WWTF Inspection

AFIN: 35-00149 Permit No.: AR0033316

OFFICE OF WATER QUALITY INSPECTION REPORT

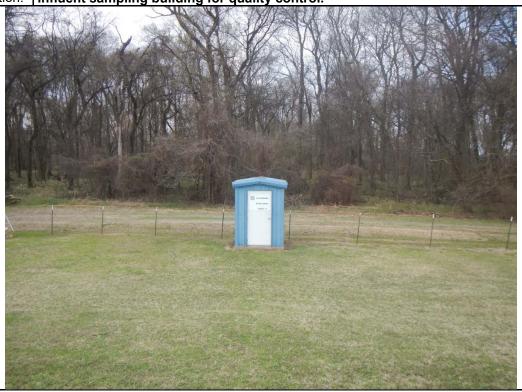
Office of Water Quality Photographic Evidence Sheet Location: Boyd Point WWTF Photographer: Michael Young Date: 02/23/2023 Time: 11:12 Witness: Robert Diaz Photo #: 1 Description: Influent sampling building for quality control.

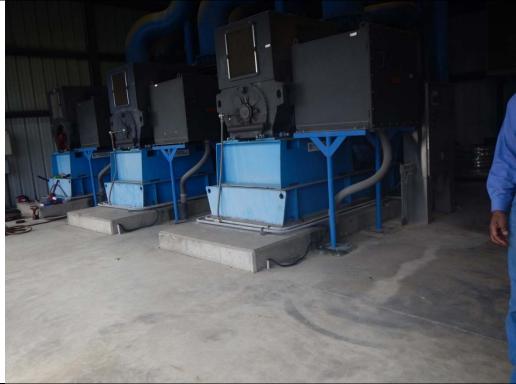
Description: Blowers for aeration basins being maintained during inspection.

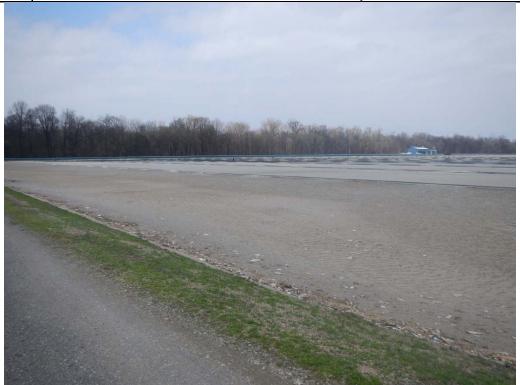
Photographer: Michael Young	Date: 02/23/2023	Time:	11:31
Witness: Robert Diaz		Photo #:	8

Description: Aeration basin with some materials and foam on top.

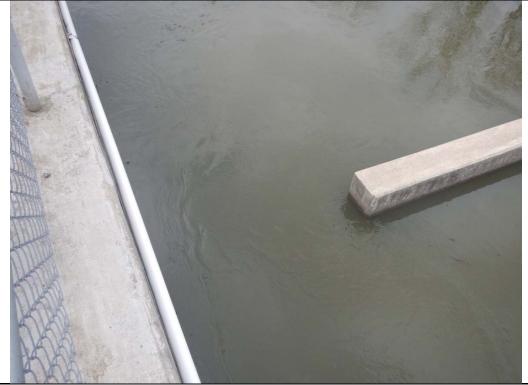
Description: Chlorine contact chamber at Boyd Point WWTF.

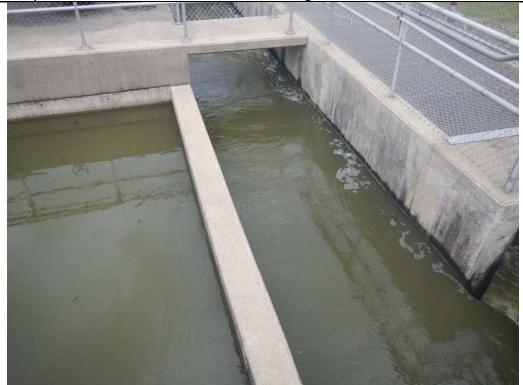
Photographer:	Michael Young	Date: 02/23/2023	Time:	11:41
Witness: Robe	ert Diaz		Photo #	: 14

Description: Chlorine contact chamber with water being disinfected.

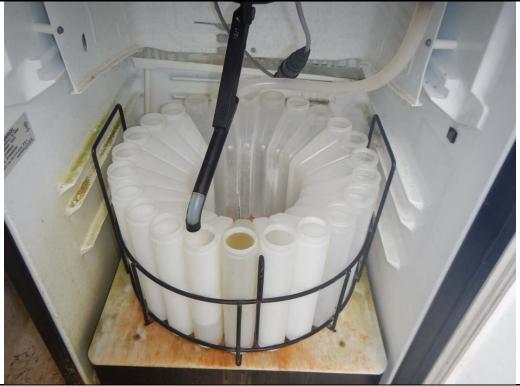
Description: Carousel and aliquots for refrigerated composite sampler.

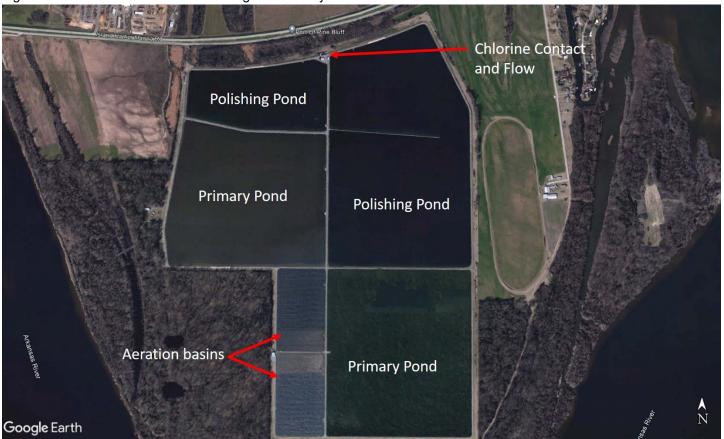
Figure 1. Overview of the treatment design for the Boyd Point WWTF.
