## OFFICE OF WATER QUALITY INSPECTION REPORT

AFIN: 26-00145 | PERMIT #: AR0033880 | DATE: 4/27/2023

I	GPS LAT: <b>34.450316</b> LONG: <b>-93.019033</b> LOCATION: <b>General Area</b>				
FACILITY INFORMATION	ON	INSPECTION INFORMATION			MATION
Davidson & Southwest Collection System		FACILITY TYPE:  1 - Municipal	INSPECTOR ID#: 34689 S - \$		
320 Davidson Drive		1 - Unsatisfacto	ry		Collection System
Hot Springs, AR 71901			RY TIME: EXIT : 14:		PERMIT EFFECTIVE DATE:
RESPONSIBLE OFFICIAL					9/1/2018 PERMIT EXPIRATION DATE:
Mr. Monty Ledbetter / Utilities Director					8/31/2023
COMPANY:		FAYETTEVILLE SHALE RELATED: <b>N</b>			
City of Hot Springs Davidson WWTP		FAYETTEVILLE SHALE VIOLATIONS: N			
320 Davidson Drive		INSPECTION PARTICIPANTS			
CITY, STATE, ZIP:  Hot Springs AR 71901  PHONE & EXT: / FAX:		Danny Burton/ C		Manag	er
501-262-1125 / 501-262-0339					
mledbetter@cityhs.net					
hmauldin@cityhs.net					
dburon@cityhs.net					
CONTACTED DURING INSPECTION: N	No				
/C=Cabi	AREA EVA sfactory, M=Marginal, U=Unsati	LUATIONS	Evaluated)

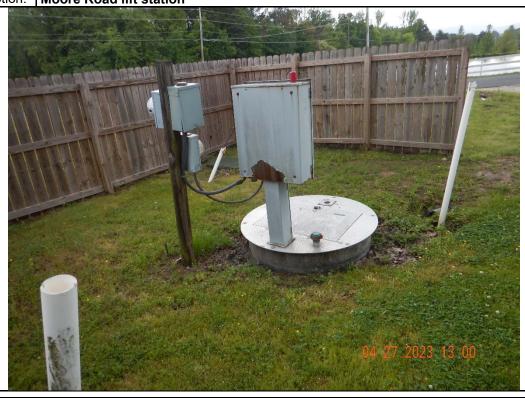
# Office of Water Quality Photographic Evidence Sheet Location: Davidson & Southwest Collection System Photographer: Travis Harmon Date: April 27, 2023 Time: 1300 Witness: None Photo #: 5 Description: Moore Road lift station

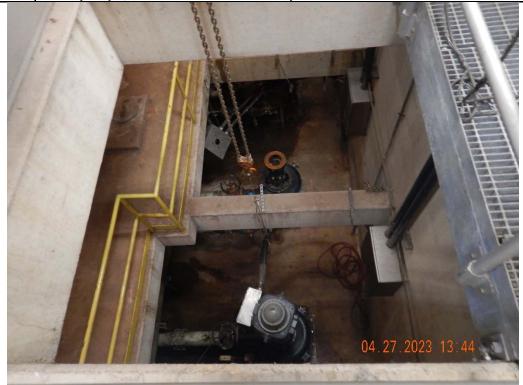
Photographer: Travis Harmon	Date: <b>April 27, 2023</b>	Time:	1344
Witness: None		Photo #:	10

Description: Three pumps; one with motor out for repair.

The pump replacement for the 70W#9 lift station has been received and is being installed as of May 25, 2023. The Gulpha pump motor is being repaired for reinstallation. However, running the Gulpha station at full capacity will further degrade the forcemain, which will be replaced in the near future as part of the greater Gulpha Basin project. Maintenance for grease at pump stations in in progress. Further photographic verification will be provided upon completion.

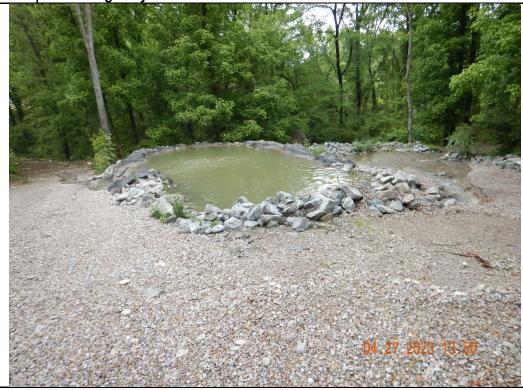
Office of Water Quality Photographic Evidence Sheet						
Location: Davidson & Southwest Collection System						
Photograp	oher:	Travis Harmon	Date:	April 27, 2023	Time:	1350
Witness:	None	•			Photo #	: 11
_	One of two manholes with active SSO adjacent/north of Gulpha lift station. Manhole

Description: One of two mannoles with active 550 adjis submerged by sewer inside rock berm.

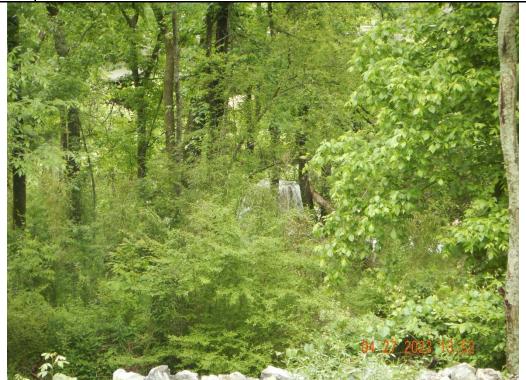
Photographer:	Travis Harmon	Date:	April 27, 2023	Time:	1352
Witness: None	1			Photo #	12

Description: Second manhole SSO near the manhole in Photo # 11.
