RE: Southside WWTP Inspection – PDS 126301 (Independence Co)
AFIN: 32-00515 NPDES Permit No.: AR0050784

<p>ENVIRONMENTAL QUALITY</p>	OFFICE OF WATER QUALITY INSPECTION REPORT		
	AFIN: 32-00515	PERMIT #: AR0050784	DATE: 6/15/2023
	COUNTY: 32 Independence	PDS #: 126301	MEDIA: WN
	GPS LAT: 35.684137 LONG: -91.622267 LOCATION: Entrance

FACILITY INFORMATION	INSPECTION INFORMATION
NAME: Southside WWTP LOCATION: 115 King George St CITY: Batesville, AR	FACILITY TYPE: 1 - Municipal INSPECTOR ID#: 84022 S - State FACILITY EVALUATION RATING: 3 - Satisfactory INSPECTION TYPE: Reconnaissance DATE(S): 6/15/2023 ENTRY TIME: 08:00 EXIT TIME: 09:15 PERMIT EFFECTIVE DATE: 3/1/2019 PERMIT EXPIRATION DATE: 2/29/2024
RESPONSIBLE OFFICIAL	FAYETTEVILLE SHALE RELATED: N FAYETTEVILLE SHALE VIOLATIONS: N
NAME / TITLE: Jared Richardson / Assistant Manager COMPANY: Southside Public Water Authority MAILING ADDRESS: 1401 Batesville Blvd CITY, STATE, ZIP: Batesville AR 72501 PHONE & EXT: / FAX: 870-251-2508 / 870-251-1481 EMAIL: spwaasstmgr@gmail.com CONTACTED DURING INSPECTION: Yes	INSPECTION PARTICIPANTS
	NAME/TITLE/PHONE/FAX/EMAIL/ETC.: Jared Richardson, Assistant Manager (Class III; Lic. #009798)/(870) 251

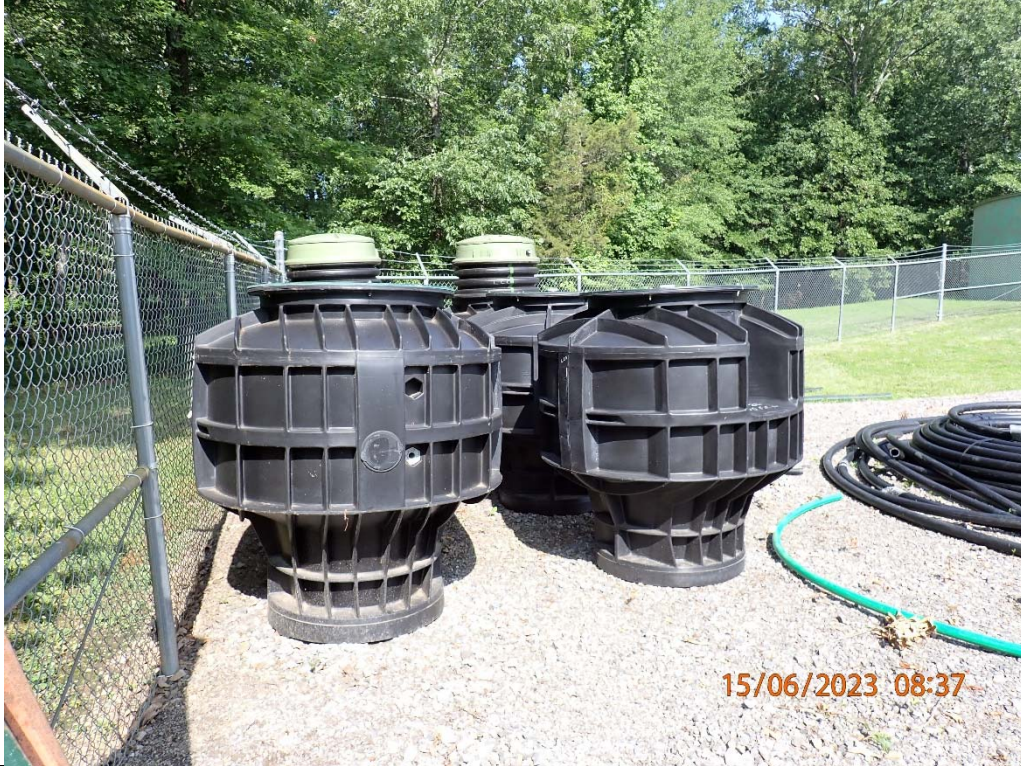
Location:	Southside WWTP		
Photographer:	Kerri McCabe	Date:	June 15, 2023
Witness:	No regulatory personnel	Time:	0837
Description:	Example of grinder pumps installed at individual homes.		
		Photo #:	1

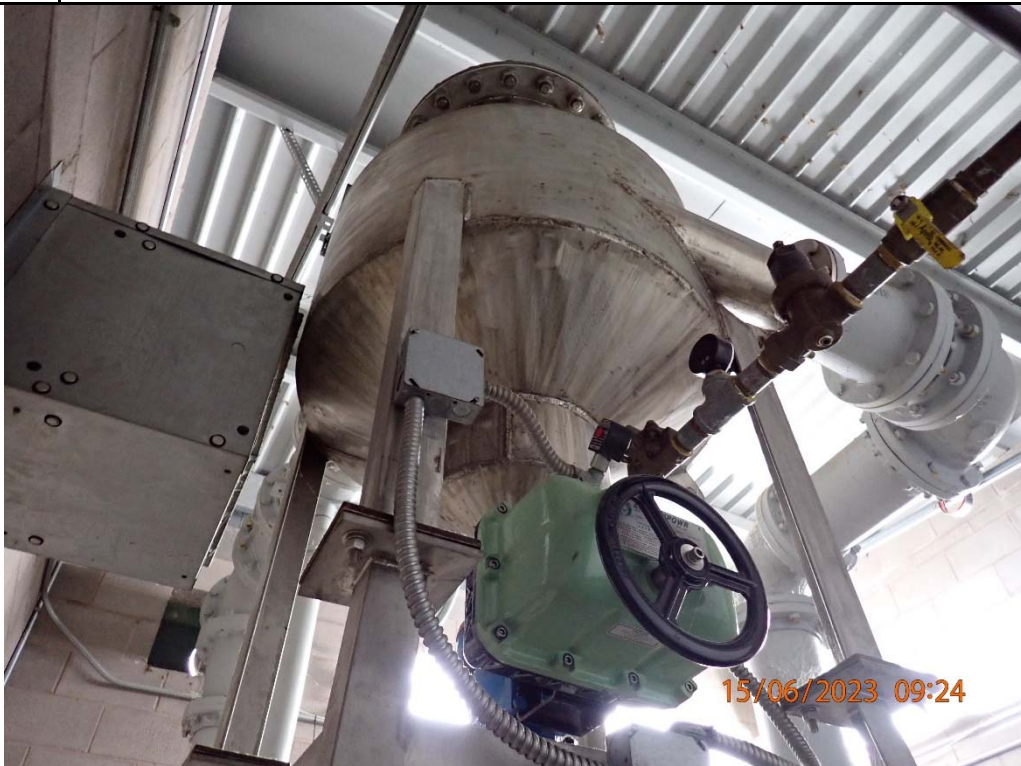
Photographer:	Kerri McCabe	Date:	June 15, 2023
Witness:	No regulatory personnel	Time:	0824
Description:	Grit chamber		
		Photo #:	2

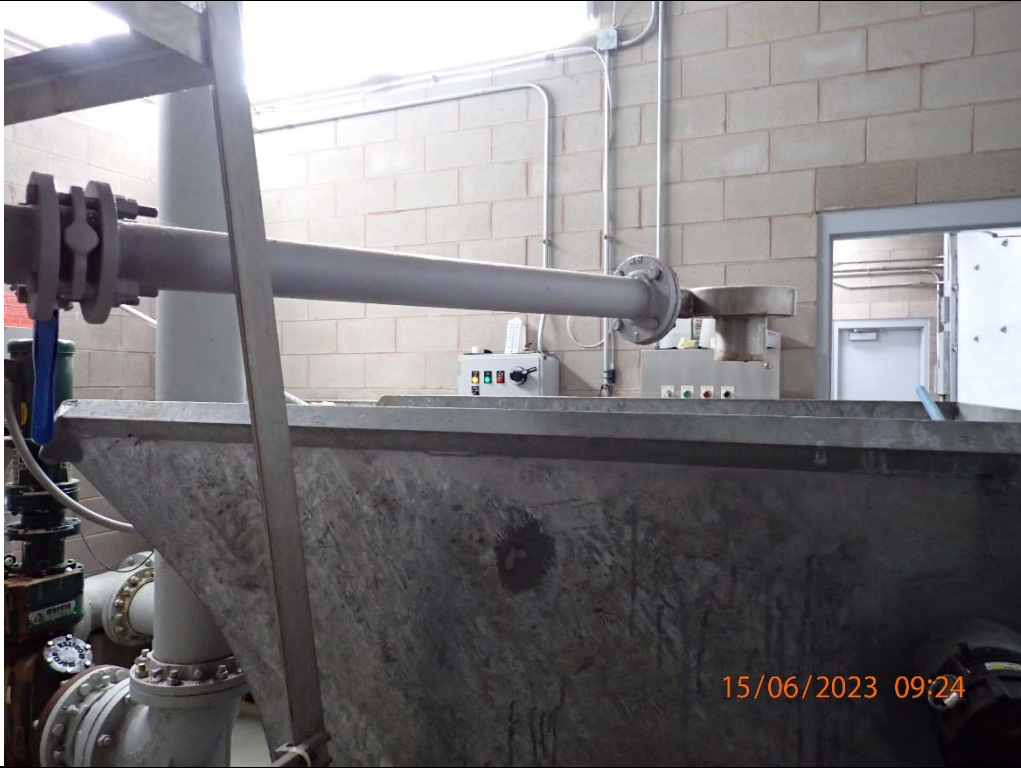
Location:	Southside WWTP		
Photographer:	Kerri McCabe	Date:	June 15, 2023
Witness:	No regulatory personnel	Time:	0824
Description:	Grit dumpster	Photo #:	3

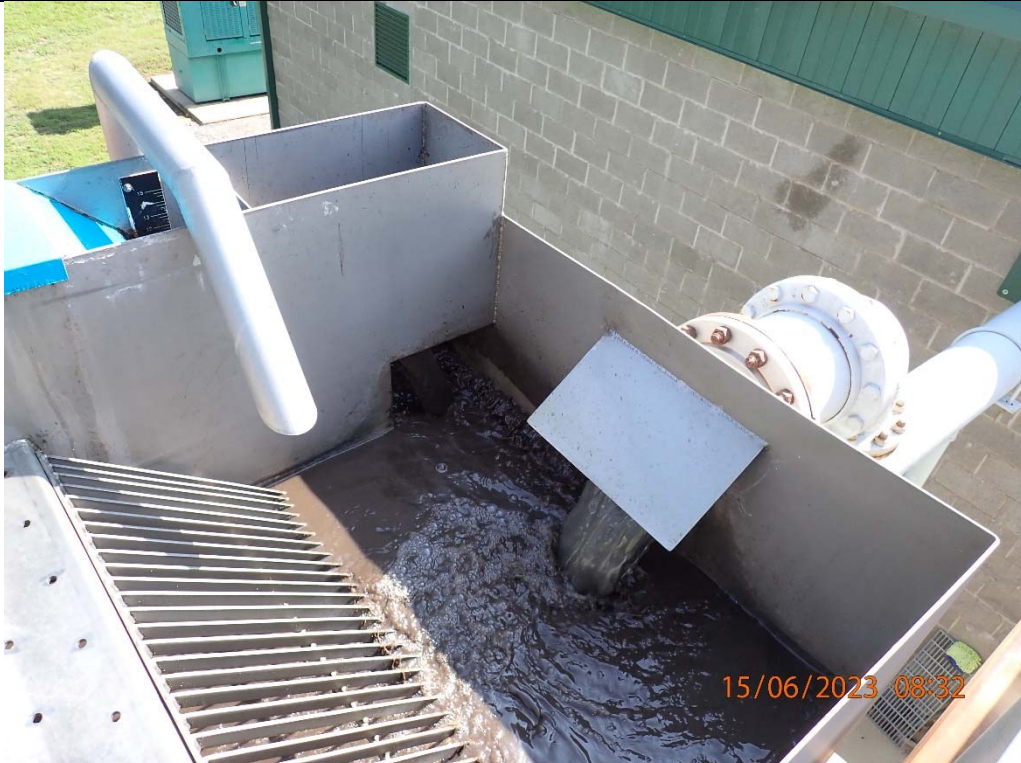
Photographer:	Kerri McCabe	Date:	June 15, 2023
Witness:	No regulatory personnel	Time:	0832
Description:	Bar screen	Photo #:	4

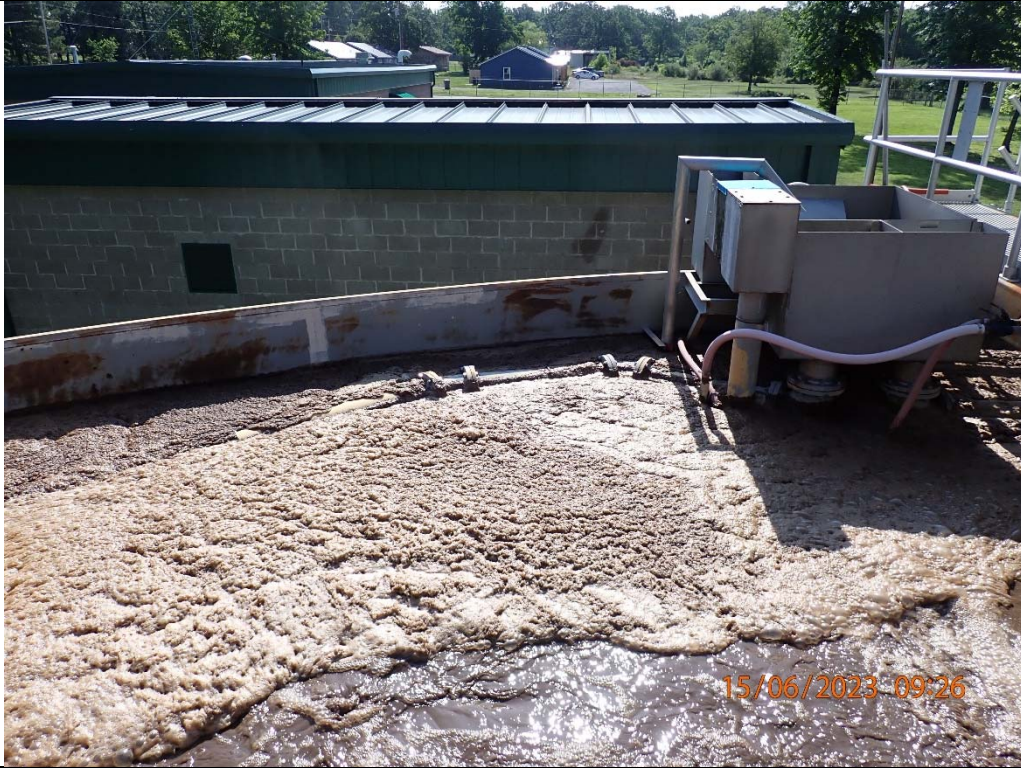
Location:	Southside WWTP		
Photographer:	Kerri McCabe	Date:	June 15, 2023
Witness:	No regulatory personnel	Time:	0826
Description:	Basin 1	Photo #:	5

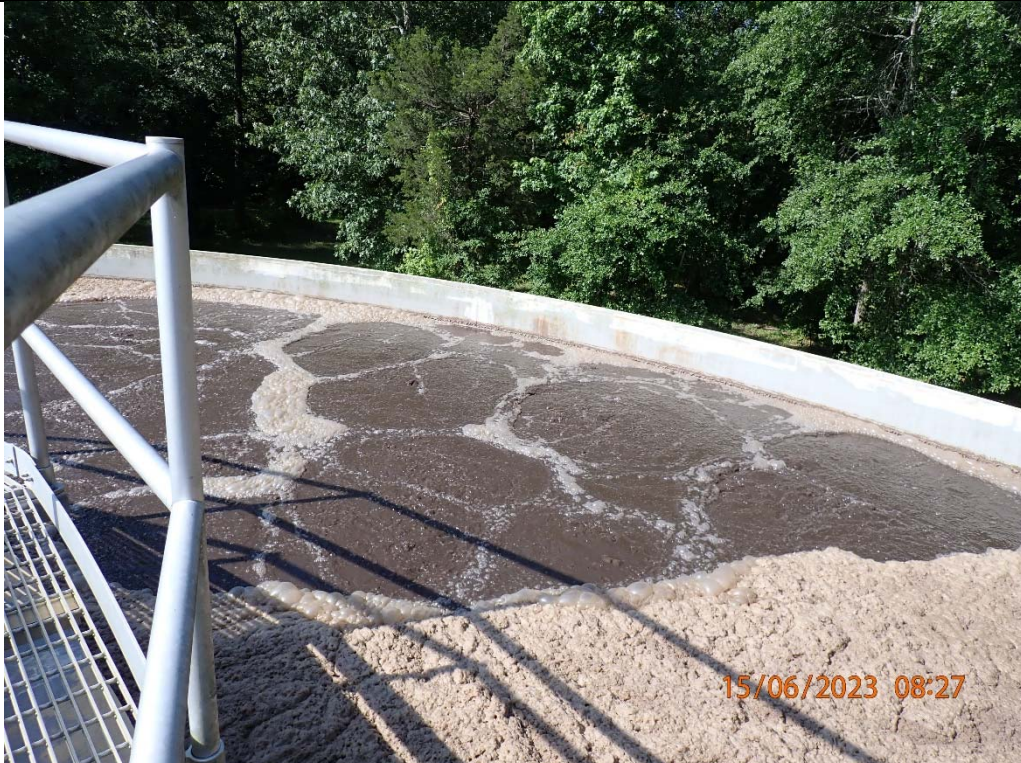
Photographer:	Kerri McCabe	Date:	June 15, 2023
Witness:	No regulatory personnel	Time:	0827
Description:	Basin 2	Photo #:	6

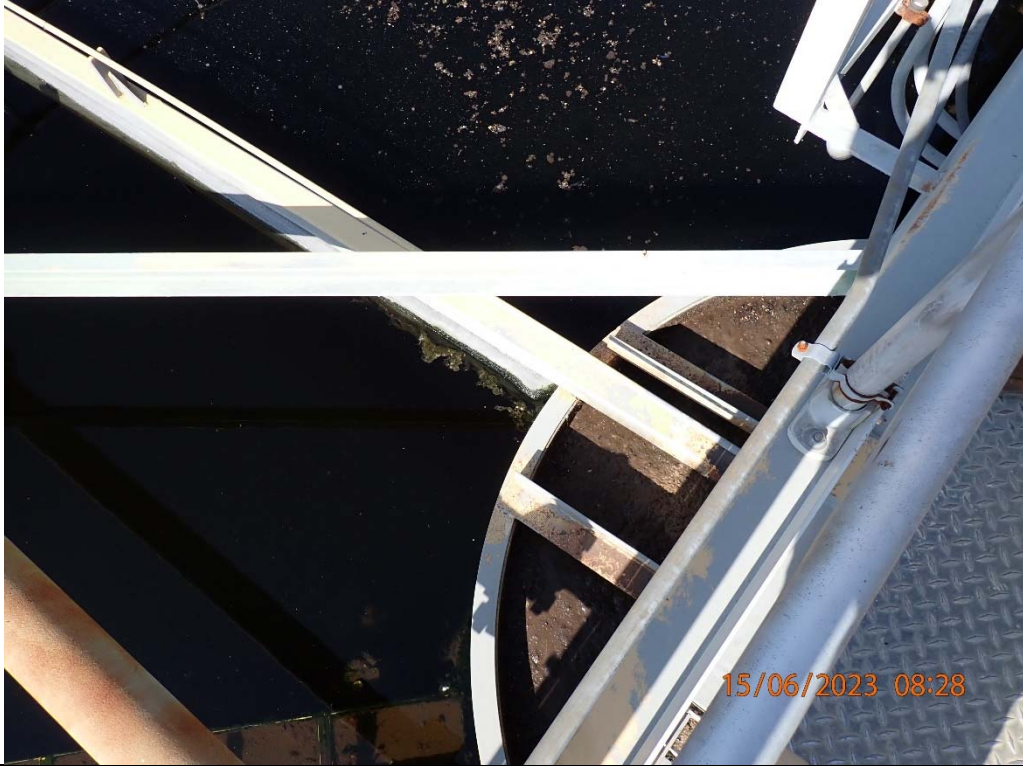
Location:	Southside WWTP		
Photographer:	Kerri McCabe	Date:	June 15, 2023
Witness:	No regulatory personnel	Time:	0828
Description:	Activated sludge entering center of clarifier.	Photo #:	7

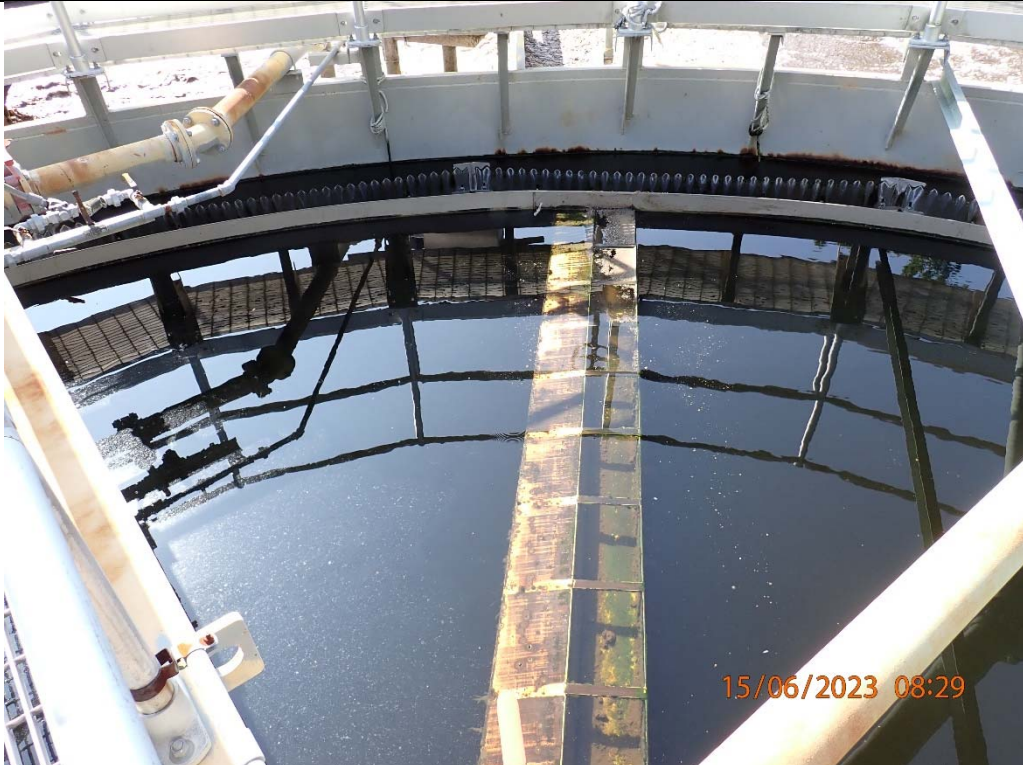
Photographer:	Kerri McCabe	Date:	June 15, 2023
Witness:	No regulatory personnel	Time:	0829
Description:	Clarifier with hopper to collect scum.	Photo #:	8

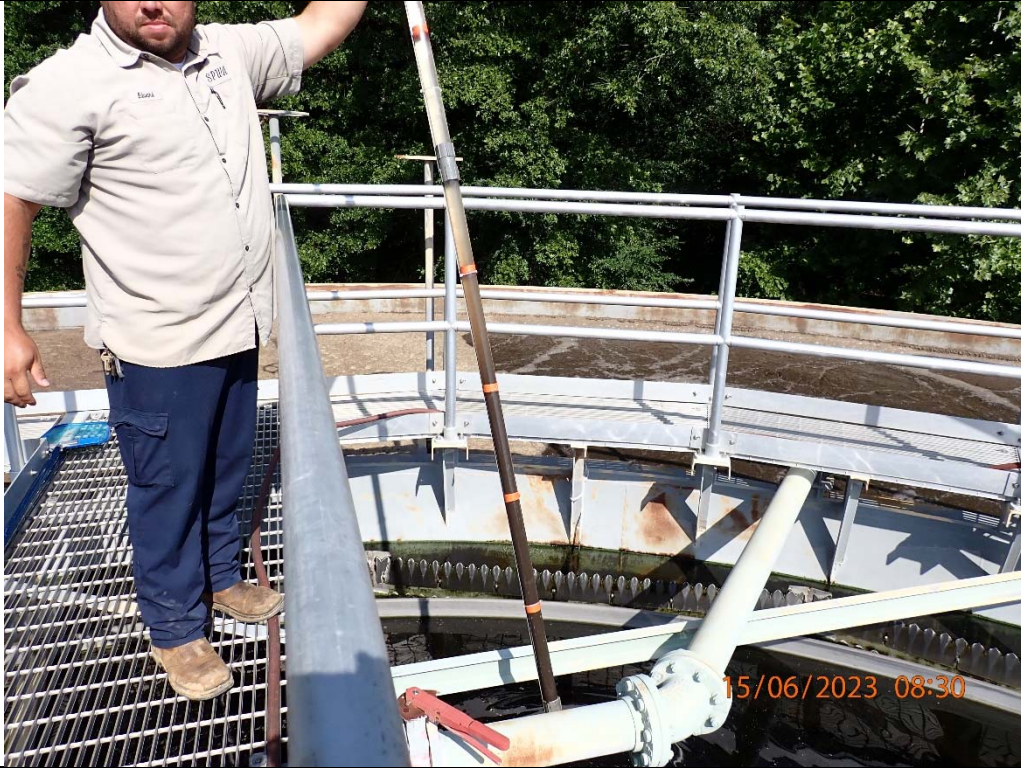
Location:	Southside WWTP			
Photographer:	Kerri McCabe	Date:	June 15, 2023	
Witness:	No regulatory personnel	Time:	0830	
Description:	Mr. Renteria demonstrating the sludge blanket depth in the clarifier.		Photo #:	9

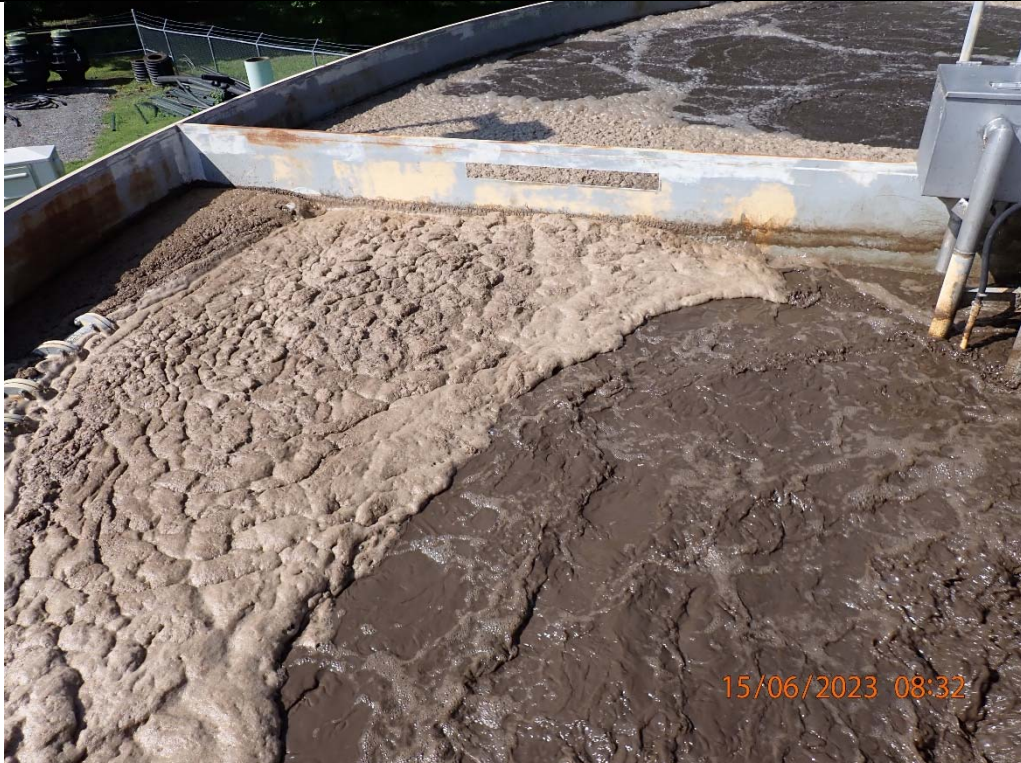
Photographer:	Kerri McCabe	Date:	June 15, 2023	
Witness:	No regulatory personnel	Time:	0832	
Description:	Digester		Photo #:	10

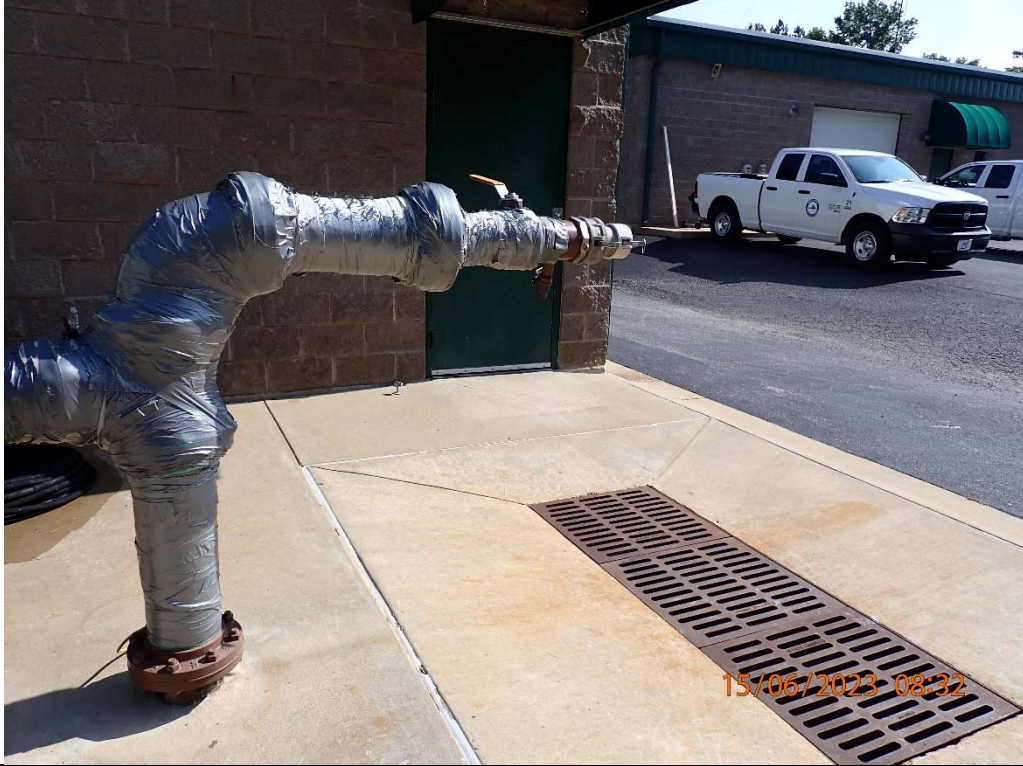
Location:	Southside WWTP			
Photographer:	Kerri McCabe	Date:	June 15, 2023	
Witness:	No regulatory personnel	Time:	0832	
Description:	Port for removing decanted sludge from the digester for hauling.		Photo #:	11

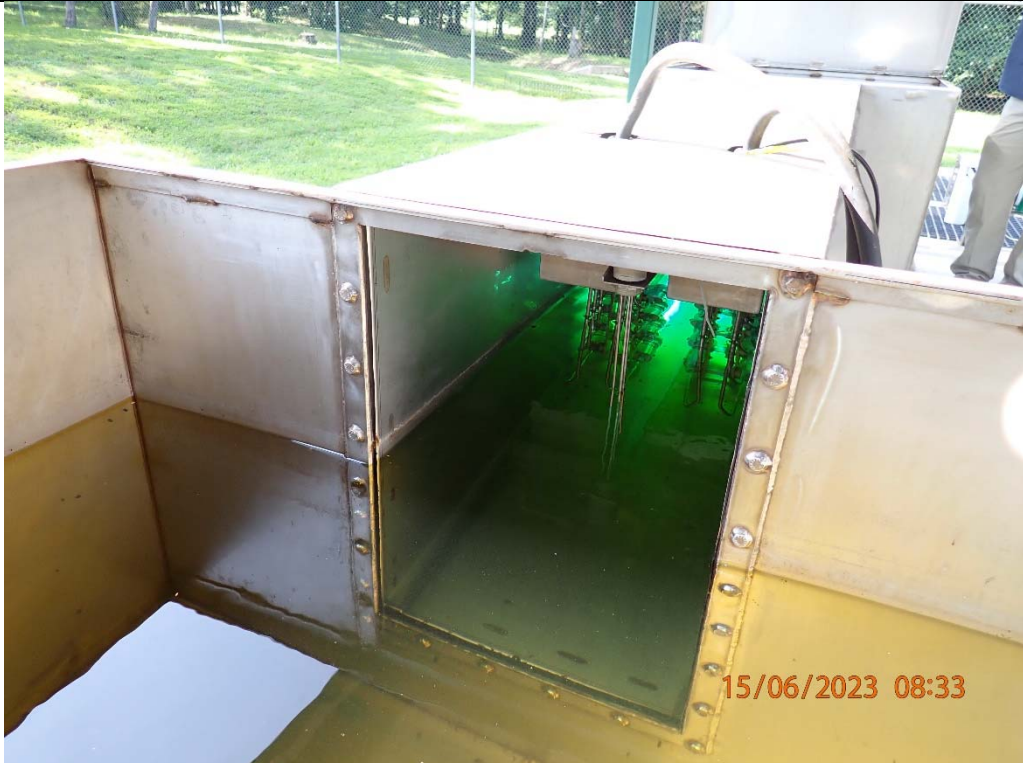
Photographer:	Kerri McCabe	Date:	June 15, 2023	
Witness:	No regulatory personnel	Time:	0833	
Description:	UV disinfection		Photo #:	12

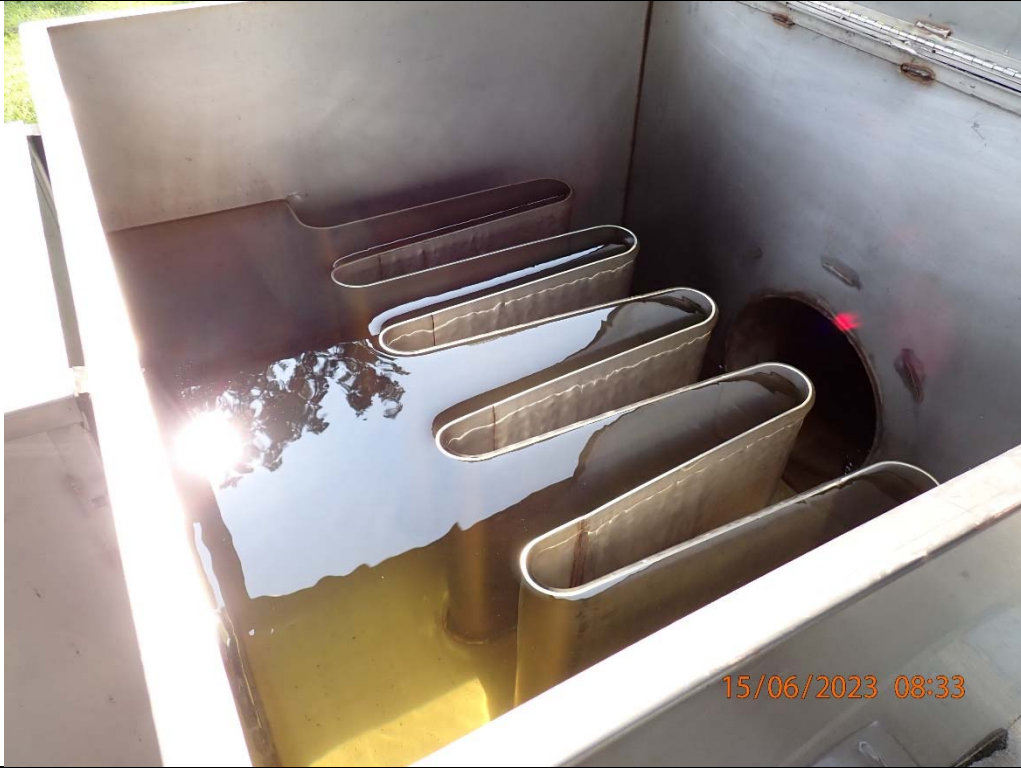
Location:	Southside WWTP		
Photographer:	Kerri McCabe	Date:	June 15, 2023
Witness:	No regulatory personnel	Time:	0833
Description:	Laundres used to keep UV bulbs submerged in effluent.

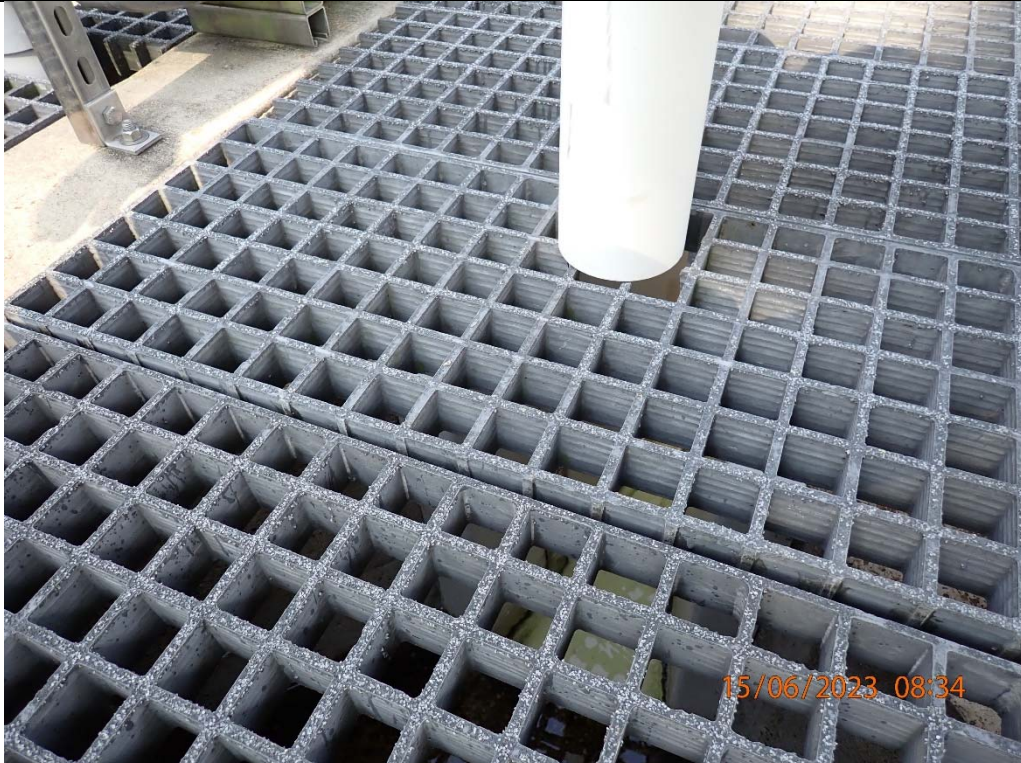
Photographer:	Kerri McCabe	Date:	June 15, 2023
Witness:	No regulatory personnel	Time:	0834
Description:	Primary flow measuring device under screen.

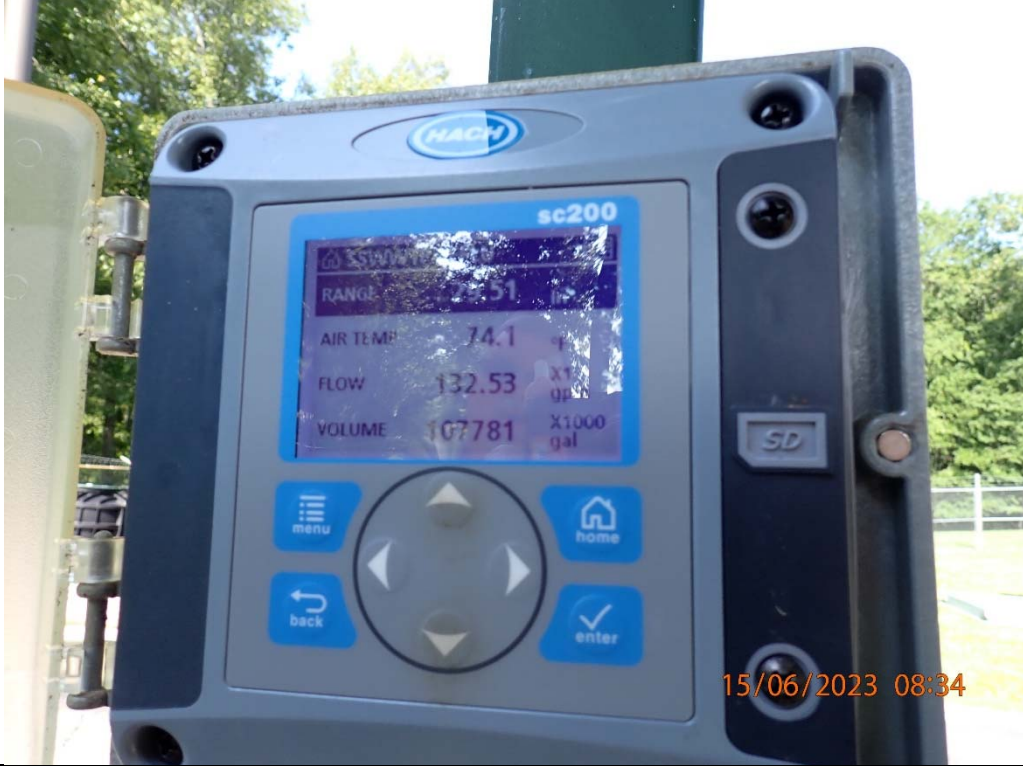
Location:	Southside WWTP		
Photographer:	Kerri McCabe	Date:	June 15, 2023
Witness:	No regulatory personnel	Time:	0834
Description:	Secondary flow measuring device.	Photo #:	15

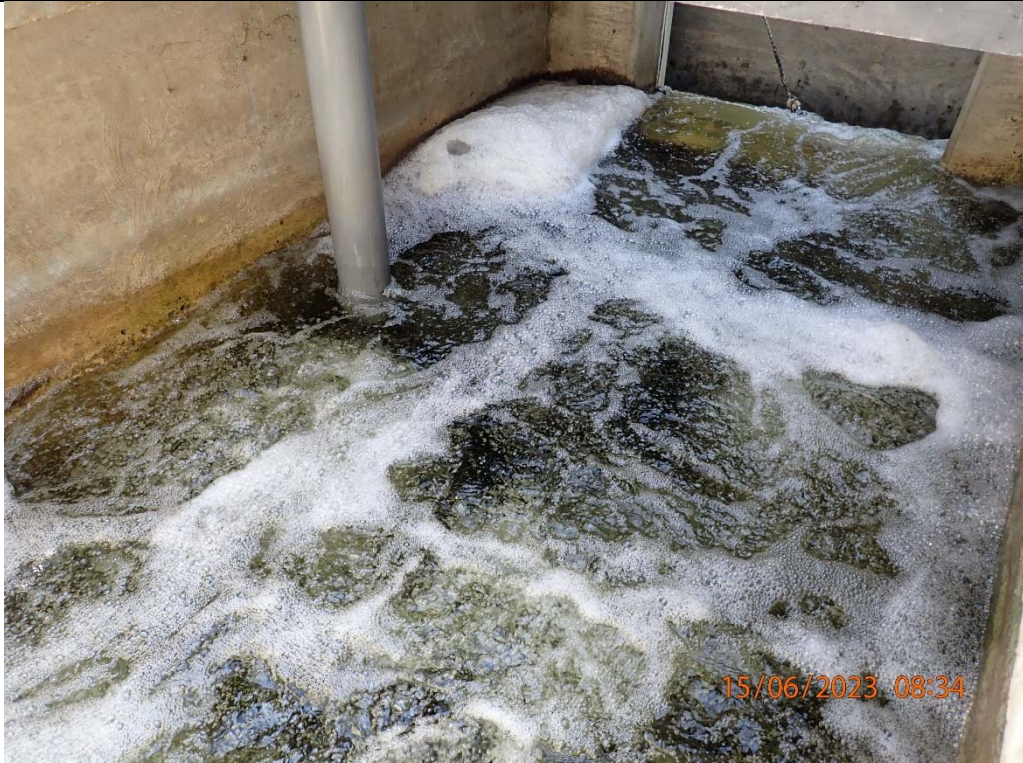
Photographer:	Kerri McCabe	Date:	June 15, 2023
Witness:	No regulatory personnel	Time:	0834
Description:	Post-aeration after flow measurement.	Photo #:	16

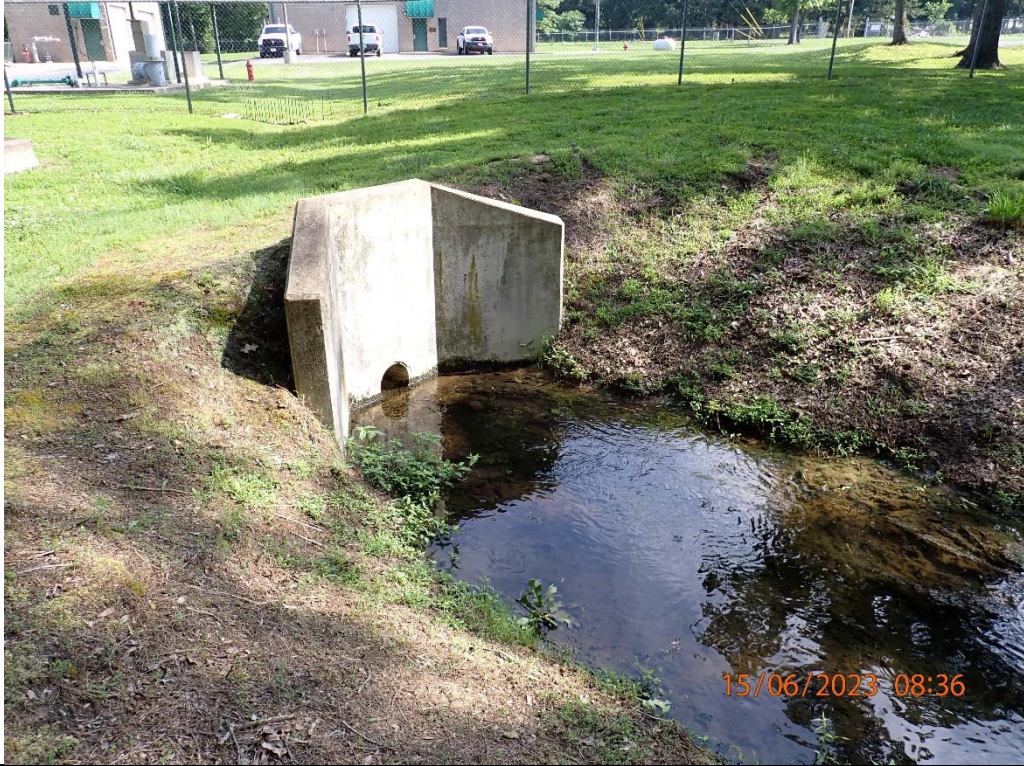
Location:	Southside WWTP				
Photographer:	Kerri McCabe	Date:	June 15, 2023	Time:	0836
Witness:	No regulatory personnel			Photo #:	17
Description:	Discharge at Outfall 001.
