RE: Danfoss Power Solutions II Inspection – Searcy WWTF Pretreatment Compliance Inspection

AFIN: 73-00055

Permit No.: AR0021601

Industrial User Site Visit

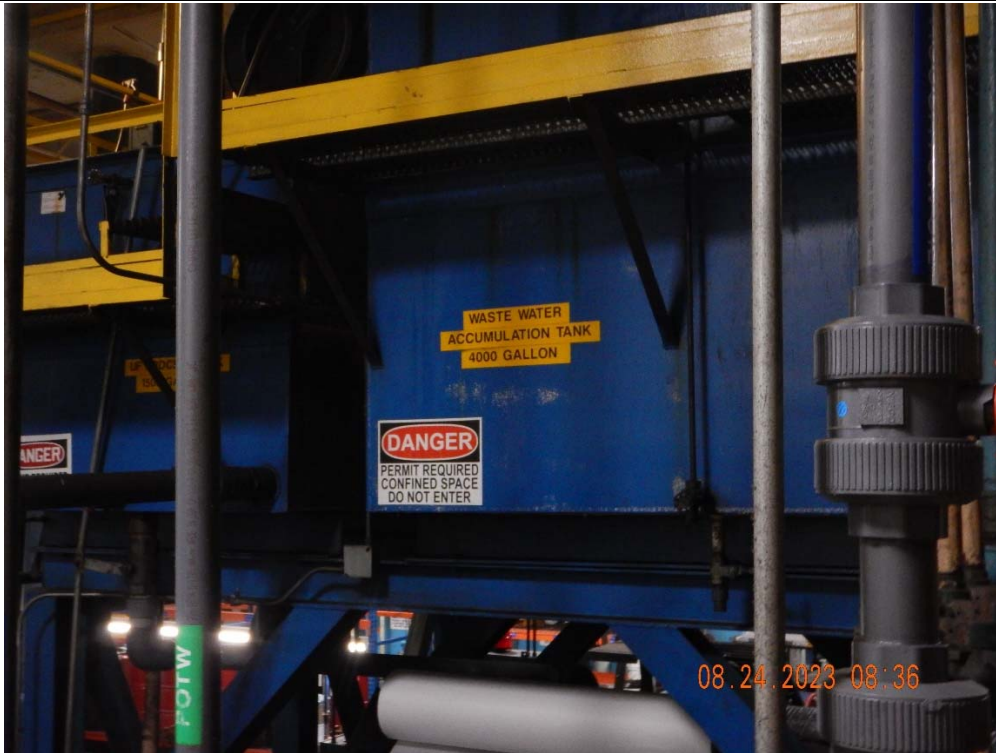
Location:	Danfoss Power Solutions II				
Photographer:	Jason Bolenbaugh	Date:	8/24/2023	Time:	08:36
Witness:				Photo #:	1
Description:	DSCN6319: 4000 gallon wastewater tank.

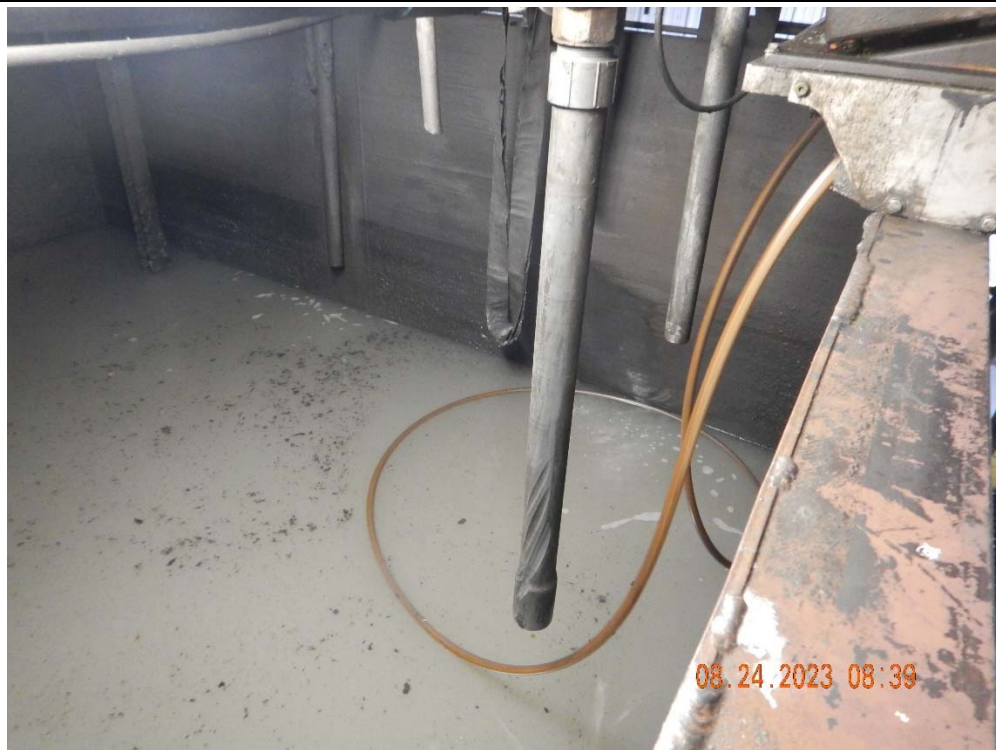
Photographer:	Jason Bolenbaugh	Date:	8/24/2023	Time:	08:39
Witness:				Photo #:	2
Description:	DSCN6320: Oil skimmer in the 4,000 gallon water tank.

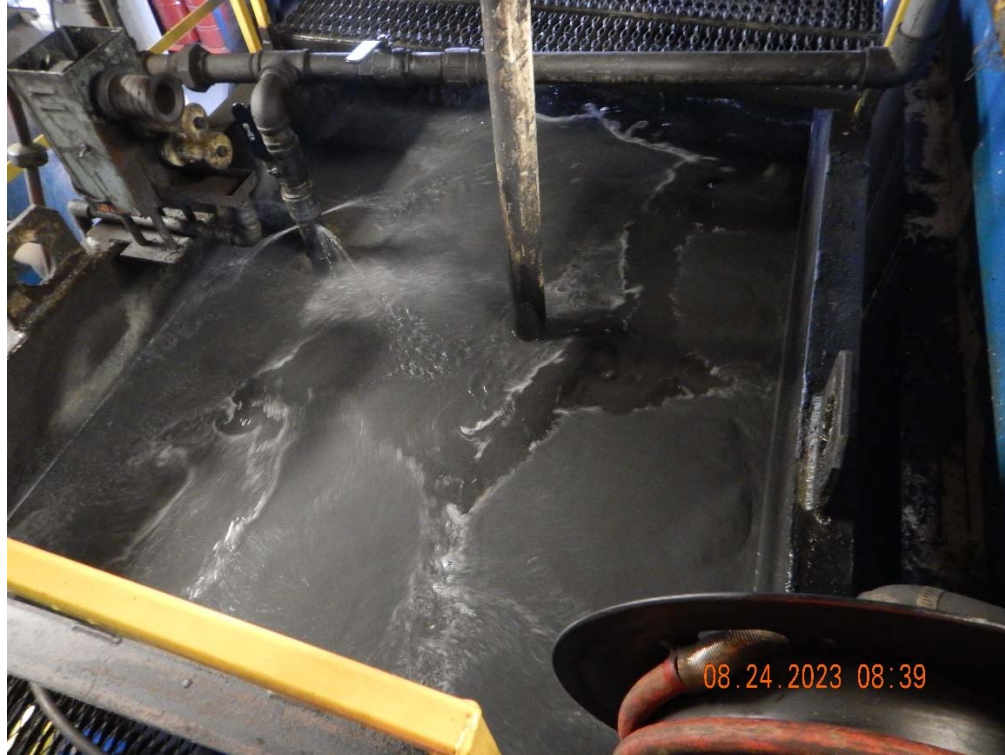
Location:	Danfoss Power Solutions II				
Photographer:	Jason Bolenbaugh	Date:	8/24/2023	Time:	08:39
Witness:				Photo #:	3
Description:	DSCN6321: Inside of the 1500 gallon UF Process tank.

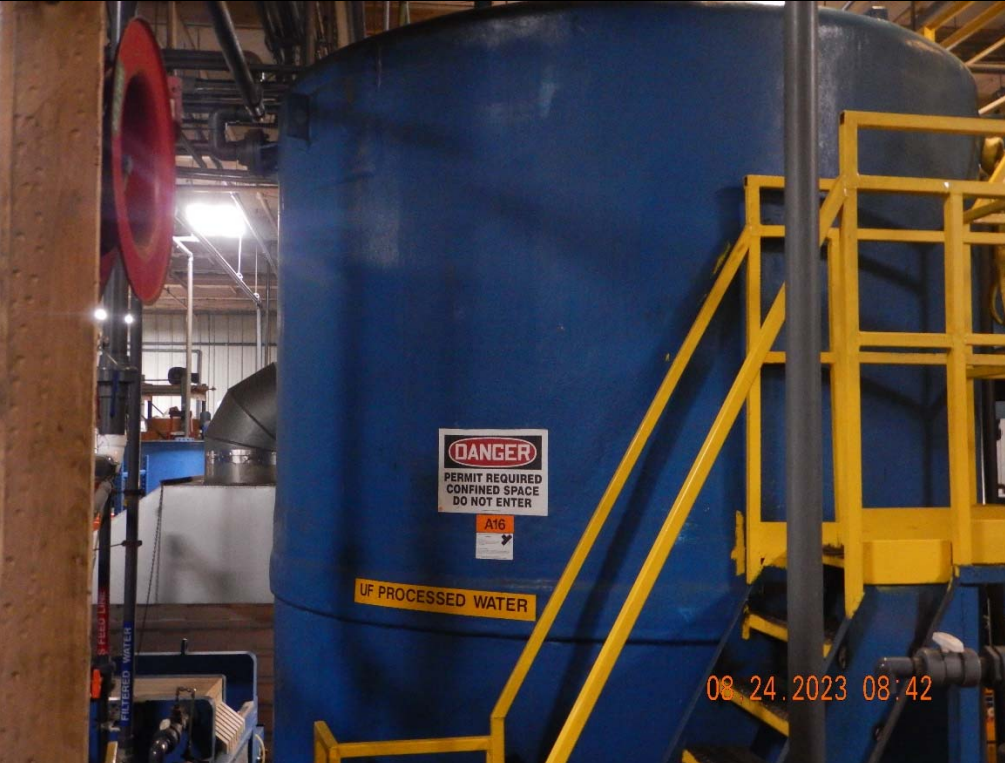
Photographer:	Jason Bolenbaugh	Date:	8/24/2023	Time:	08:42
Witness:				Photo #:	4
Description:	DSCN6322: Processed water tank.

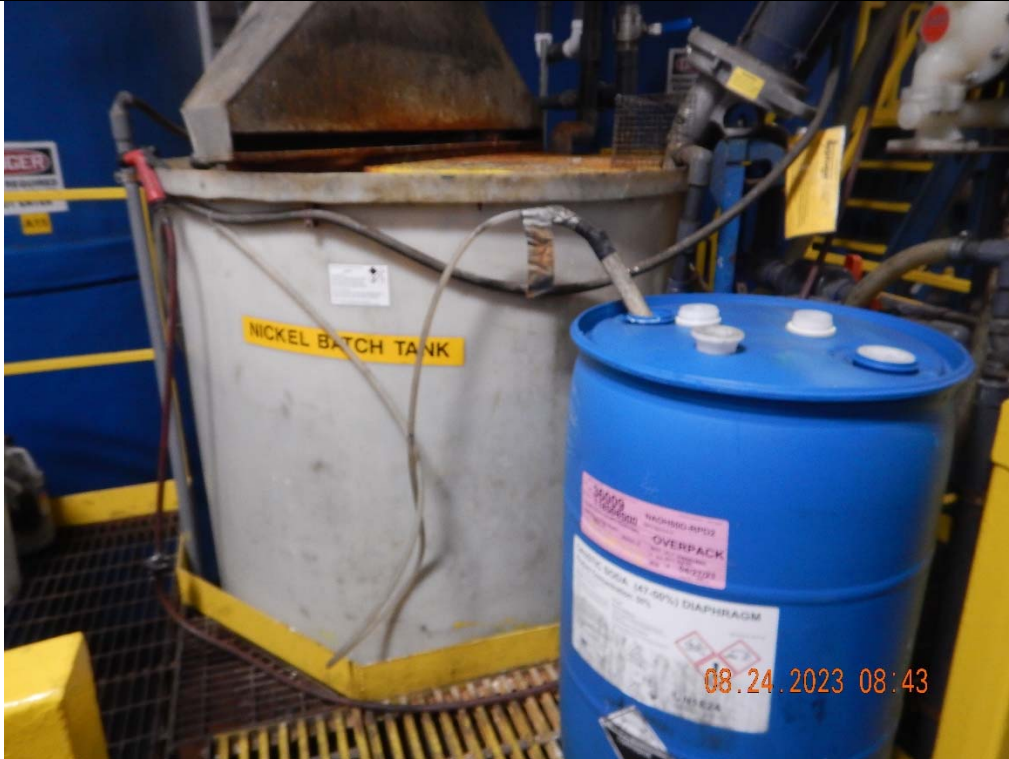
Location:	Danfoss Power Solutions II				
Photographer:	Jason Bolenbaugh	Date:	8/24/2023	Time:	08:43
Witness:				Photo #:	5
Description:	DSCN6323: Nickel batch tank.

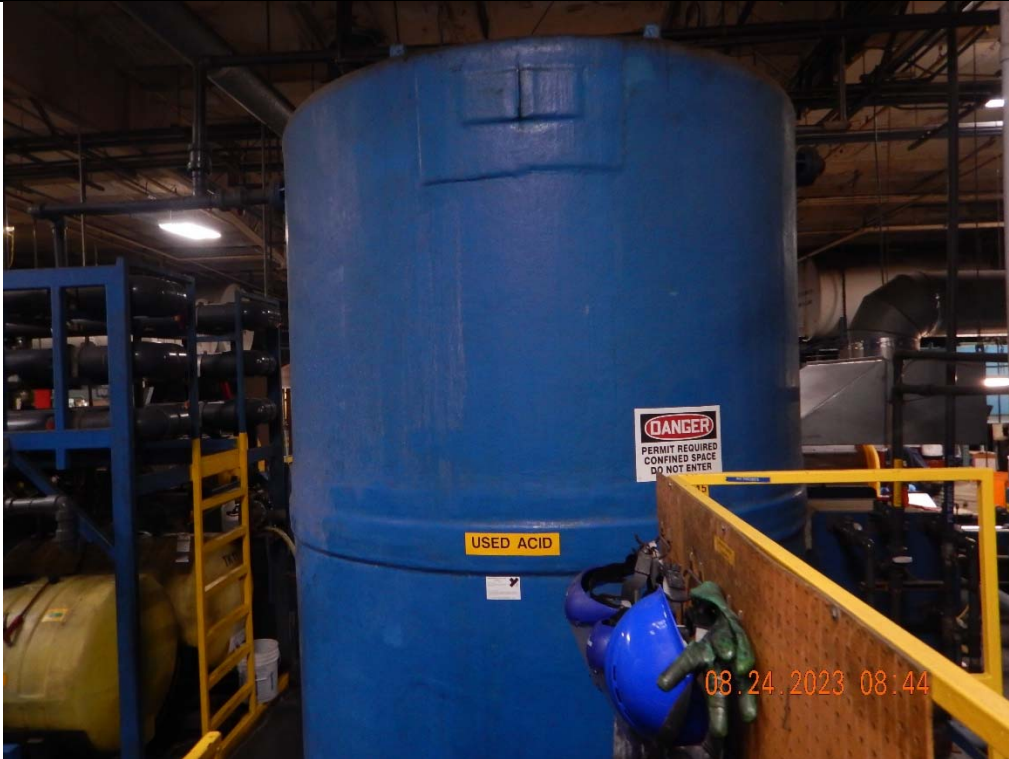
Photographer:	Jason Bolenbaugh	Date:	8/24/2023	Time:	08:44
Witness:				Photo #:	6
Description:	DSCN6324: 4000 gallon used acid tank.

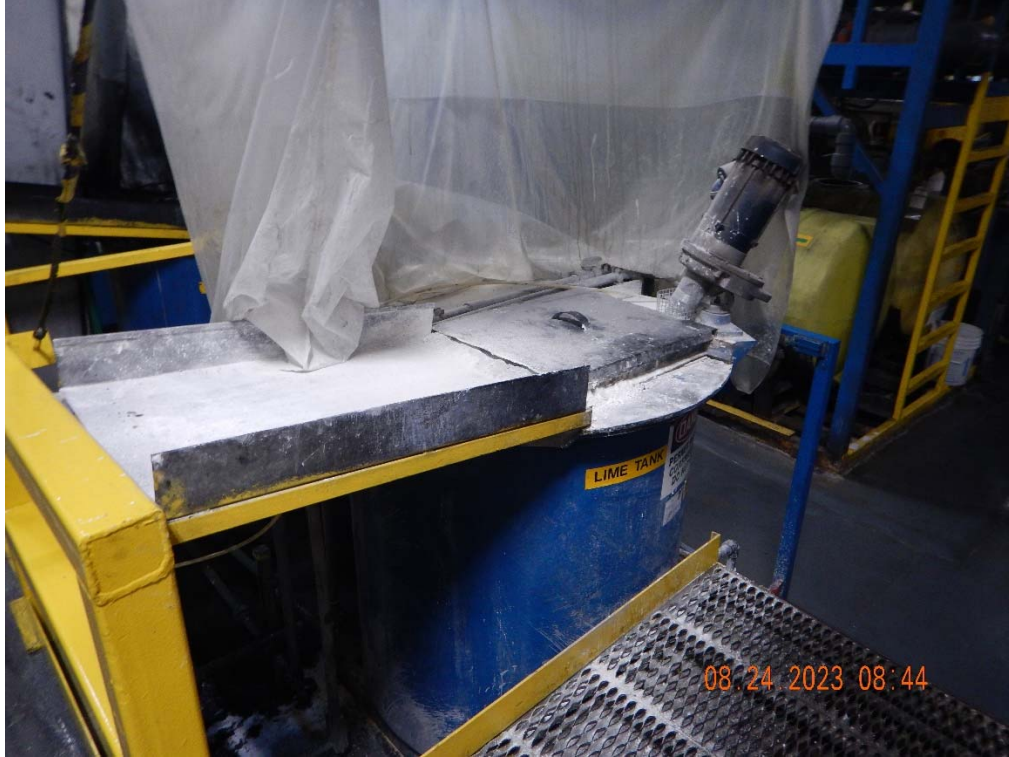
Location:	Danfoss Power Solutions II				
Photographer:	Jason Bolenbaugh	Date:	8/24/2023	Time:	08:44
Witness:				Photo #:	7
Description:	DSCN6325: Hydrated lime addition tank.

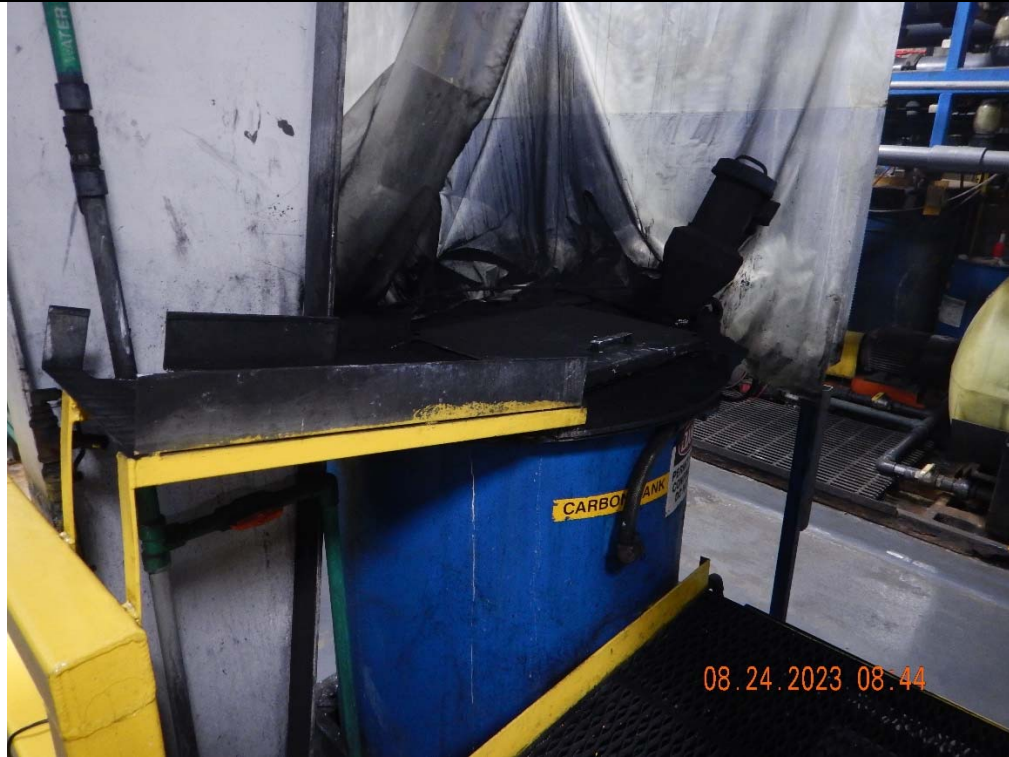
Photographer:	Jason Bolenbaugh	Date:	8/24/2023	Time:	08:44
Witness:				Photo #:	8
Description:	DSCN6326: Carbon addition tank.

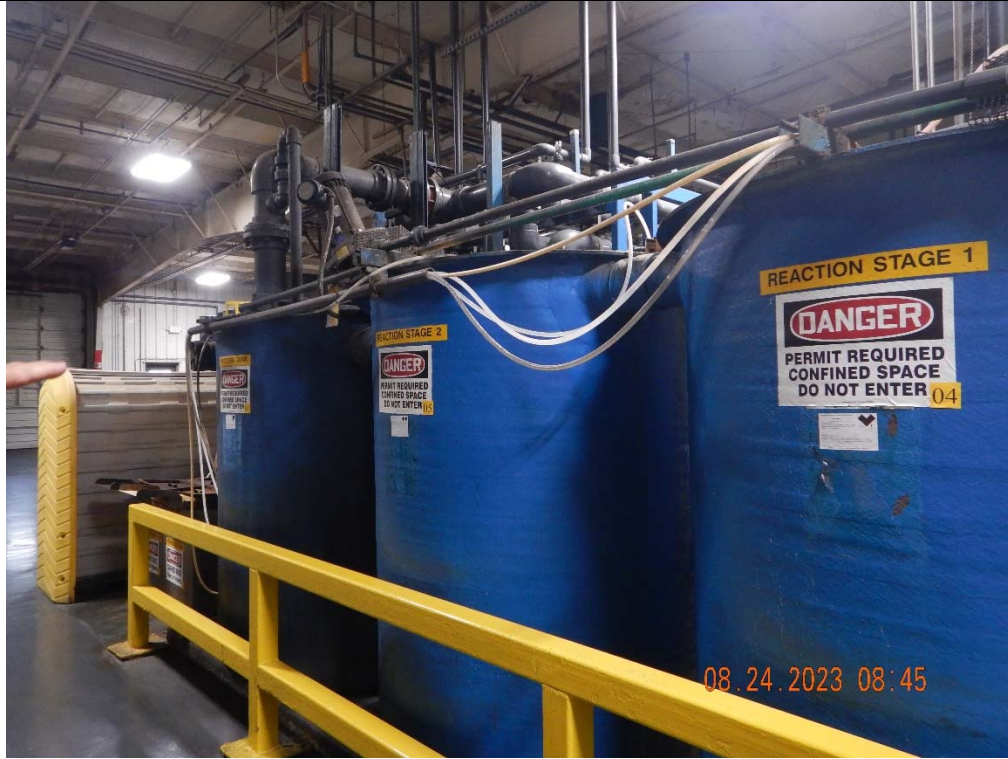
Location:	Danfoss Power Solutions II		
Photographer:	Jason Bolenbaugh	Date:	8/24/2023
Time:	08:45	Witness:	
Photo #:	9	Description:	DSCN6327: MEMTEK Reaction Tanks 1 & 2, and Process Tank.

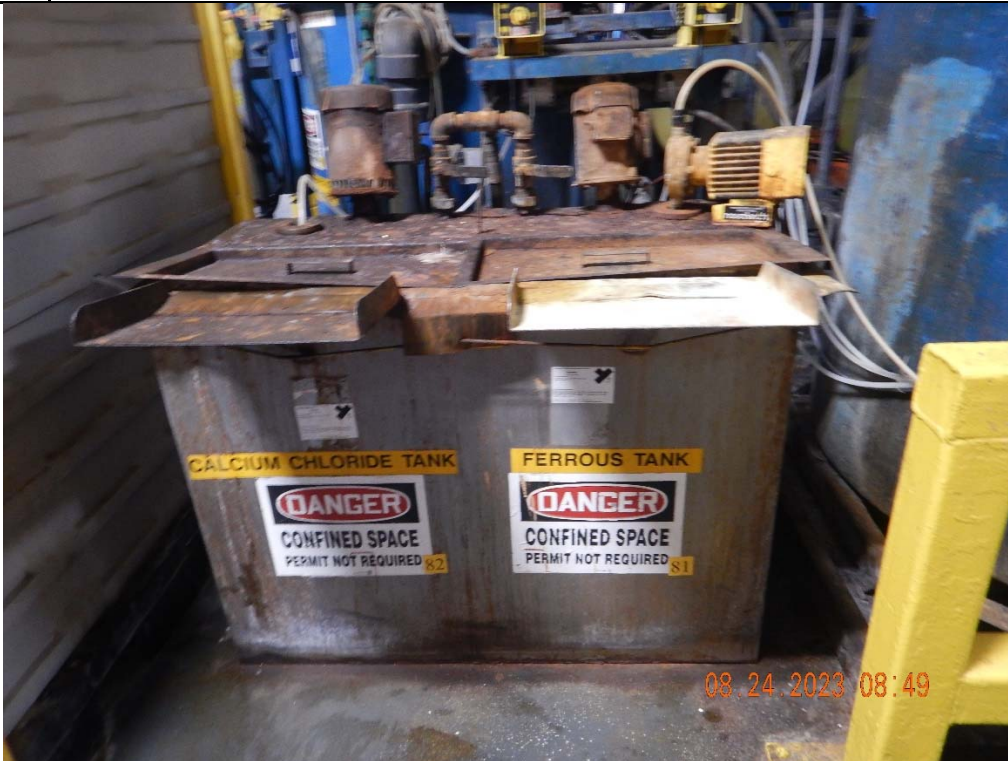
Photographer:	Jason Bolenbaugh	Date:	8/24/2023
Time:	08:49	Witness:	
Photo #:	10	Description:	DSCN6328: Chemical additions to the MEMTEK Process Tank.

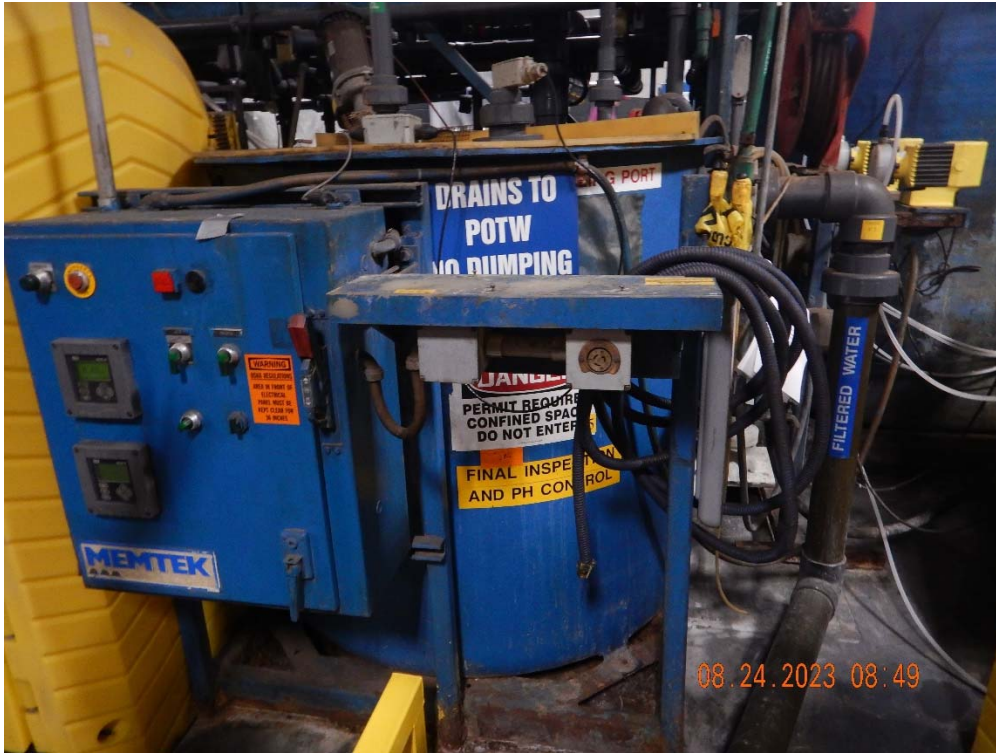
Location:	Danfoss Power Solutions II		
Photographer:	Jason Bolenbaugh	Date:	8/24/2023
Witness:		Time:	
		Photo #:	11
Description:	DSCN6329: Final 500 gallon tank prior to the pretreated wastewater discharging to the collection system.

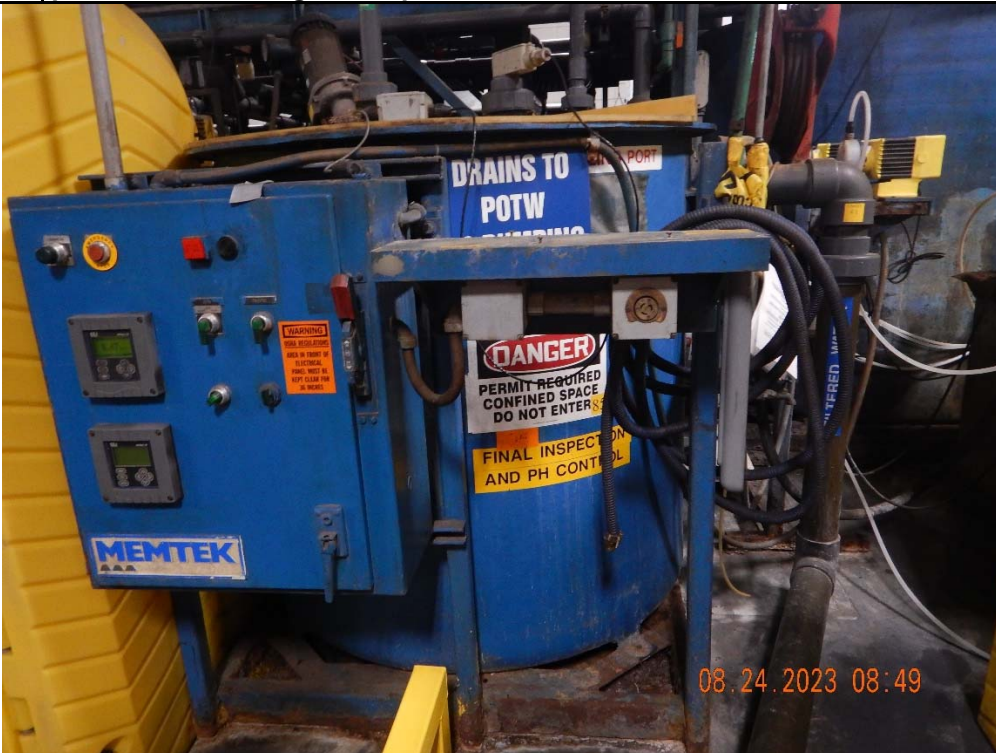
Photographer:	Jason Bolenbaugh	Date:	8/24/2023
Witness:		Time:	08:49
		Photo #:	12
Description:	DSCN6330: Duplicate photo to #11. Provided so the facility has a copy of all of the photos taken during the inspection.

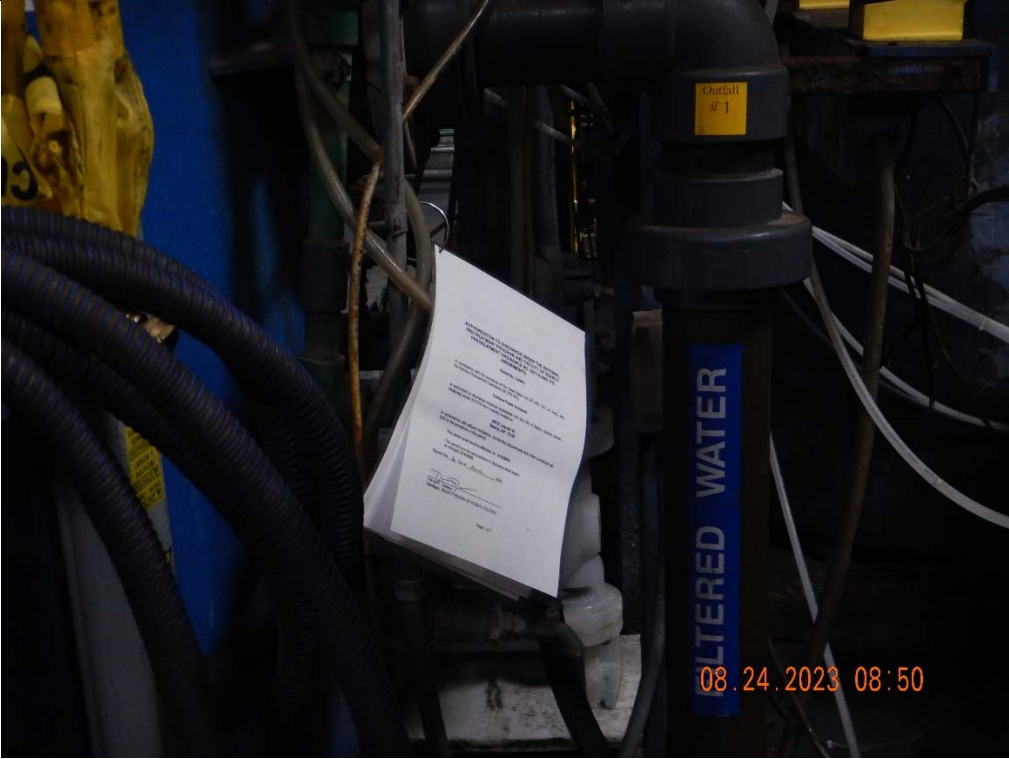
Office of Water Quality Photographic Evidence Sheet			
Location:	Danfoss Power Solutions II		
Photographer:	Jason Bolenbaugh	Date:	8/24/2023
Time:	08:50	Witness:	
Photo #:	13	Description:	DSCN6331: Permit issued by the Searcy PT Program hanging at the effluent monitoring station.

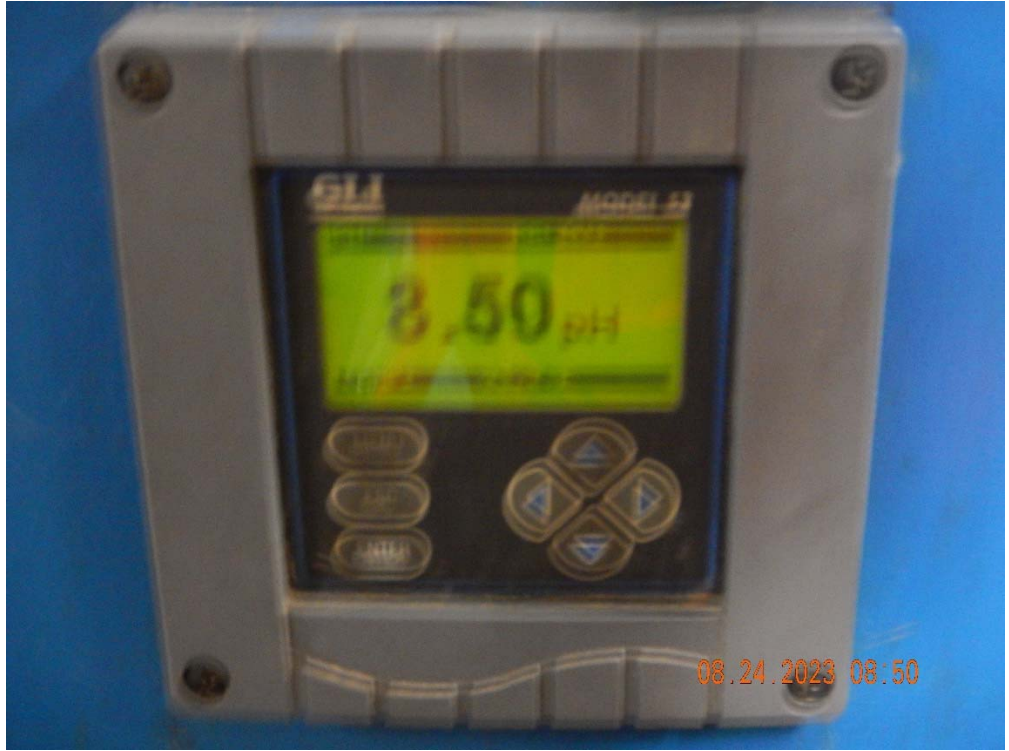
Photographer:	Jason Bolenbaugh	Date:	8/24/2023
Time:	08:50	Witness:	
Photo #:	14	Description:	DSCN6332: Continuous effluent pH monitoring.

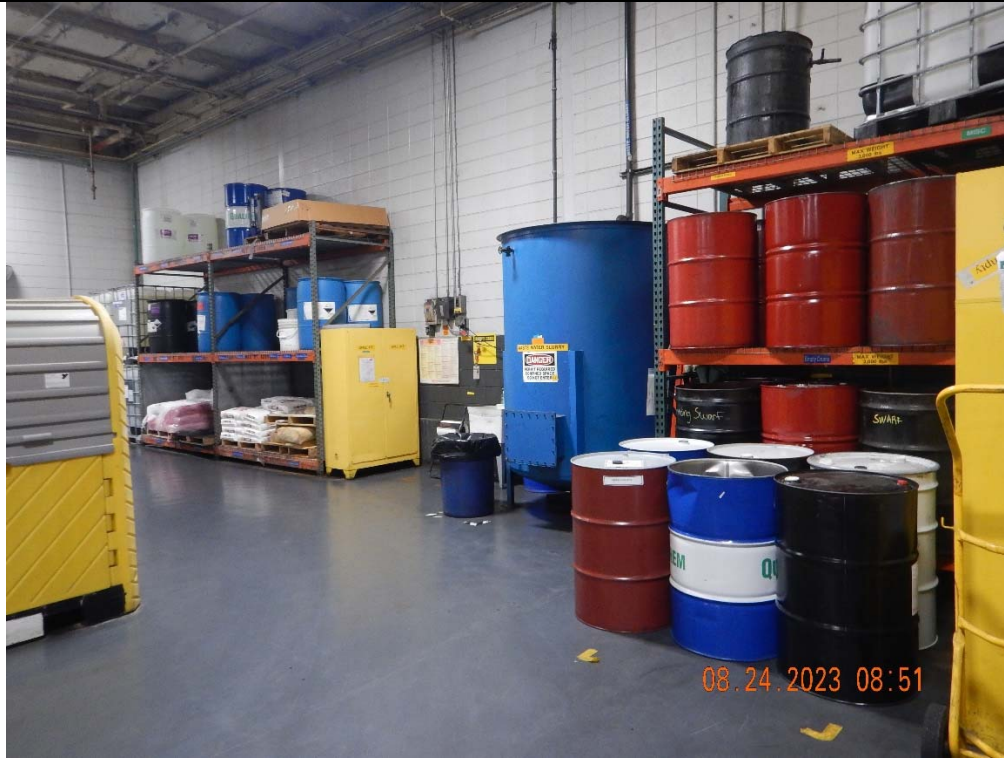
Location:	Danfoss Power Solutions II		
Photographer:	Jason Bolenbaugh	Date:	8/24/2023
Witness:		Time:	08:51
		Photo #:	15
Description:	DSCN6333: Chemical storage in the pretreatment area.

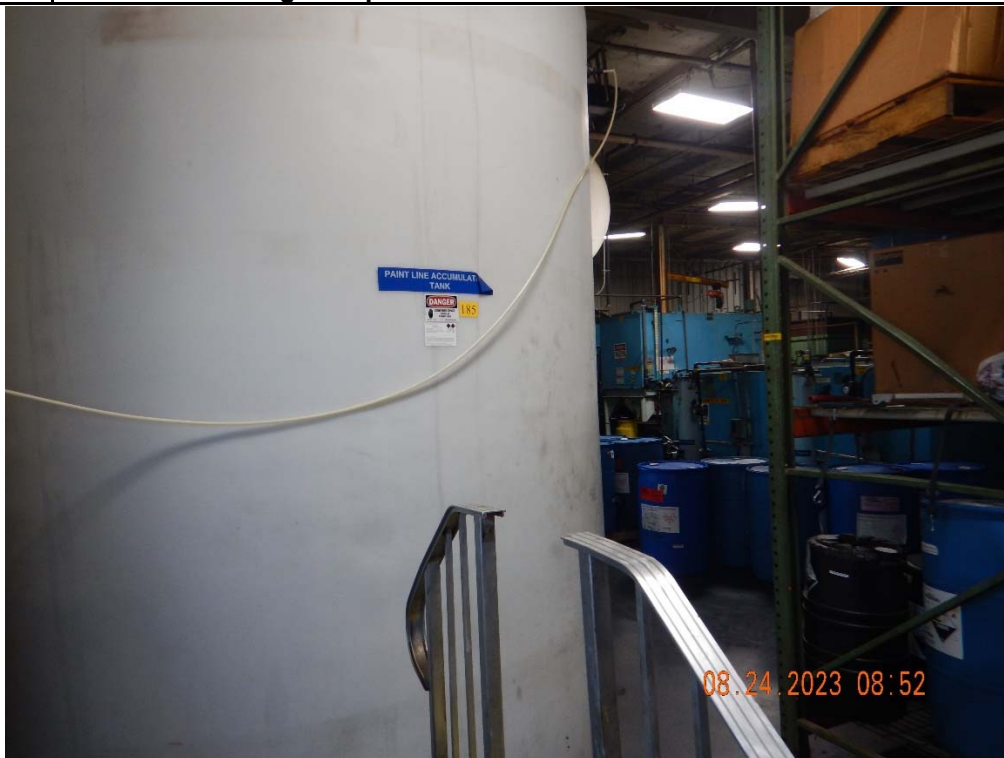
Photographer:	Jason Bolenbaugh	Date:	8/24/2023
Witness:		Time:	08:52
		Photo #:	16
Description:	DSCN6334: 6500 gallon paint line water accumulation tank.

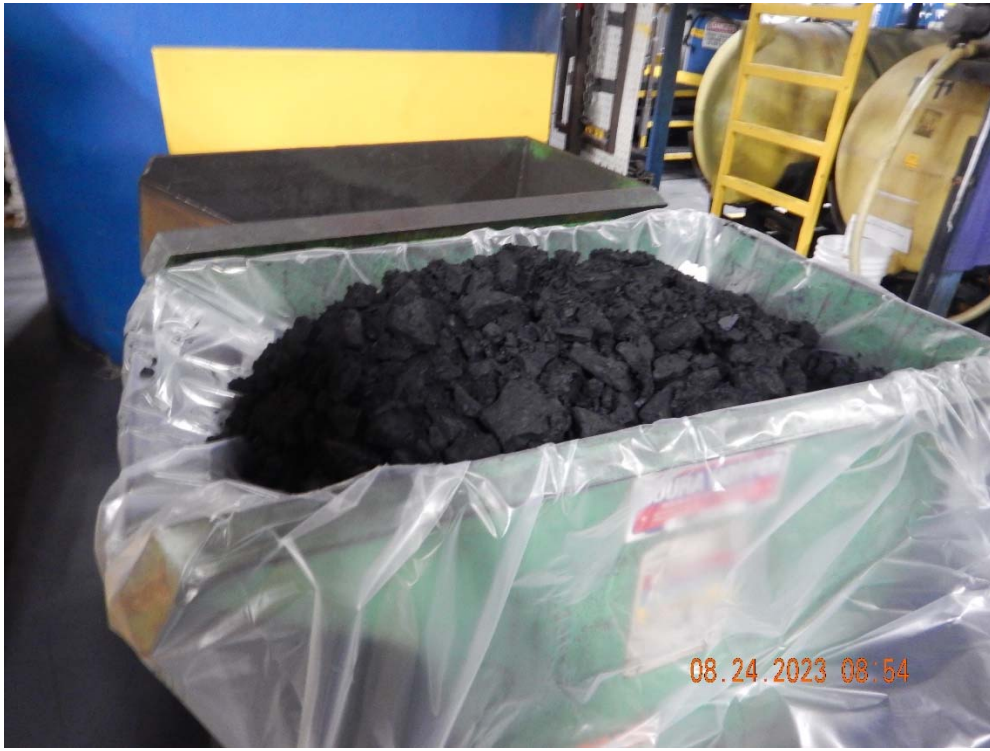
Location:	Danfoss Power Solutions II		
Photographer:	Jason Bolenbaugh	Date:	8/24/2023
Time:	08:54	Witness:	
Photo #:	17	Description: DSCN6335: Filter cake (non-hazardous waste) from the large filter press.

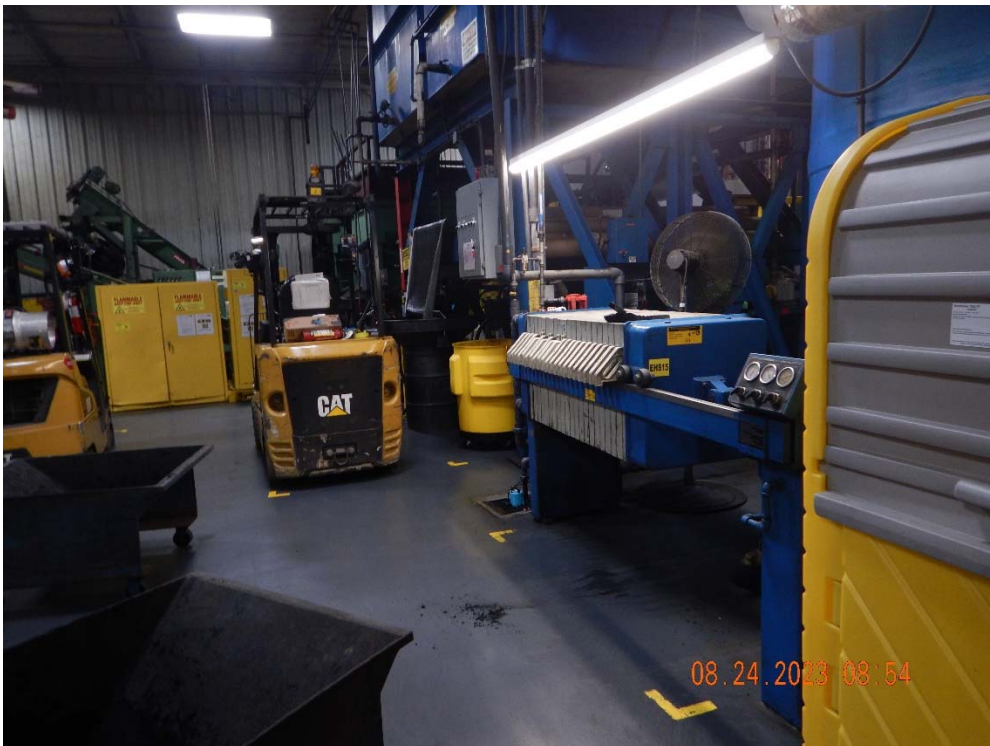
Photographer:	Jason Bolenbaugh	Date:	8/24/2023
Time:	08:54	Witness:	
Photo #:	18	Description: DSCN6336: Largest filter press that was currently being cleaned.

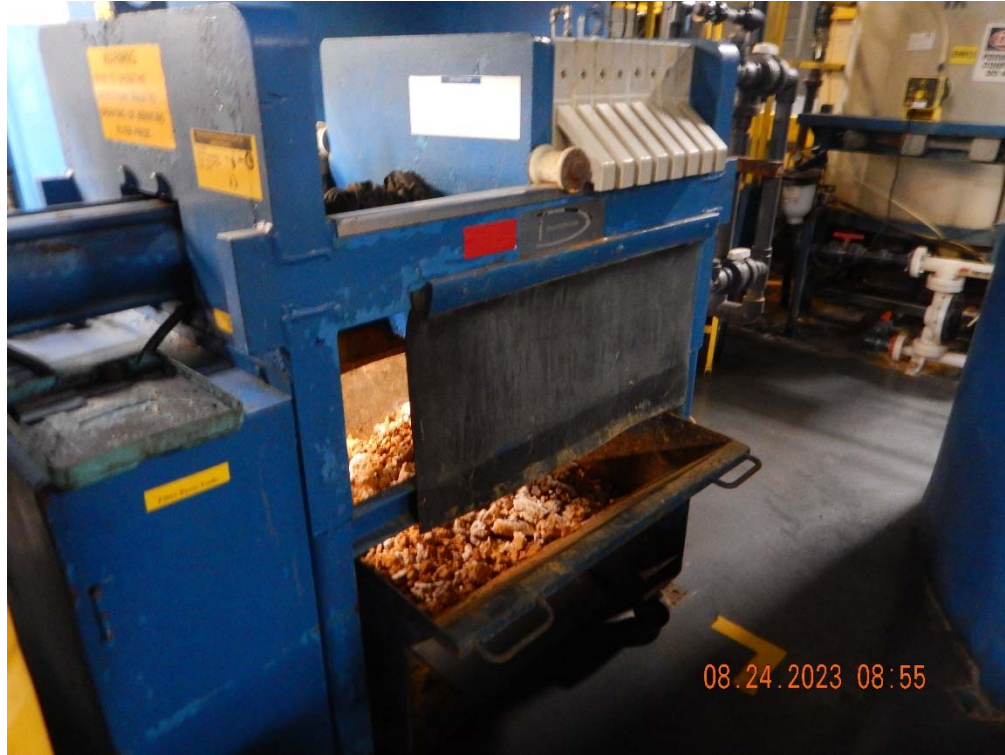
Location:	Danfoss Power Solutions II				
Photographer:	Jason Bolenbaugh	Date:	8/24/2023	Time:	08:55
Witness:				Photo #:	19
Description:	DSCN06337: One of the filter presses with filter cake (non-hazardous waste).

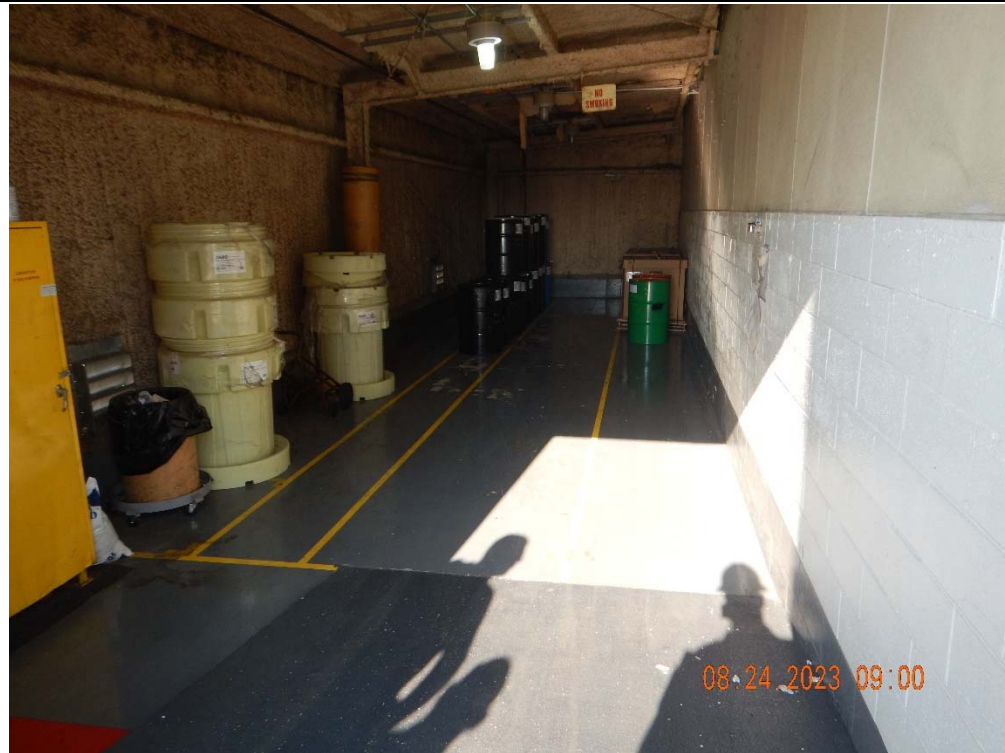
Photographer:	Jason Bolenbaugh	Date:	8/24/2023	Time:	09:00
Witness:				Photo #:	20
Description:	DSCN6338: Hazardous waste storage area within secondary containment.

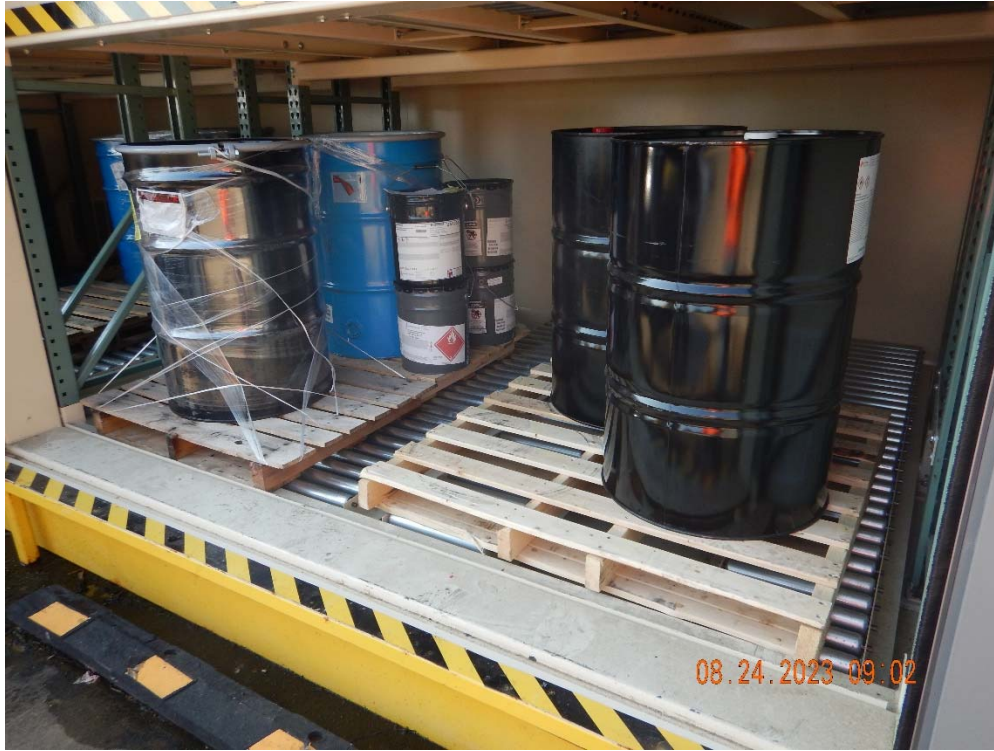
Location:	Danfoss Power Solutions II		
Photographer:	Jason Bolenbaugh	Date:	8/24/2023
Time:	09:02	Photo #:	21
Witness:			
Description:	DSCN6339: Outdoor, enclosed chemical storage area within secondary containment.

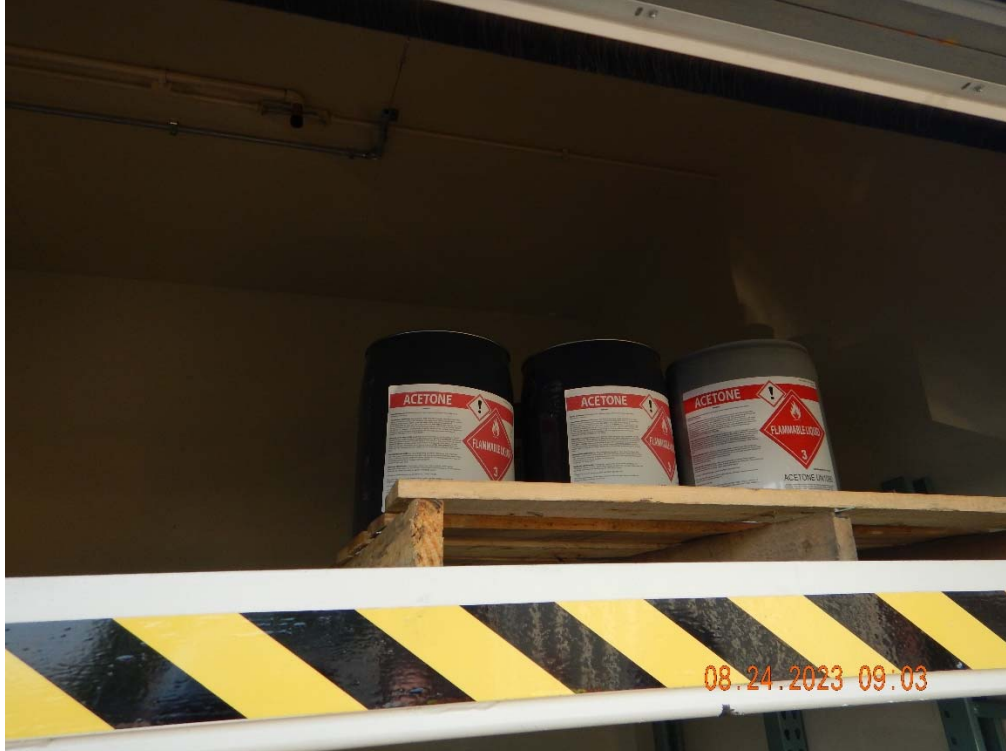
Photographer:	Jason Bolenbaugh	Date:	8/24/2023
Time:	09:03	Photo #:	22
Witness:			
Description:	DSCN6340: Outdoor, enclosed chemical storage area within secondary containment.
