CORRECTIVE ACTION PLAN

NPDES PERMIT NO. AR0021768, AFIN 58-00105

CAO LIS No. 22-088

Pollution Control Works

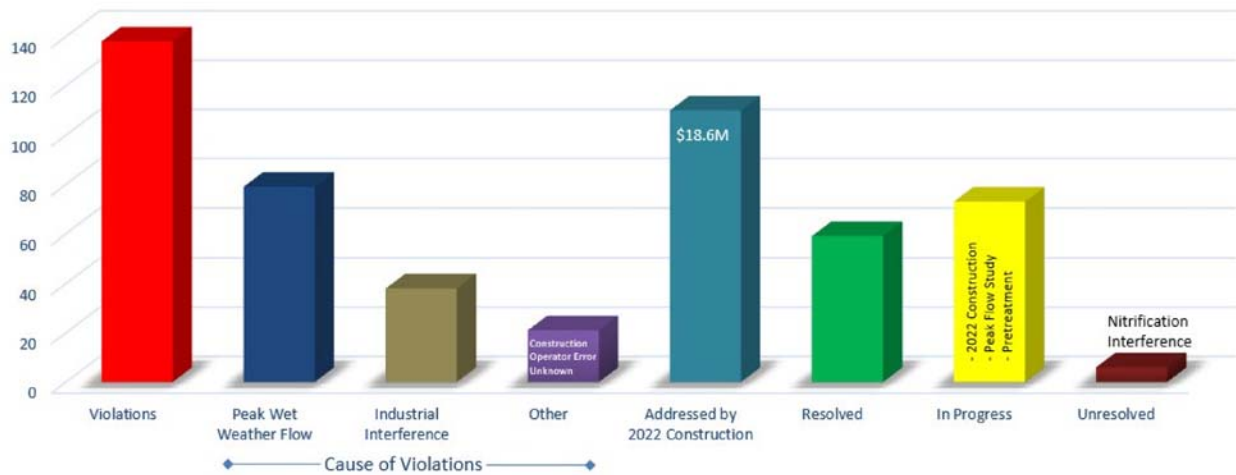
Figure 2.1: NPDES Permit Violation Summary

During the 37-month period between January 2019 and February 2022, RCC reported effluent violations on twenty-three discharge monitoring reports (DMRs). The one hundred thirty-eight permit violations resulted primarily from peak wet weather flows, industrial batch loading, and operational limitations caused by plant construction projects. Figure 2.1 below illustrates the causes of the permit violations as well as the corrective measures taken by RCC.
