**WASTEWATER COLLECTION SYSTEM – SSES PHASE 2
(BASINS RV07, RV14 & RV23)**

FINAL REPORT

**CITY OF
RUSSELLVILLE, ARKANSAS**

NOVEMBER 2011

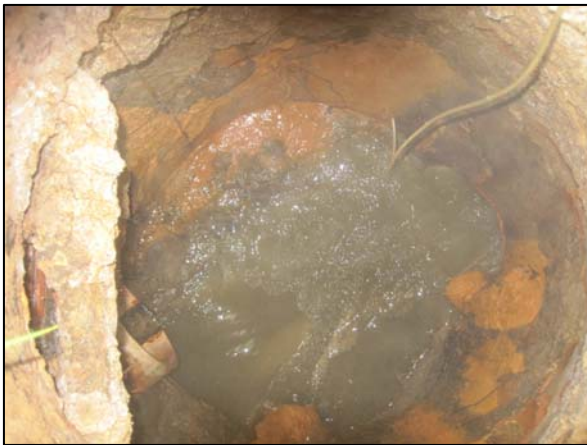
*Deteriorated Manhole
(RV07)1001*

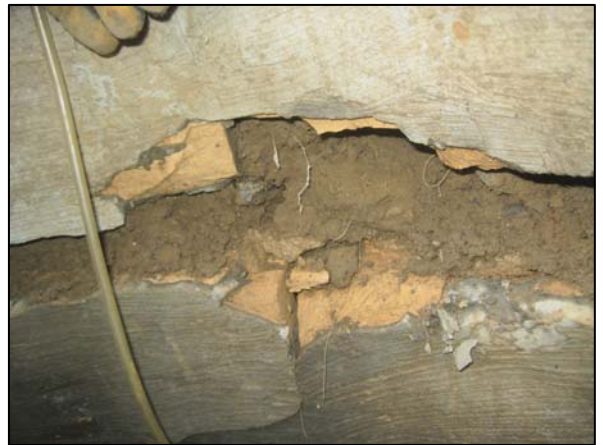
*Broken Corbel
(RV07)1829*

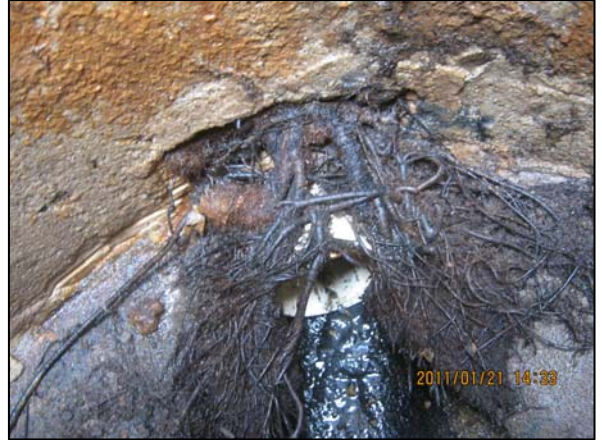
Inspections indicated defective pipe seals to be prime sources of infiltration. A total of 24 manholes with defective pipe seals contributing approximately 0.024 mgd of infiltration have been found. The picture to the right is a manhole with a cracked pipe seal.

*Cracked Pipe Seal with Roots
(RV14)2846*

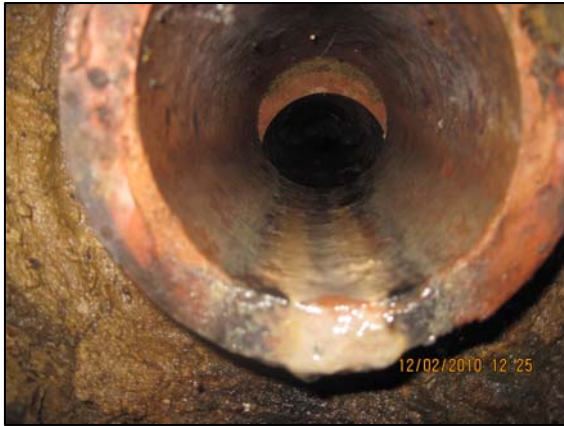
*Offset Joint
(RV07)6141*

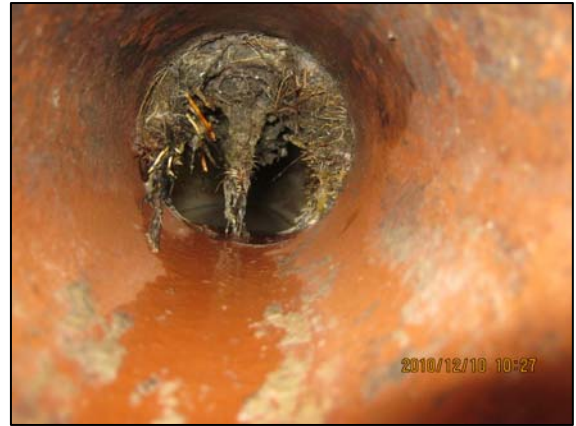
*Roots at Joint
(RV07)6106*

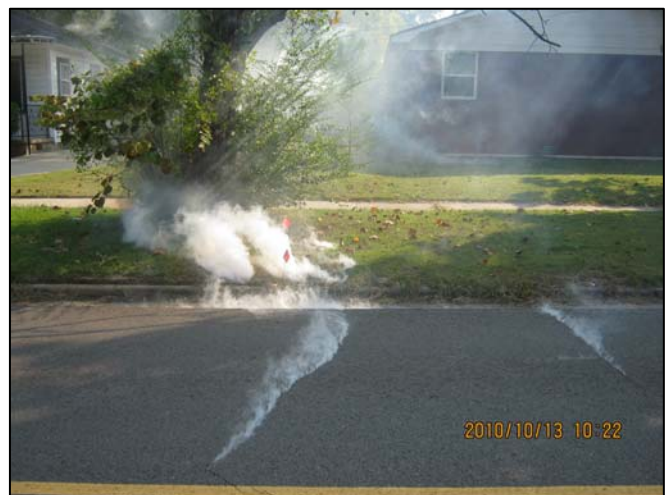
Inflow source identified during smoke testing

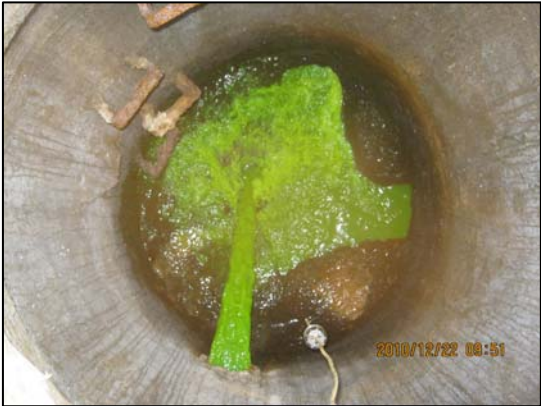
*Positive Dye Test
(RV14)1046*

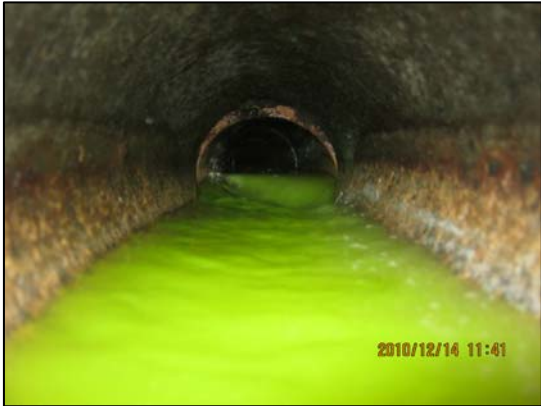
*Positive Dye Test
(RV23)1482*

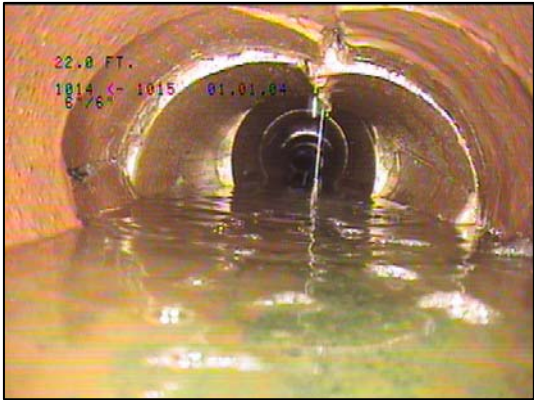
Broken Pipe
(RV14)1015-1014

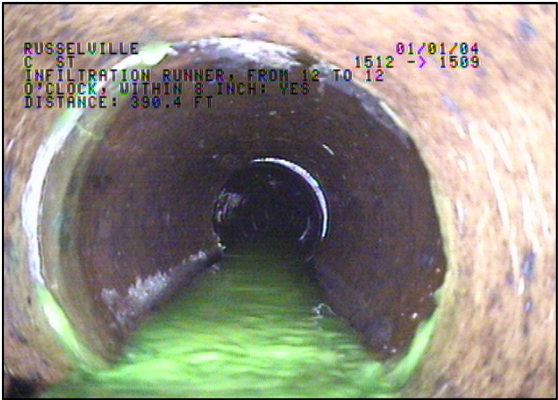
Separated Joint with Infiltration
(RV23)1512-1509
