**Re: City Corporation-CAO**  
**Final Report SSES Phase II (Basins RV13, RV16, RV26)**  
**NPDES Permit No. AR0021768**  
**CAO LIS No. 09-146**  
**AFIN 58-00105**

Russellville City Corporation  
Wastewater Collection System

SSES Phase 2 2015-2016

(Basins RV13, RV16, & RV26)

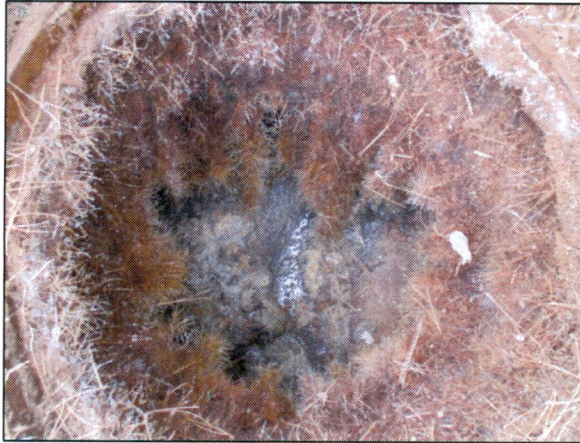
*Manhole with Severe Roots  
(RV26)8632*

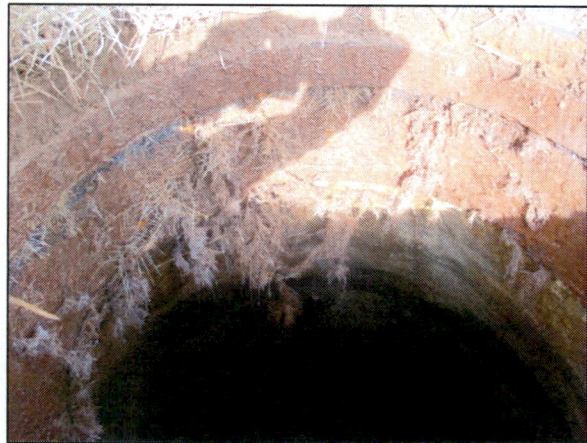
*Defective Frame Seal  
(RV16)1420*

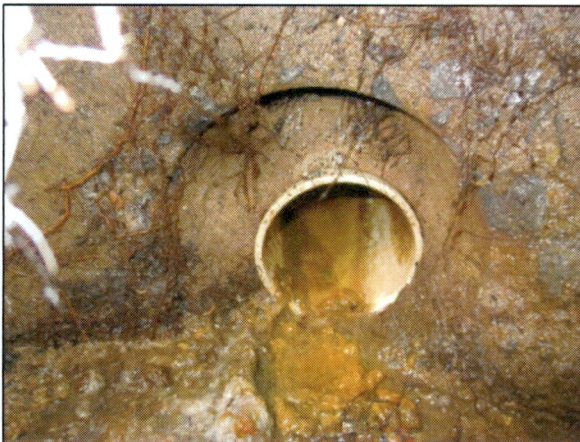
*Defective Pipe Seal  
(RV26)8640*

Inspections indicated defective pipe seals to be prime sources of infiltration. A total of 119 manholes with defective pipe seals contributing approximately 0.319 mgd of inflow and infiltration were discovered. The pictures above depicts defective pipe seals.

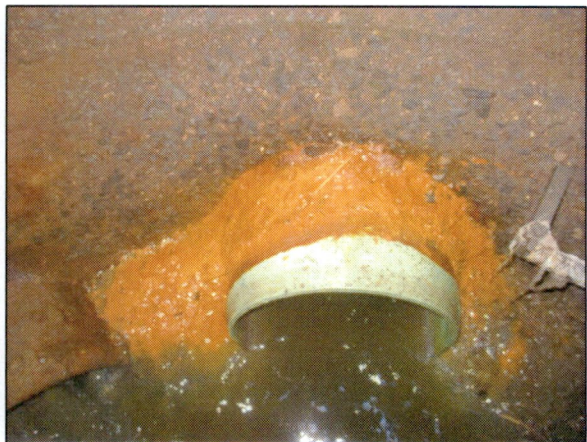
*Defective Pipe Seal  
(RV26)8001*

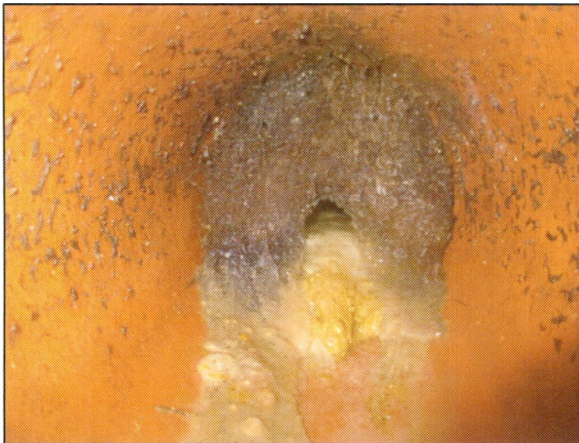
*Roots  
(RV13)1835-N In*

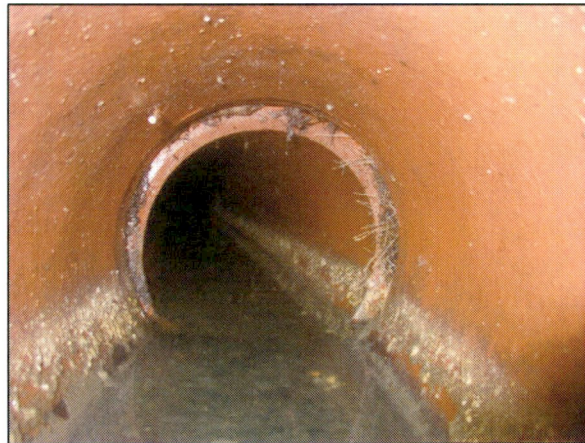
*Offset and Roots  
(RV13)4076-N In*

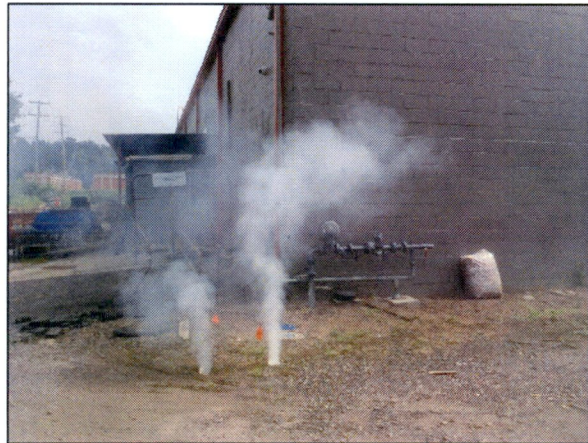
*Missing and Defective Cleanout  
Line Segment  
(RV26) 8013-8012*

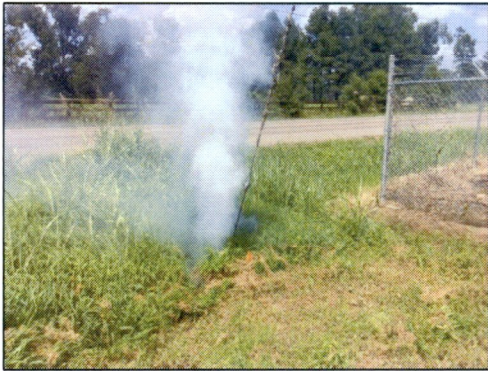
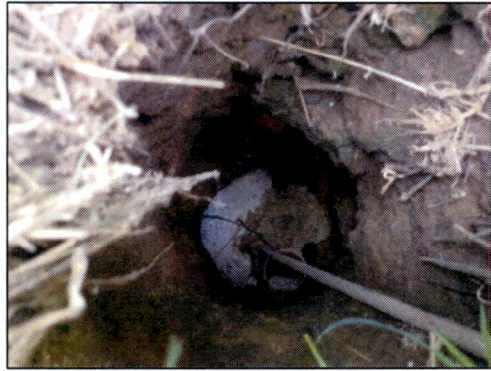
During smoke testing, a mainline defect was observed from a guy wire puncturing the sewer main between 8043-8044. RJN informed City Corp of the severity of the defect, and it was addressed by City Corp. Therefore, this defect was not subjected to dyed water confirmation. The defect was quantified during analysis to reflect the attributed flow during the flow monitoring period. A summary can be found in the Appendix C.

*Mainline Defect  
(RV26)8043-8044*

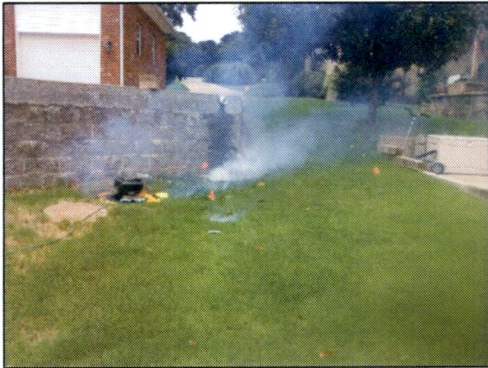
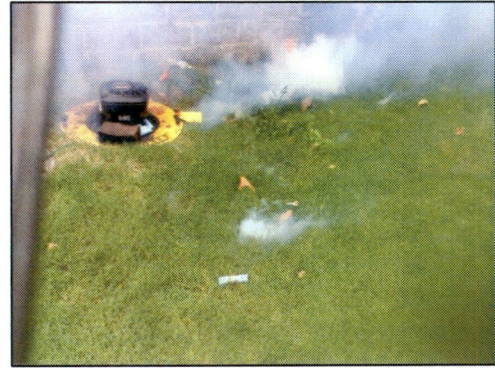
Line segment 8036-8032 was subjected to dyed water testing at the locations where smoke was observed during smoke testing, displayed in the pictures below. Dyed water was introduced at these locations and no dye was observed at the manhole. Further service inspection is recommended for this segment due to the likelihood of a service connection defect from manhole 8032.

*Smoke Testing Defect  
(RV26)8036-8032*

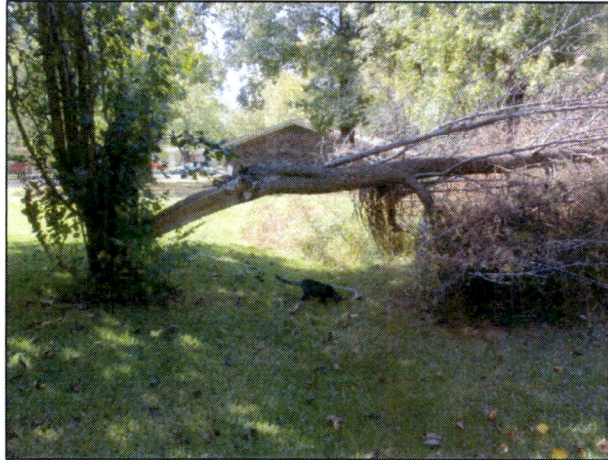
*Dye Testing - Area  
(RV13)4075-4073*

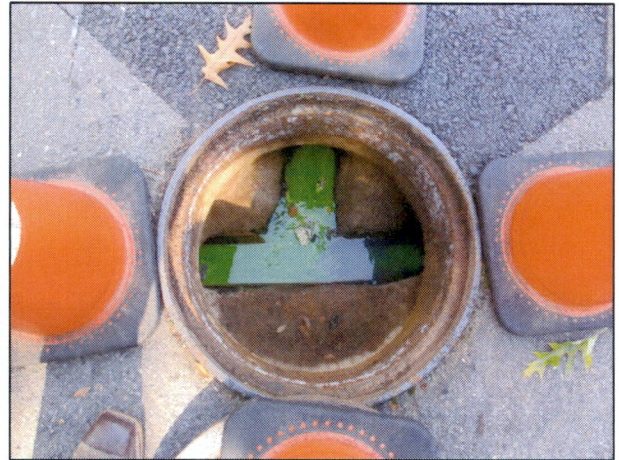
*Dye Testing – Topside - Positive  
(RV13)4075-4073*

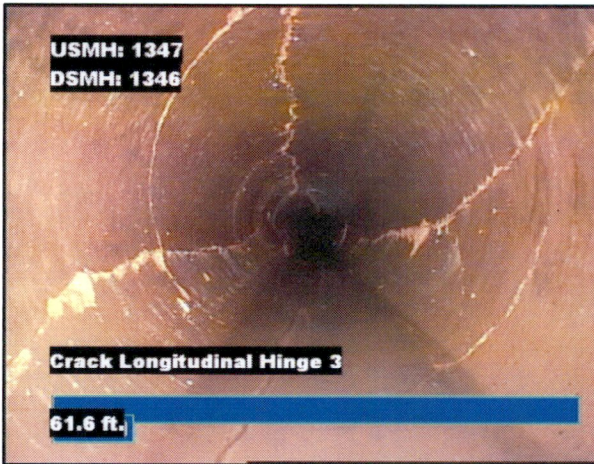
*Hinge Cracks  
Line Segment 1347-1346*

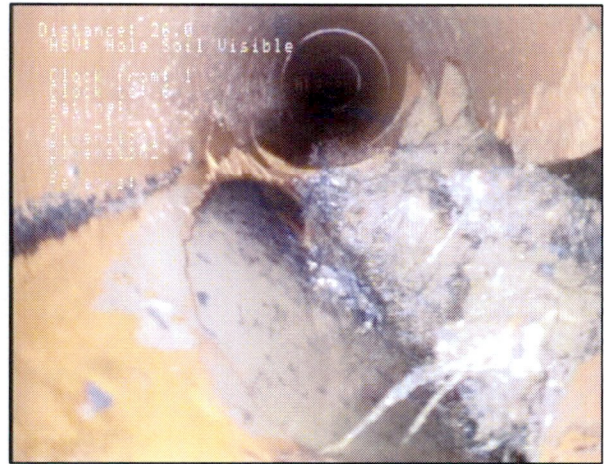
*Hole with Soil Visible  
Line Segment 1004-1004A*

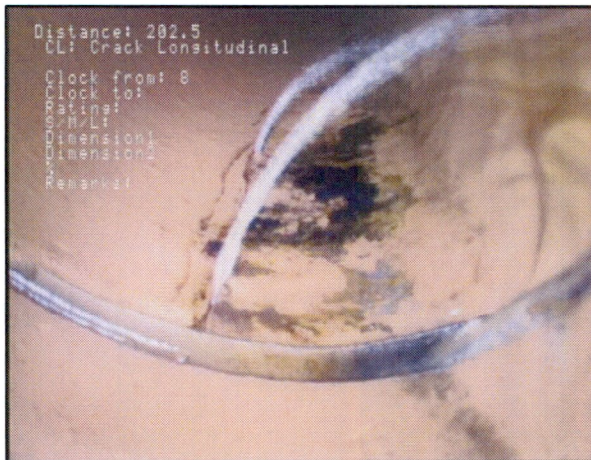
*Active Infiltration  
Line Segment 1419-1417*

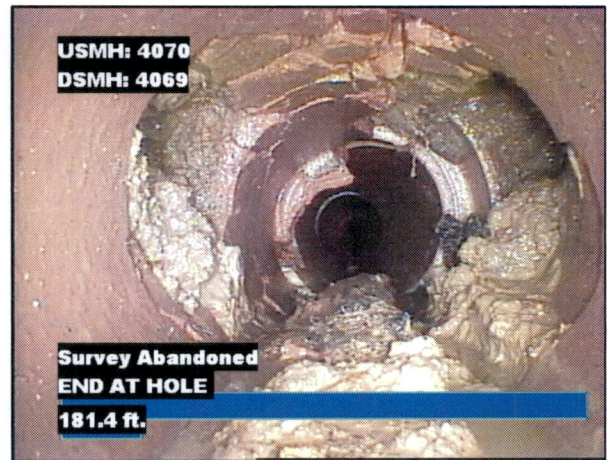
*Hole with Void Visible  
Line Segment 4070-4069*
