**City of Helena-West Helena (AR0043389 & AR0022021)
Quarterly Progress Reports
July 2023 – September 2023**

Report Date : Oct 06, 2023
Current CAO Completion Date : TBD (Applied for extension on May 22, 2023)

**System Assessment Report
Existing Operational Condition
Helena-West Helena
(2017)**

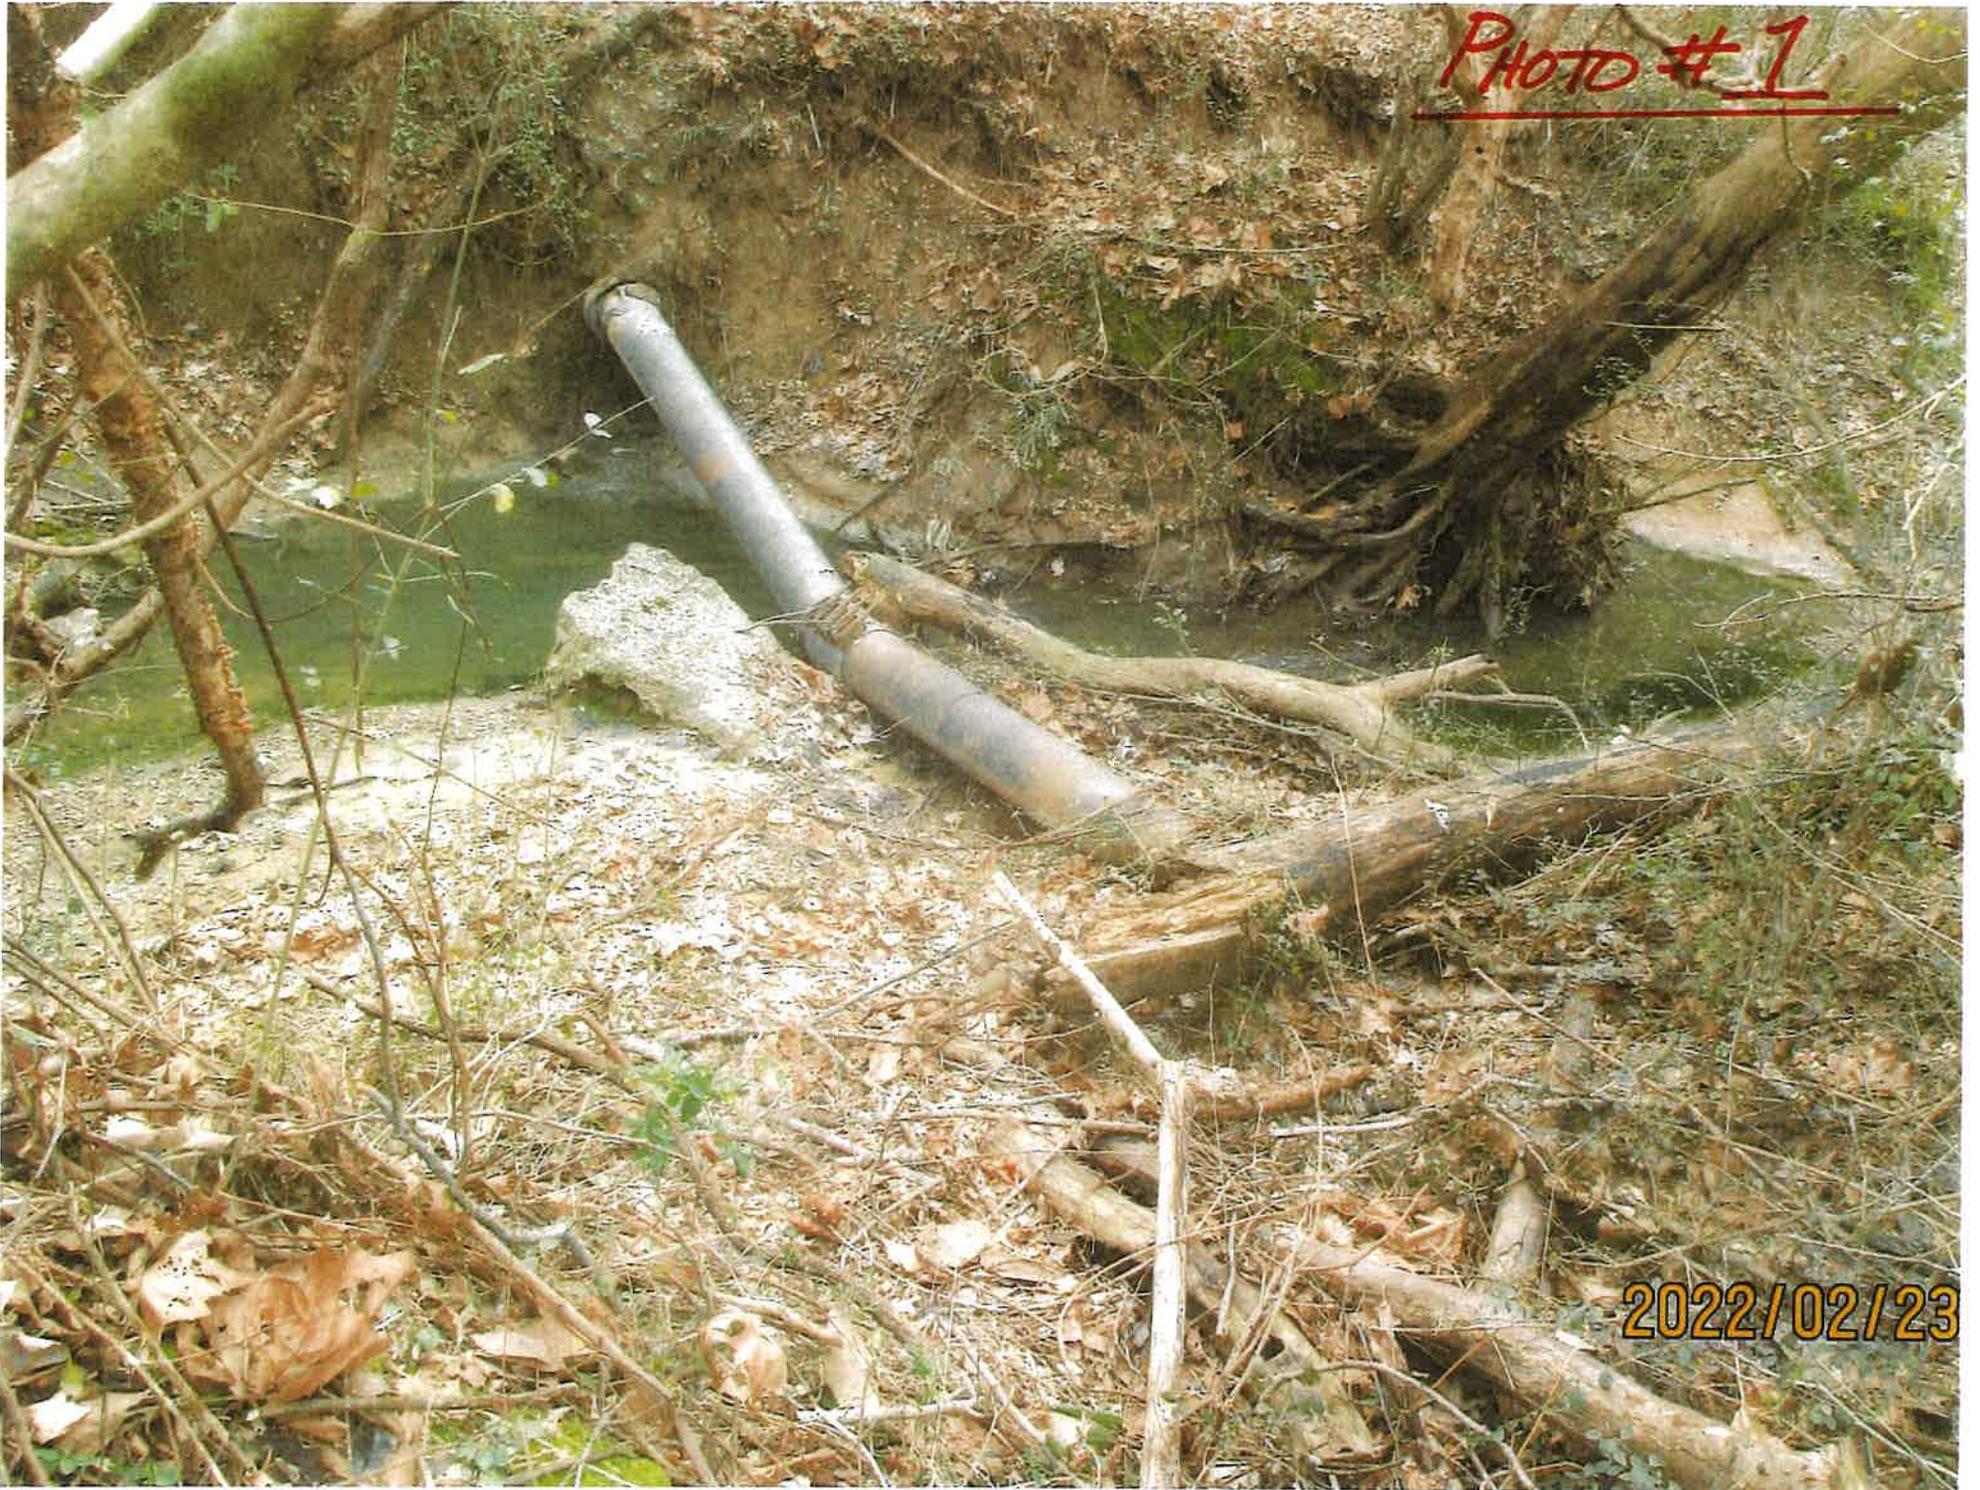
PHOTO # 1

1. Actions taken from 1200 Thursday, 24 February 2022 to 1600, 01 March 2022
 - 1) Engineer and staff made a field reconnaissance of the broken sewer line and began reviewing available plans of the line and adjoining manholes in order to make a rational plan to make the repair necessary to halt the sewer overflow. (Photo #1)

- 3) After the field reconnaissance and plan review, engineer developed a plan of how the existing broken line could be reconnected in a manner that would stop leakage using mechanical joints that would hold the line together and using ready mix bags to construct a temporary support pillar to lift the line back into alignment. The plan was discussed with water department staff to coordinate acquisition of the materials.

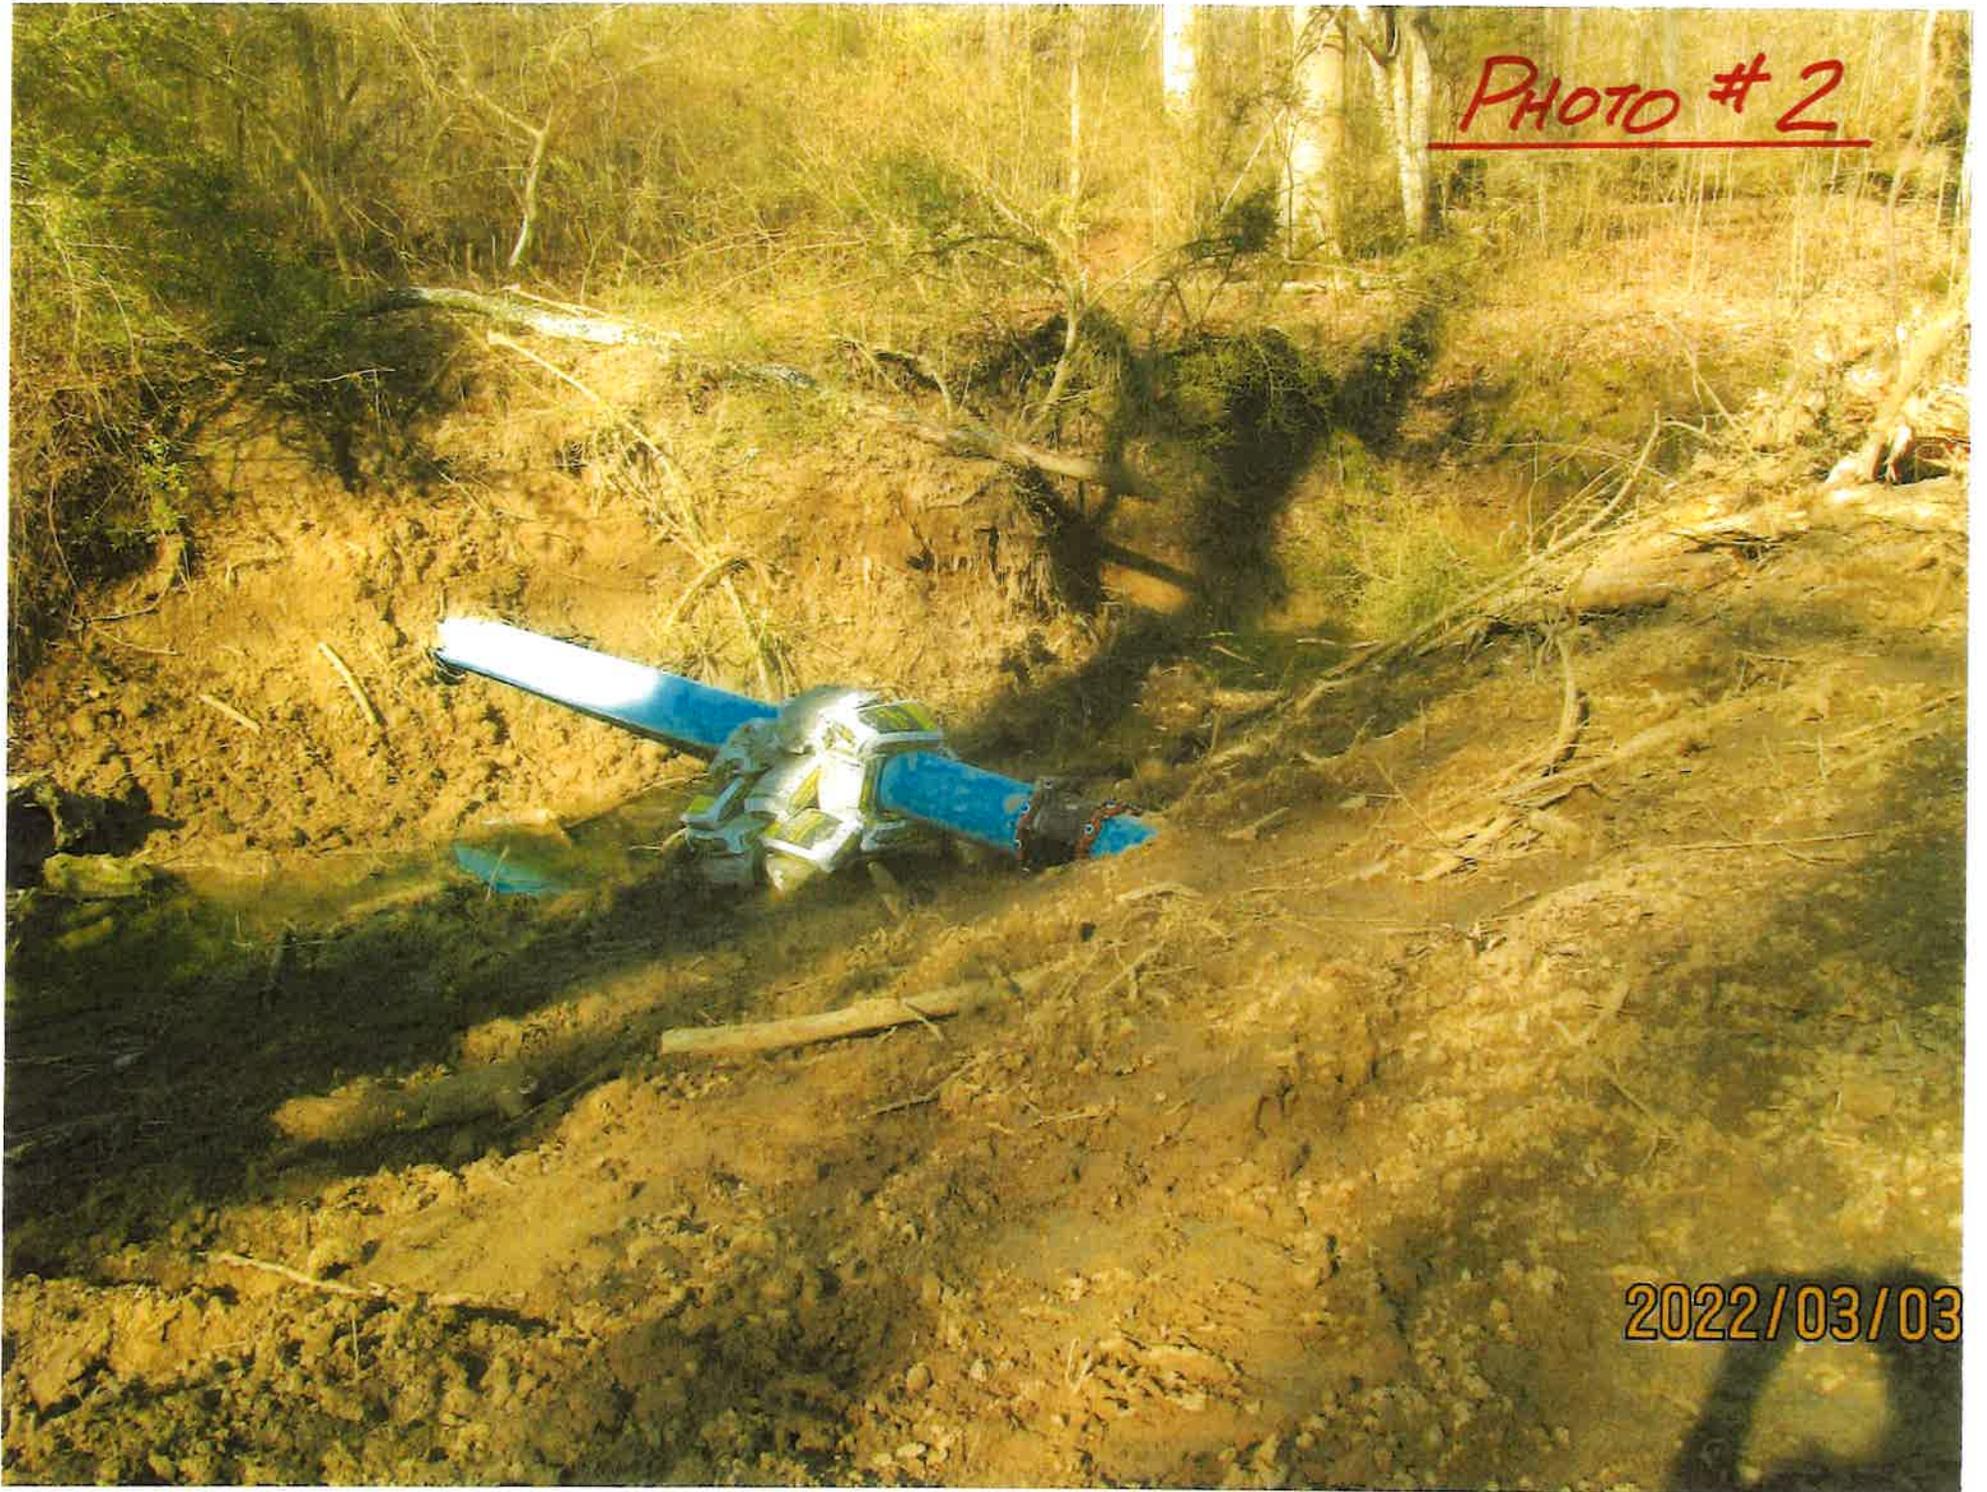
PHOTO # 2

- 5) All repairs and clearing of the blocked line were completed as of 1600, Tuesday, 01 March 2022. The engineer and the utility contractor demobilized from the site. (Photo #2)

- 2) The "temporary" repair was made in such a manner that the repair may serve more than just a short-term leak stoppage. The weak joint that was over the middle of the ditch was shifted closer to the support of the embankment which strengthens the section spanning the stream bed. There is no data as to how high nor at what velocity water moves down the stream during major rainfall events. There is no data on how much debris or the nature of the debris that moves down the stream. It is recommended that city personnel make onsite inspections of the stream during the next heavy rainfall events to determine if significant

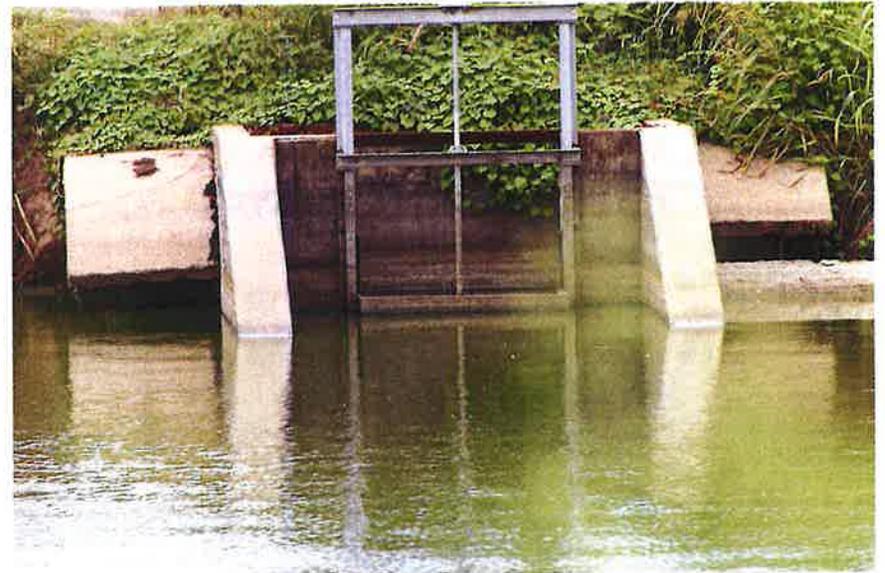
Helena WWTP Cell 1, South Side Wall

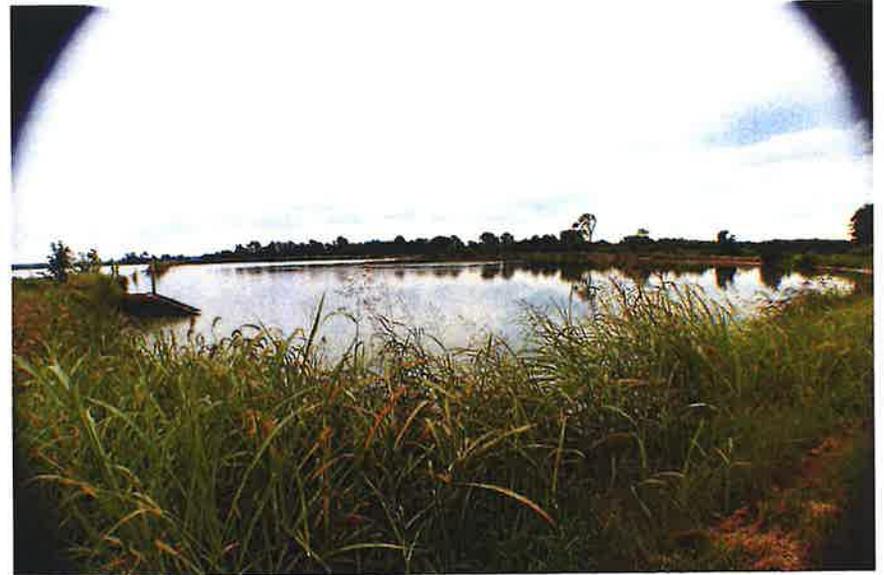
HWWTP Cell 2 & 3 Levee Wall Collapse

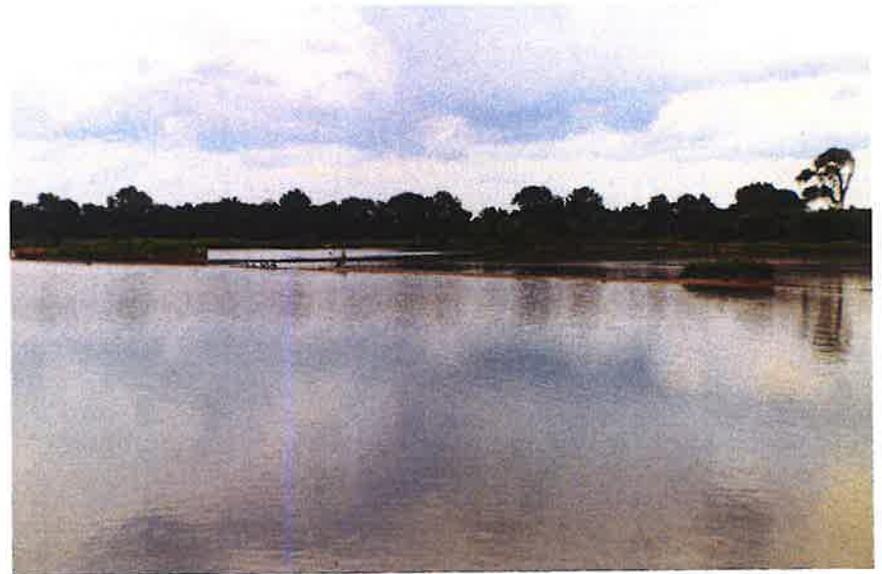
Helena WWTP Cell 2 & 3 Complete Levee Wall Collapse between Cells

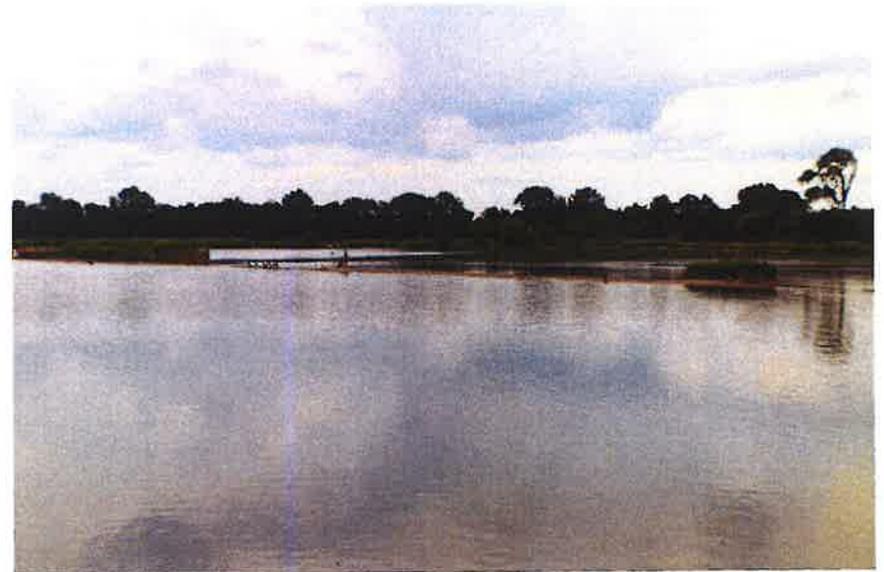
Helena WWTP Cell 2 & 3 Complete Levee Wall Collapse between Cells

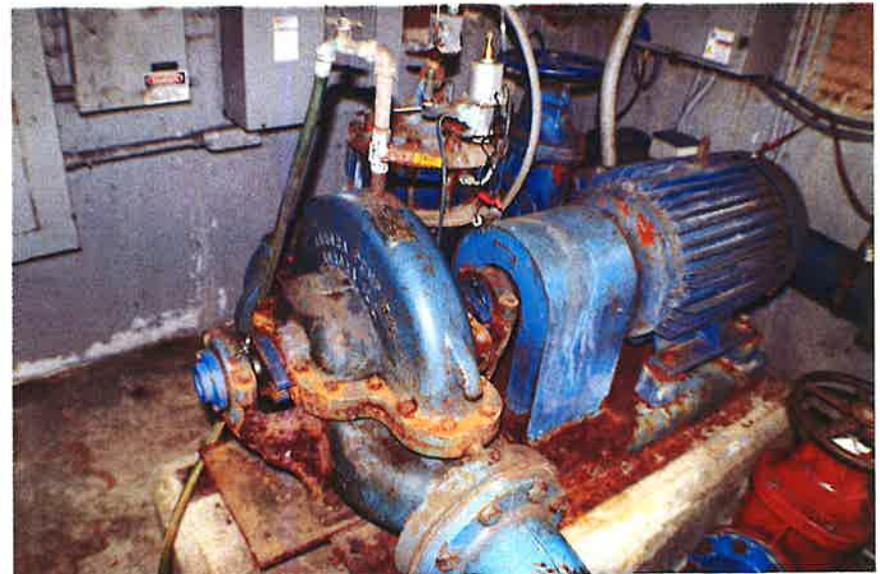
Helendale Booster Station Pumps Complete Rebuilds with new Seals, Bearings, Impellers

- O. Both pumps failed at the Helendale booster station and we had to rebuild the #1 pump due to leaking seals. The coil on the #2 pump failed and we had it replaced. Fred Garrison Co. helped wire the pumps because the RTU is inoperative.

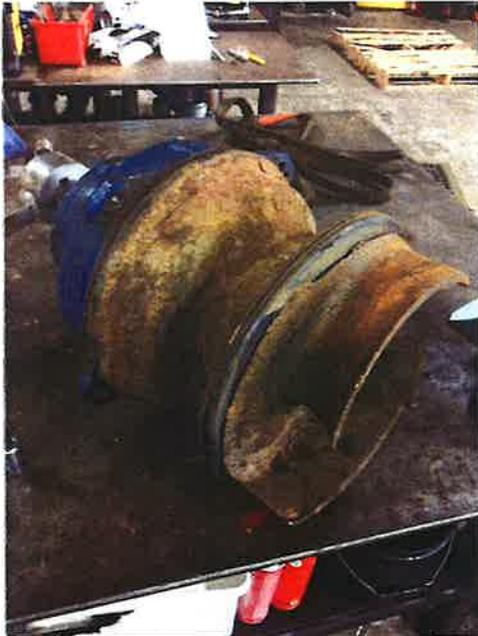
Rotating assembly pulled from Pump #1 station #5. The impeller is very bad worn condition. The bearing cavity oil was in extremely poor condition. The mechanical seal cavity oil had a large amount of water mixed in with the oil.

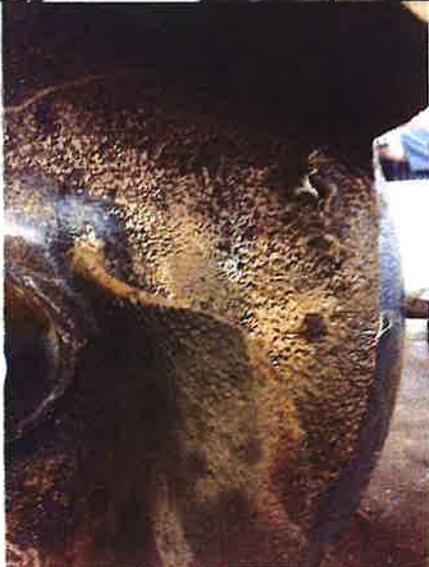
Holes in the impeller.

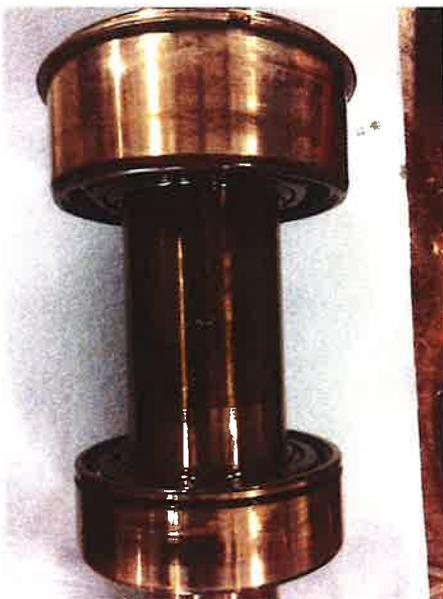
Bearings show damage from spinning inside the housing from lack of proper Lubrication and excessive heat build up.

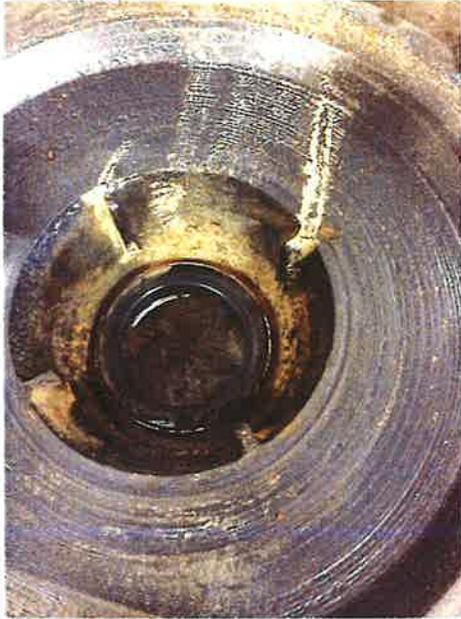
Seal plate is ok. The mechanical seal is bad.

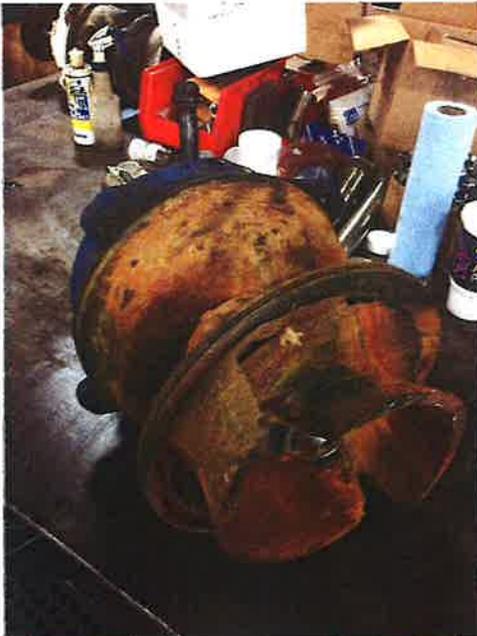
Rotating assembly pulled from pump #2 station #5. The impeller is in very bad worn condition. The bearing cavity oil was in very poor condition. The mechanical seals are leaking, water in the seal cavity oil.

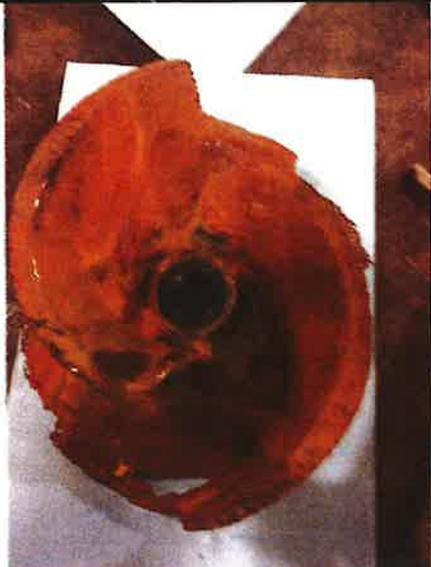
Worn out and holes in the impeller.

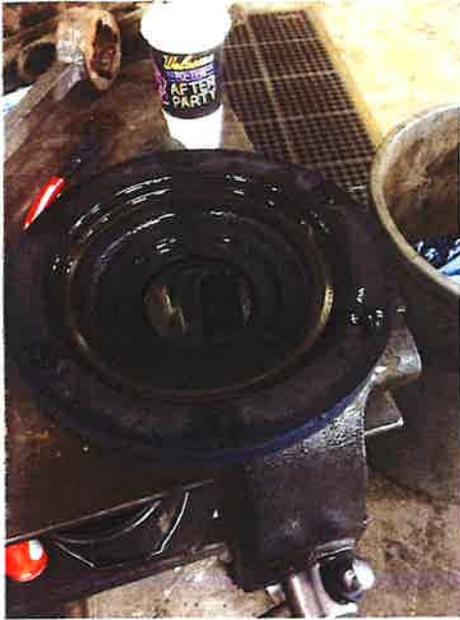
Oil in poor condition, metal particles in the oil.

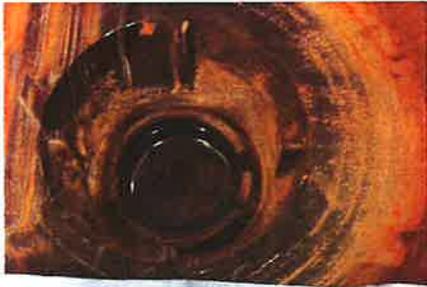
Mechanical seal plate is ok, the mechanical seal is bad.
