Plastic  
Failure  
LABS

January 17, 2017

## Failure Analysis of 14" JM Eagle PVC C-905 Buried Force Main Pipe

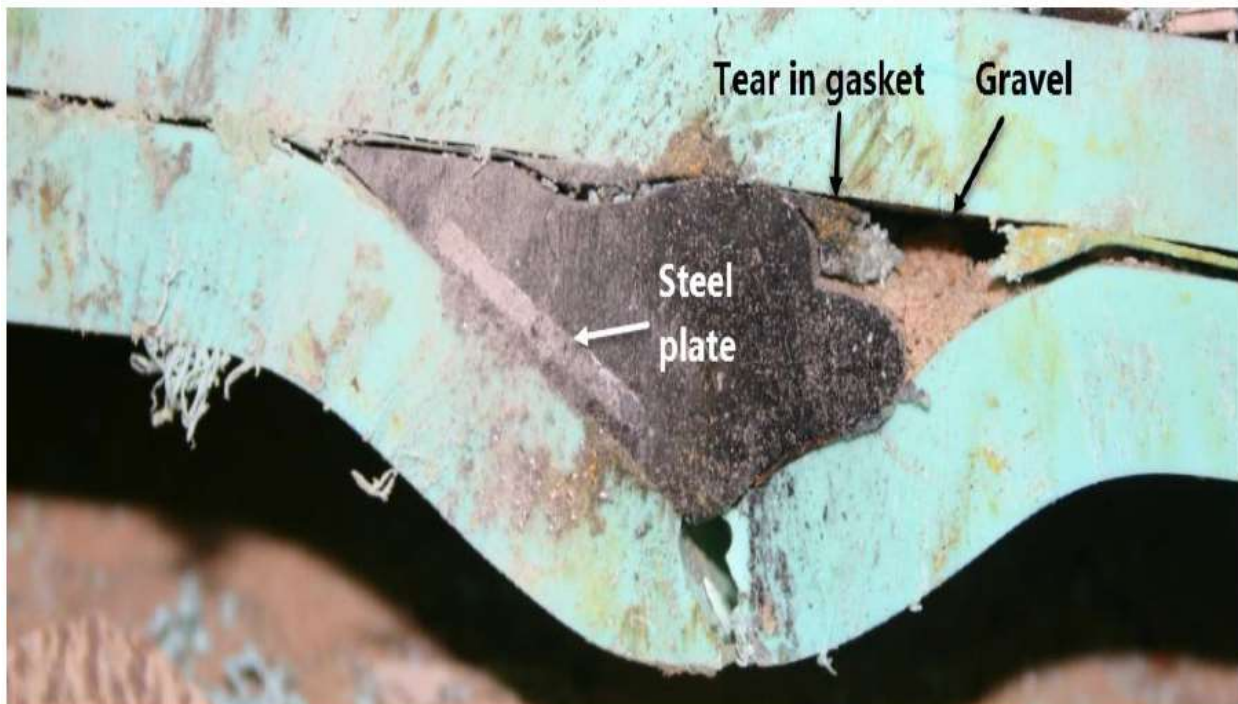
- 1) The spigot of the pipe was dirty and coated with dirt/gravel (Figure 1).
- 2) As the dirty spigot was inserted into the bell, the gravel coating on the spigot likely wedged underneath and likely tore the gasket causing poor sealing (Figure 2).
- 3) A slow leak through the gasket increased in rate over time eventually reaching a velocity fast enough to cause erosion of the pipe (Figures 3 and 4).
- 4) The flow of leaking water eroded away the supporting earth underneath the bell allowing the bell to sag.
- 5) The bending moment on the sagging pipe joint caused the bell to fracture at its weakest point (Figure 5).
- 6) The weakest point in the bell is in the gasket trough where the material is the thinnest. Also, the change in direction at the gasket trough acted to concentrate stresses.
- 7) Once the bell fractured, the leak went from slow to catastrophic.

**Figure 2.** Cross-sectional view of the gasket reveals the torn gasket and gravel inside the seal/trough.

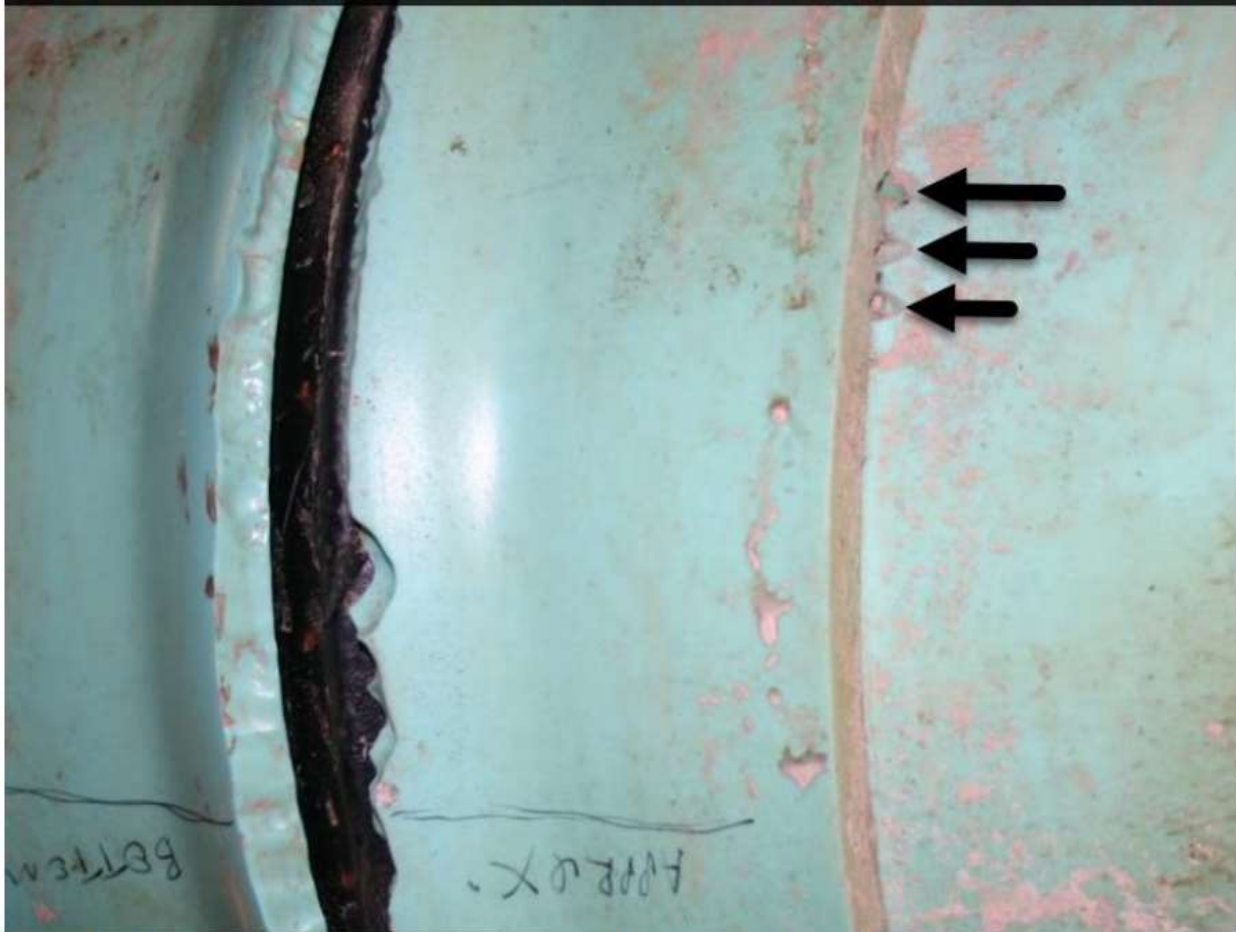
Figure 3. Black arrows indicate erosion caused by the exit of water from the joint before the circumferential crack formed in the gasket trough.

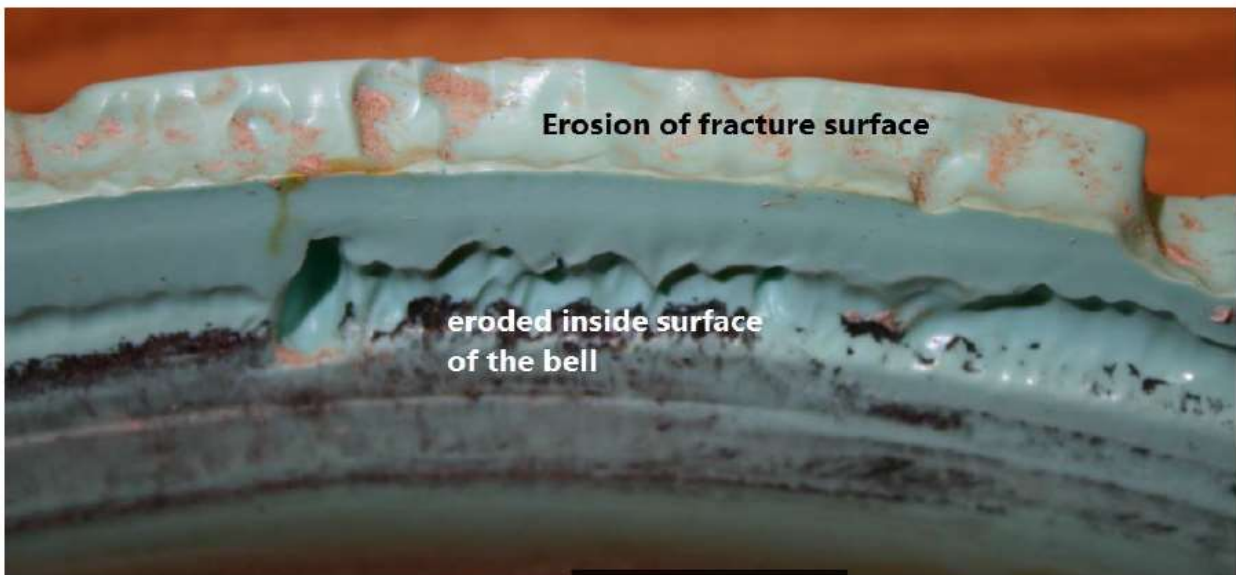
Figure 4. Erosion of the inside of the bell and the fracture surface by the water leaking passed the gasket.

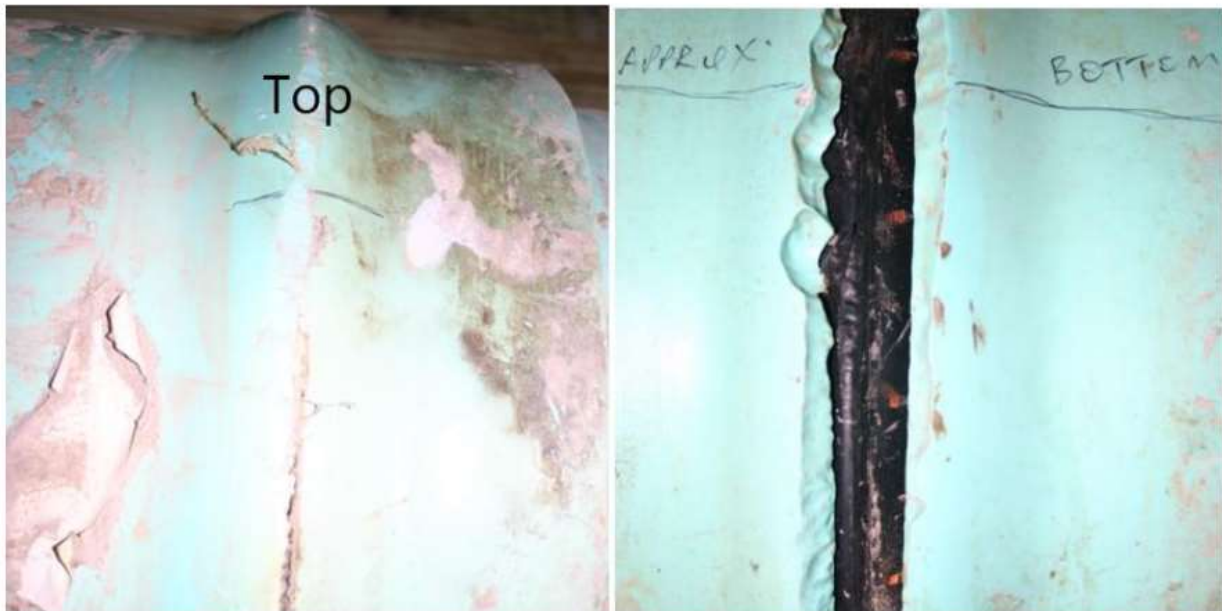
The pipe sample was about 10 feet in length and contained a circumferential crack about 90% around its circumference in the seal trough in the bell (Figure 5). Reportedly there have been seven failures in the pipeline and all of the failures have been similar.

**Figure 5.** Photographs showing the top and bottom locations of the fracture in the bell of the pipe as received. Notice the extensive erosion of the fracture surface in the photo on the right. The erosion was caused by the rapid flow of water through the crack over an extended period of time. The gasket/seal is visible through the crack on the photograph on the right.

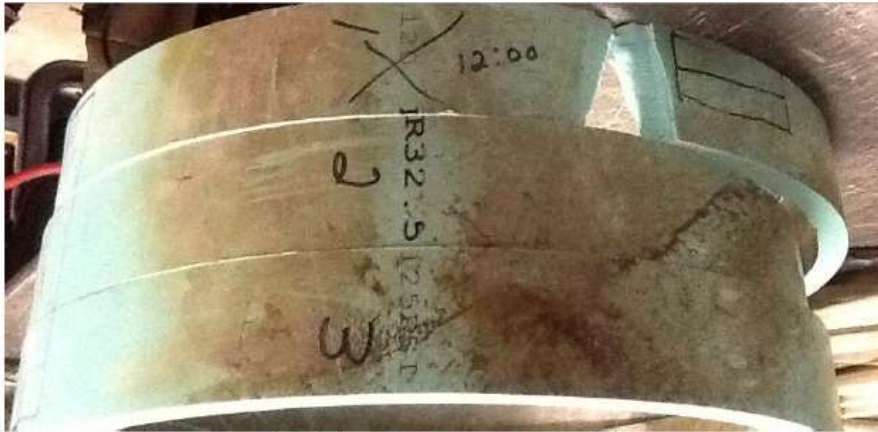
Three test rings were machined from the pipe near the bell. Two test rings passed the test demonstrating high ductility. However, one ring fractured during the test (Figure 6). Figure 7 shows the flattening test being run on a test ring of PVC pipe. Notice that the points of highest stress are on four locations in the ring. The test ring that fractured, broke where the top of the ring contacts the compression plate. Computer modeling reveals that the contact points of the ring with the parallel plates are the highest stress points and predicts that, if failure occurs, it would occur at these locations. Note that the test was only used for diagnostics purposes as the pipe is not required to pass the test once it has been installed. The main utility of the test is to

expose weak extrusion knitlines in the wall of the pipe. The results reveal that the pipe DID NOT have weak extrusion knitlines.

Figure 6. Photograph of the three test rings following completion of the ASTM D2412 compression test. One of the three rings (top) fractured with expulsion of a triangular shaped piece.

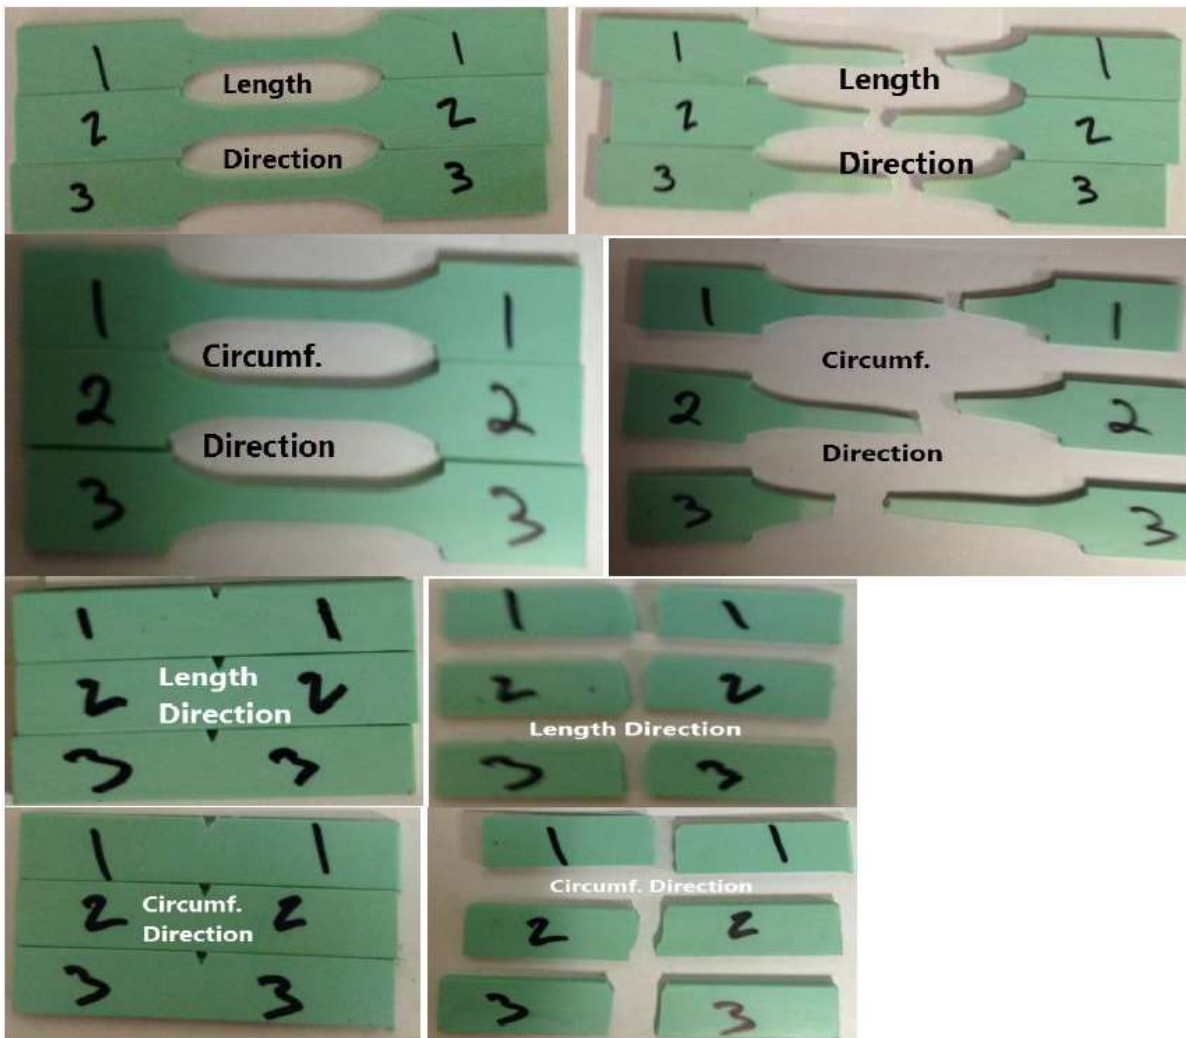
Figure 9. Photograph of the tensile and IZOD impact test bars before (left) and after (right) testing. Test results reveal that the pipe material is strong and exceeds minimum strength specifications.

AWWA C905 requires that the PVC pipe material meet the 12454 PVC cell classification. This PVC cell classification requires a tensile strength >7000 psi and an IZOD impact strength of >0.65. The test data (Table 1) indicate that the pipe material has well above the minimum strength properties. The %Elongation at break of the test samples in both directions was >50% revealing that the pipe material is highly ductile and will undergo significant deformation before it breaks.

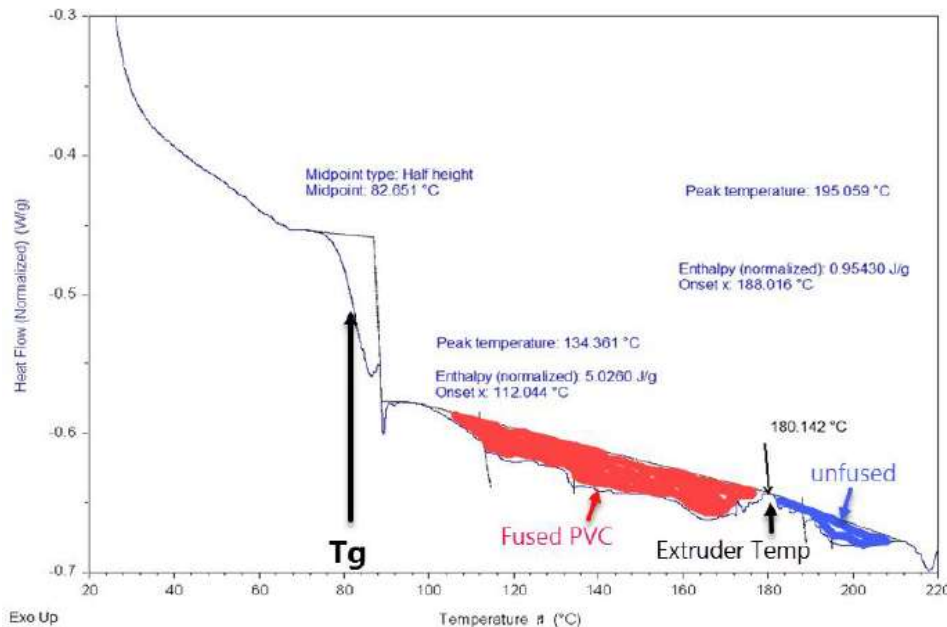
These four points of interest are seen in the DSC thermogram shown in Figure 12 which is a typical DSC thermogram for rigid PVC pipe. The ISO18373 data reveal that the extrusion temperature was 180 °C and the degree of fusion was 84%. As shown in Figure 11, the optimum balance of strength properties are achieved at a degree of fusion of between 45 and 70%. However, even though the degree of fusion is not optimal, the strength properties of the pipe are well above the minimum requirements for C905 pipe.

**Figure 12.** ISO18373 DSC thermogram for sample collected from the core of the pipe wall near failure point reveals pipe was extruded under proper conditions to achieve a high level of fusion (84%) at an extrusion temperature of 180 °C.
