PROJECT REPORT

REPORT NUMBER: GBM-120816-1-RP1

DATE: April 11, 2017

GBMc and Associates
219 Brown Lane
Bryant, AR 72022
Attn: Chuck Campbell

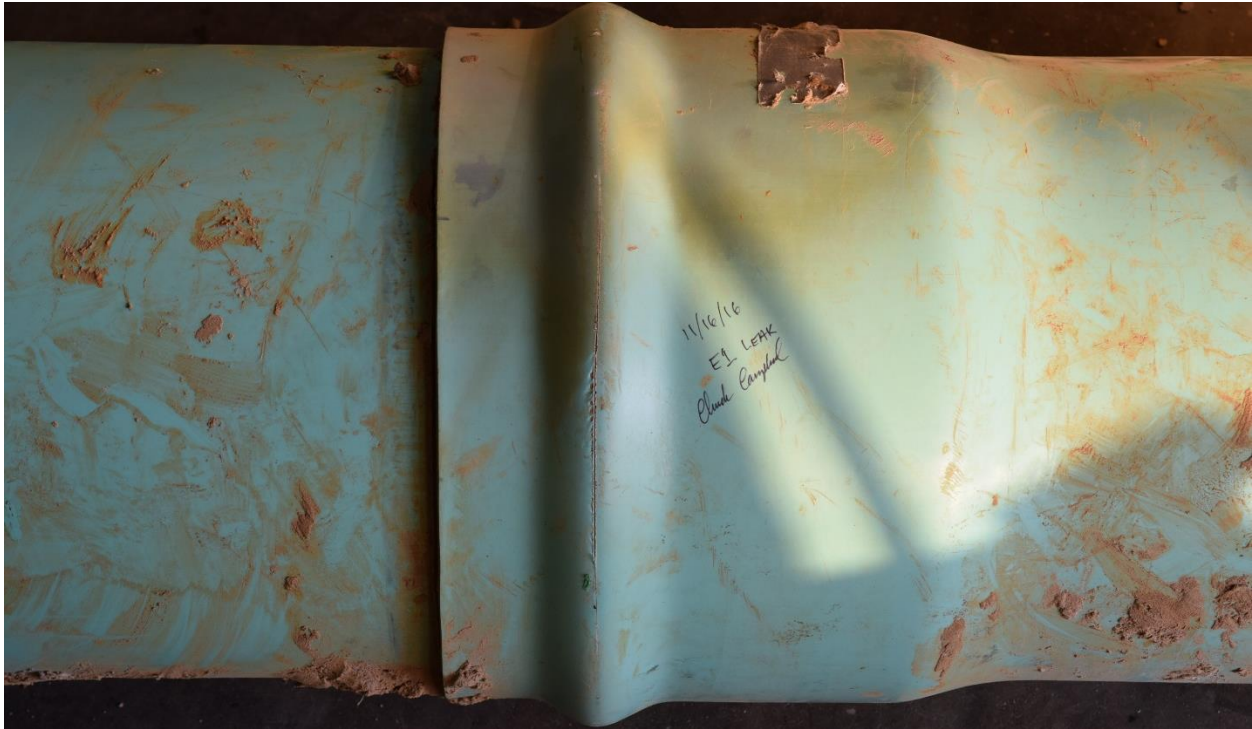
Figure 2. Digital image of Sample E1 with removal date of 11/16/16.

The samples display circumferential brittle fractures which are centered on the “crown” or peak of the gasket race.

The joints were also found to be slightly deflected with the maximum gap approximately opposite the center of the circumferential fracture length.

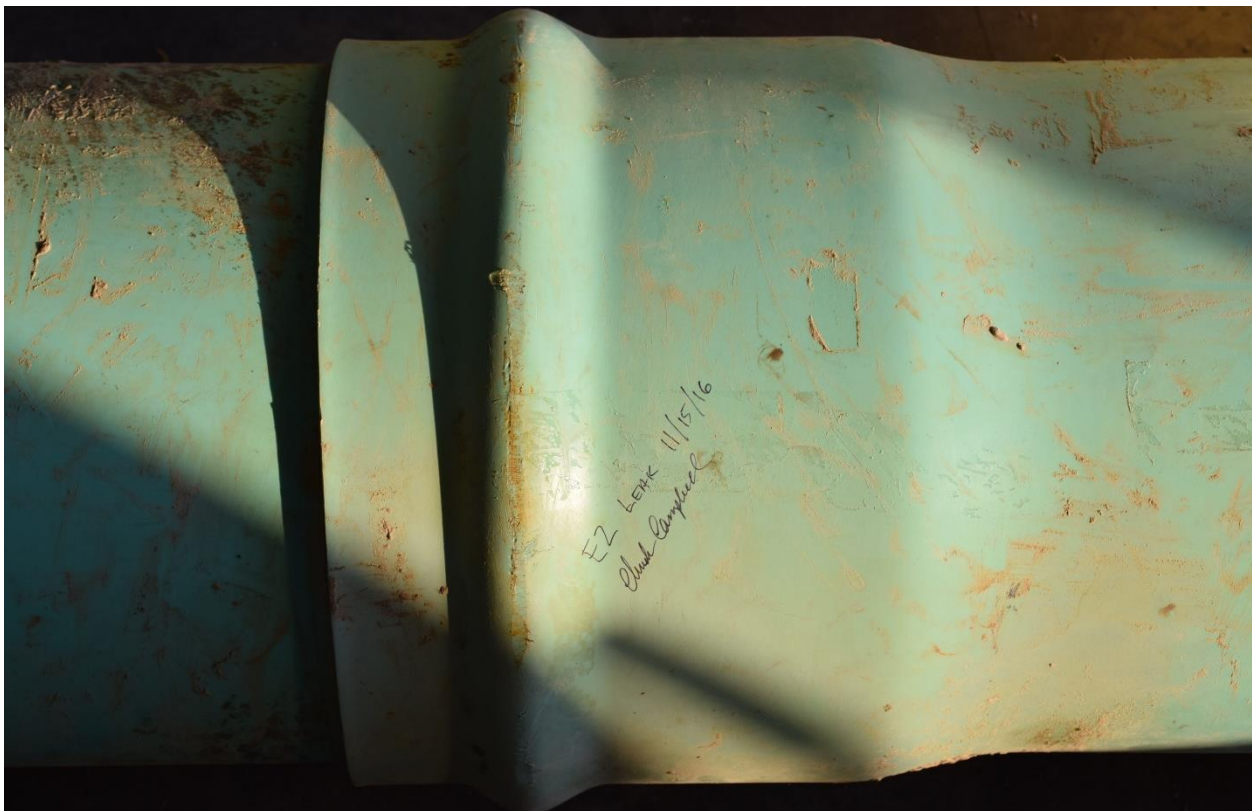
Figure 3. Digital image of Sample E2 with removal date of 11/15/16.

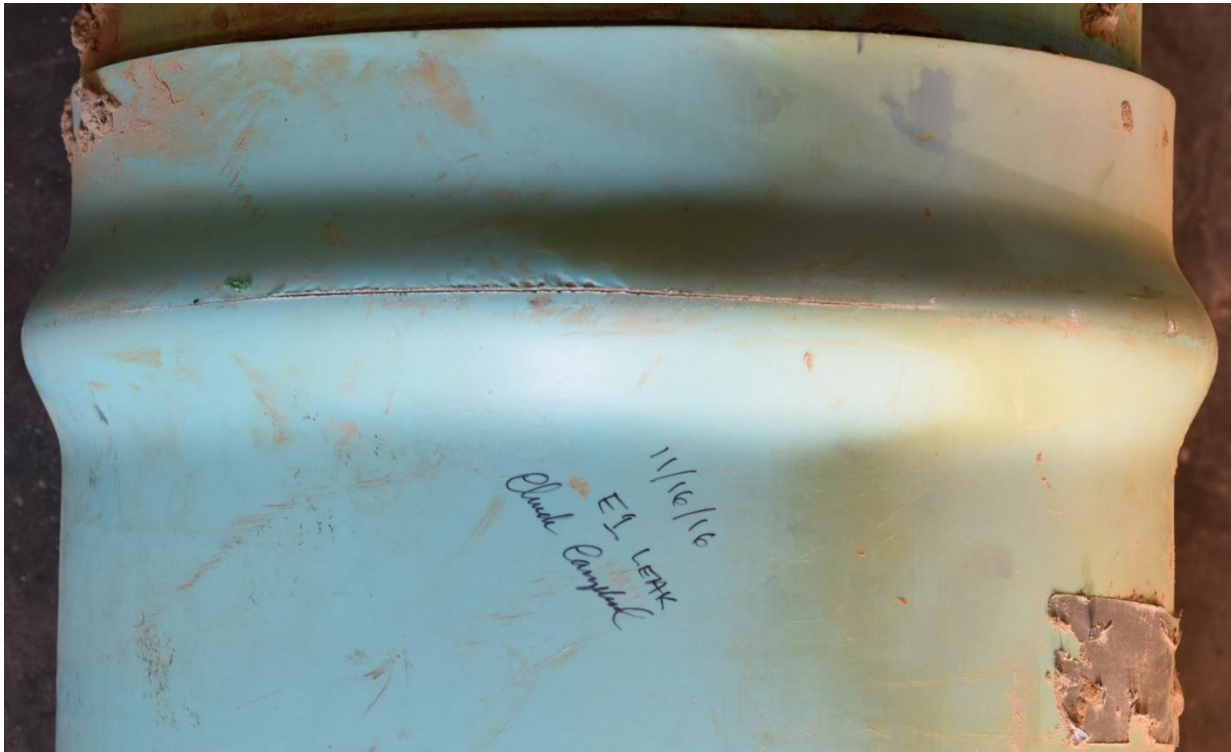
The circumferential fractures initiate on the inner wall of the pipe which is “behind” the manufactured-in gasket. The fractures are macroscopically brittle, with little or no ductility in evidence. Figure 4 displays the main fracture area of Sample E1.

Figure 4. Digital image of Sample E1 with circumferential brittle fracture located at the “crown” of the gasket race. Note macroscopically brittle structure, with slight erosion near the center of the fracture.

Circumferential fractures within bell and spigot gasketed PVC piping systems are exceptionally rare. First and foremost, the stress that causes any fracture is oriented perpendicular to the fracture orientation at the origin. As such, the stress which would cause a circumferential fracture would have to be axially (or longitudinally) oriented; because the PVC pipe contains gasketed joints that can move axially, there is essentially no way to develop axial (longitudinal) stresses in the bell from internal pressure. While bending or deflection across the bell/spigot joint can certainly alter the local stress field and generate small axial stresses (as well as shear stresses), these stresses are typically not high enough to cause fracture. Related, if the spigot is over-inserted and the joint is then deflected, the final failure mode is typically an axial fracture initiating at the bell lip. Finally, it should be noted that any failure due to long-term stress, such as that caused by bending, would occur via creep rupture. A creep rupture failure in PVC would display microscopically ductile fracture morphology at the origin of the fracture.

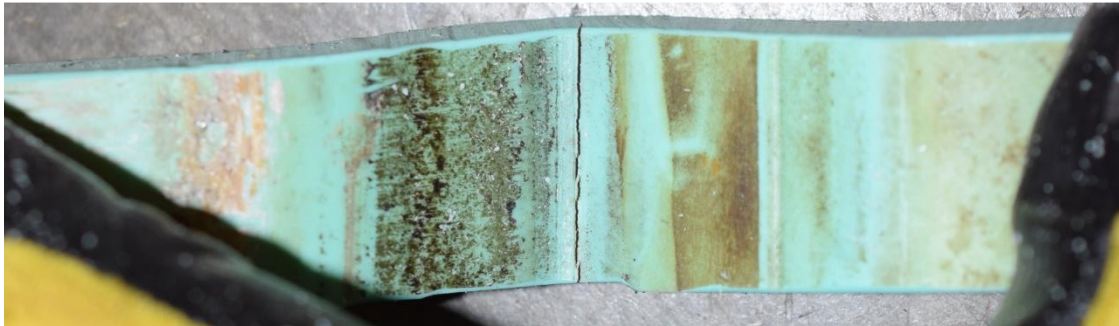
For both samples, while there are certainly more than one fracture origins present within the fractures (based on adjacent fracture “steps” which then join or coalesce into the main fractures; see Figure 5), there were no fracture origins outside of the gasket race crown inner diameter surface. Also, while microscopically brittle, the inner wall fracture structure is not glassy within the fracture surface (see Figures 6-8).

Figure 5. “Steps” present within the Sample E1 fracture. Inside diameter view, with circumferential fracture in the middle of the image running top to bottom. Each “step” represents a distinct fracture origin.

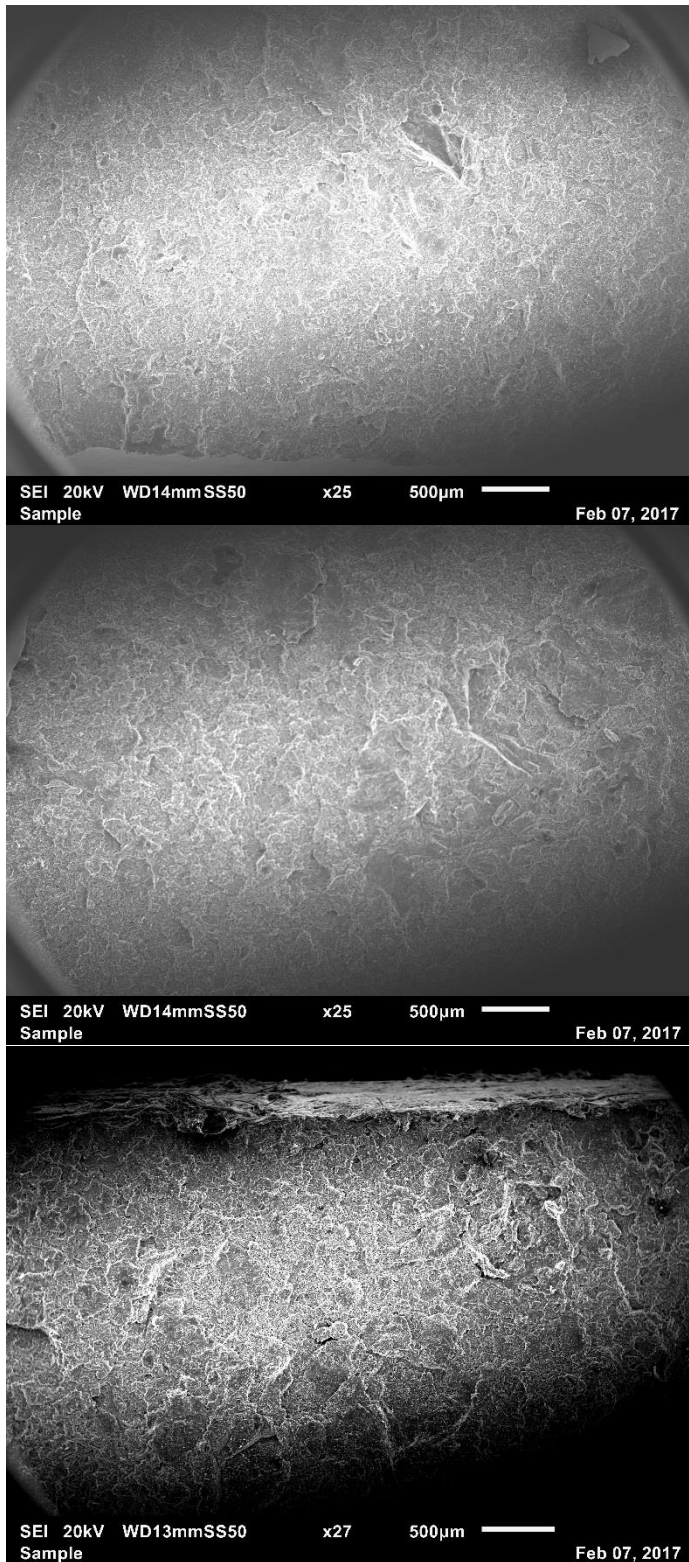
The fracture morphology is microscopically brittle with very little ductility in evidence. In general, fractures in PVC which are both macroscopically brittle as well as microscopically brittle are not common, and typically attributed to environmental stress cracking (ESC) when they occur after installation. High strain rate and/or low temperature effects can also be causative of brittle fractures in PVC but were not considered to be causative in this case since the buried pipeline cannot see low temperatures and once buried cannot be exposed to high strain rate (typically caused by impact events). One typical attribute of ESC failures in general is a multitude of fracture initiations which then coalesce into a larger (single) fracture. Additionally, the fracture origins within ESC failures are typically very brittle, almost “glassy” in appearance, with little microscopic structure in evidence. Note that while some (few) multiple fracture initiations were in evidence along the gasket race crown based on the presence of “steps” in the fracture on the inner wall surface (see Figure 5), no additional initiations were visible anywhere away from the main fracture.

Figure 6. Three SEM images of the Sample E1 fracture at the approximate inner, middle, and outer wall locations (top to bottom respectively; 25X original magnification).

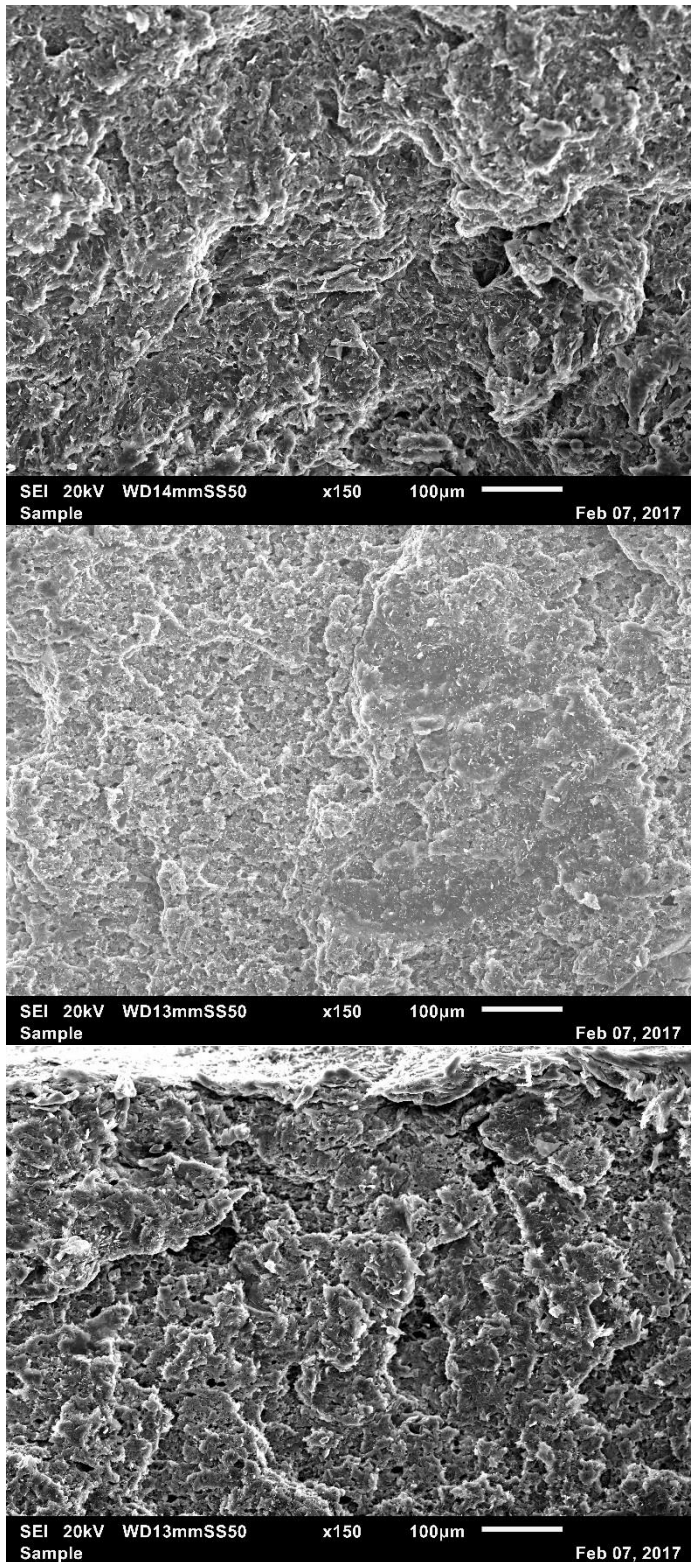
Figure 7. Three SEM images of the Sample E1 fracture at the approximate inner, middle, and outer wall locations (top to bottom respectively: 150X original magnification).

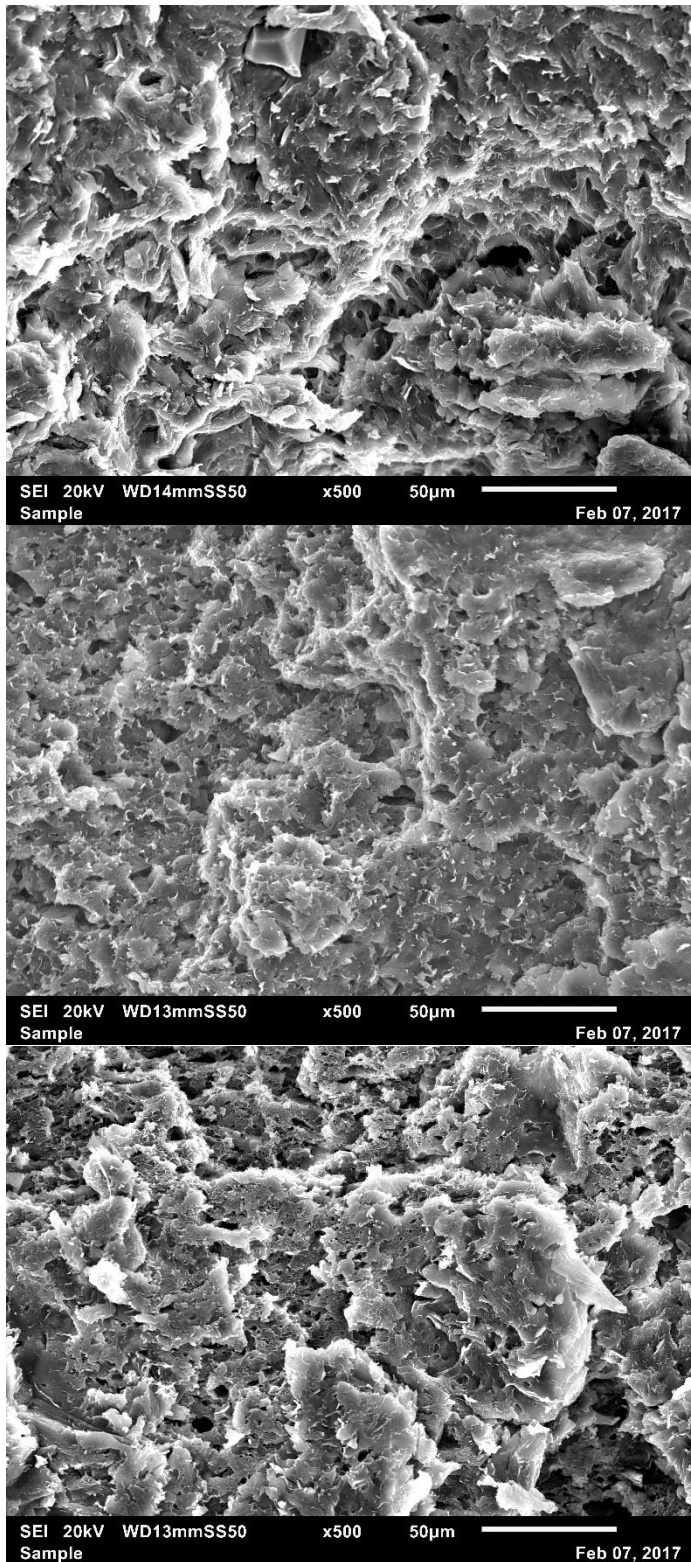
Figure 8. Three SEM images of the Sample E1 fracture at the approximate inner, middle, and outer wall locations (top to bottom respectively: 500X original magnification)

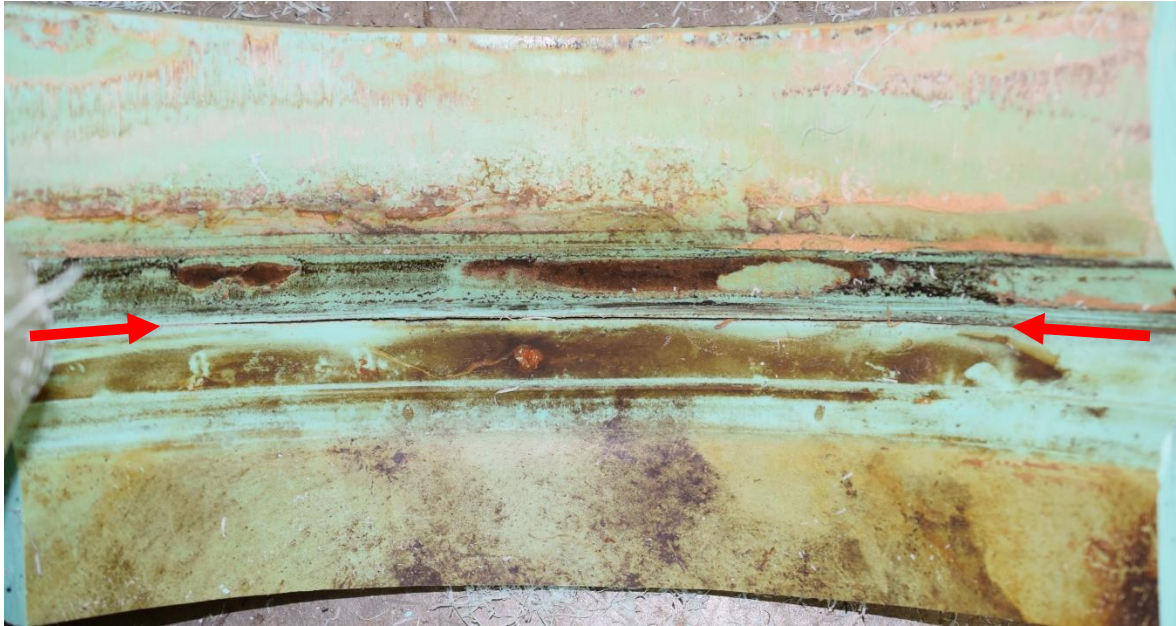
Figure 9. Sample E1 gasket race area with circumferential fracture after initial cutting and removal from the bell. Note circumferential fracture at the approximate mid-height of the image (at red arrows), as well as residue present in the gasket race “behind” where the gasket was previously placed. Non-pressure side of the gasket and bell lip are at image top, while the pressure side of the gasket and bell barrel are at image bottom.

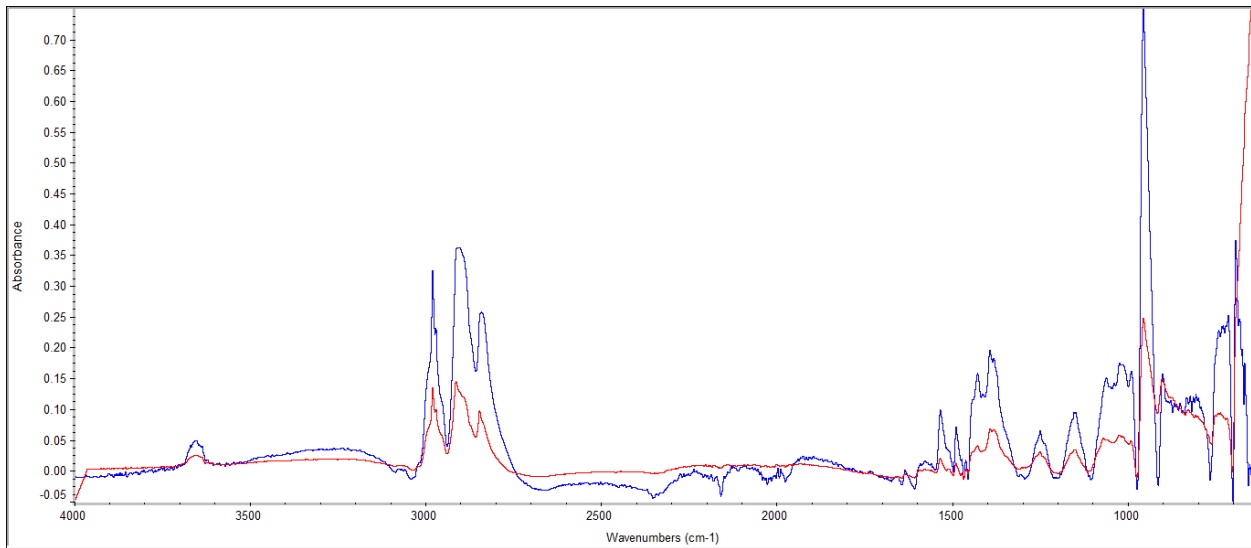
Residue removed from the gasket race “outside” of the gasket was tested. Figure 9 displays the general location of sampling. Figure 10 displays the stacked FTIR spectra from residue removed from the pressure side of the gasket race as well as the non-pressure side of the gasket race (both on the “outside” surface of the gasket). The spectra are essentially identical and do not display any substantive differences.

Figure 10. Sample E1 residue sampled from the gasket race (behind the gasket) near the center of the circumferential fracture. Note that these spectra are baseline corrected. The red trace represents the non-pressure (i.e. bell-lip) side of the gasket race while the blue trace represents the pressure (i.e. pipe barrel) side of the gasket race. Note also the generally similar if not practically identical chemical makeup based on the presence of identical peaks within each spectrum.

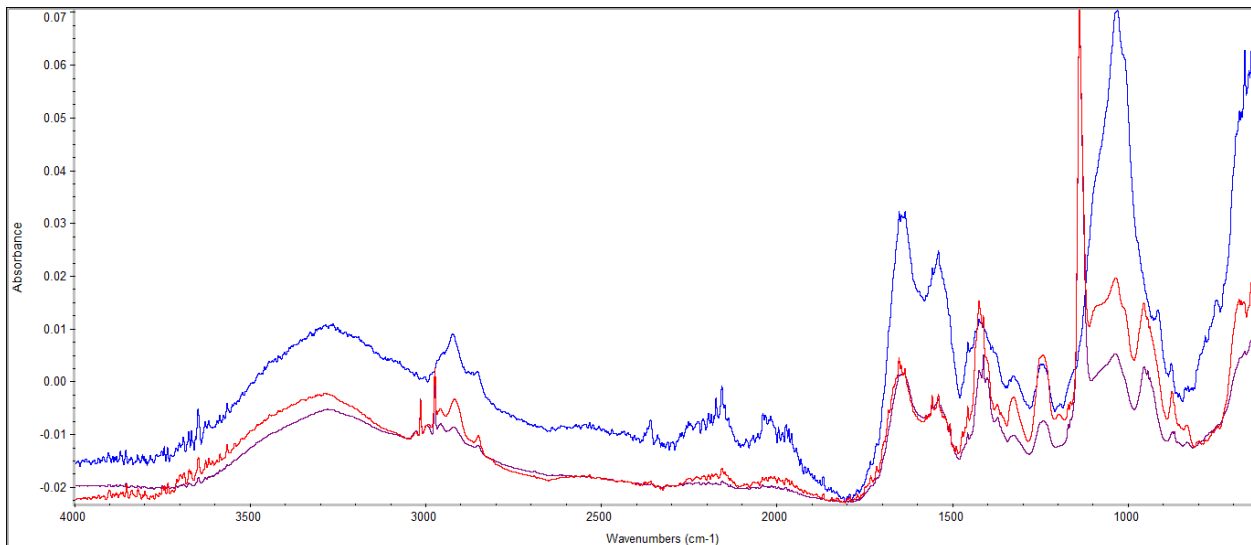
Three different locations from the pipe inside diameter surface within the (pressure side) bell barrel area were removed from Sample E1 and tested. Figure 11 displays the stacked FTIR spectra from these locations. The spectra are generally similar and do not display any substantive differences.

Figure 11. Sample E1 joint residue sampled from the (pressure side) bell barrel ID surface. Note the generally similar chemical makeup based on the presence of identical peaks within each spectrum.

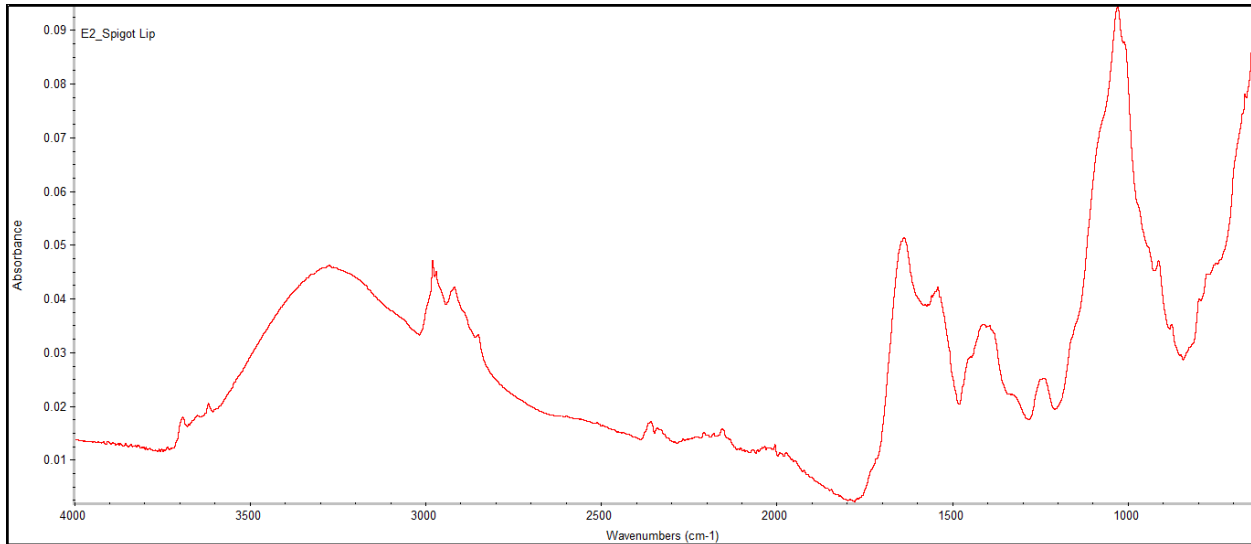
Figure 12. Sample E2 joint residue sampled from the bell ID at the (pressure side) bell lip.

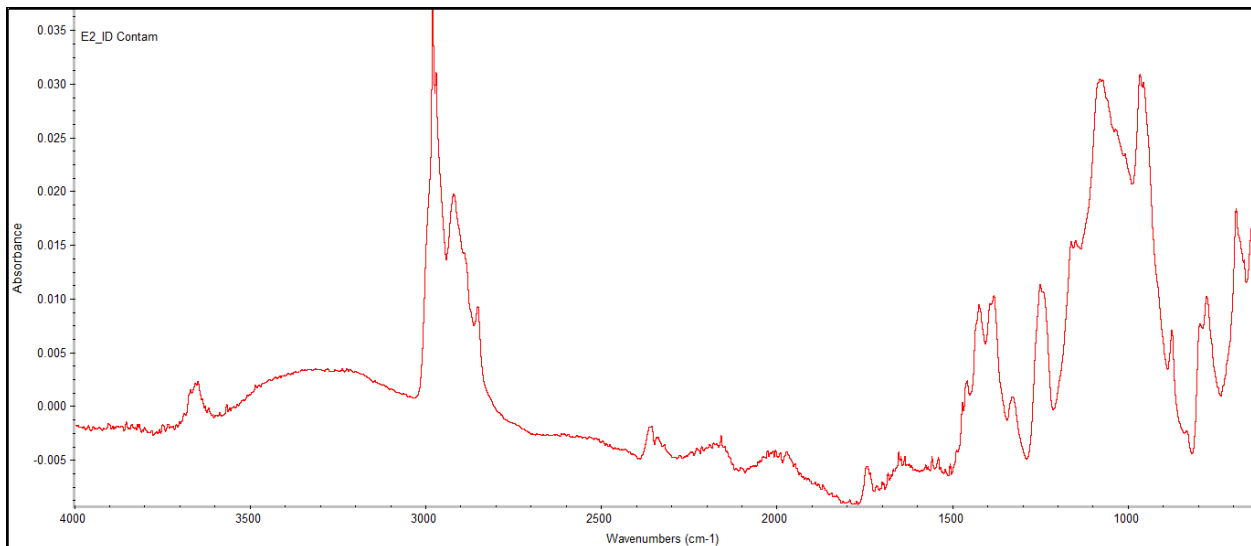
Figure 13. Sample E2 joint residue sampled from the (pressure side) bell barrel ID. Note the generally similar chemical makeup to the similar sampling locations from Sample E1 based on the presence of identical peaks within each spectrum (see also Figure 13).

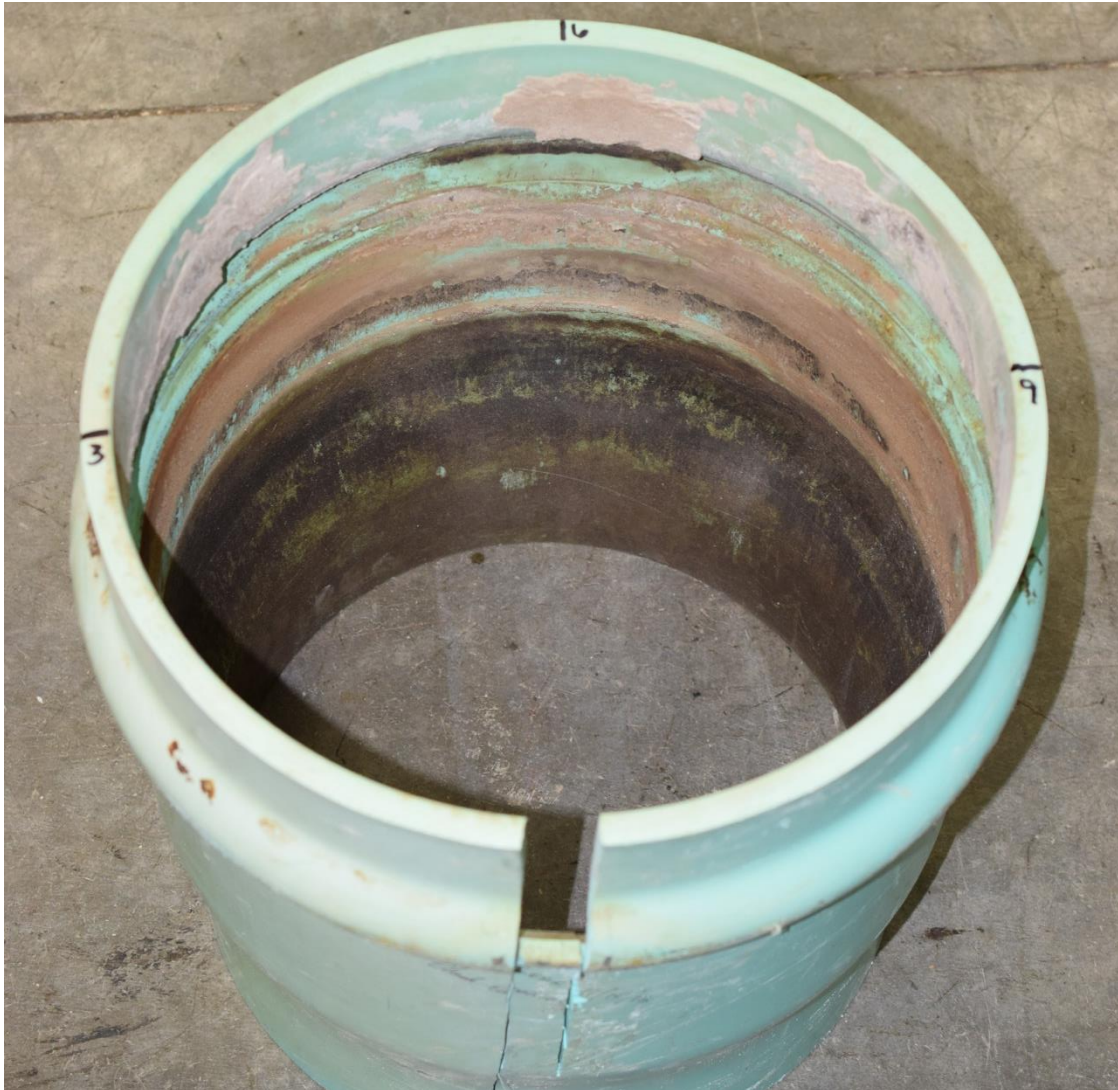
Regarding the joint assembly workmanship and alignment, the two samples were received in generally straight alignment, although some deflection was evident based upon annular gaps around the bell lip circumference. As noted prior, the spigots were appropriately belled, i.e. generally inserted to the manufacturer's recommended minimum insertion mark, i.e. just up to the first of the two manufacturer's marks. There was some amount of fine-grained debris in the joint area, both in the gap between the gasket sealing lobes as well as fore and aft of the gasket, including behind the gasket as previously discussed, with Sample E2 containing much more of this fine grained debris in comparison (see Figure 17). Note that the fine grained debris was most likely NOT present during insertion as no translational artifacts were noted within the debris filled areas.

Figure 17. Sample E2 just after extraction of the spigot and gasket by sectioning and disassembly. Note fine grained debris present on both sides of the gasket race. Also note circumferential fracture at the gasket race at the as-installed 12 o'clock location (near image bottom with small section missing).

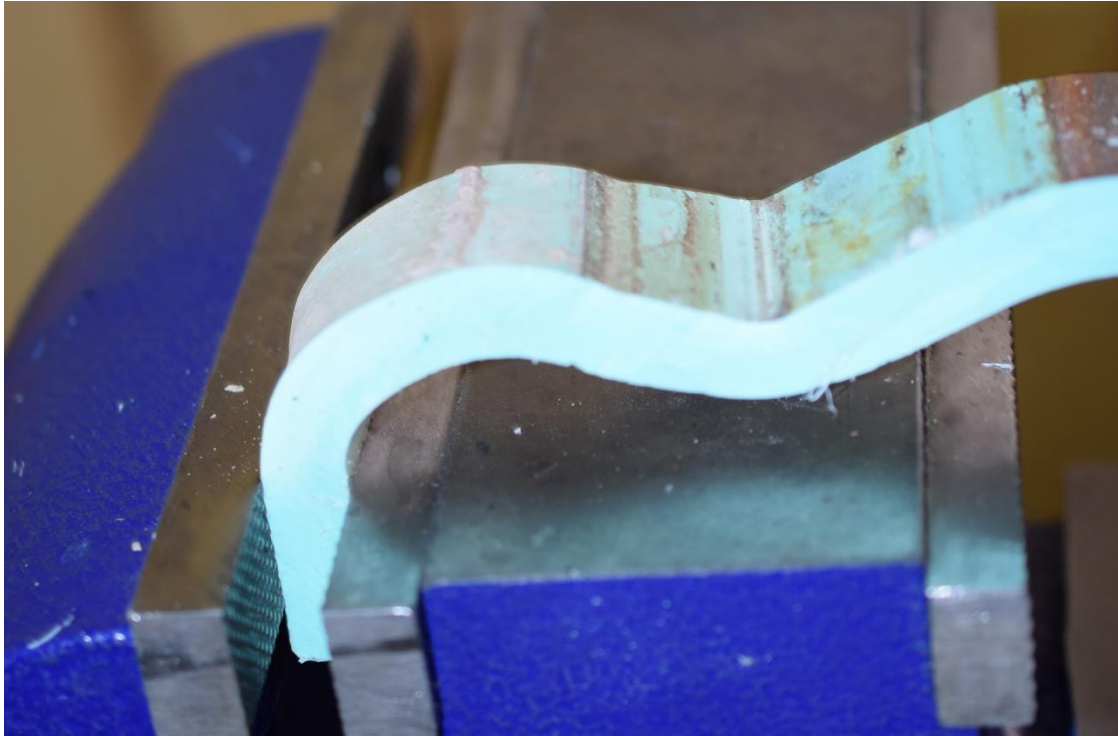
Sample E2 was further sectioned to provide approximately 1 inch wide strips from the 3, 6, and 9 o'clock locations which were used as a gross ductility check for the material specifically within the gasket race (also in comparison to the tensile properties test results discussed above). These strips were secured in a vise at the bell lip, then bent approximately 90-120 degrees back on itself, typically described as a “bendback” test, placing the inner wall at the crown of the gasket race in tension (see Figure 18). Two of the three bendback test samples fractured, although the microscopic fracture morphology at origin at the inner diameter surface at the top of the gasket race was ductile; there were no pre-existing fractures in evidence. Bendback test samples from the 6 and 9 o'clock locations fractured, while the 3 o'clock location did not.

Figure 18. Typical Sample E2 gasket race ductility check by bendback testing. Note ability to deflect at the bell lip with gross ductility in evidence (Sample E2, 3 o'clock test sample specifically).

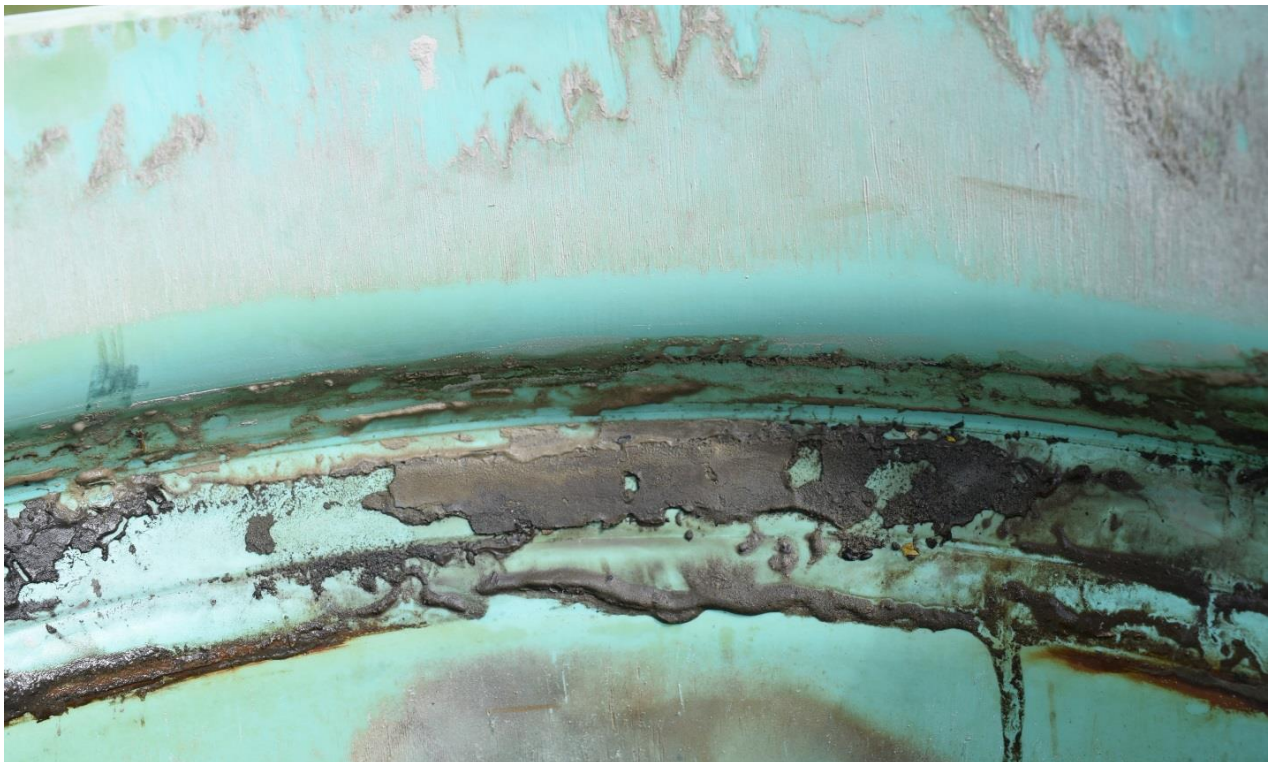
During the March 2017 El Dorado, AR site visit by S. Ferry where various additional joints were excavated a second joint failure mode was discovered, specifically leakage without fracture (4 of 17 total failures). While still present at the pipeline one of these leaking joints was disassembled in the field. The joint appeared to have been appropriately assembled (up to the manufacturer's minimum insertion mark) and there was no evidence of poor workmanship. The gasket was still retained within the gasket race and had no evidence of "rolls" or tears which would be typical of a leaking gasket. Similar to Samples E1 and E2, there was some amount of fine grained debris present in the joint area, which appeared to have been introduced AFTER assembly of the joint, again because of the presence of this material "behind" the gasket within the gasket race area and lack of translational damage artifacts which are typical of "dirty" installations (see Figure 19).

Figure 19. Sample E10 just after extraction of the spigot and gasket in the field. Note fine grained debris predominantly present on the pressure side of gasket race. Bell lip is at image top.
