SUMMERFORD ENGINEERING, INC.

April 8, 2015

RE: NPDES AR0034380, AFIN 01-00041
Flow Regulating Wastewater Storage Pond
Sewerage Treatment Facilities
Stuttgart, Arkansas

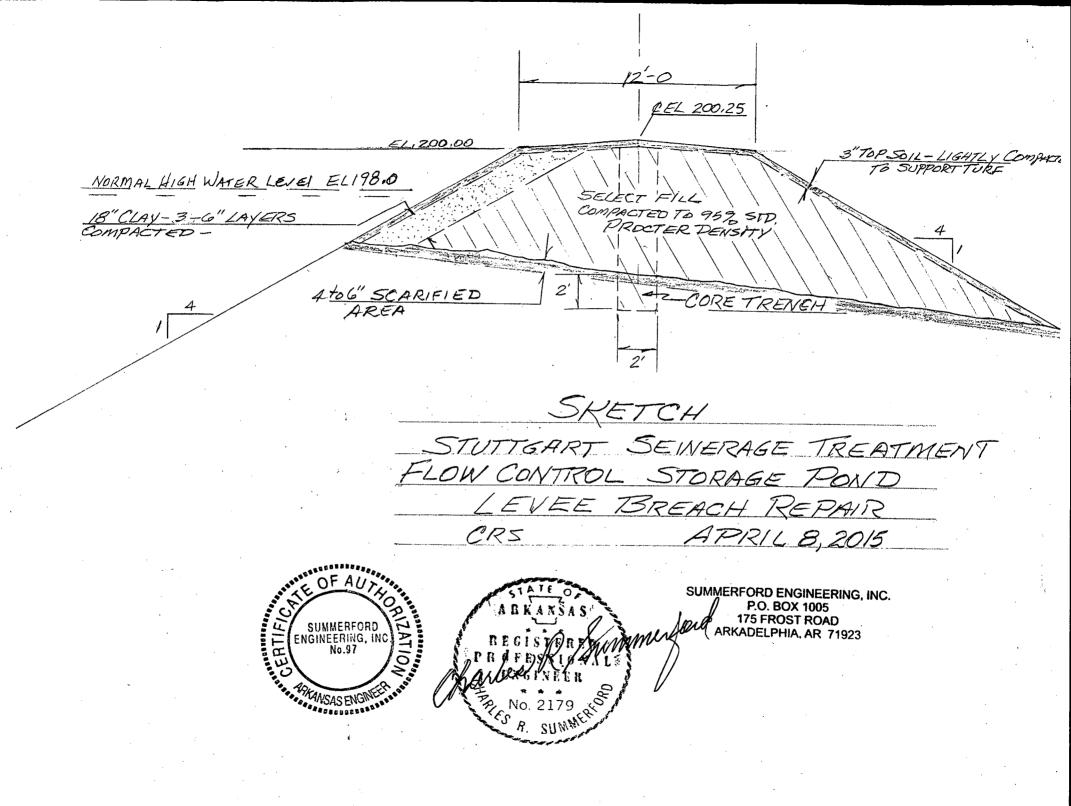
Enclosure: Sketch

In response to your request of repairing the breach wash out in the wastewater storage pond, we offer the following:

- 1. Once the wastewater pond water level is lowered to a point 5 feet below the bottom of the washout and allowed to dry for a week minimum, the loose and/or wet portion in the bottom of the breach area should be mopped out and the concrete, asphalt, and old pipe pieces shall be removed. The breach area shall then be scarified with a disk or tiller to a depth of 4 to 6 inches.

- 2. Haul in a select fill material of sandy/gravelly clay, CL, clayey sand/gravel GC SC having a Liquid Limit 35 to 40 and a plasticity index of above 15. A core trench shall be excavated along centerline of levee completely across the washed out area; then the core trench filled with the excavated material or select fill and compacted to a density of 95% of Standard Proctor Density. Continue placing the select fill in 6 to 8-inch layers over the washed out area and compact with a small sheepsfoot roller with fill material near optimum moisture content until sheepsfoot rolls out and reaches 95% Standard Proctor Density. Continue placing the select fill in layers and compacting until the fill reaches a point 21 inches below the surface of the inside levee slope and 3 inches below the top of the existing levee and exterior slope.

- 3. Haul in a clay fill material and lay in 6-inch layers and compact 18" clay liner on front slope of levee over washed out area up to within 3 inches of inside of levee to replace the clay liner using care to match existing clay liner with new clay material.

- 4. Haul in topsoil to cover the levee top and slopes of washed out area with 3-inches of topsoil to support and develop a turf cover, then lightly compact.
- 5. Then apply 15#/acre of bermuda grass seed, 700#/acre of 13-13-13 commercial fertilizer and cover area with straw.
- 6. The repaired area should be sprinkled until wet and kept damp until the bermuda seed germinates and is a uniform green over the repaired area.
- 7. Attached is a general sketch showing the proposed repair work.
