SEWER SYSTEM EVALUATION STUDY (SSES)

BENTON PUBLIC UTILITY COMMISSION,
BENTON, ARKANSAS

August 12, 2013

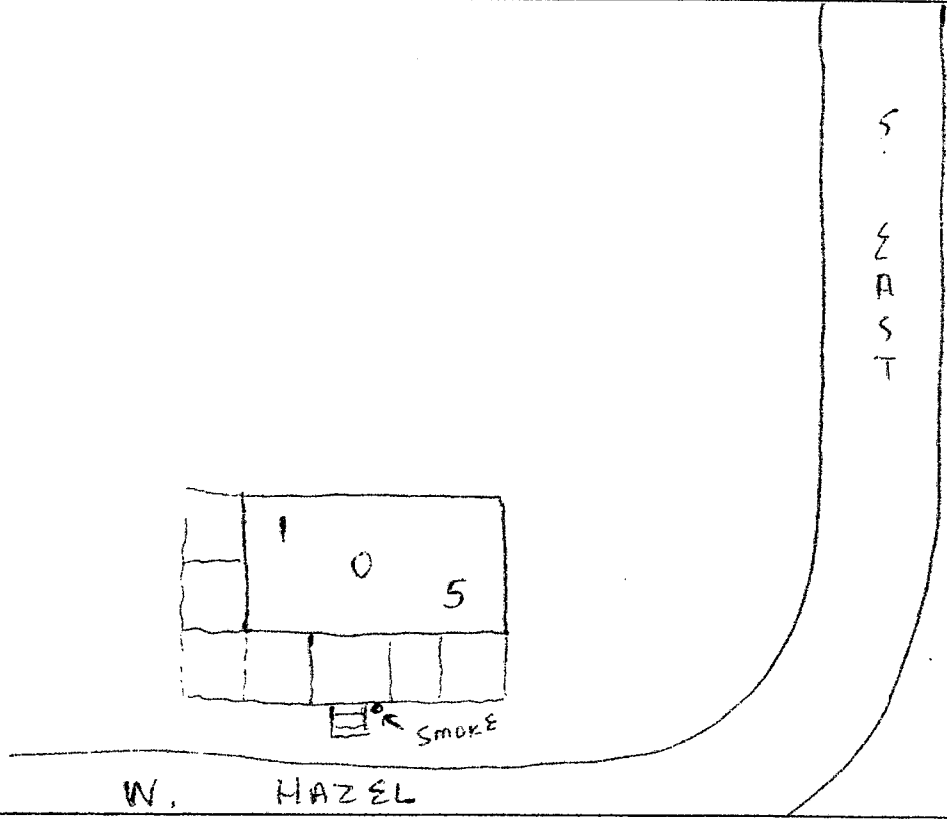
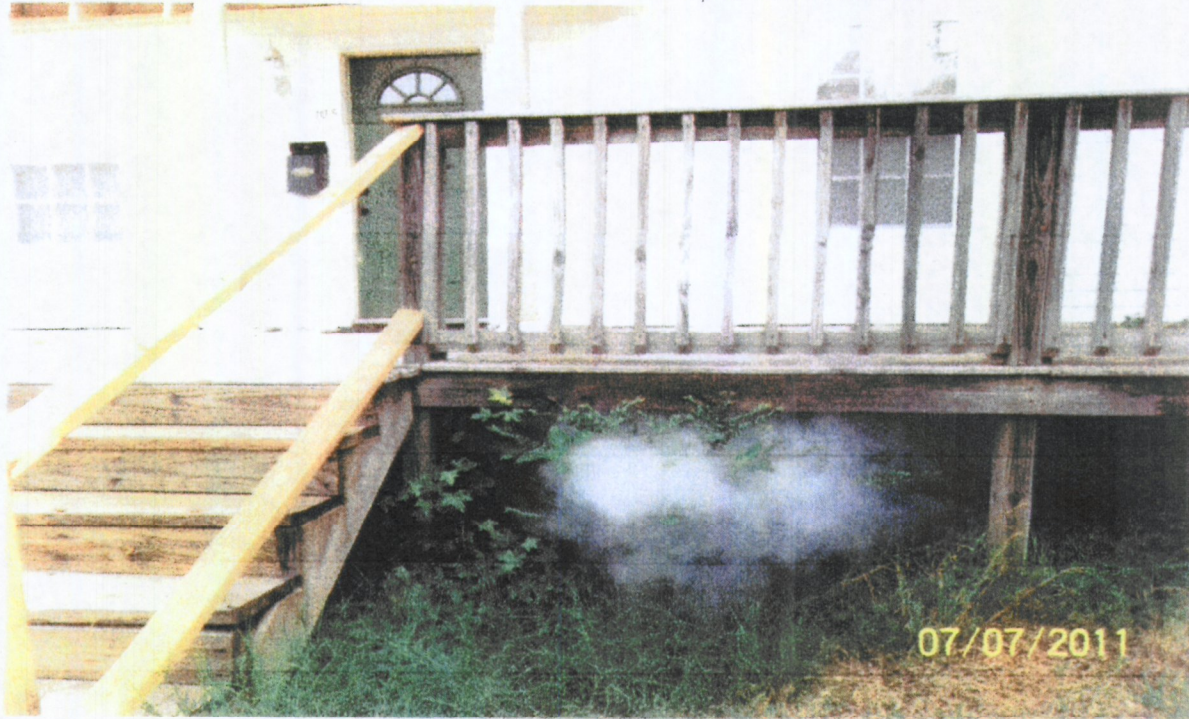
Photo # 100-0477

Defect Location: Main Line ___ Service Line ___ Clean Out Leak at Manhole # _____ Cross Connect ___
Other (describe) _____

Comments: TOP OF CLEAN OUT BROKEN- NEEDS REPLACED
