RE: Corrective Action Plan for City of Hope, AR  
 Bois D'Arc WWTP, NPDES Permit No. AR0038466, AFIN 29-00034  
 Pate Creek WWTP, NPDES Permit No. AR0038458, AFIN 29-00512

# Sanitary Sewer Evaluation Survey Final Report

**City of Hope, Arkansas**

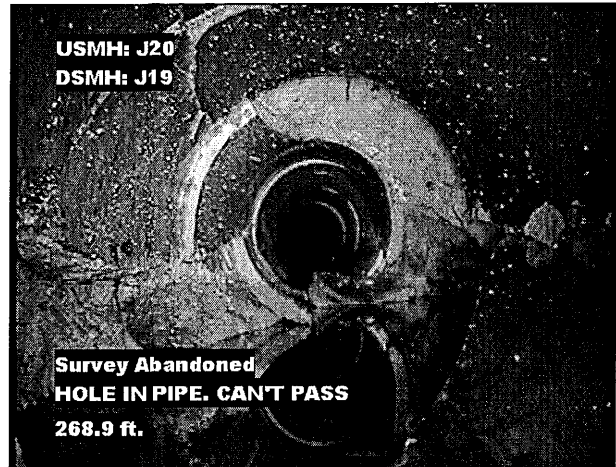
Portion of pipe missing  
Segment J20-J19
