RE: Corrective Action Plan for City of Hope, AR  
 Bois D'Arc WWTP, NPDES Permit No. AR0038466, AFIN 29-00034  
 Pate Creek WWTP, NPDES Permit No. AR0038458, AFIN 29-00512

# Sanitary Sewer Evaluation Survey Final Report

**City of Hope, Arkansas**

**June 2015**

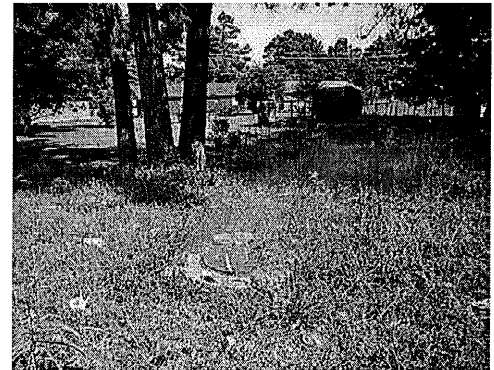
Defective Manhole  
Eastside Basin, Manhole D6

Smoke Testing also identifies defects on manholes that may be a potential source of I/I. Often the smoke exits through a poor casting or frame. The smoke may also exit from the manhole structure itself. Manholes exhibiting defects from the manhole structure are recommended for further manhole inspection to determine if the source of the smoke, i.e. defective pipe seals, manhole wall, defective joints, etc. Appendix A presents a summary of recommended repairs and those manholes recommended for inspection. A summary of the estimated repair cost is presented in Table III-2.

Manhole rehabilitation recommendations include minor repairs or inspection of the manhole to determine condition. Minor repairs include realigning or replacing the casting and installation of inflow inserts. Manholes that exhibited smoke coming from the manhole structure itself should be inspected to determine if the source of the smoke, i.e. defective pipe seals, manhole wall, defective joints, etc.

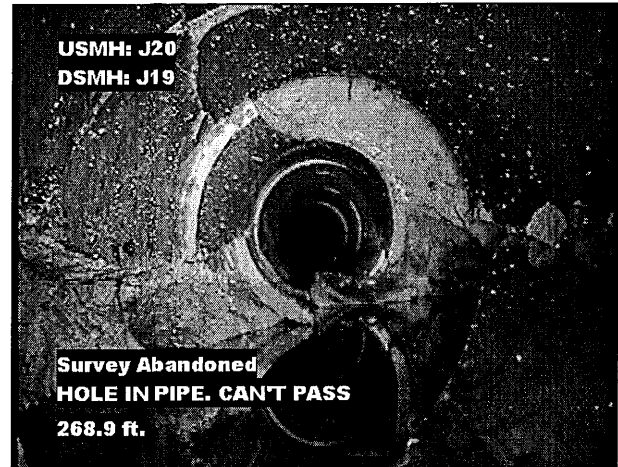
Portion of pipe missing  
Segment J20-J19

Total cost for repairs to municipal pipelines is summarized in Table III-3. Priority 1 recommendations are repairs that should be performed as soon as practical. Priority 2 recommendations are repairs that need to be addressed, but may be scheduled as budget allows.
