Jacksonville Wastewater Utility

RE: NPDES Permit No.: AR0041335, AFIN: 60-00543
Sanitary Sewer Overflows (SSOs)

This Corrective Action Plan (CAP) is being provided in response to your letter dated November 7, 2016. I would like to provide some history of inflow/infiltration (I/I) repairs done as a part of our on-going CAP depicting the serious consideration given and actions taken by Jacksonville Wastewater Utility (JWWU) in an attempt to eliminate SSOs from 1995 to date.

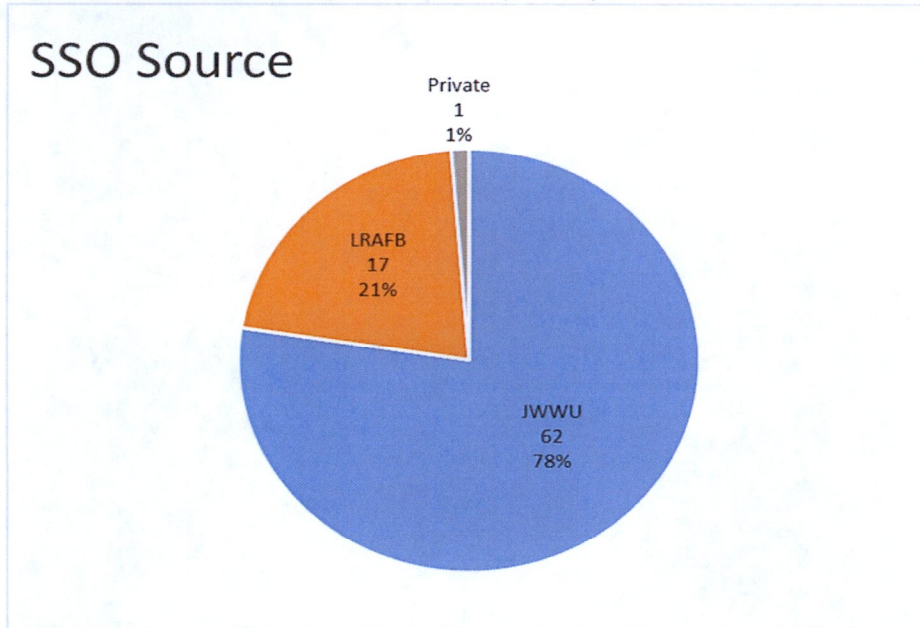
Figure 1: A breakdown of the source of SSOs from 2013-2016.

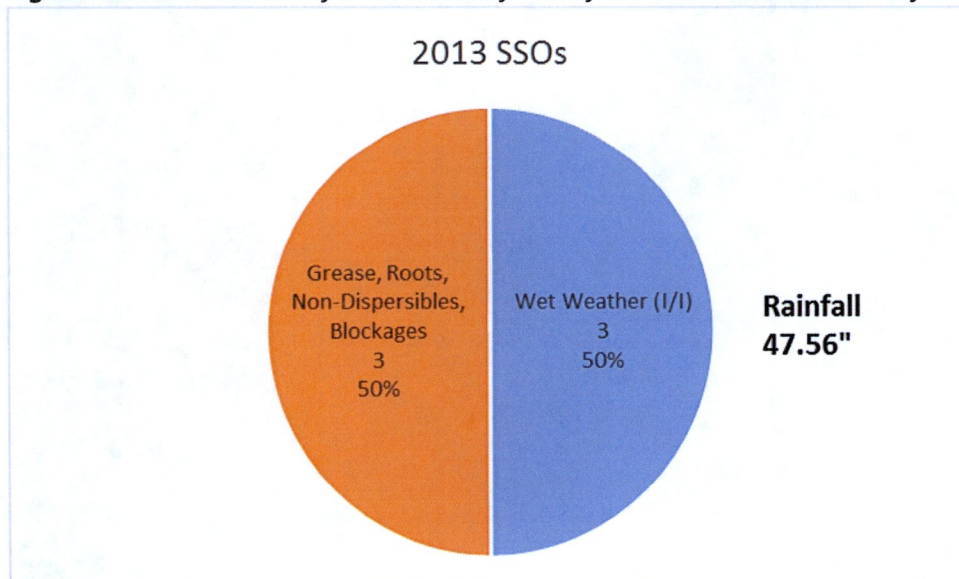
Figure 2: A breakdown of the causes of SSOs from 2013 and amount of rainfall.

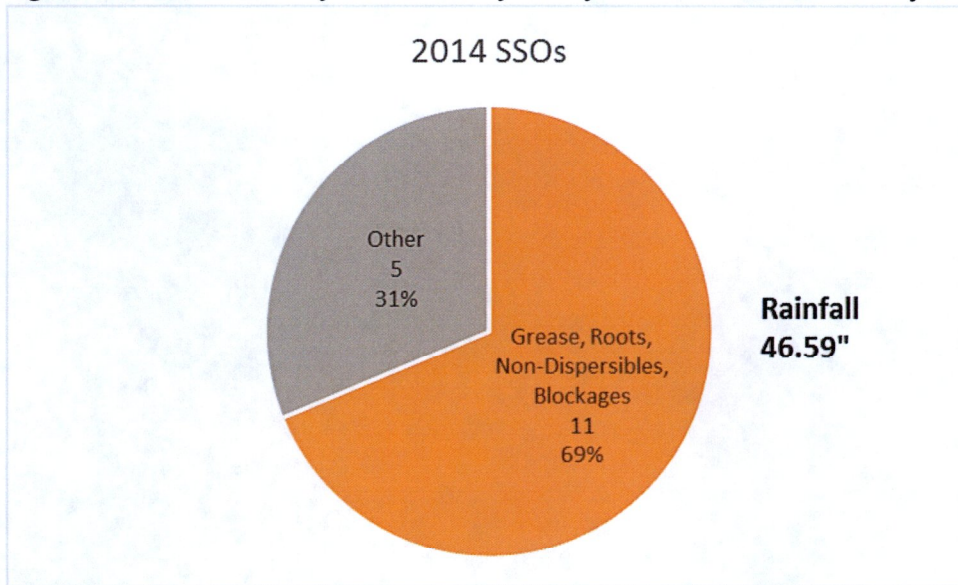
Figure 3: A breakdown of the causes of SSOs from 2014 and amount of rainfall.

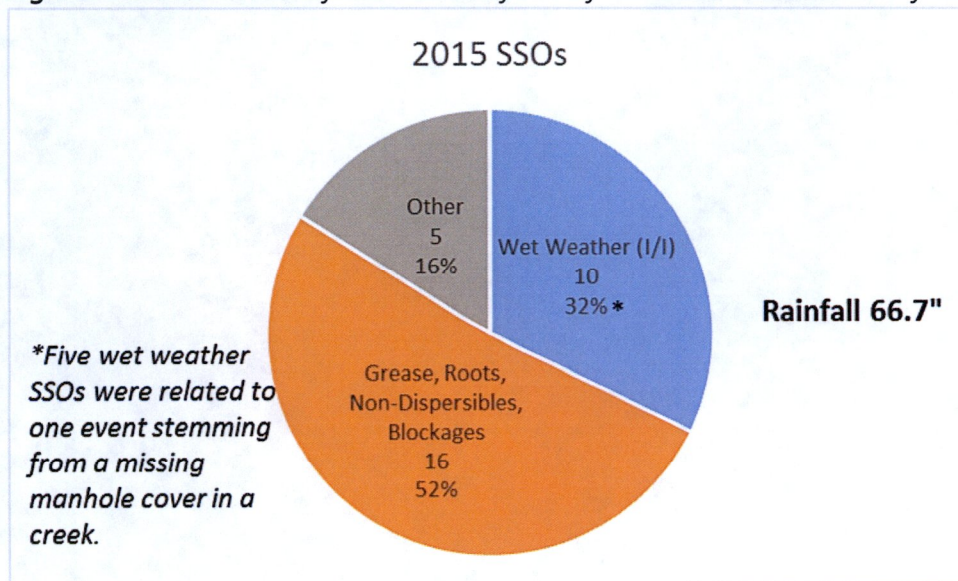
Figure 4: A breakdown of the causes of SSOs from 2015 and amount of rainfall.

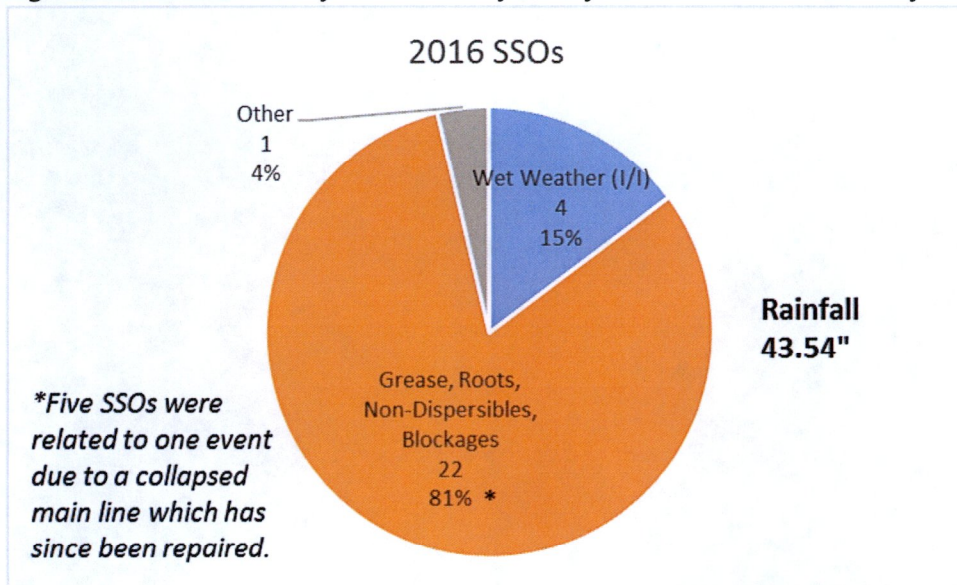
Figure 5: A breakdown of the causes of SSOs from 2016 and amount of rainfall.

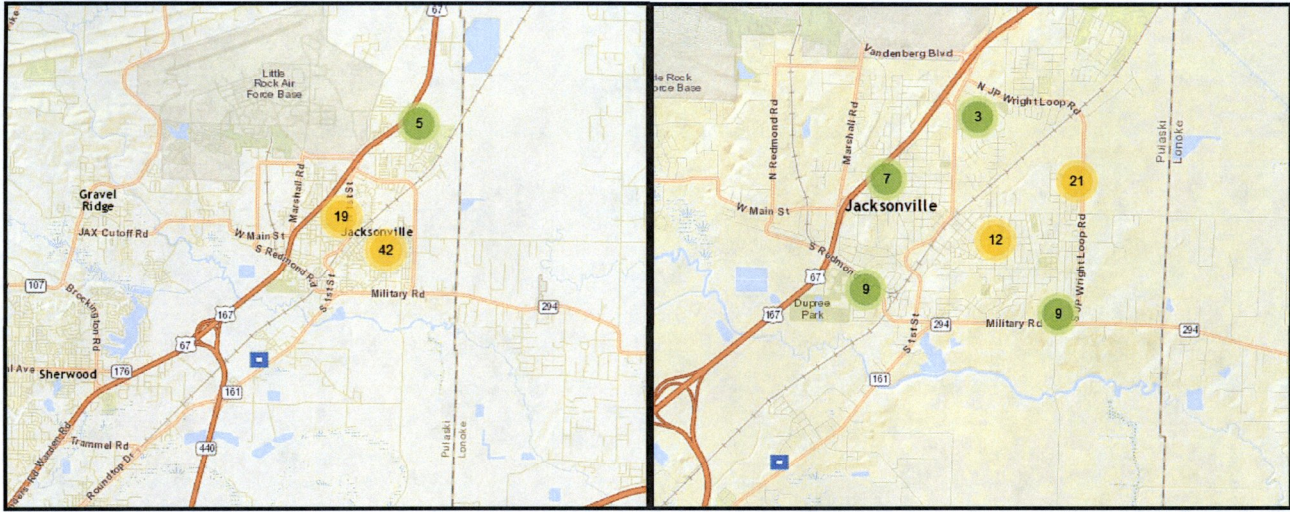
Figure 9: A cluster map at various zoom levels that displays SSOs related to rainfall from 2008-2015.

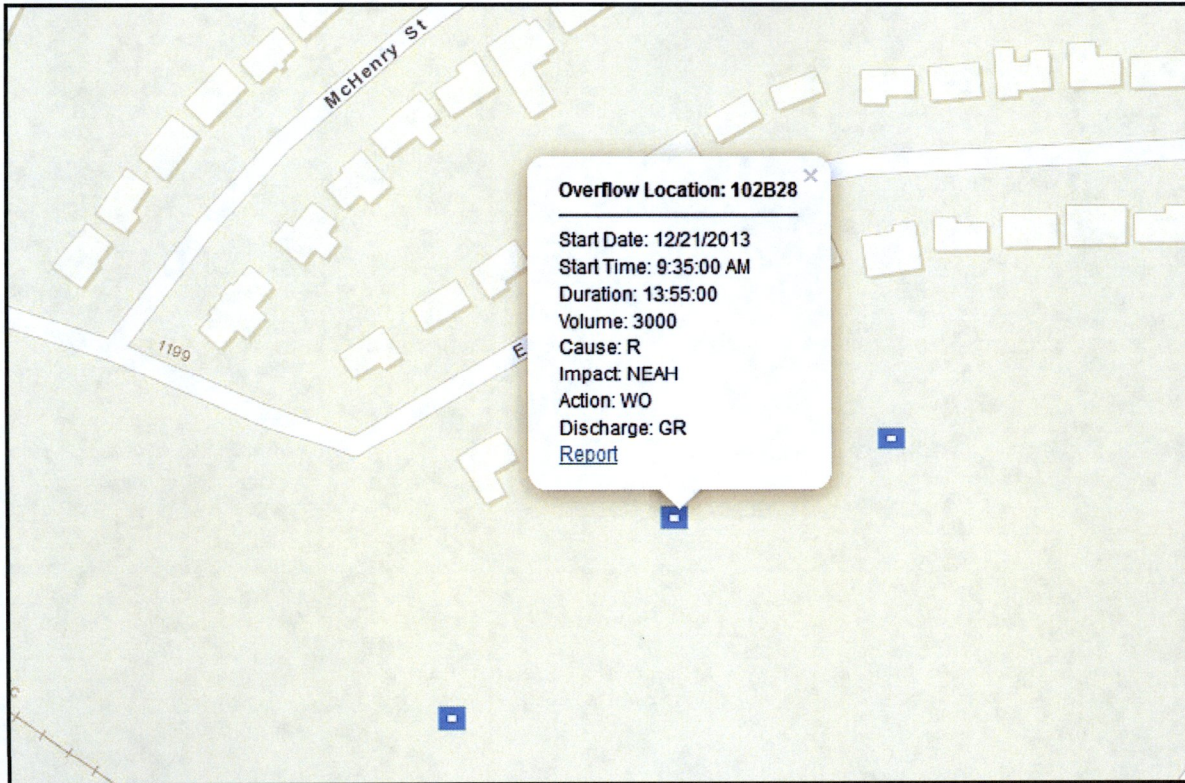
Figure 10: A cluster map at various zoom levels that displays SSOs related to rainfall beginning in 2008.
