ARKANSAS
Department of Environmental Quality

RE: Dam construction on Kelly Creek

UNITED STATES ENVIRONMENTAL PROTECTION AGENCY Washington, D.C. 20460	Form Approved OMB No. 2040-0003
<h1 style="margin: 0;">NPDES Compliance Inspection Report</h1>

Section B: Facility Data					
Name and Location of Facility Inspected (<i>For industrial users discharging to POTW, also include POTW name and NPDES permit number</i>) The Darrell Smith Dam Construction Site Canyon Spring Circle Royal, AR	<table border="1" style="width:100%; border-collapse: collapse;"> <tr> <td style="width:50%;">Entry Time/Date 1050 8/1/08</td> <td style="width:50%;">Permit Effective Date Not Permitted</td> </tr> <tr> <td>Exit Time/Date 1215 8/1/08</td> <td>Permit Expiration Date</td> </tr> </table>	Entry Time/Date 1050 8/1/08	Permit Effective Date Not Permitted	Exit Time/Date 1215 8/1/08	Permit Expiration Date
Entry Time/Date 1050 8/1/08	Permit Effective Date Not Permitted				
Exit Time/Date 1215 8/1/08	Permit Expiration Date				
Name(s) of On-Site Representative(s)/Title(s)/Phone and Fax Number(s) Darrell Smith (Owner)	Other Facility Data				
Name, Address of Responsible Official/Title/Phone and Fax Number Darrell Smi

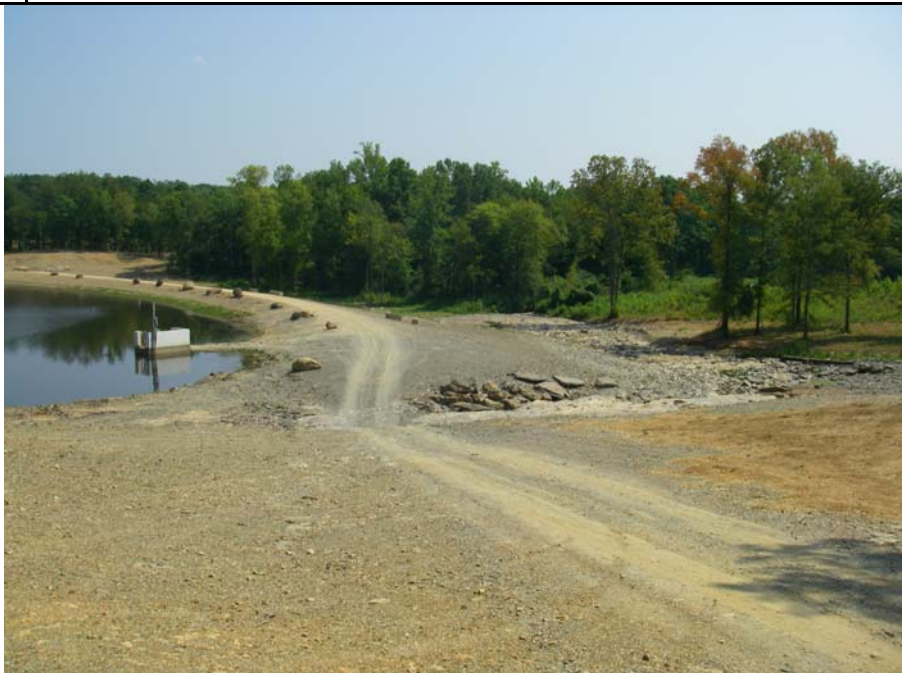
Photo #	1	Of	12		Date:	8/1/08	Time:	1110
----------------	---	-----------	----	--	--------------	--------	--------------	------

Description:	Photo of the earthen embankment constructed by Mr. Smith						
---------------------	--	--	--	--	--	--	--

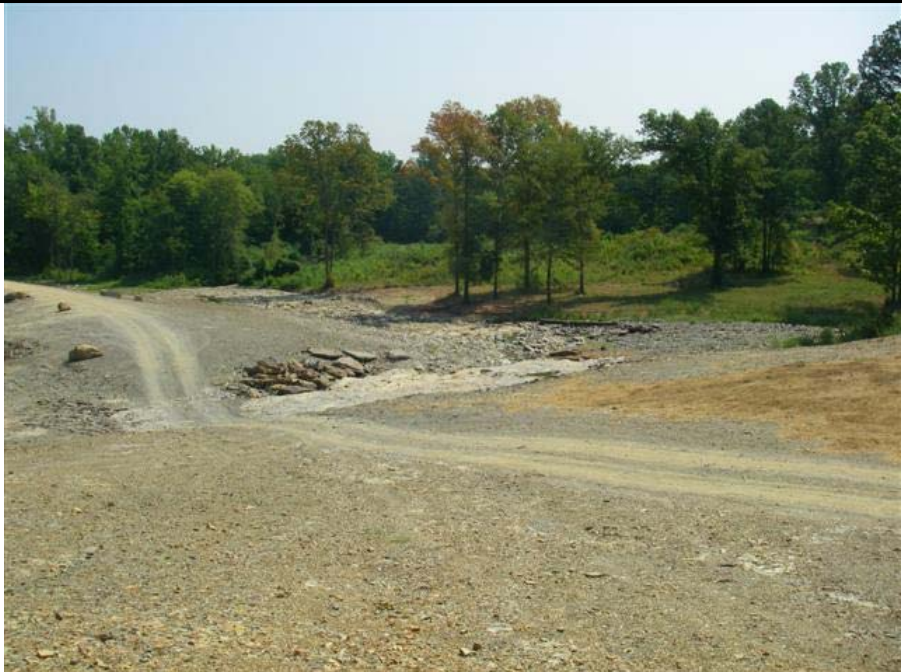
Photo #	2	Of	12		Date:	8/1/08	Time:	1111
----------------	---	-----------	----	--	--------------	--------	--------------	------

3. While still under construction, a portion of the embankment washed out depositing excessive amounts of sediment into Kelly Creek; this is a violation of the Arkansas Water and Air Pollution Control Act 8-4-217.(a)(1).

Description:	Area of the embankment that washed out						
---------------------	--	--	--	--	--	--	--

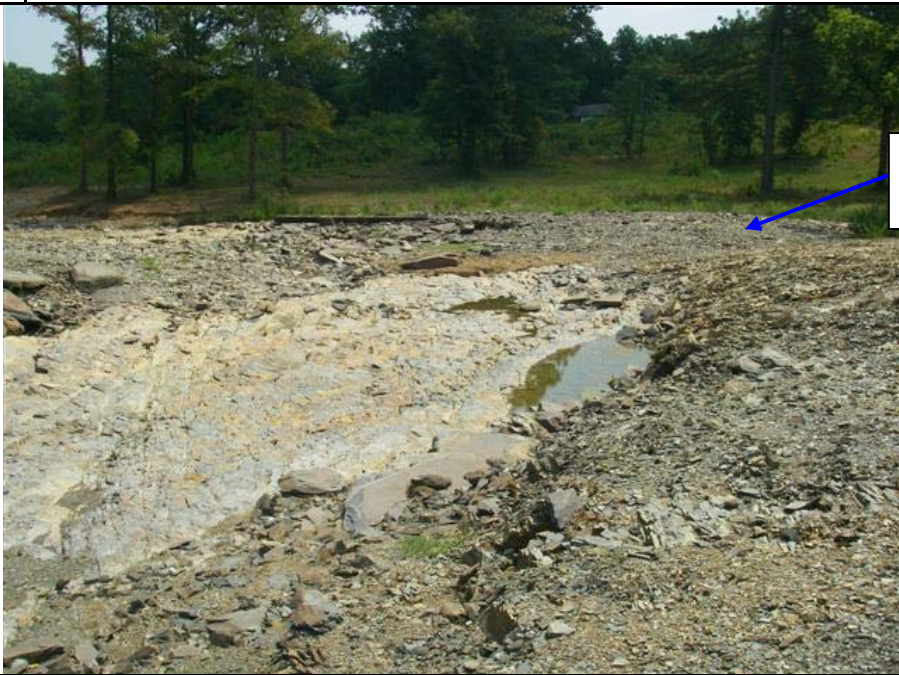
Photo #	3	Of	12	Date:	8/1/08	Time:	1111
----------------	---	-----------	----	--------------	--------	--------------	------

Description:	Close-up of the washed out embankment						
---------------------	---------------------------------------	--	--	--	--	--	--

A intermittent tributary flows thru here

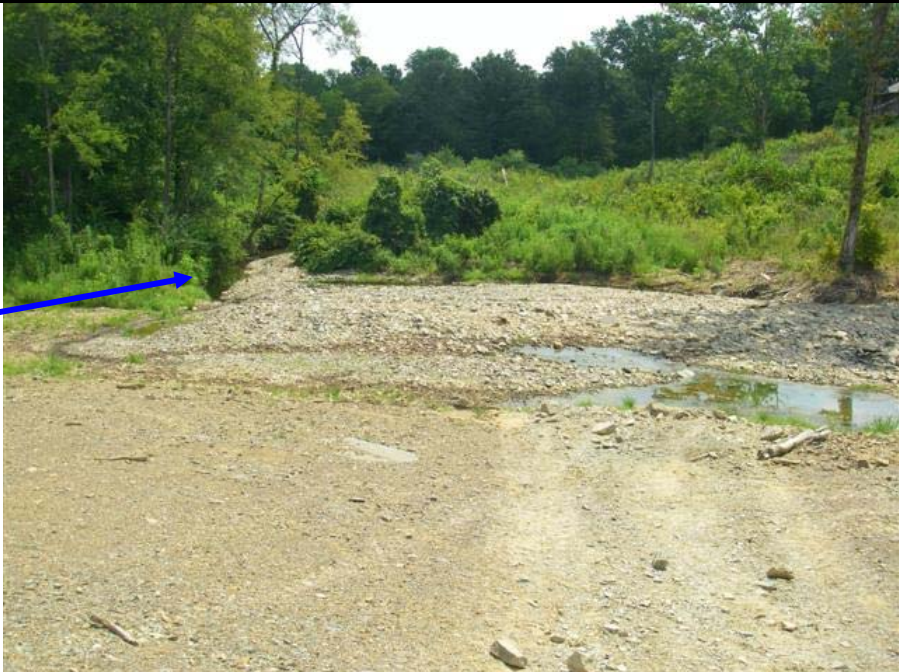
Photo #	4	Of	12	Date:	8/1/08	Time:	1146
----------------	---	-----------	----	--------------	--------	--------------	------

Description:	Photo of the sediment deposited into Kelly Creek						
---------------------	--	--	--	--	--	--	--

Kelly Creek

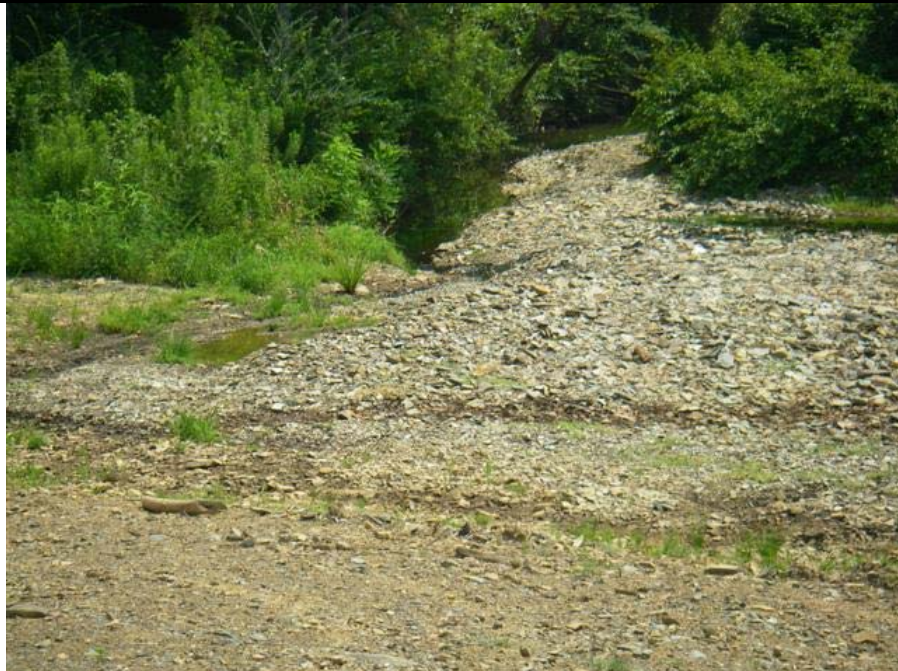
Photo #	5	Of	12		Date:	8/1/08	Time:	1146
----------------	---	-----------	----	--	--------------	--------	--------------	------

Description:	Sediment deposited into Kelly Creek						
---------------------	-------------------------------------	--	--	--	--	--	--

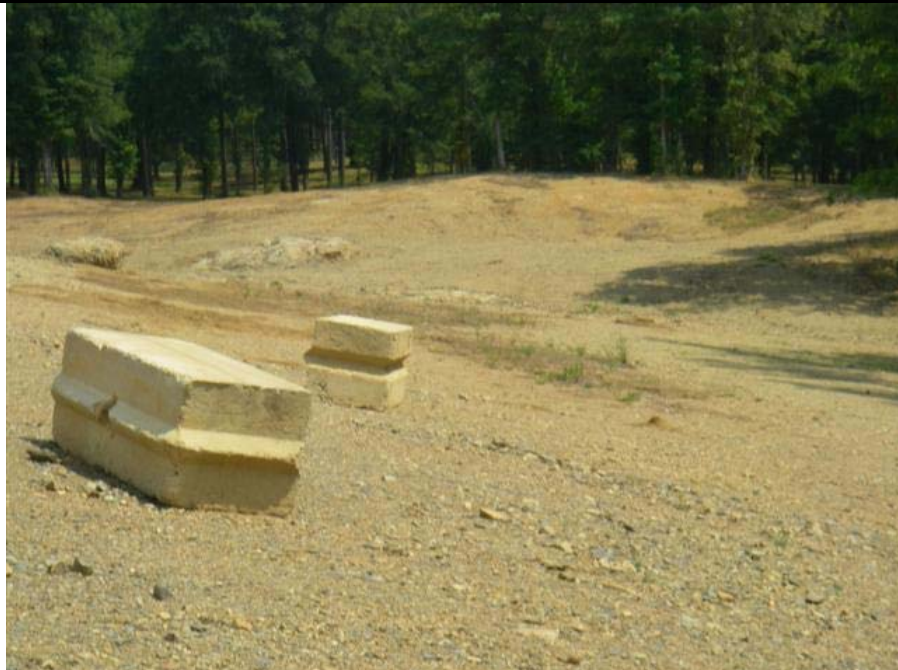
Photo #	6	Of	12		Date:	8/1/08	Time:	1147
----------------	---	-----------	----	--	--------------	--------	--------------	------

4. There has been no effort to stabilize the exposed areas or use sediment controls to prevent further sediment from entering the waters of the state.

Description:	The back side of the embankments (no stabilization)						
---------------------	---	--	--	--	--	--	--

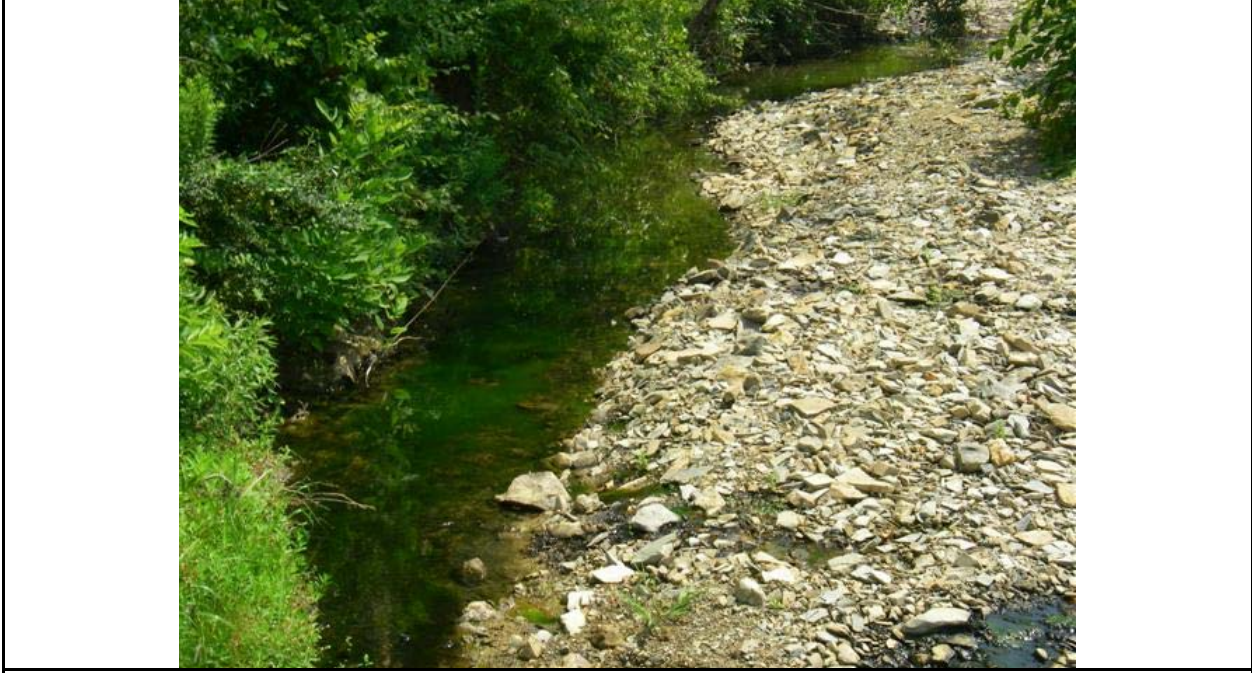
Photo #	7	Of	12	Date:	8/1/08	Time:	1148
----------------	---	-----------	----	--------------	--------	--------------	------

Description:	Sediment in Kelly Creek						
---------------------	-------------------------	--	--	--	--	--	--

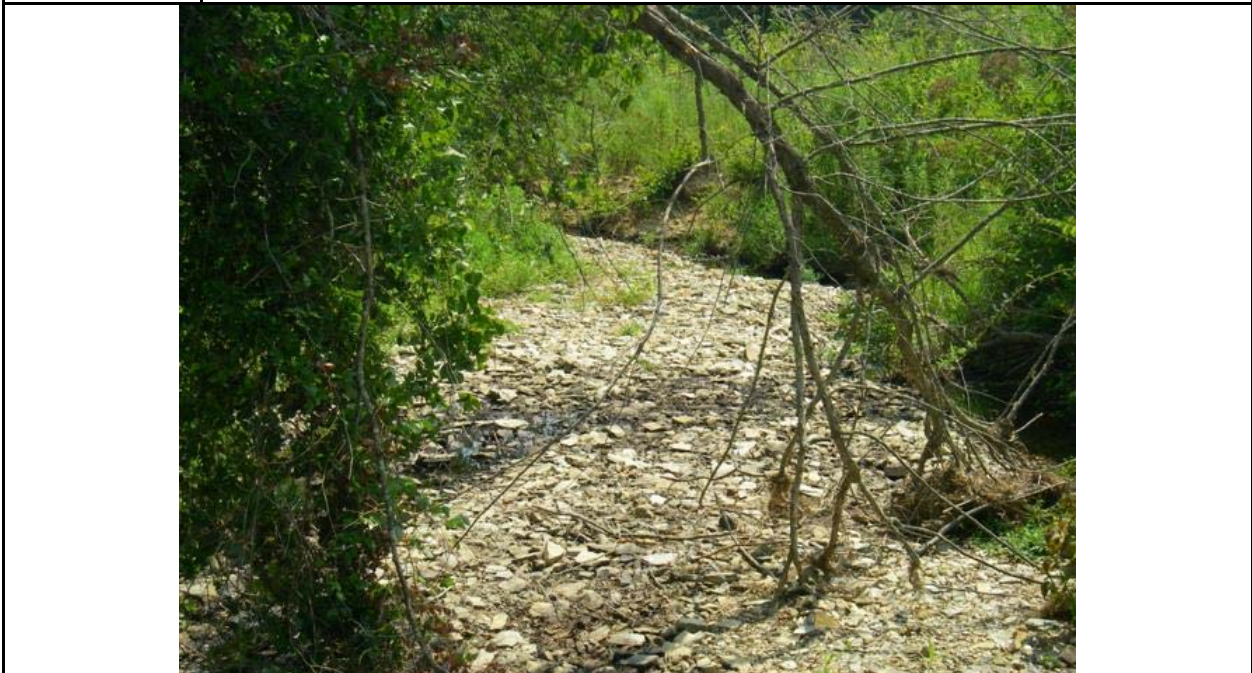
Photo #	8	Of	12	Date:	8/1/08	Time:	1148
----------------	---	-----------	----	--------------	--------	--------------	------

Description:	Sediment in Kelly Creek (Photos taken as I walk down Kelly Creek.)						
---------------------	--	--	--	--	--	--	--

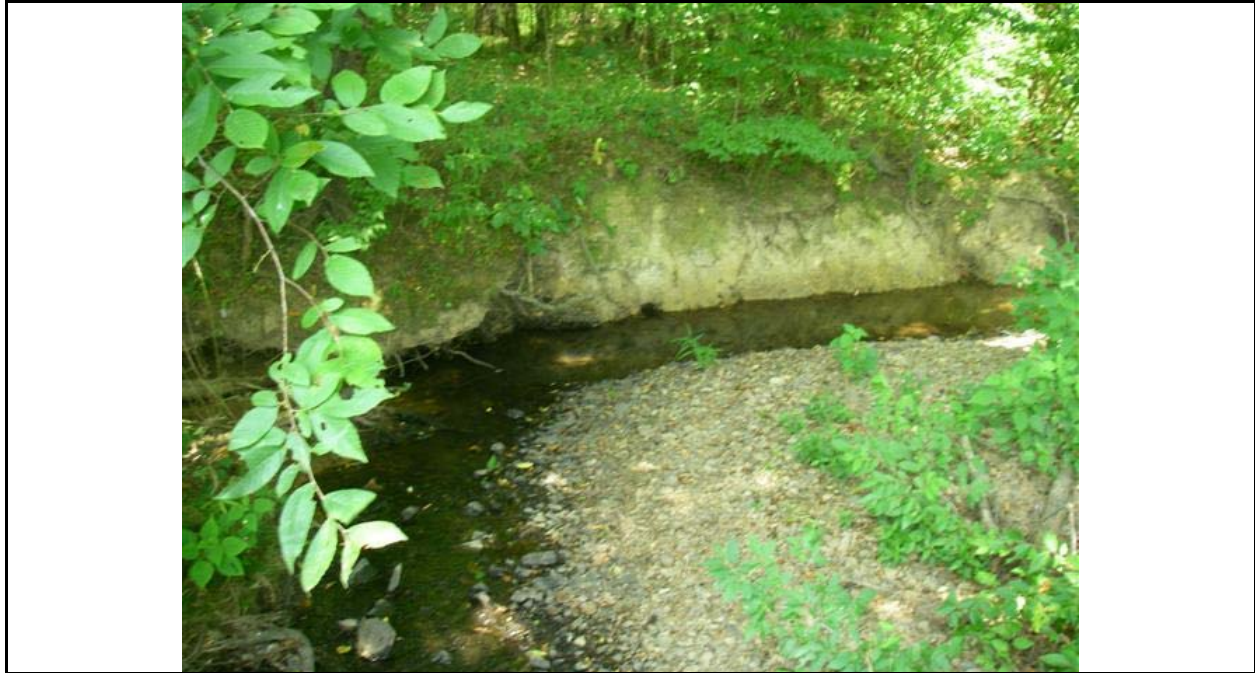
Photo #	9	Of	12	Date:	8/1/08	Time:	1150
----------------	---	-----------	----	--------------	--------	--------------	------

Description:	Sediment in Kelly Creek (Photos taken as I walk down Kelly Creek.)						
---------------------	--	--	--	--	--	--	--

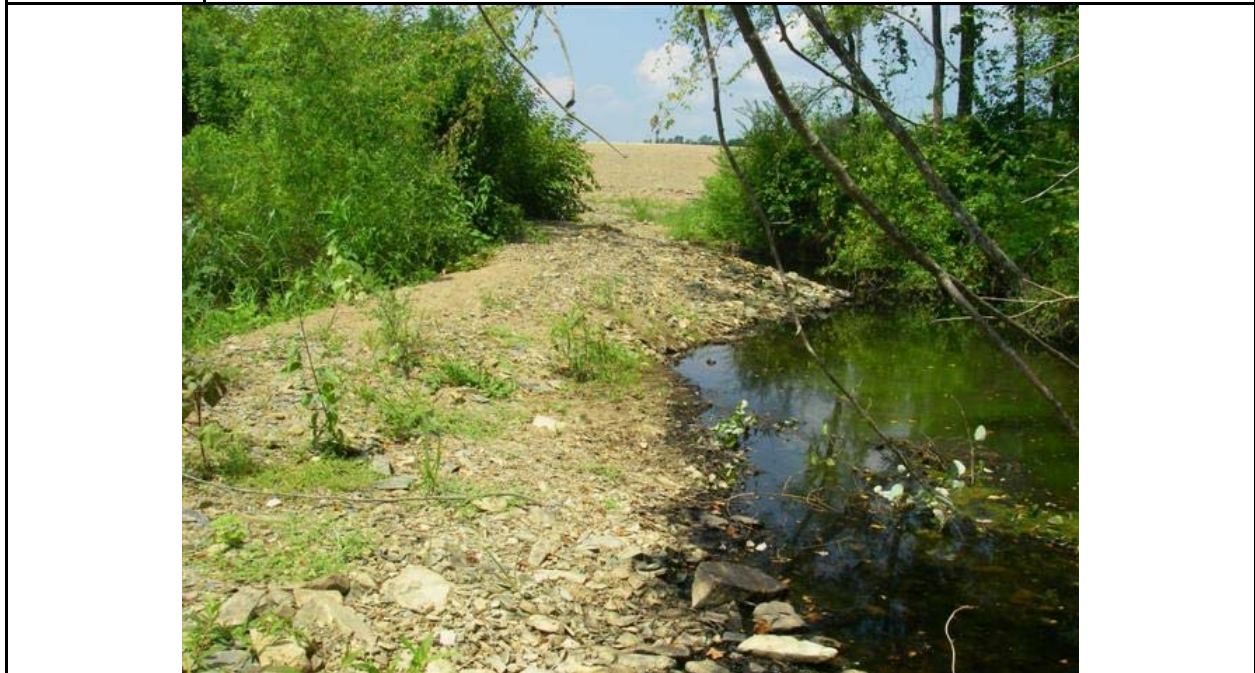
Photo #	10	Of	12	Date:	8/1/08	Time:	1152
----------------	----	-----------	----	--------------	--------	--------------	------

Description:	Photo taken from Kelly Creek looking back towards the embankment (in the background)						
---------------------	--	--	--	--	--	--	--

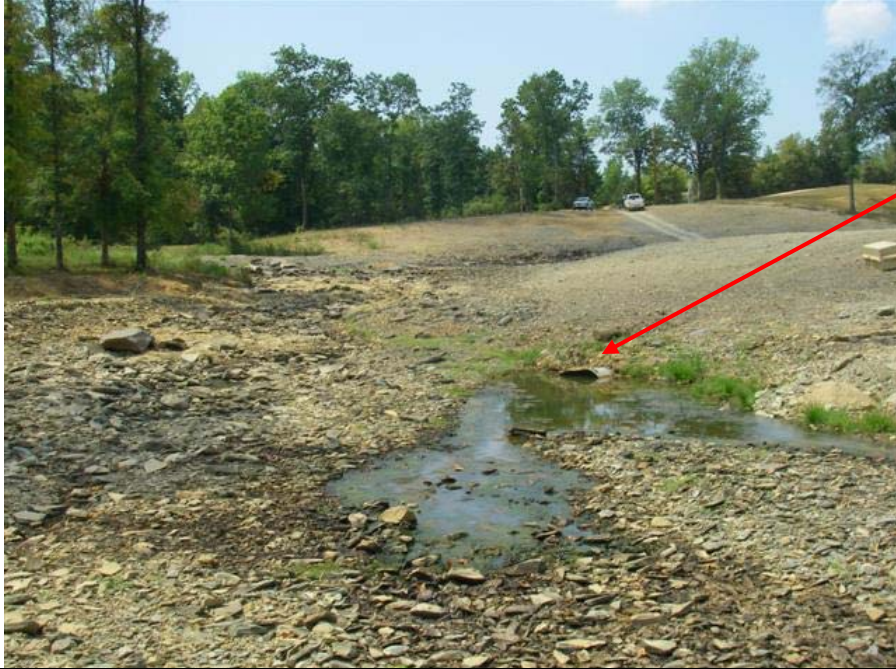
Photo #	11	Of	12	Date:	8/1/08	Time:	1153
----------------	----	-----------	----	--------------	--------	--------------	------

Description:	Photo taken from Kelly Creek looking back down the backside of the embankment						
---------------------	---	--	--	--	--	--	--

Outfall from the overflow structure seen in photo 1

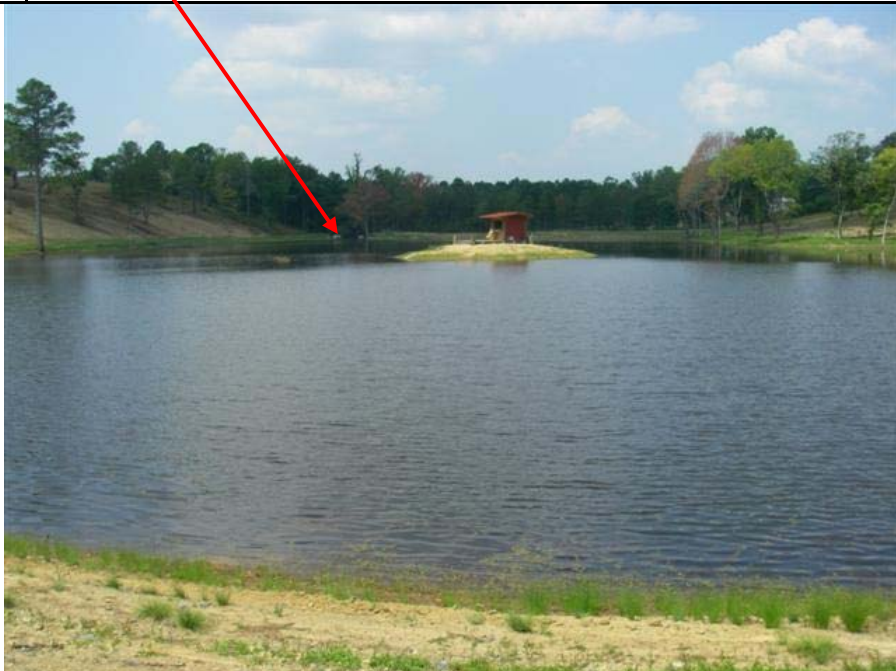
Photo #	12	Of	12	Date:	8/1/08	Time:	1156
----------------	----	-----------	----	--------------	--------	--------------	------

Description:	Standing on the embankment. Overall view of the lake. The inflow from Kelly Cr. In the background.						
---------------------	--	--	--	--	--	--	--
