RE: Lightning Electric Warehouse Construction Site

AFIN: 72-01867

NPDES Permit No.: ARR152624

NPDES Compliance Inspection Report

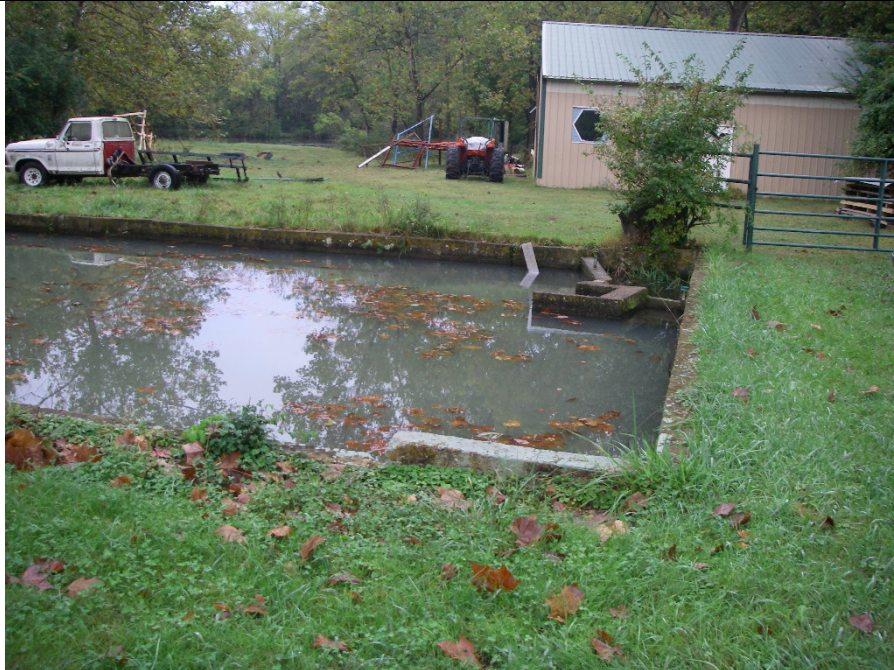
Photo #	1	Of	8	Date:	10/07/08	Time:	0858		
----------------	---	-----------	---	--------------	----------	--------------	------	--	--

Description:	The complainant's spring-fed pond. Stated that oil from site present in pond. None observed.								
---------------------	--	--	--	--	--	--	--	--	--

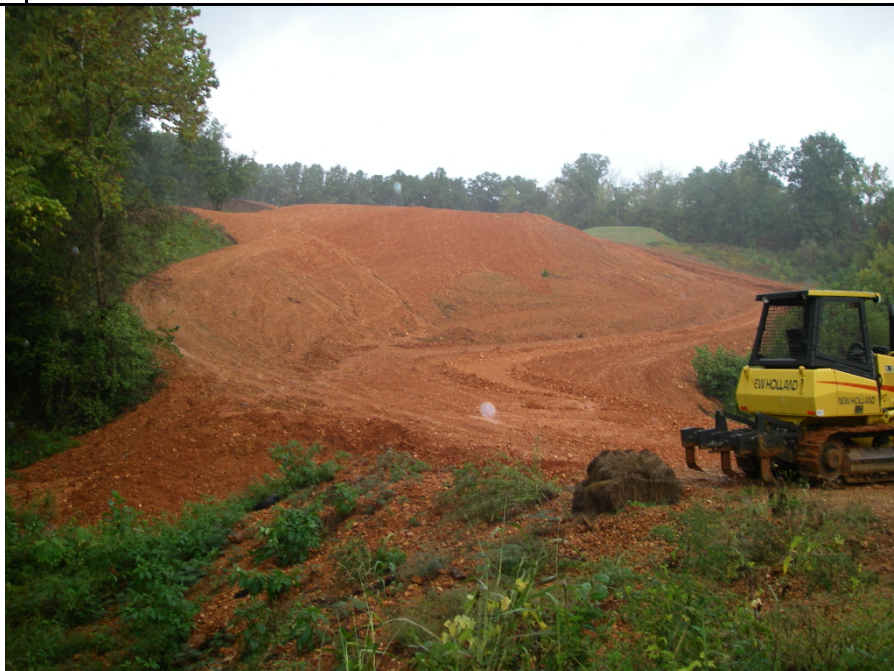
Photo #	2	Of	8	Date:	10/07/08	Time:	0903		
----------------	---	-----------	---	--------------	----------	--------------	------	--	--

Description:	Overview of construction site. Looking west from N. Double Springs Rd.								
---------------------	--	--	--	--	--	--	--	--	--

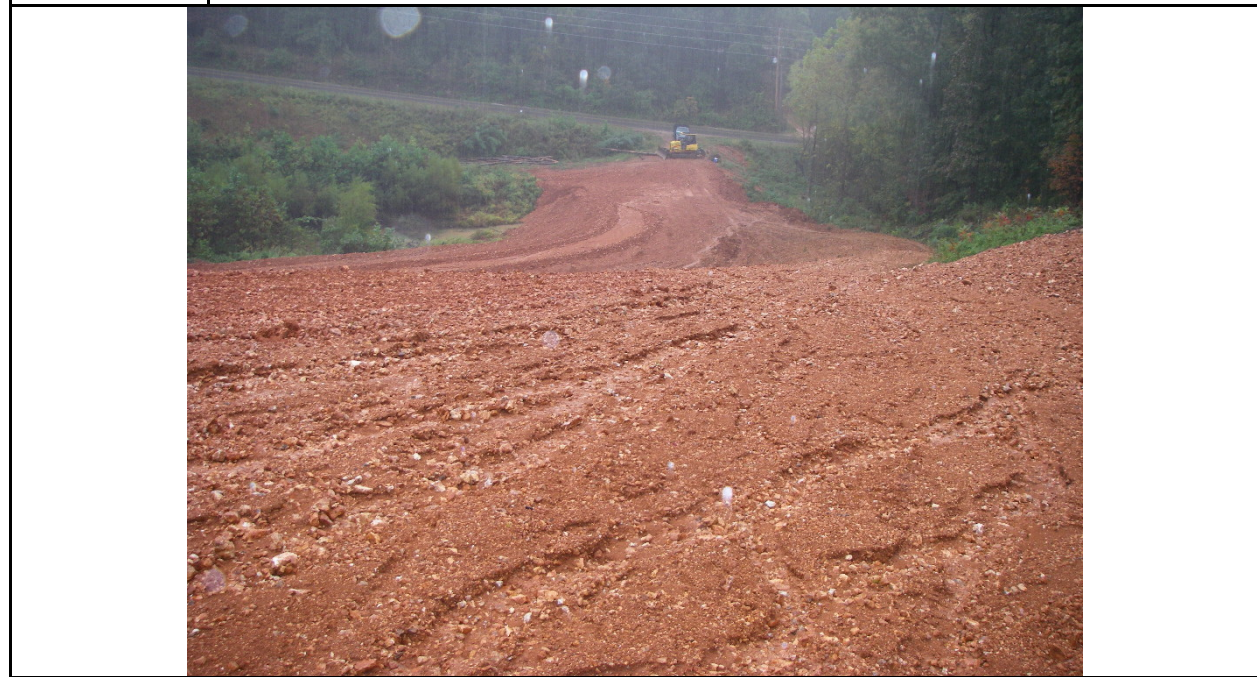
Photo #	3	Of	8	Date:	10/07/08	Time:	0907
----------------	---	-----------	---	--------------	----------	--------------	------

Description:	Erosion occurring along steep eastward facing slope. Outfall to right (south) of construction site entrance at bottom of hill.
---------------------	--

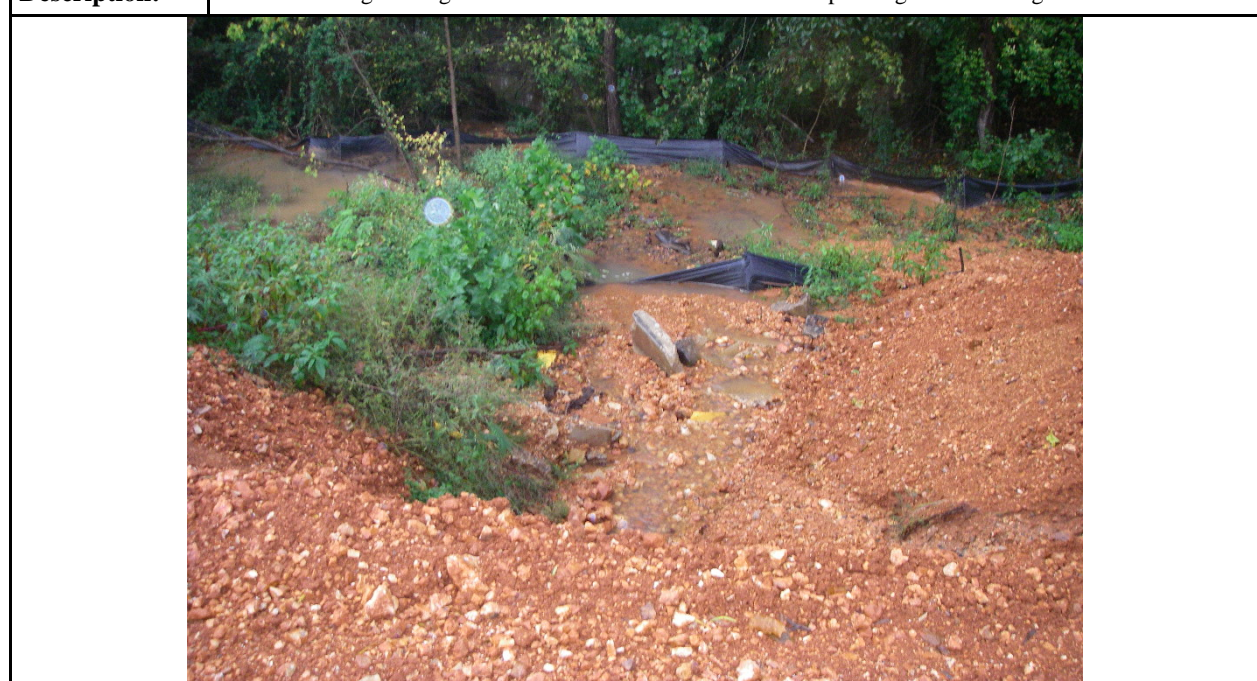
Photo #	4	Of	8	Date:	10/07/08	Time:	0904
----------------	---	-----------	---	--------------	----------	--------------	------

2. Sediment and erosion controls were not being maintained and were inadequate in critical areas. This is a violation of Part I.C.3 of the permit. The silt fencing used at the outfall described in #1 above was ineffective in eliminating or minimizing pollutants in the storm water discharges from your site and was largely inappropriate for use in that area. The silt fencing created a dam across the drainage. As a result, pollutants in the storm water were caused to discharge untreated over the dam and into the drainage course and pond south of your site. Your storm water pollution prevention plan (SWPPP) map indicates that rip-rap coupled with filter fabric were to be used at this outfall location. These controls would have allowed for treatment of the storm water prior to discharge from your site. In addition, silt fencing in the drainage before the outfall was nearly buried in sediment. It is strongly recommended that while grading activities continue temporary stabilization measures be employed as necessary to prevent further erosion of the slopes at your site.

Description:	Sediment filling drainage south of construction entrance. Note ponding at silt fencing at outfall.
---------------------	--

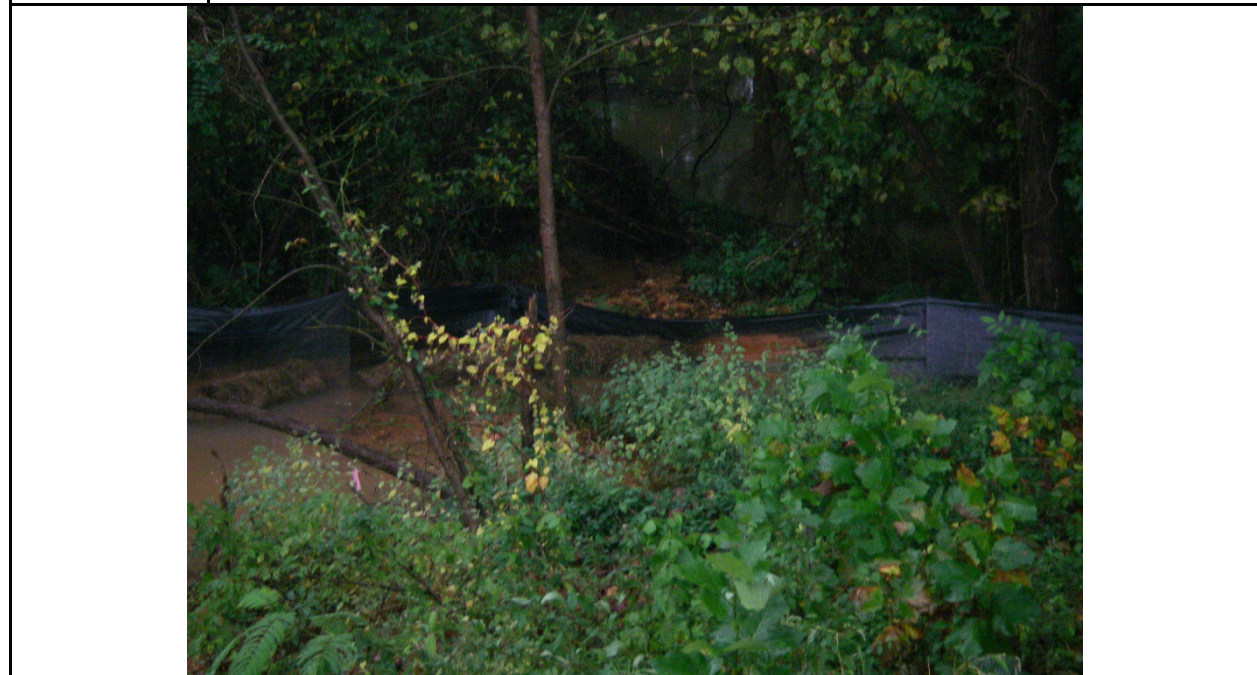
Photo #	5	Of	8		Date:	10/07/08	Time:	0905	
----------------	---	-----------	---	--	--------------	----------	--------------	------	--

1. Transport of sediment from the construction site causing pollution to the waters of the State. This is in violation of the Arkansas Water and Air Pollution Control Act 8-4-217,(a)(1). Sediment eroded from large unstabilized areas of your site has been transported over the silt fencing at the outfall located at the southeast corner of your site into the natural drainage that flows southward from your site. This drainage is a tributary to the pond on the north end of the complainant's property. This pond has been impacted from the sediment. I received a telephone call from your site inspector following our inspection. He contended that the sediment in the drainage and pond originated from a resident's driveway located on the east side of N. Double Springs Rd. Although gravel from the resident's driveway was observed in the road, it was evident from the site conditions observed during the inspection that sediment present in the drainage and pond originated from your construction site.

Description:	Sediment visible beyond silt fence (outfall) in drainage offsite. Looking south from construction entrance. This is above impacted pond (next photo). According to SWPPP, riprap and filter fabric were to be used at outfall.								
---------------------	--	--	--	--	--	--	--	--	--

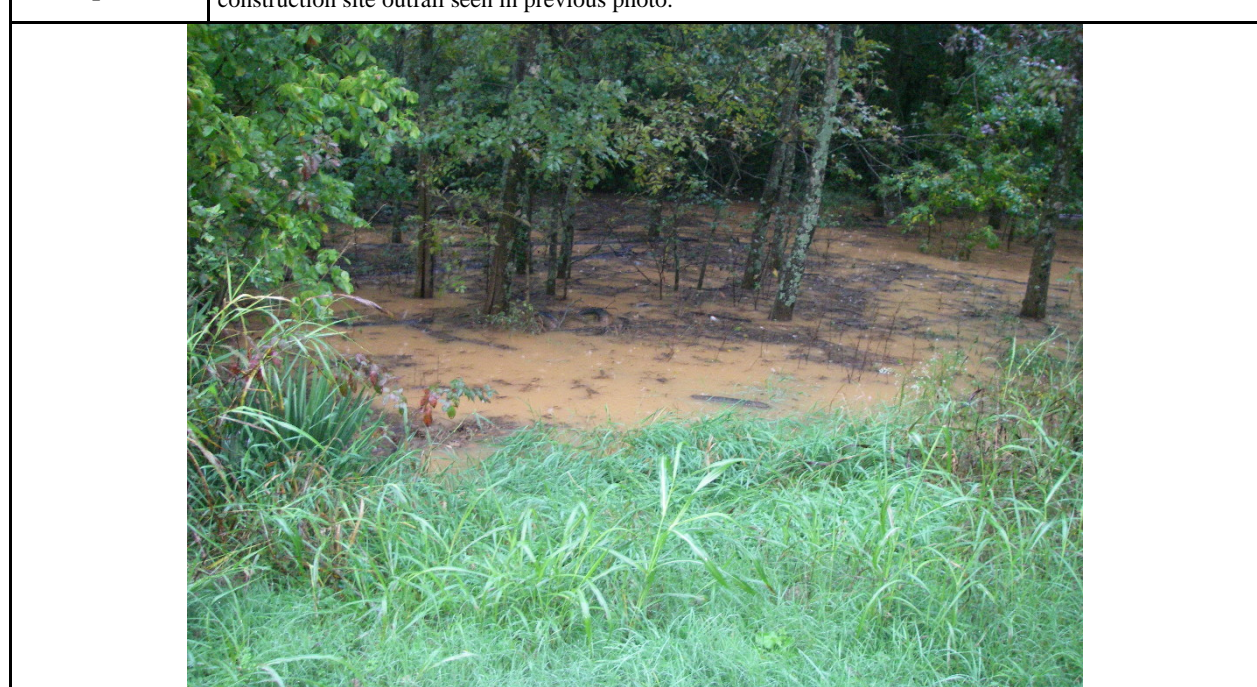
Photo #	6	Of	8		Date:	10/07/08	Time:	0911	
----------------	---	-----------	---	--	--------------	----------	--------------	------	--

Description:	Turbid pond conditions on north end of complainant's property. Receives storm water discharge from construction site outfall seen in previous photo.								
---------------------	--	--	--	--	--	--	--	--	--

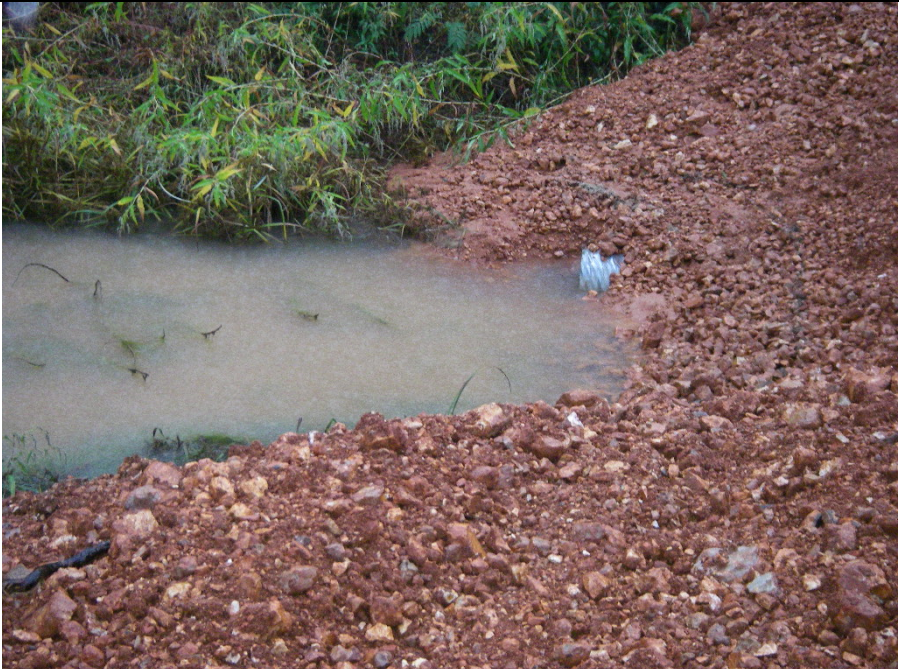
Water Division Construction Storm Water Photographic Evidence Sheet									
Location:		Lighting Electric Warehouse							
Photographer:		John Fazio				Witness:		Alison West	
Photo #	7	Of	8		Date:	10/07/08	Time:	0909	
Description:		No sediment and erosion controls in drainage upstream of construction site entrance. Culvert visible.

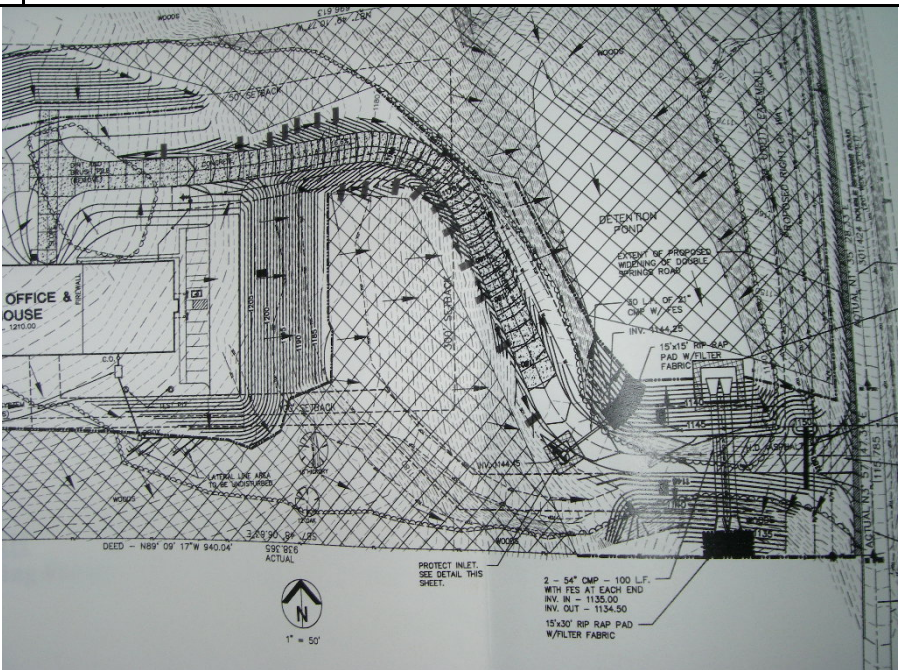
3. The SWPPP was not being kept current. This is in violation of Part II.A.3 of the permit. The SWPPP map identifies and locates many sediment and erosion controls that have not been implemented at your site including 18 check dams and two rip-rap pads with filter fabric. The plan must be amended whenever there is a change in design, construction, operation, or maintenance which has a significant effect on the potential for the discharge of pollutants to the waters of the State. Compliance with this requirement can be accomplished by indicating on the SWPPP map where, in what manner, and on what date modifications of the plan occurred. Each amendment should be initialed by the responsible official.

Photographer:		John Fazio				Witness:		Alison West	
Photo #	8	Of	8		Date:	10/07/08	Time:	0935	
Description:		SWPPP map: series of check dams (dark rectangles) and areas where rip-rap w/ filter fabric are depicted but not used. Bottom right of map shows a 15' X 30' rip-rap pad w/ filter fabric at outfall within drainage.
