RE: City of Minturn Waste Water Collection System

Satellite Collection System of Hoxie (AR0020141)

On September 15, 2010, Brent Walker and I performed an inspection of the waste water collection system in accordance with the provisions of the Federal Clean Water Act, the Arkansas Water and Air Pollution Control Act, and the regulations promulgated thereunder. This inspection revealed the following violations:

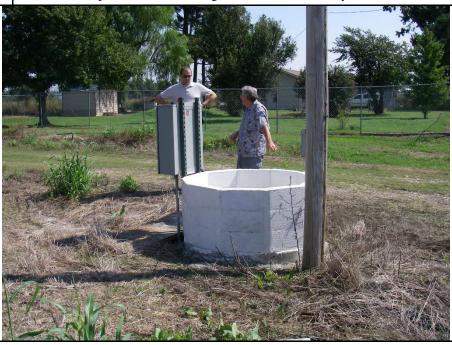
Water Division NPDES Photographic Evidence Sheet														
Location:	Approximately 1 mile southeast of Minturn on County Road #712. (Lawrence County)														
Photographe	er:	Mike K	Kennedy		Witness:	Light									
Photo #	Photo # 3 Of 13 Date: 9-15-10 Time: 1118														
Description: A view of Pump Station #2 bordering on north side of County Road #712.

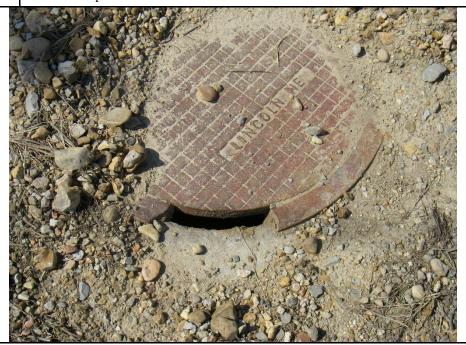
- a. The Auto System was not operational and the pumps had to be started manually.
- b. Only one of two pumps at the station was operational at the time of the inspection.
- c. The cover over the sewer line running parallel with County Road #712 was not sealed properly. The grout around the cover was missing in one section, thus allowing inflow and outflow of liquid. This line is located approximately 20-25 feet south of this pump station.

Photograph	ier:	Mike I	Kennedy		Witness:	Brent Walke	er and Gary	Light			
Photo #	4	Of	13		Date:	9-15-10	Time:	1123			
	A view of a broken cover over the sewer line running parallel with County Road #712 a few feet

A view of a broken cover over the sewer line running parallel with County Road #712 a few feet south of Pump Station #2 above.

- c. In regards to the missing section of grout, a new seal has been obtained and has been installed. The city of Hoxie donated a used grout ring, so no cost was associated with this repair.

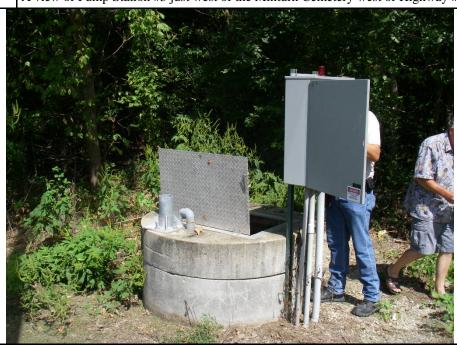
Water Division NPDES Photographic Evidence Sheet													
Location:	Location: In Minturn at the cemetery off Highway #67 on the west side (Lawrence County)													
Photograph	er: N	Aike k	Kennedy		Witness:	Brent Walke	r and Gary	Light						
Photo #	Photo # 5 Of 13 Date: 9-15-10 Time: 1152													
Description: A view of Pump Station #3 just west of the Minturn Cemetery west of Highway #67.

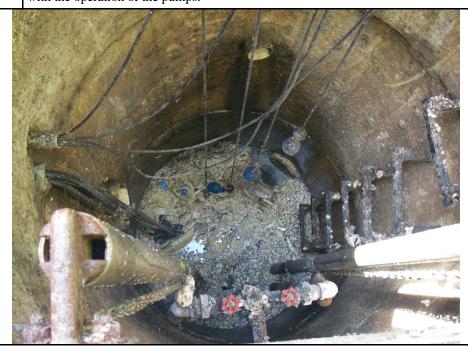
a. There was an excessive accumulation of grease in the wet well.

Photograph	ier:	Mike Kennedy			Witness:	Brent Walker and Gary Light		
Photo #	6	Of	13		Date:	9-15-10	Time:	1153
Description	:			to the pump station showing of the pumps.	ing grease b	alls on the water	er, but this c	lid not interfere

a. In regard to the excess grease accumulation in the wet well, the grease has been removed from the wet well. The grease was removed via a dip net and was disposed of properly and the wet well has been pressure washed to remove any build up in the wet well. No cost associated with this repair.

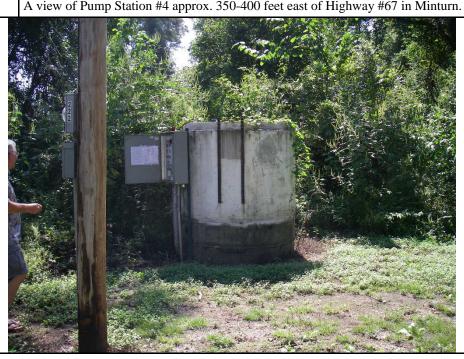
a. The pump station is built high above ground level and the lid over the well cannot be observed from the ground without using a ladder to get to the top of the pump station and there was no ladder at the pump station.

Wate	er Division NPDES Photo	ographic E	vidence Sheet		
Location:	In M	linturr	n approx.	300 feet east of Highway	#67 (Lawı	rence County)		
Photograph	er: N	Iike K	Kennedy		Witness:	Brent Walke	r and Gary	Light
Photo #	7	Of	13		Date:	9-15-10	Time:	1143
Description	: A	view	of Pump	Station #4 approx. 350-4	00 feet east	of Highway #6	7 in Mintur	n.

a. In regard to the lack of access to the above ground access for this pump station, a ladder has been donated to be left on site. Also a more permanent solution is being devised for this station. No cost has been associated with this repair thus far.

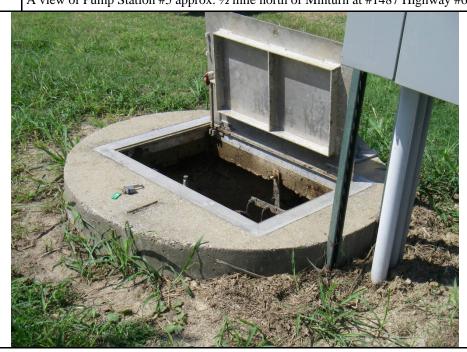
a. The Auto System was not operational and the pumps had to be started manually.

Photographer:Mike KennedyWitness:Brent Walker and Gary LightPhoto #8Of13Date:9-15-10Time:1201Description:A view of Pump Station #5 approx. ½ mile north of Minturn at #1487 Highway #67.

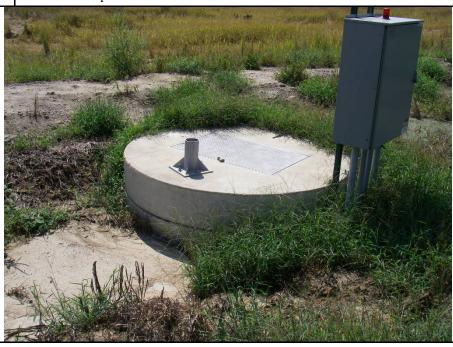
Wate	er Division NPDES Photo	ographic Ev	vidence Sheet		
Location:	App	rox. 2	miles no	rth of Minturn on the east	side of High	hway #67 (Lav	wrence Cou	inty)
Photograph	er: N	Iike K	Kennedy		Witness:	Brent Walke	r and Gary	Light
Photo #	9	Of	13		Date:	9-15-10	Time:	1215
Description	: A	view	of Pumr	Station #6.

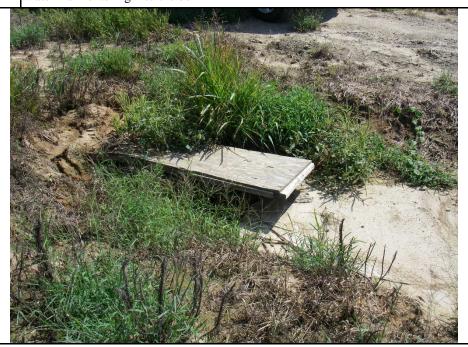
- a. A piece of plywood was used as a cover over the valve box connected to the pump station. The cover was partially open and not providing a proper seal for the box thus allowing inflow of liquid, to the valve box located below the surrounding level of the ground.
- 7. Grinder Pump at the junction of County Roads #712 & #716
 - a. The electrical control panel door was open exposing the wiring and connections.
 - b. The alarm light was not operational.
 - c. The water level in the grinder pump was full to the top of the pump and the top of the pump is located above the surrounding level of the ground.
- 8. Grinder Pump on County Road #712
 - a. The alarm light was not operational
 - b. The cover over the grinder pump was not properly sealed, thus allowing inflow of rainwater or other liquid into the pump area.

Photogra	pher:	Mike I	Kennedy		Witness:	Brent Walker and Gary Light		
Photo #	10	Of	13		Date:	9-15-10	Time:	1217
Description	n:			alve box connected to Purring into the box.	np Station #	6. Note not pro	operly cove	red to prevent

a. In regard to the valve box being covered with a piece of plywood, a proper lid is being ordered that will provide a proper seal for the box. It is anticipated that the lid will be installed within the next thirty (30) days. The lid for this box has not yet arrived.

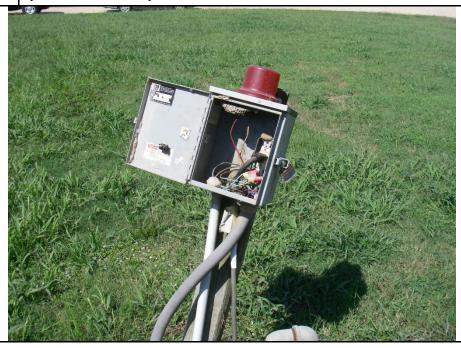
Wate	er Division NPDES Photo	ographic E	vidence Sheet			
Location:	tion: Approx. 1 mile southeast of Minturn at the junction of County Roads #712 & #716.								
Photograph	er:	Mike Kennedy			Witness:	Brent Walke	Brent Walker and Gary Light		
Photo #	11	Of	13		Date:	9-15-10	Time:	1129	
Description	:			ler Pump #1 at the junctio is not operational.	n of County	Roads #712 &	#716. Not	e control box

- a. In regards to the electrical control panel door being open the door has been secured with a lock. Cost approx: \$5 for a pad lock.
- b. In regard to the alarm light being non-functional we will work to determine the cause and repair the light within the next thirty (30) days.
- c. In regard to the water level being too high in the sump basin a new pump has been obtained for this station and has been installed. Cost: \$49.00 for a new pump.

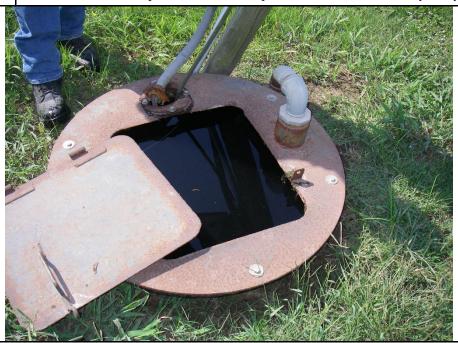
Photographer:Mike KennedyWitness:Brent Walker and Gary LightPhoto #12Of13Date:9-15-10Time:1128

Description: Note water full to the top of the Grinder Pump. The waste water could very easily overflow.

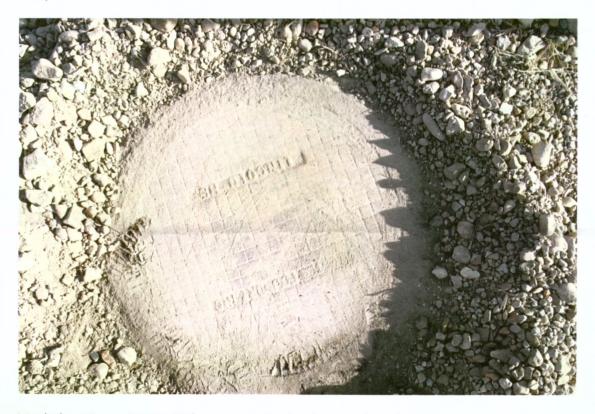
Manhole at Pump Station #3 (note grout ring has been replaced)

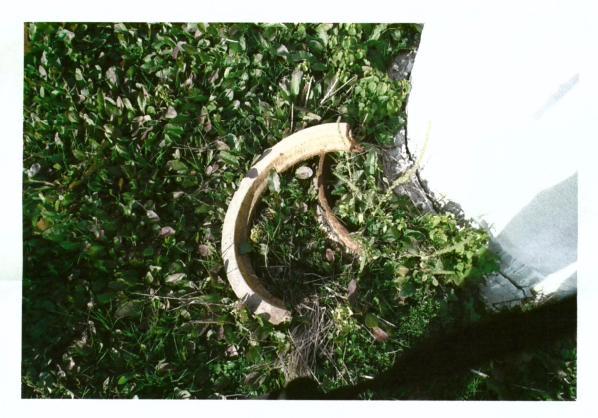
Old grout ring removed from manhole at pump station #2

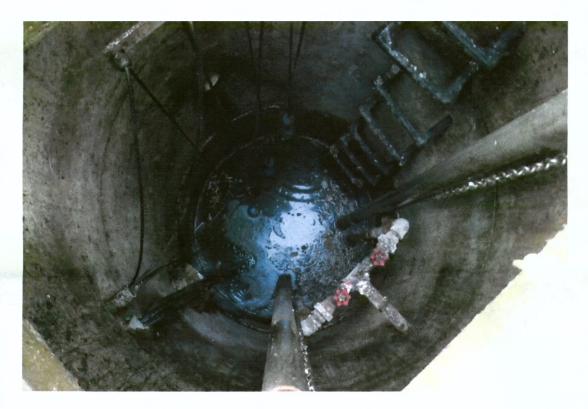
Pump Station #3 Interior (note excess grease removal)

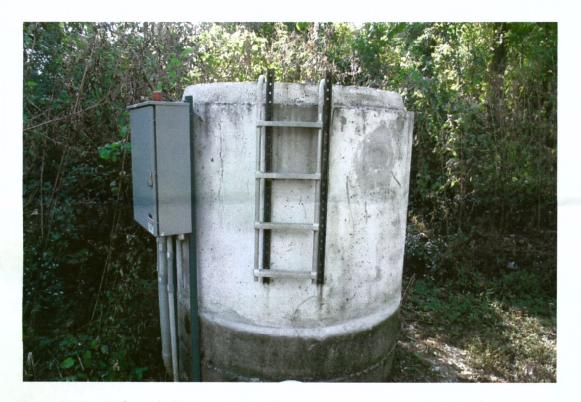
Pump Station #4 (note ladder, we are working on a more permanent solution)

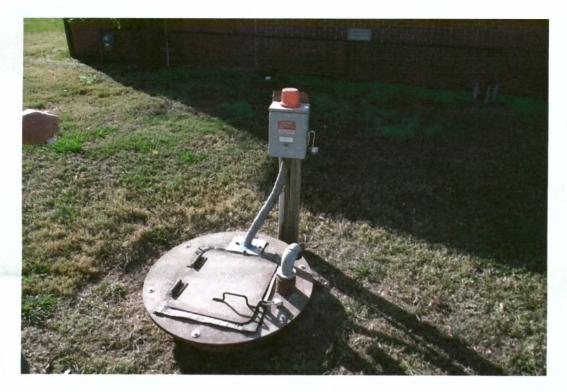
Grinder Pump at County Roads #712 and #716(note reconfiguration of post and installation of new lock on the control panel)

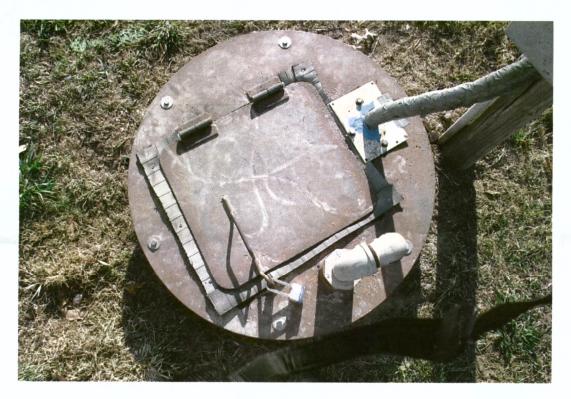
Grinder Pump at County Roads #712 & #716 (note lid repairs and lock)

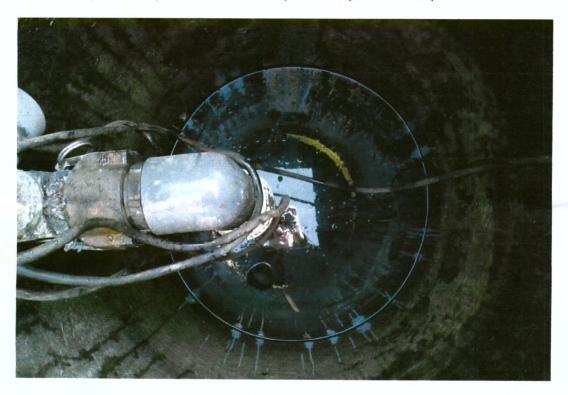
Grinder Pump at County Roads #712 & #716(note water level down due to installation of new pump)

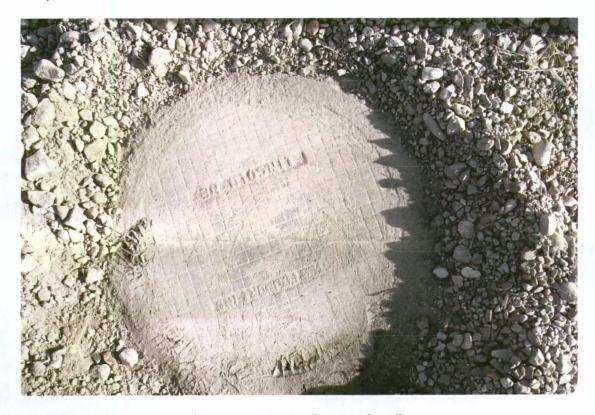
Manhole at Pump Station #3 (note grout ring has been replaced)

- a. In regards to the automatic function of this pump station not functioning, Instrument Supply of Hot Springs has made the necessary repairs and the station is now functioning correctly in the automatic position. A bill has not been issued by Instrument Supply at this time for repairs made.
- b. In regard to only one of the pumps in this duplex station being operational, this problem has been addressed and is now functioning properly. This problem was solved with the removal of a frog from the control panel.
- c. In regards to the missing section of grout, a new seal has been obtained and has been installed. The city of Hoxie donated a used grout ring, so no cost was associated with this repair.

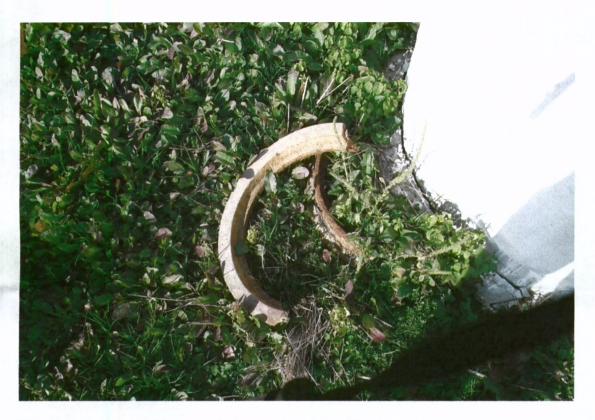
Old grout ring removed from manhole at pump station #2

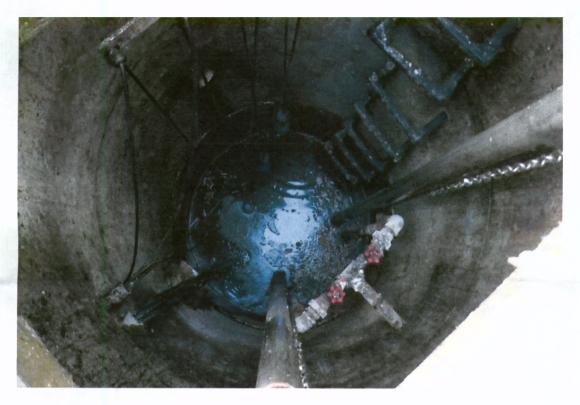
Pump Station #3 Interior (note excess grease removal)

a. In regard to the excess grease accumulation in the wet well, the grease has been removed from the wet well. The grease was removed via a dip net and was disposed of properly and the wet well has been pressure washed to remove any build up in the wet well. No cost associated with this repair.

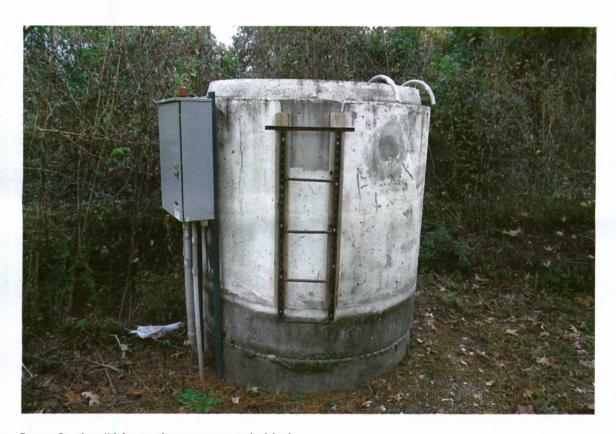
Pump Station #4 (note the permanent ladder).

a. In regard to the lack of access to the above ground access for this pump station, a ladder has been manufactured and installed at the station in a permanent manner so as to allow for ease of access.

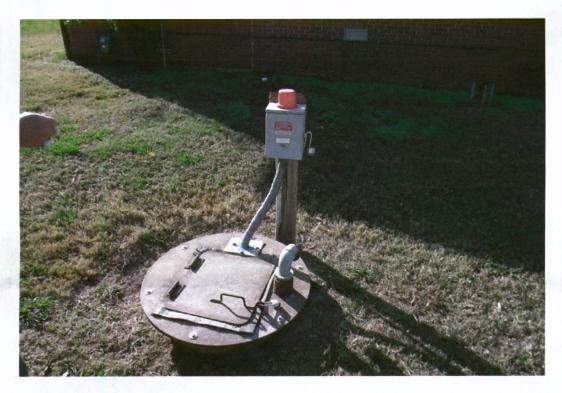
Grinder Pump at County Roads #712 and #716(note reconfiguration of post and installation of new lock on the control panel)

- a. In regards to the electrical control panel door being open the door has been secured with a lock. Cost approx: \$5 for a pad lock.
- b. In regard to the alarm light being non-functional we have contacted Tim Carry of Arkansas Rural Water to assist with troubleshooting this problem and are currently waiting for him to fit us into his schedule.
- c. In regard to the water level being too high in the sump basin a new pump has been obtained for this station and has been installed. Cost: \$49.00 for a new pump.

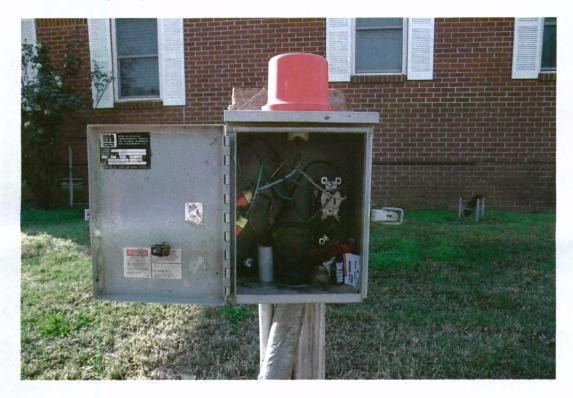
Grinder Pump at County Roads #712 & 716 Control Box (note emergency light still in need of repair)

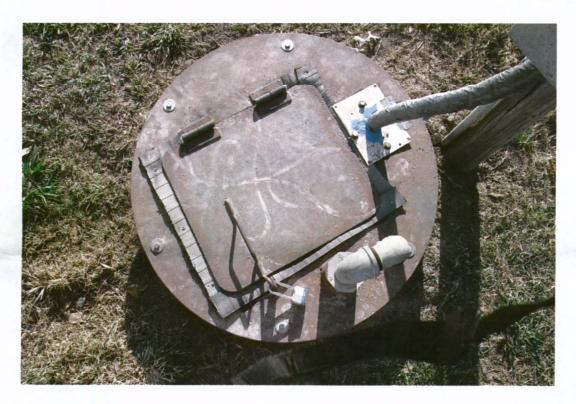
Grinder Pump at County Roads #712 & #716 (note lid repairs and lock)

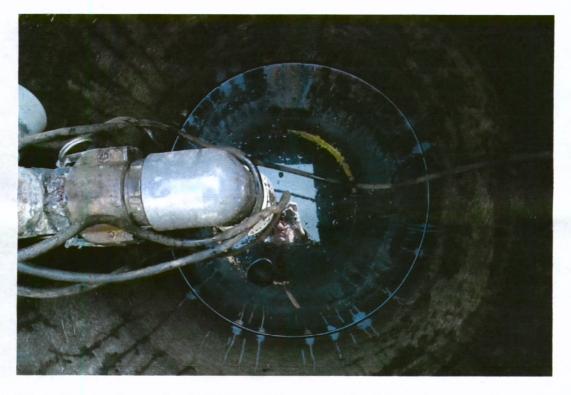
Grinder Pump at County Roads #712 & #716(note water level down due to installation of new pump)

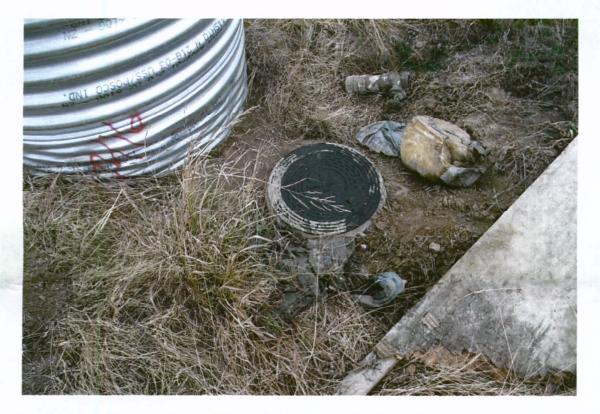
Pump Station #6 (note the new lid installed to replace the plywood cover.)

a. In regard to the valve box being covered with a piece of plywood, a proper lid has been installed that provides a proper seal for the box. This lid was provided at no cost to the utility.

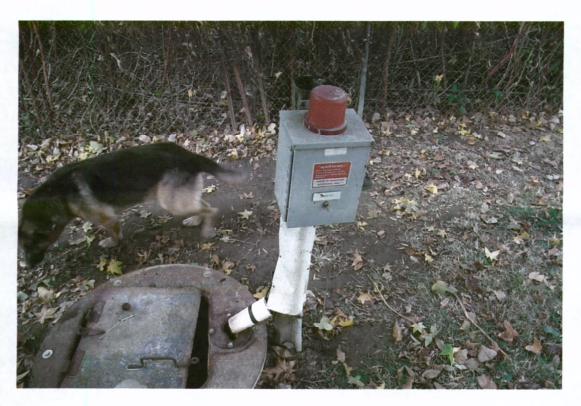
Grinder Pump on CR #712 (Lid still in need of repair and emergency light needs repair).

- a. In regard to the alarm light being non-functional we have contacted Tim Carry of Arkansas Rural Water to assist with troubleshooting this problem and are currently waiting for him to fit us into his schedule.
- b. In regard to the grinder pump not being sealed properly, the resident at the address has agreed to make repairs to the lid. As of today the resident has not made the repairs but we will continue to monitor his progress and if repairs are not made in reasonable amount of time the City of Minturn will make the necessary repairs themselves.
