**RE: Complaint investigation of possible gas well related fluids in a stream
in Van Buren County**

A R K A N S A S Department of Environmental Quality		WATER DIVISION COMPLAINT REPORT		
		AFIN: 71-00000		PERMIT #: N/A
		COUNTY: 71 Van Buren		PDS #:
		GPS LOCATION: LAT: 35.481483 LONG: -92.615380 <input type="checkbox"/> Discharge Site / <input checked="" type="checkbox"/> General Area / <input type="checkbox"/> Entrance		
COMPLAINANT NAME: Bill Chwalinski		COMPLAINT AGAINST: XTO Energy, Inc.

Water Division Photographic Evidence Sheet			
Location:	XTO Energy, Inc.Culvert on Pleasant Grove Loop Road (35.481483, -92.615380), Van Buren County		
Photographer:	David Young	Date:	5-17-13
Witness:	None	Time:	1:32
Description:	Water downstream of culvert under Pleasant Grove Loop Road.

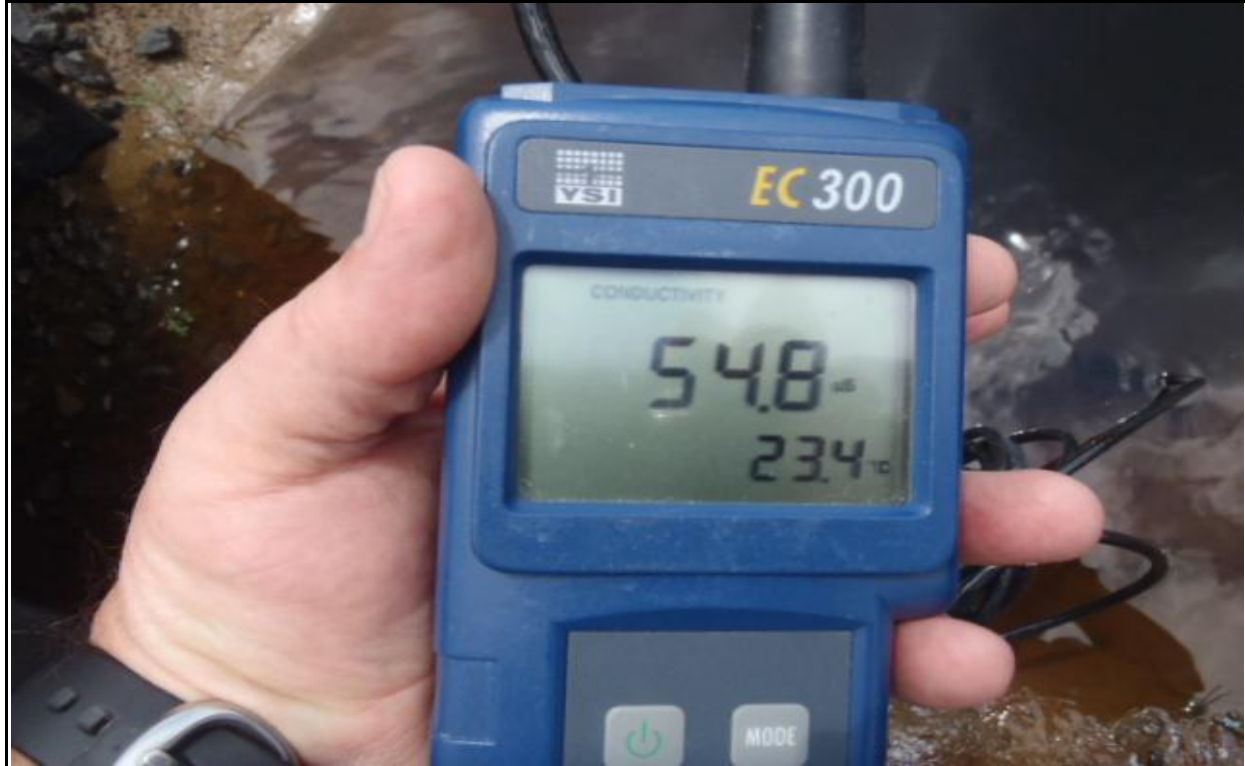
Photographer:	David Young	Date:	5-17-13	Time:	1:31
Witness:	None	Photo #:	2		
Description:	Conductivity reading downstream of the culvert.

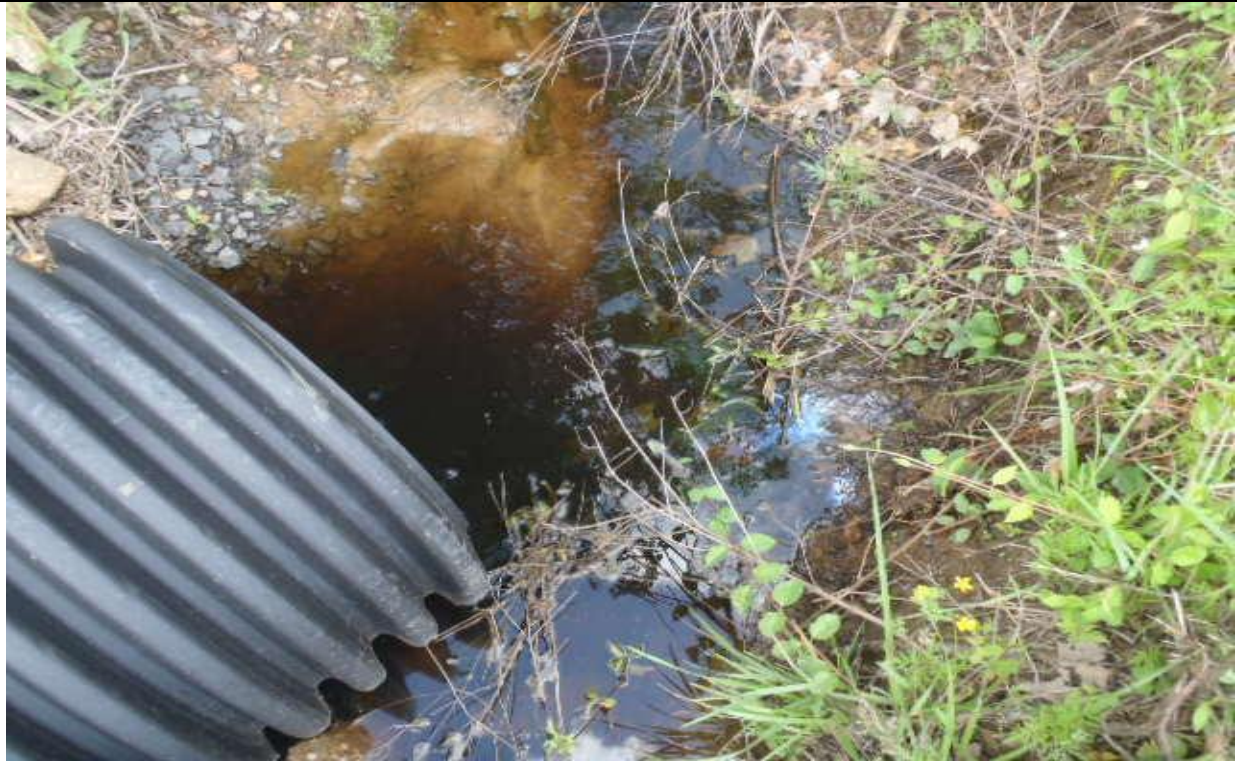
Location:	Culvert on Pleasant Grove Loop Road (35.481483, -92.615380), Van Buren County				
Photographer:	David Young	Date:	5-17-13	Time:	1:37
Witness:	None			Photo #:	3
Description:	Water upstream of the culvert (note biological sheen on right).

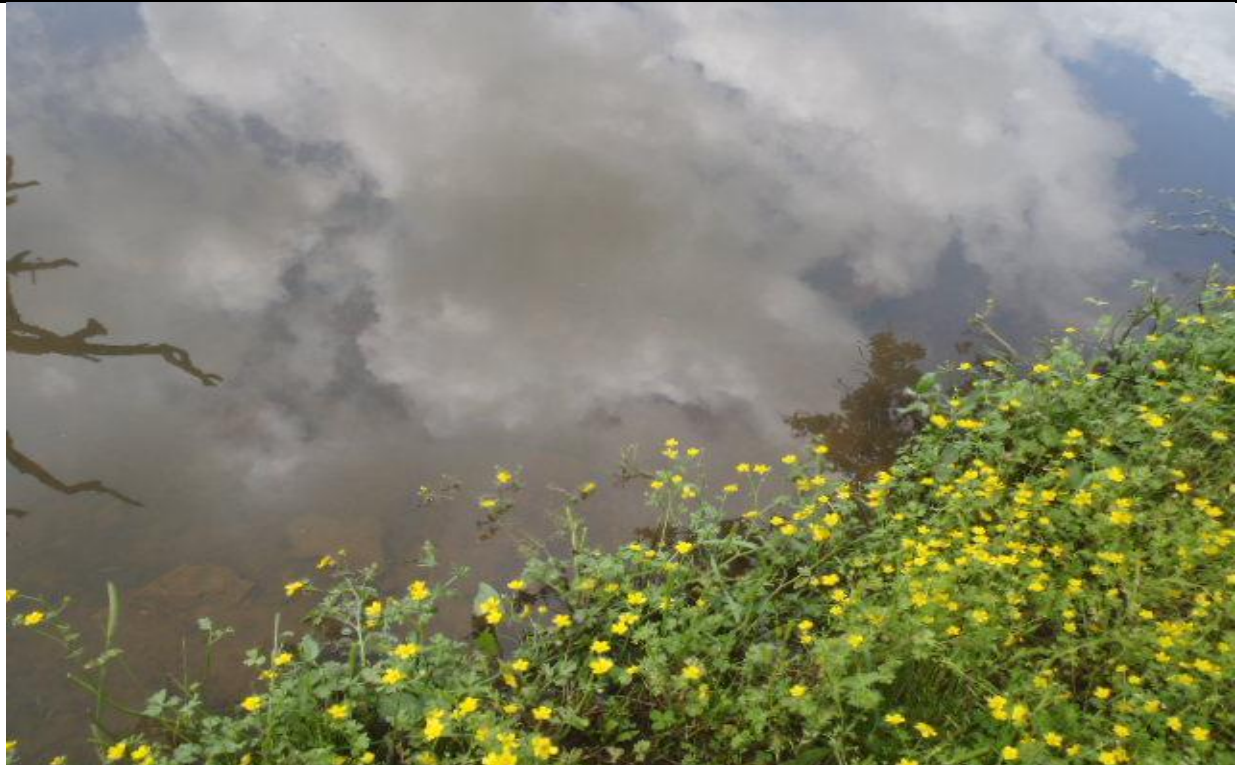
Photographer:	David Young	Date:	5-17-13	Time:	1:48
Witness:	None			Photo #:	4
Description:	Water in Mr. Chwalinski's pond (clear to brown).

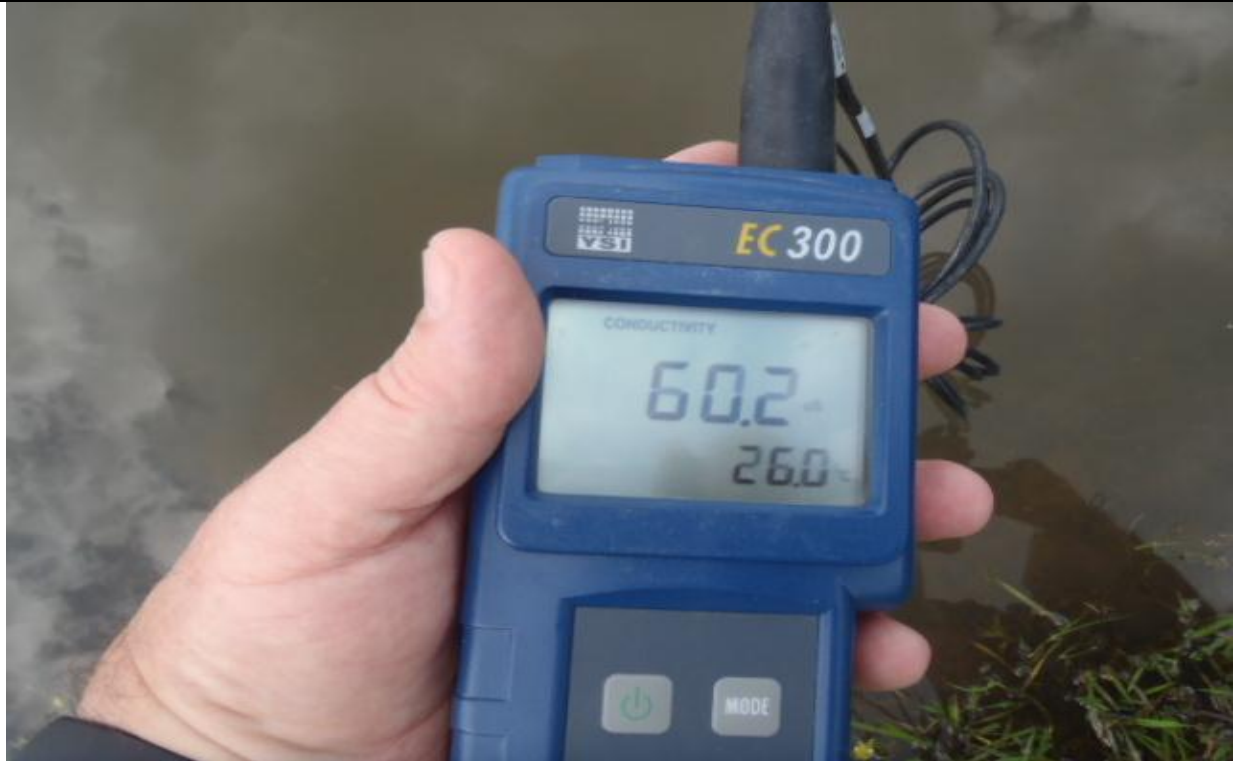
Location:	Culvert on Pleasant Grove Loop Road (35.481483, -92.615380), Van Buren County				
Photographer:	David Young	Date:	5-17-13	Time:	1:46
Witness:	None			Photo #:	5
Description:	Conductivity reading from Mr. Chwalinski's pond (deep end).

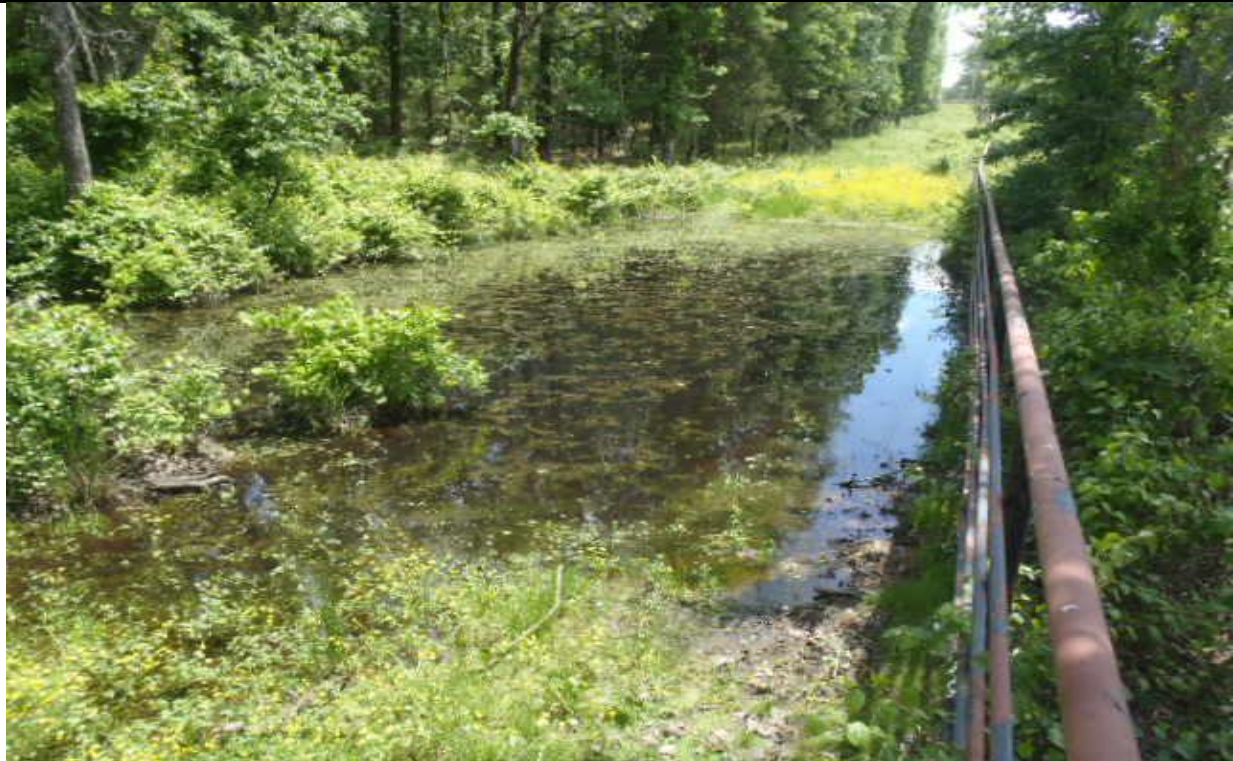
Photographer:	David Young	Date:	5-17-13	Time:	2:00
Witness:	None			Photo #:	6
Description:	Ponded area just upstream of culvert (note black water).

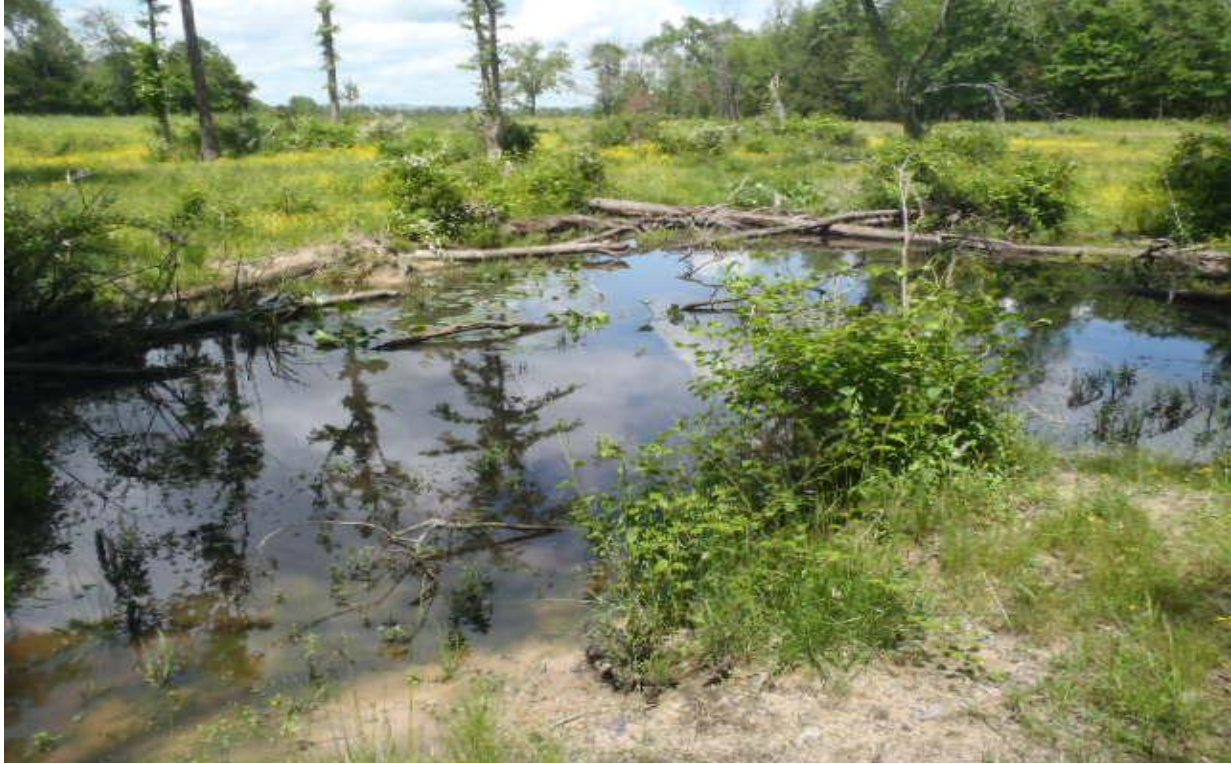
Location:	XTO Energy, Inc. Culvert on Pleasant Grove Loop Road (35.481483, -92.615380), Van Buren County				
Photographer:	David Young	Date:	5-17-13	Time:	2:07
Witness:	None			Photo #:	7
Description:	Second, smaller ponded area near pasture.

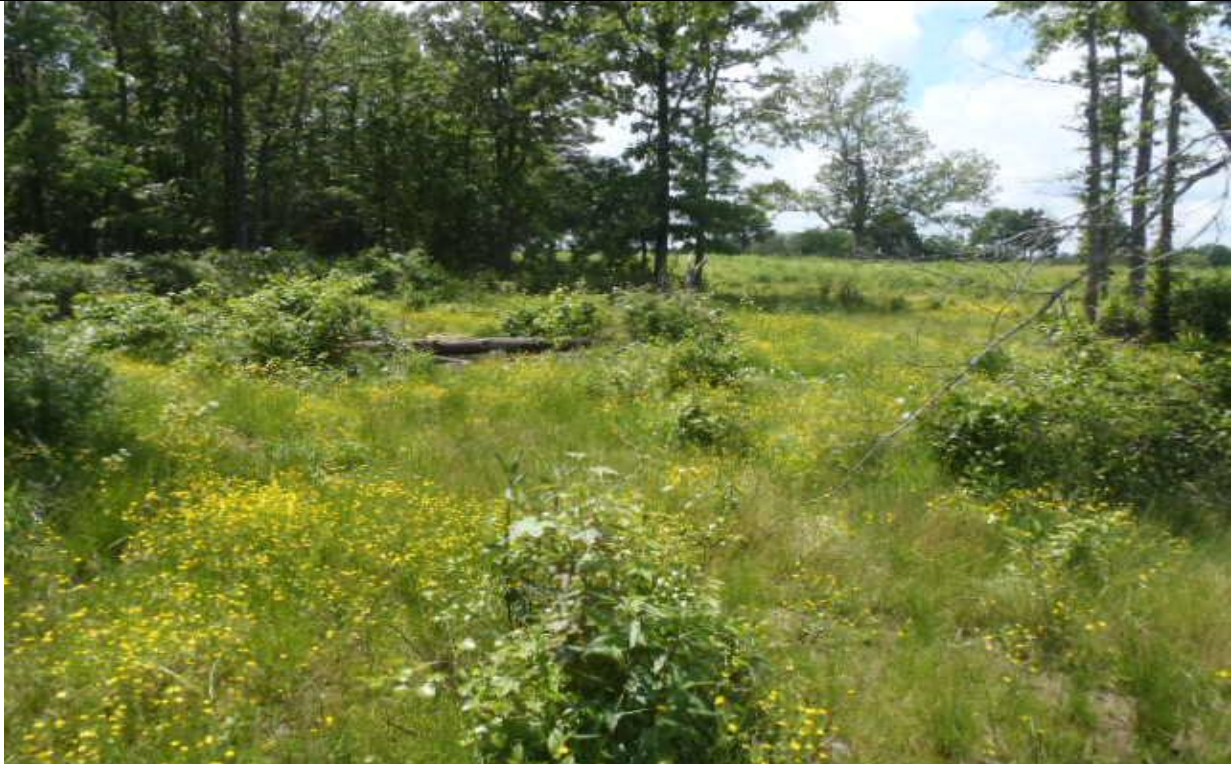
Photographer:	David Young	Date:	5-17-13	Time:	2:07
Witness:	None			Photo #:	8
Description:	Pasture near second ponded area (to the left in this photo).

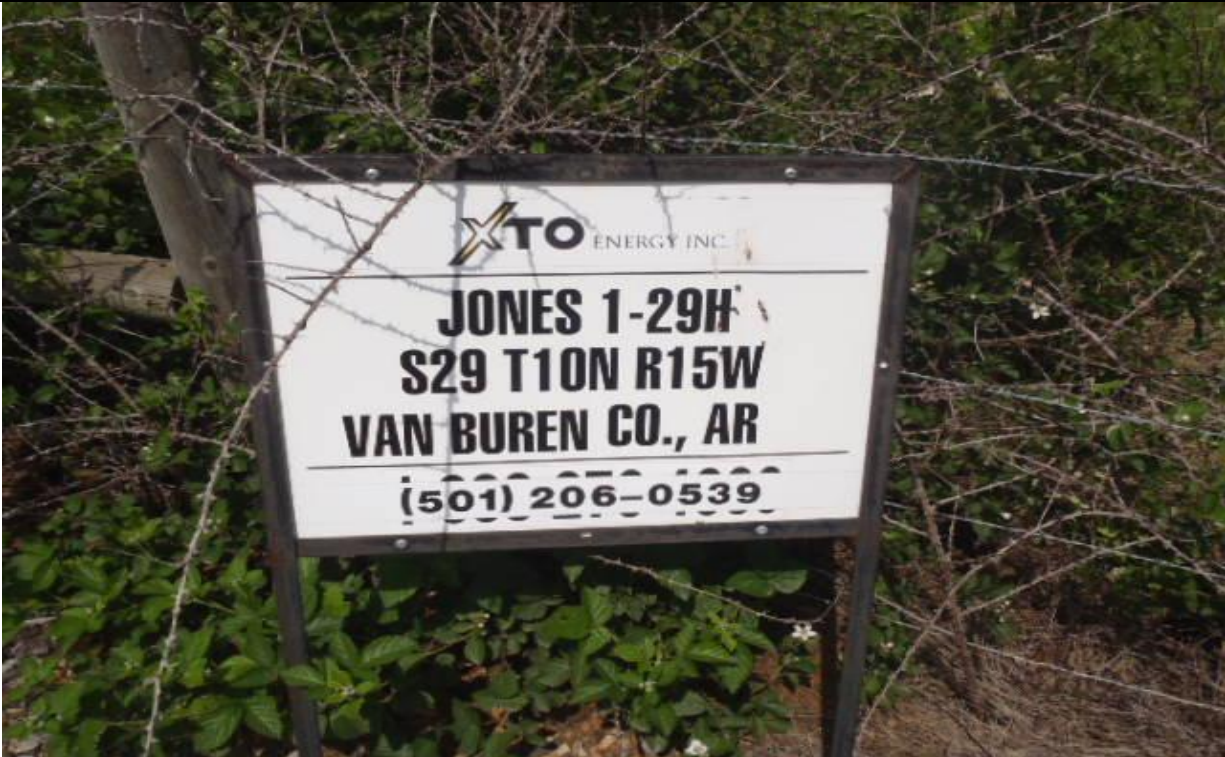
Location:	Culvert on Pleasant Grove Loop Road (35.481483, -92.615380), Van Buren County				
Photographer:	David Young	Date:	5-17-13	Time:	2:24
Witness:	None			Photo #:	9
Description:	Site identification for XTO Energy's Jones 10-15 #1-29H gas well.

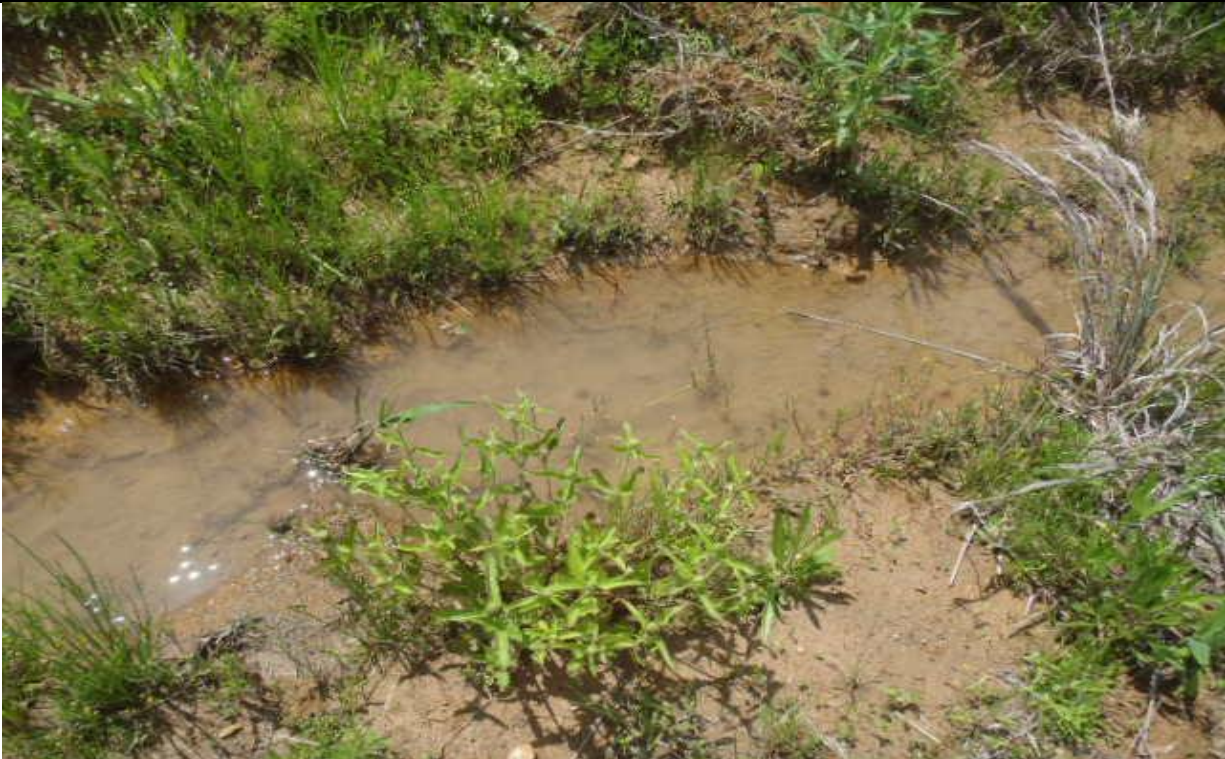
Photographer:	David Young	Date:	5-17-13	Time:	2:29
Witness:	None			Photo #:	10
Description:	Relatively clear water in drainage ditch at well pad.
